JN 23271

Subject: **Geotechnical Engineering Study**
Proposed Deck / Roof Addition to Existing Residence
5642 East Mercer Way
Mercer Island, Washington

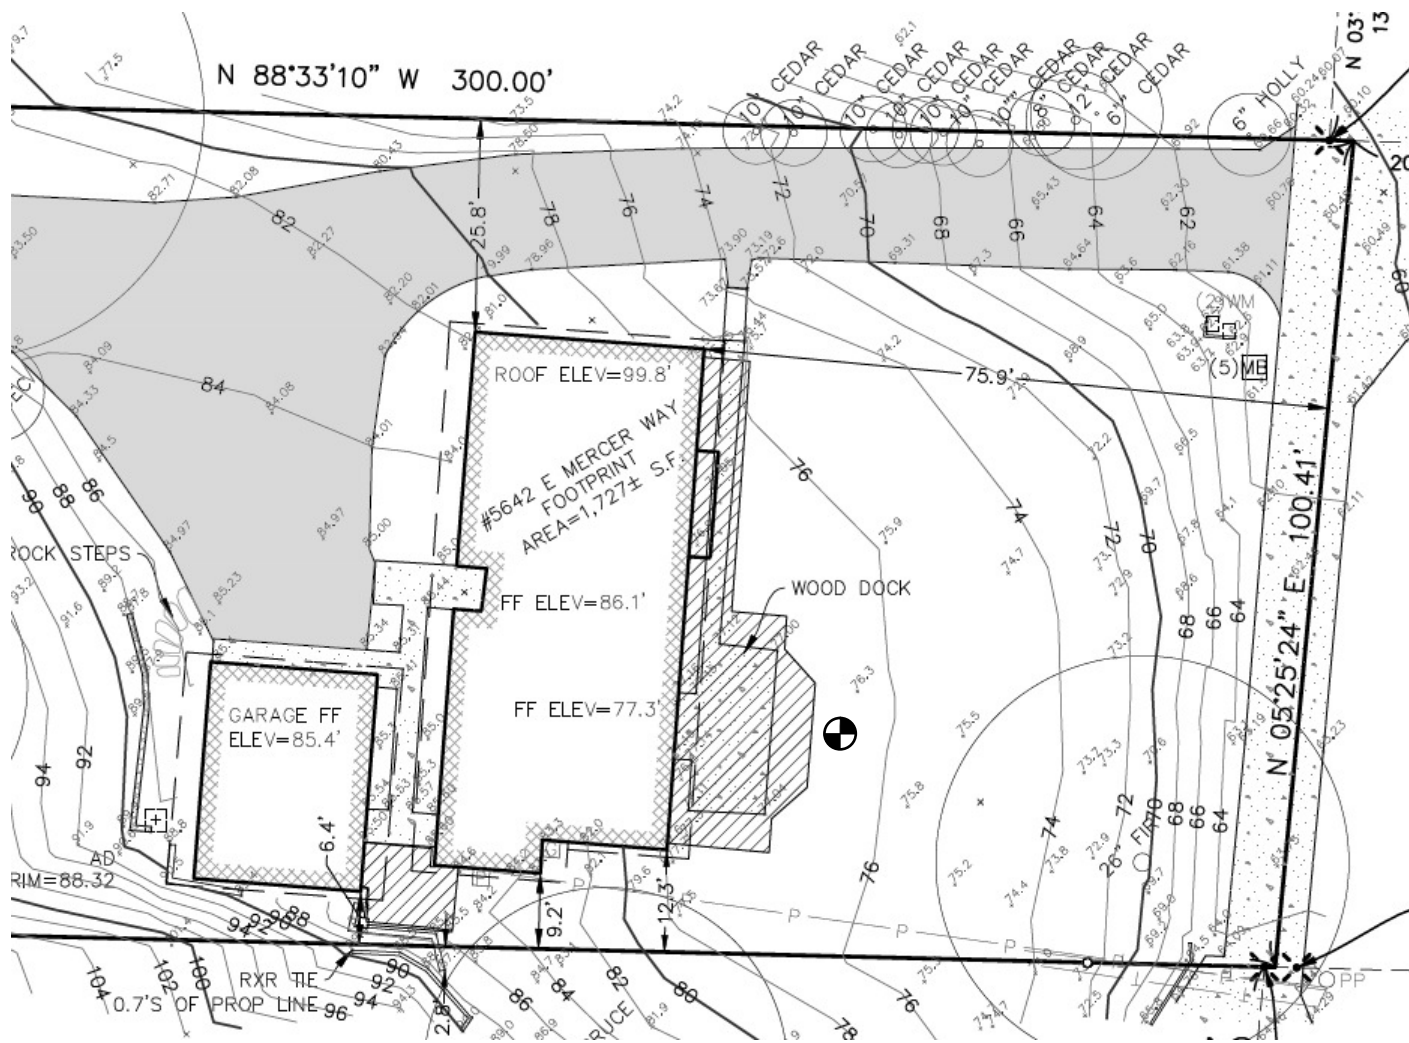
SITE EXPLORATION PLAN
5642 East Mercer Way
Mercer Island, Washington

Test Hole Location
