*Subsurface Exploration, Geologic Hazard, and
Geotechnical Engineering Report*

MERCER ISLAND SFR

Mercer Island, Washington

Project No. 20220159E001

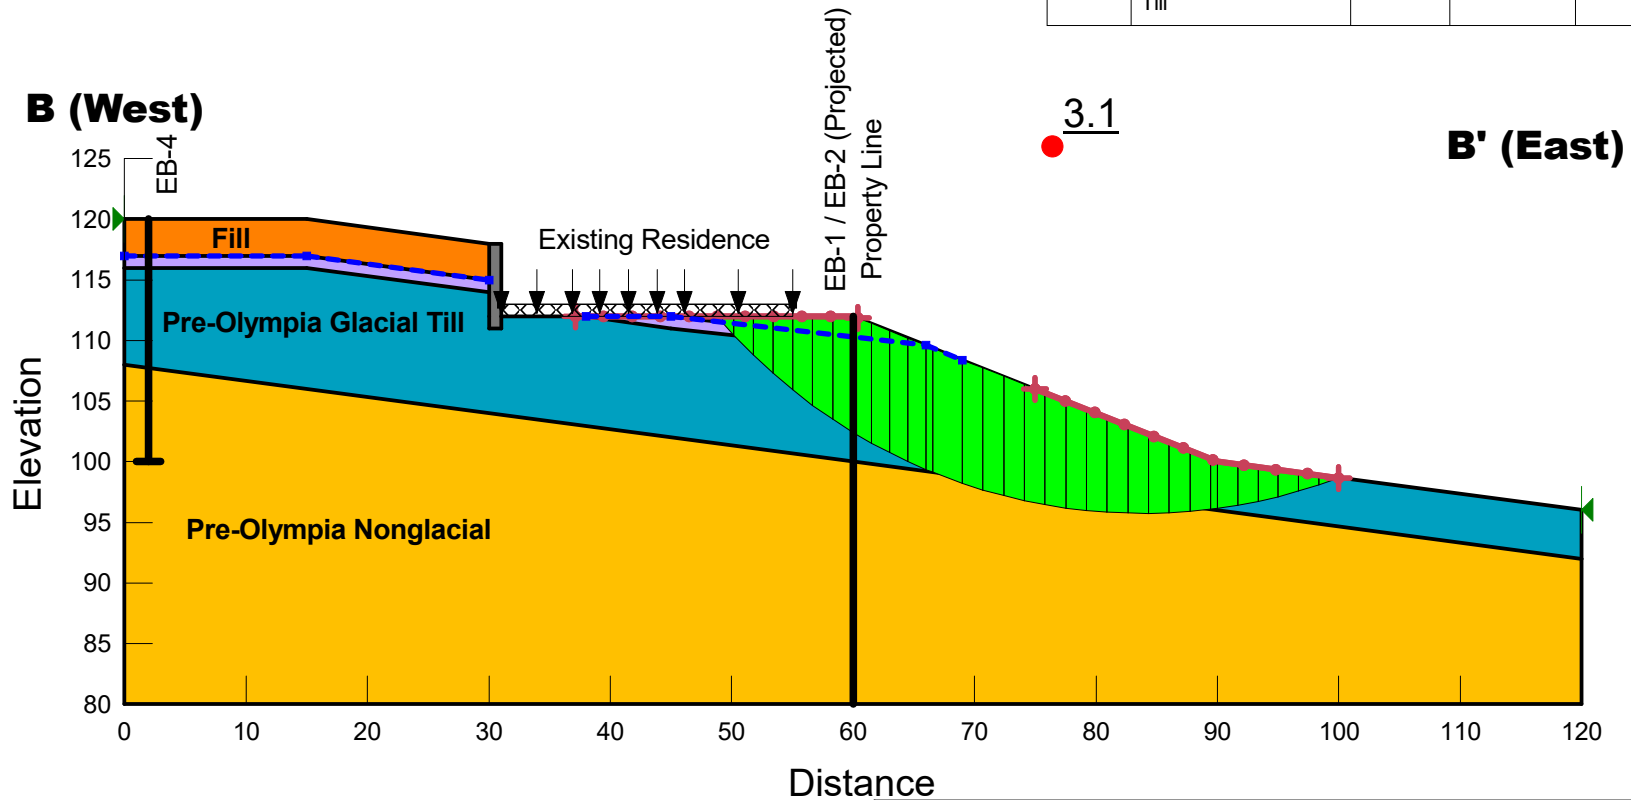
B-B': Existing Slope - Static

Color	Name	Unit Weight (pcf)	Cohesion' (psf)	Phi' (°)
Grey	Basement Wall	150		
Orange	Fill	125	0	30
Blue	Pre-Olympia Glacial Till	125	200	38
Yellow	Pre-Olympia Nonglacial Deposits	125	0	38
Green	Structural Fill	125	0	34
Purple	Weathered Pre-Olympia Glacial Till	125	200	34

A numerical slope stability analysis of the each of the steep slopes present at the site was completed using the computer program SLOPE/W, Version 8.16 by GeoSlope International. The program used the Morgenstern-Price method for evaluating a rotational failure. Input parameters for the analysis included slope geometry, geology, and soil strength parameters. The profiles used for our analysis were located along section lines A-A’ and B-B’ as depicted on Figure 2. The LiDAR-based topography presented on Figure 2 was used for the existing slope conditions. The geology of the slopes was based on the subsurface conditions encountered in our

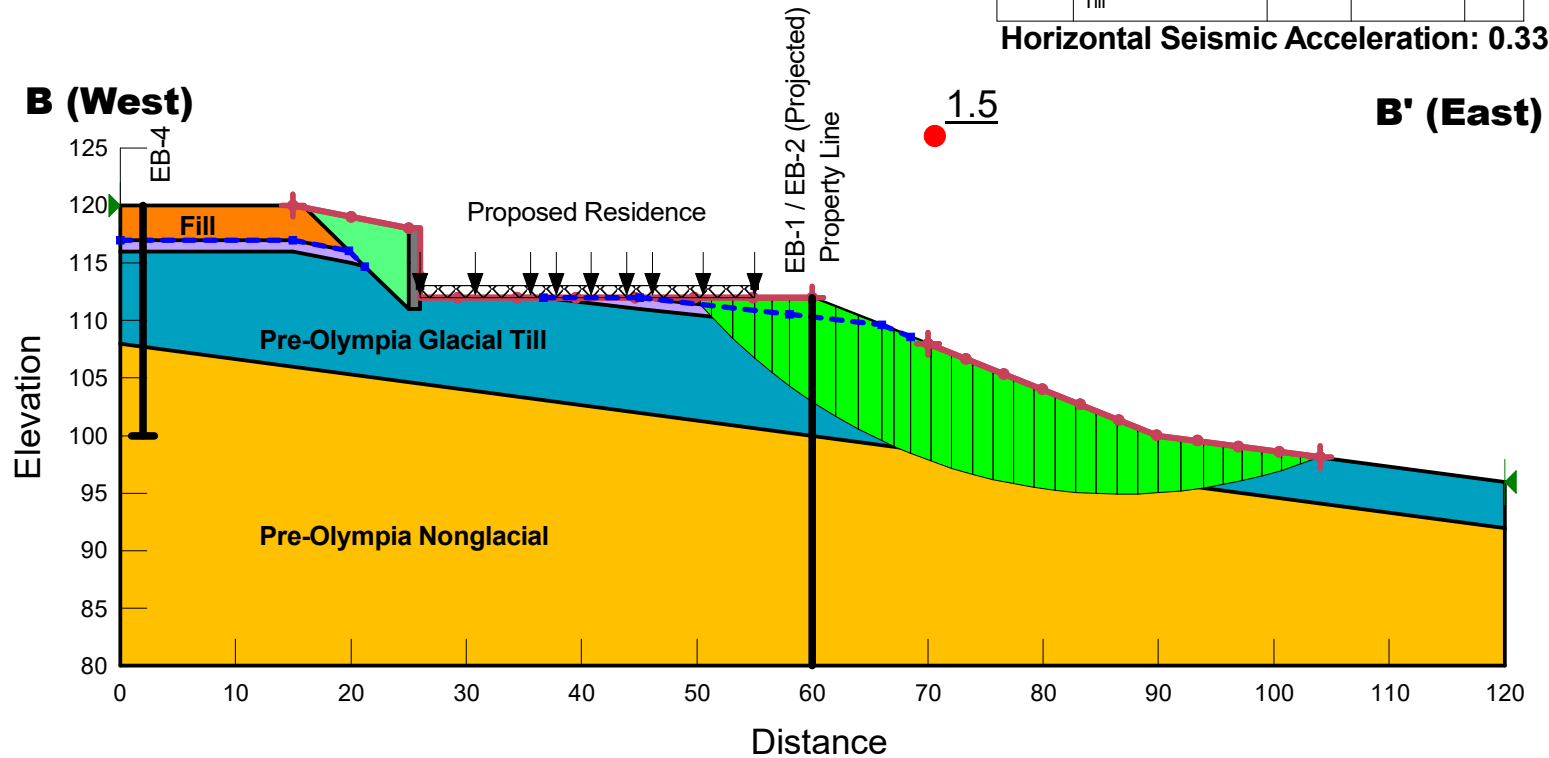
B-B': Proposed Slope - Seismic

Horizontal Seismic Acceleration: 0.33

Color	Name	Unit Weight (pcf)	Cohesion' (psf)	Phi' (°)
Grey	Basement Wall	150		
Orange	Fill	125	0	30
Blue	Pre-Olympia Glacial Till	125	200	38
Yellow	Pre-Olympia Nonglacial Deposits	125	0	38
Green	Structural Fill	125	0	34
Purple	Weathered Pre-Olympia Glacial Till	125	200	34
