# ECTYPOS ARCHITECTURE

**Memo: Critical Area Review 2** for a New Residence at 4332 W. Mercer Way

The proposed project is for the demolition of an existing residence within the Np Watercourse Buffer and construction of a new residence beyond it as well as related site work and restoration.

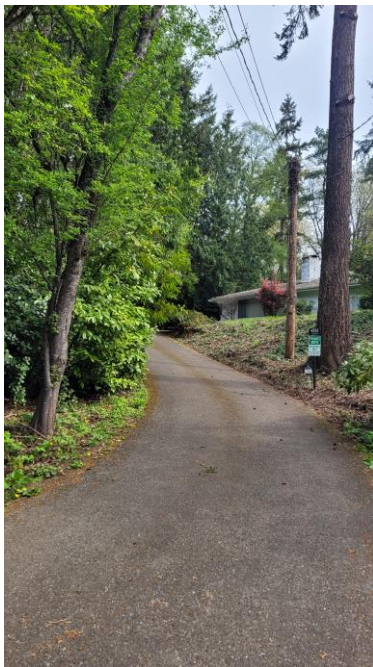
**A.**

**A)** From W. Mercer Way up driveway

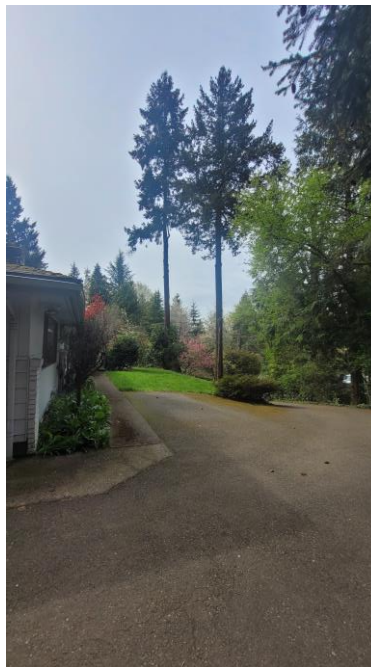
**B.**

**B)** T.O. Driveway as it turns toward future house.

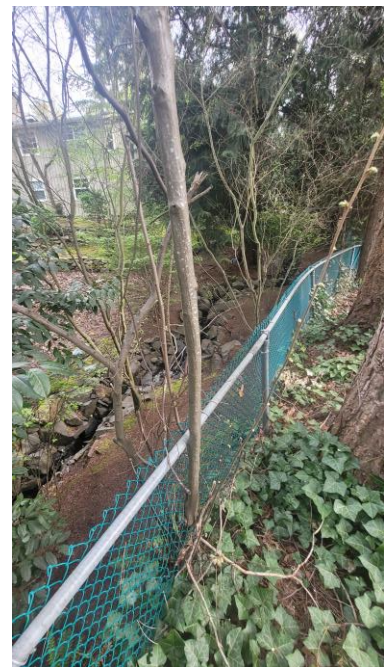
**C.**

**C)** Plastic lined rocky watercourse

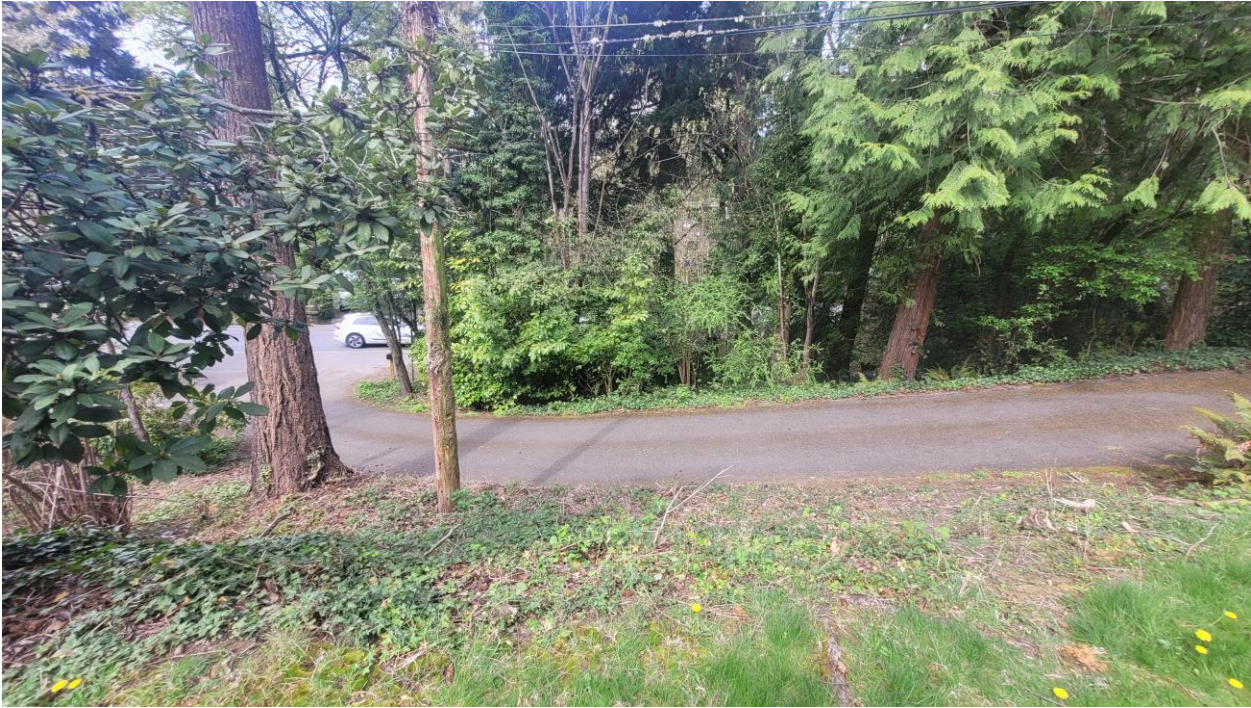
D) Driveway as it cuts across steep westerly hillside. One large doug fir on left.

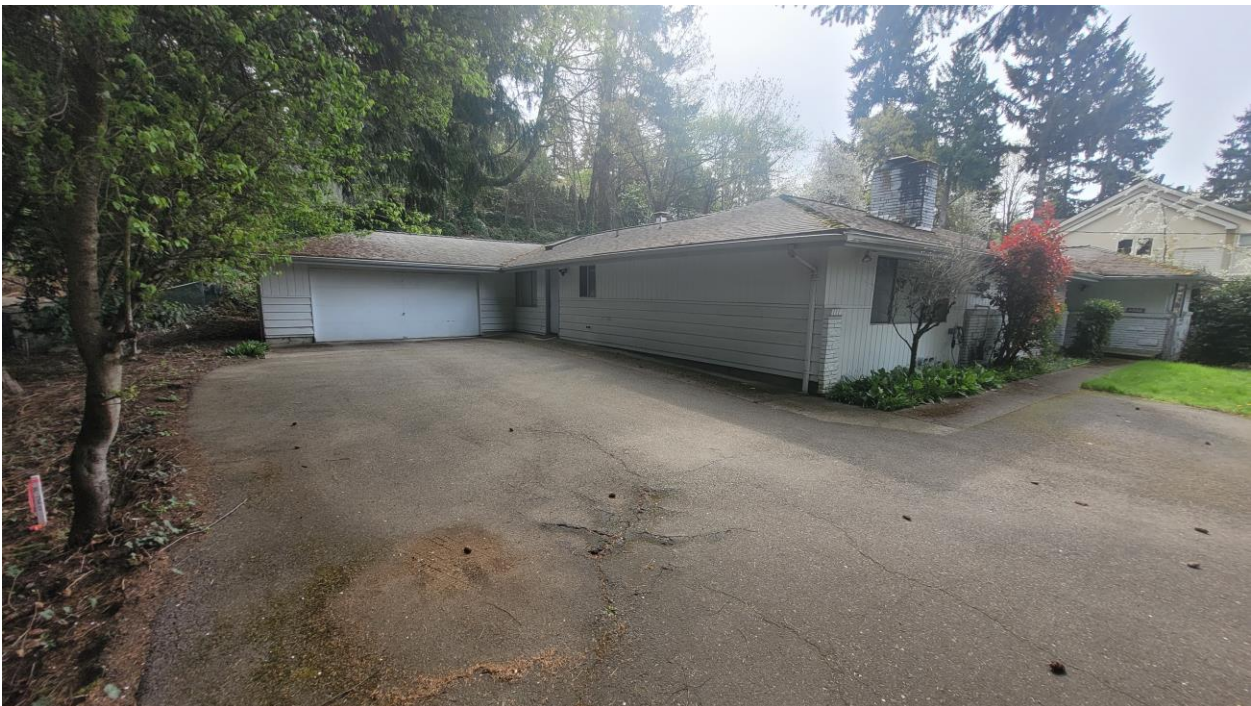
E. Existing house and driveway. Watercourse is to the left; future house is to the right.

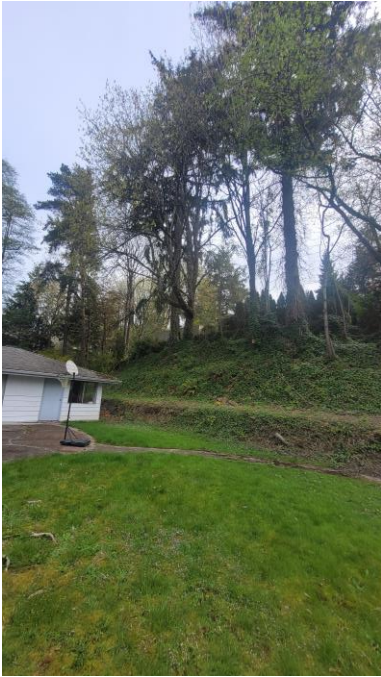
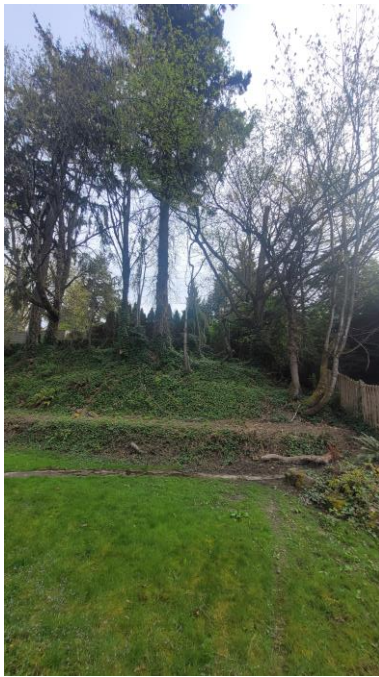
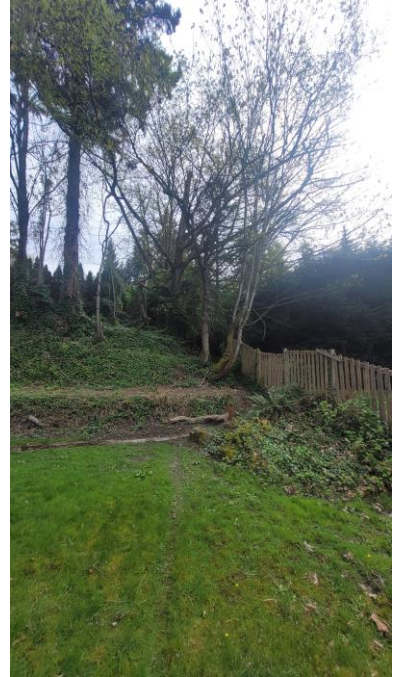
**F.** “Bench” building pad in foreground. Shelf and then steep easterly slope. Catchment wall will be at toe of slope.

The house is sited in the "sweet spot" between the easterly and westerly hillsides to minimize geologic impacts. A 6' high soldier pile catchment wall is to be constructed at the toe of the easterly slope to protect the house against potential landslides. (1) tree will be removed with (6) replacements as part of the Buffer Enhancement Plan see sheet A1.2. (MS-A Avoiding Impact; MS-B Minimizing Impact; MS-C Rectifying Impact; MS-E Compensating for Impact)
