GEOTECHNICAL ENGINEERING REPORT

PROPOSED SINGLE-FAMILY RESIDENTIAL REMODEL 8441 SE 33rd Place Mercer Island, Washington 98040

Project No. 2727.01
28 November 2023

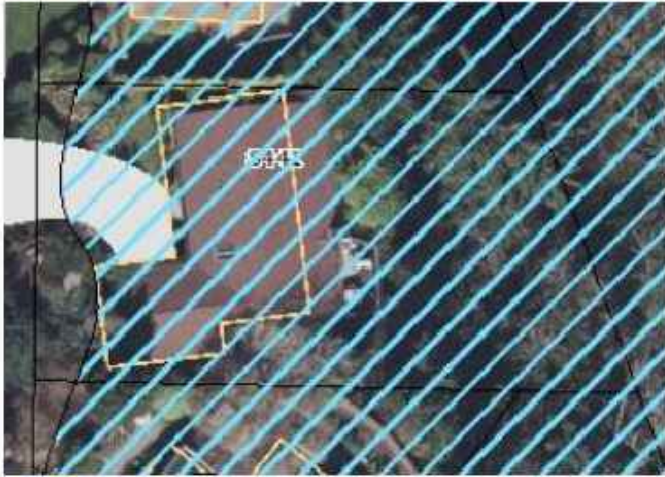
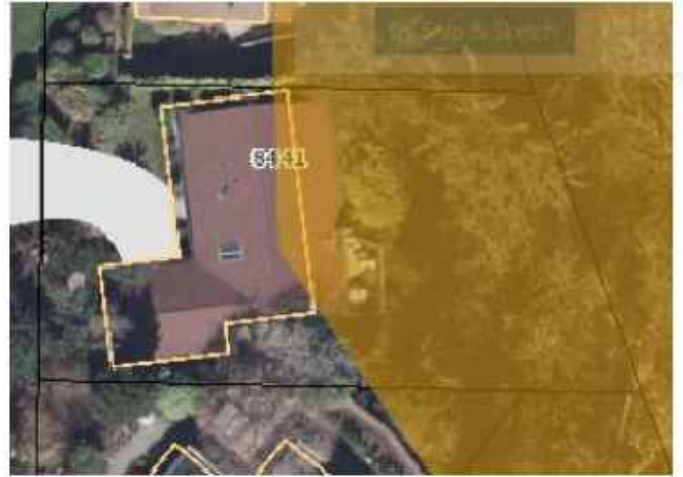
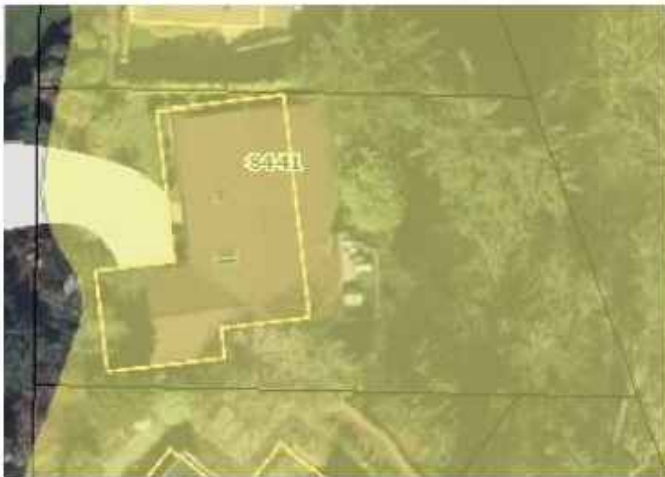
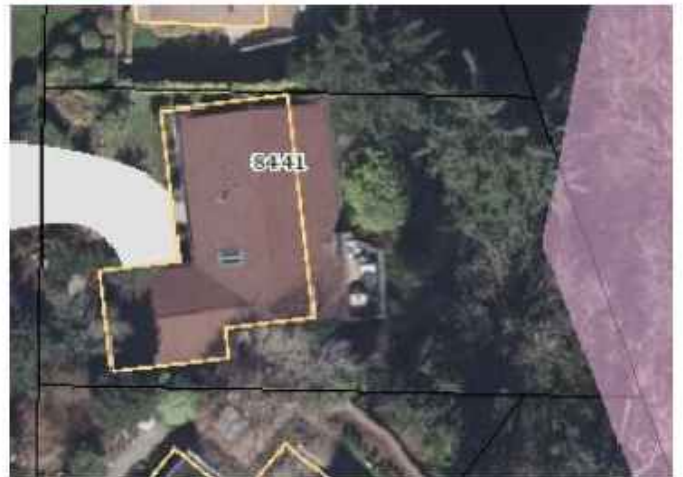
KORPELA RESIDENCE REMODEL 8441 SE 33RD PLACE MERCER ISLAND, WASHINGTON		
CRITICAL AREAS MAP		
DATE: NOVEMBER 2023	Job No.	2727.01
Zipper Geo Associates, LLC 19019 36th Ave. W., Suite E Lynnwood, WA	FIGURE	2
	SHT. 1 of 1

Potential Slide:

Steep Slope:

Erosion:

Seismic:

Figure 2 – Critical Areas Map

Chapter 19 of the Mercer Island City Code (MICC) regulates development activities in critical areas and their associated buffers. The property has been mapped by the City of Mercer Island as being within the following regulated geologic hazard areas or their buffers: potential landslide, steep slope, erosion, and seismic. The approximate extents of these regulated hazards/buffers on and near the property as mapped by the City are shown on the Critical Areas Map, Figure 2. The steep slope, potential slide, and erosion hazards are all related to the eastern slope. The City may allow alteration within a regulated geologic hazard area or buffer if the alteration proposal effectively demonstrates that there is no impact on the regulated areas or that it adequately mitigates risks of the hazards.

Seismic hazard areas are those subject to severe risk of damage as a result of earthquake-induced ground shaking, slope failure, settlement or subsidence, soil liquefaction, surface faulting, or tsunamis. City mapping as shown on Figure 2 includes a very small area in the lower eastern portion of the site as within a seismic hazard area, and we suspect that this is likely due to mapping of non-glacially consolidated outwash soils at this location. The explorations completed for our evaluation disclosed some fill material above dense native advance outwash soils. We did not observe groundwater at our exploration locations, nor did we observe groundwater seepage on the eastern slope below the dwelling. Based on these conditions, it is our opinion that the risk of liquefaction and associated settlement is low. Given the site location, it would not be subject to tsunamis.

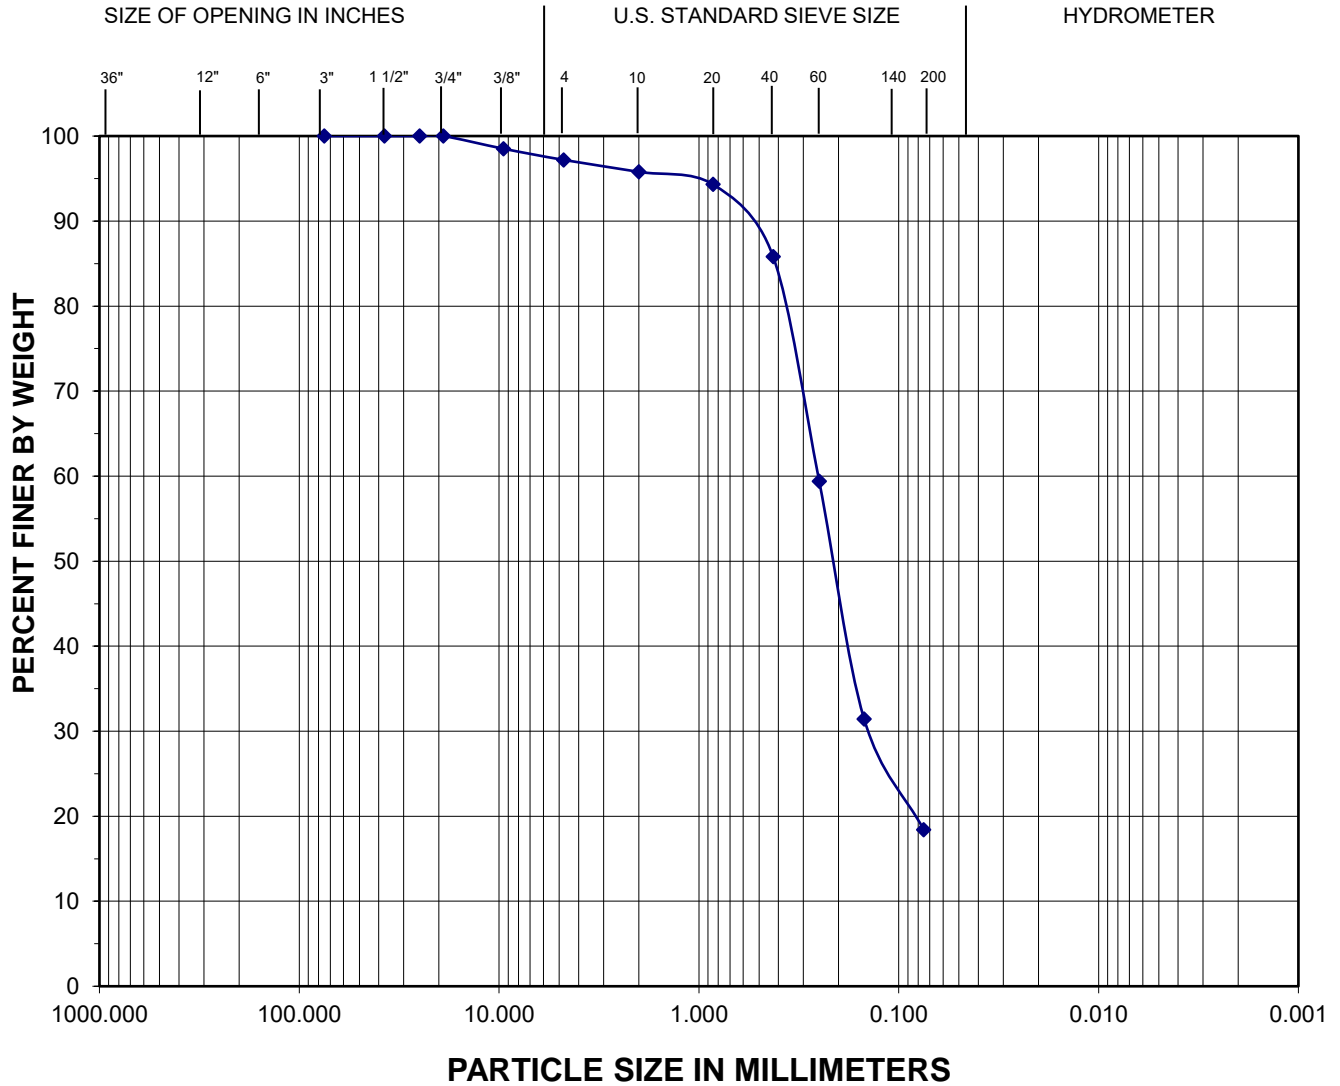
Test Results Summary

ASTM D6913

BOULDERS	COBBLES	Coarse	Fine	Coarse	Medium	Fine	Silt	Clay
		GRAVEL		SAND			FINE GRAINED

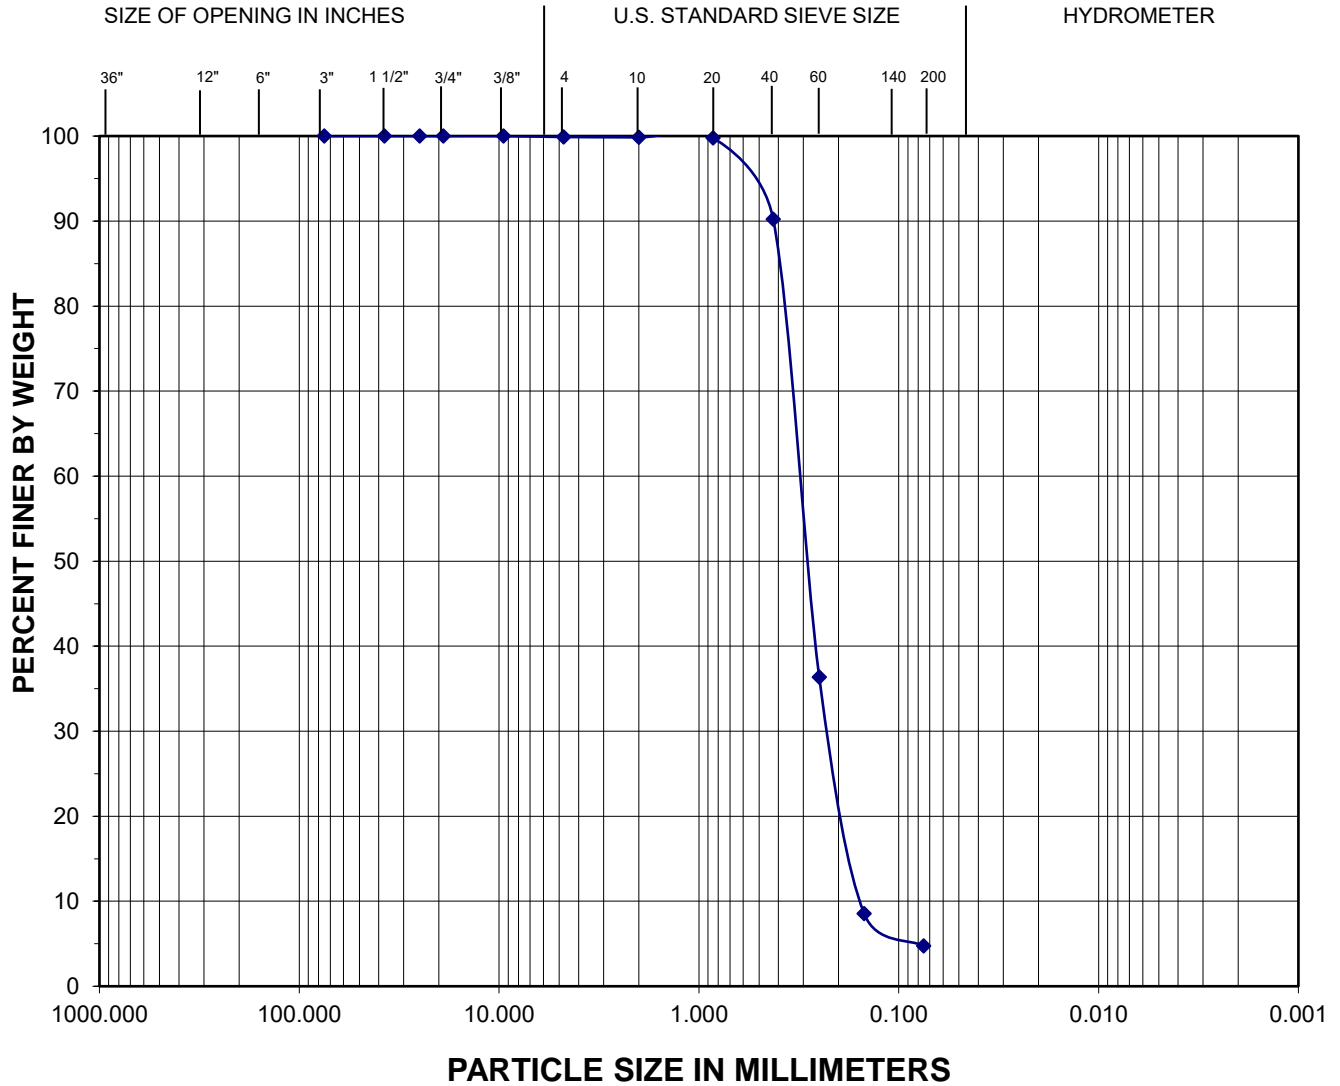
Test Results Summary

ASTM D6913

BOULDERS	COBBLES	Coarse	Fine	Coarse	Medium	Fine	Silt	Clay
		GRAVEL		SAND			FINE GRAINED
