Ecological No Net Loss Assessment Report

**Douglas and Deborah Rosen
5995 SE 30th Street
Mercer Island, WA 98040**

PROPOSED: PIER REPAIR

PURPOSE: RESTORE PIER INTEGRITY

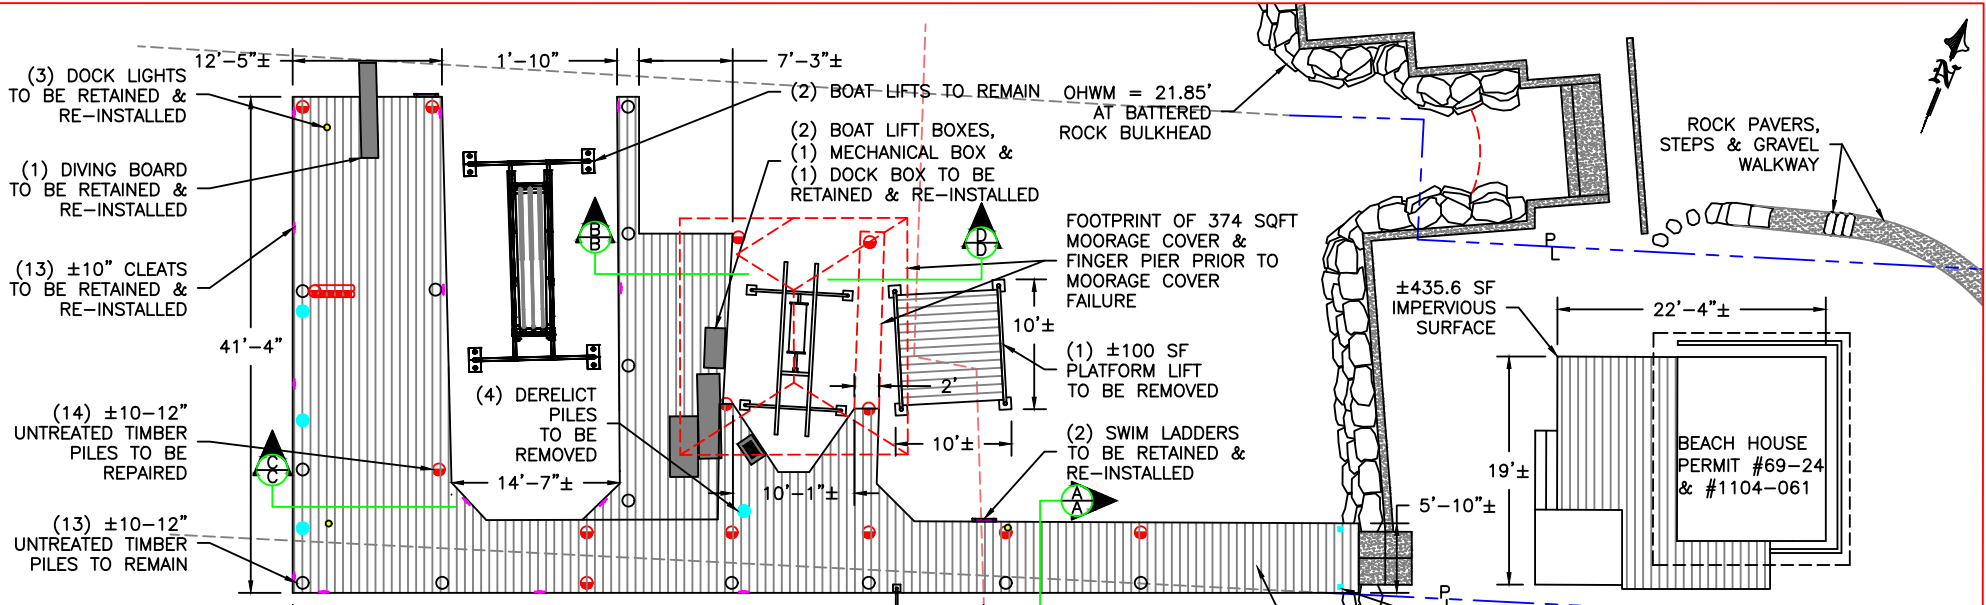
EXISTING DETAIL VIEW
SCALE: 1/16"=1'

- = PILES TO REMAIN (13)
- = PILES TO REPAIR (14)
- = PILES TO REMOVE (4)
- = POSTS TO REMOVE (2)

Existing structures on the property include a single-family residence, a guest house, and the existing pier. As described above, the pier is 1,320 square feet with two boat lifts, a 100-square-foot platform lift, a jet ski lift, a diving board, and a 380-square-foot moorage cover (which has been damaged). The pier is 89 feet long, with 41-foot-long finger piers (Sheet 4 of 10). The pier sits in water up to 13 feet deep (Sheet 4 of 10).

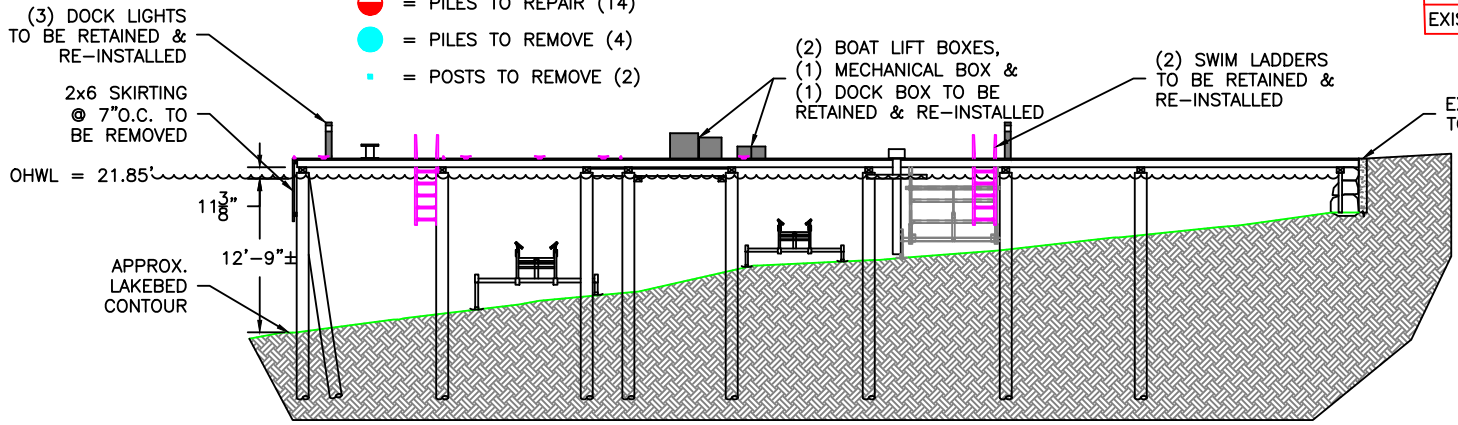
EXISTING ELEVATION VIEW

EXISTING SQUARE FOOTAGE = 1340 SQFT
EXISTING TIMBER PILES/POSTS = 33

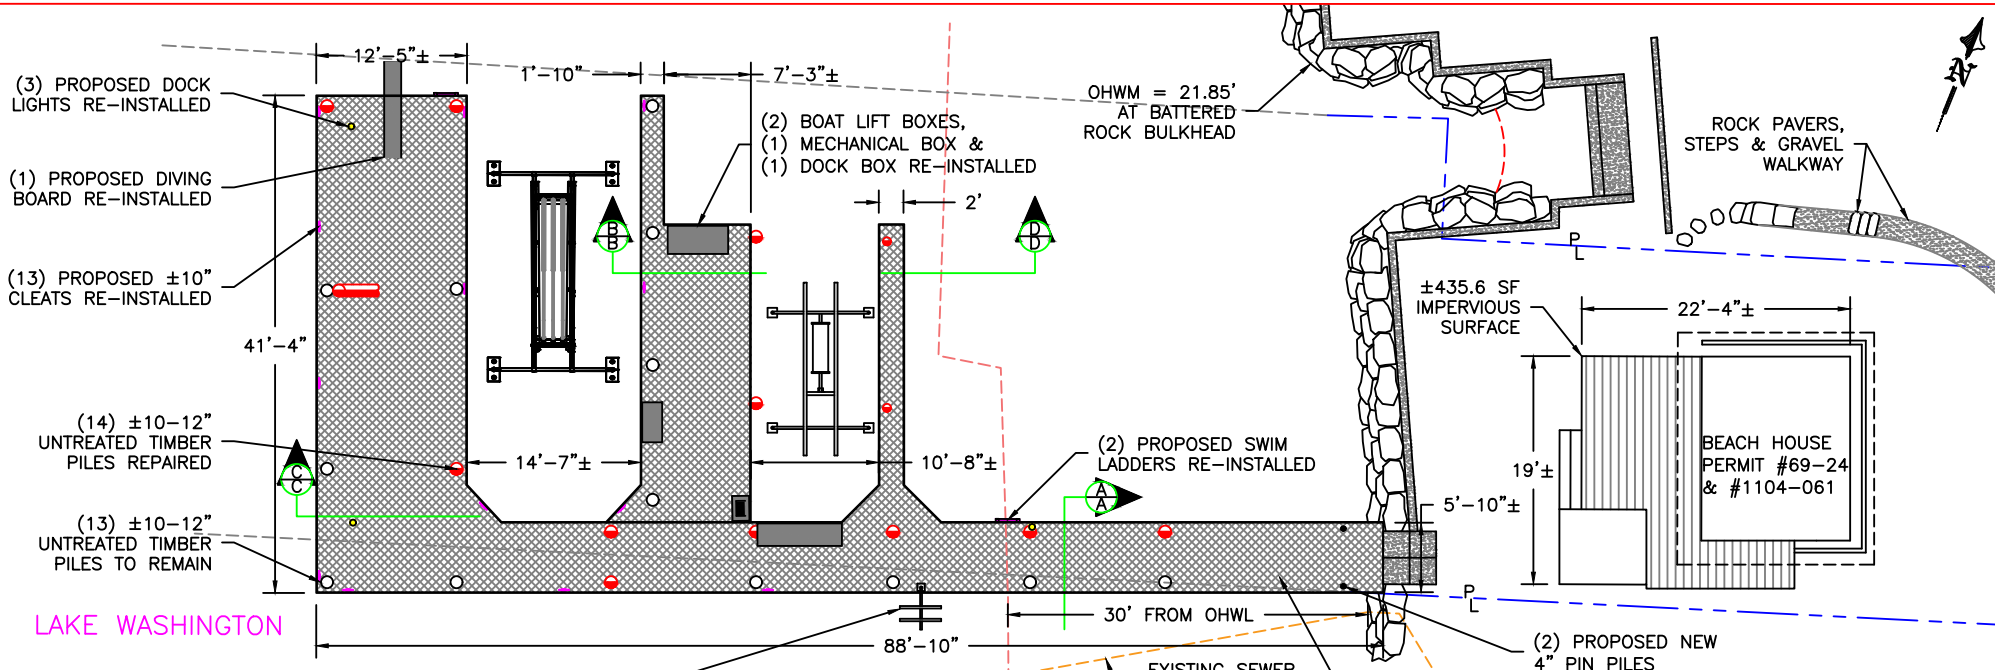
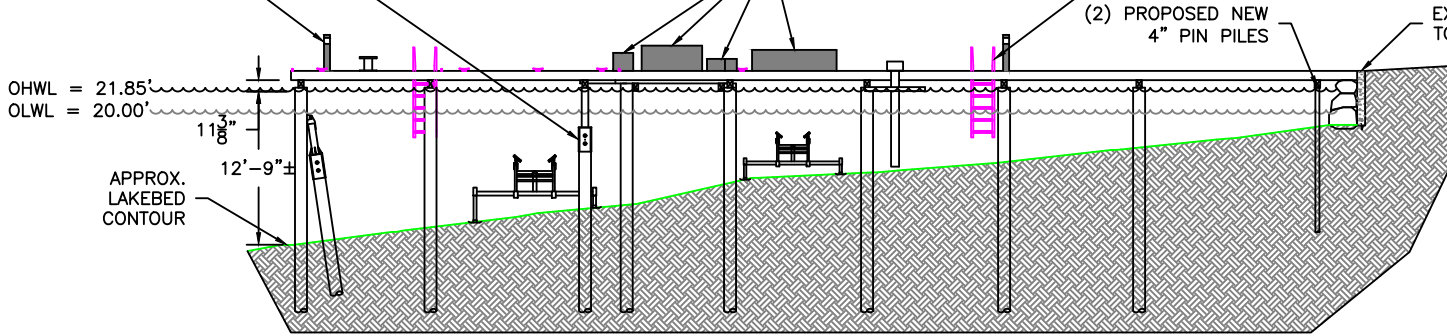
- (14) ±10-12" UNTREATED TIMBER PILES REPAIRED
- (3) DOCK LIGHTS TO BE RETAINED & RE-INSTALLED

- = PILES TO REMAIN (13)
- = PILES REPAIRED (14)
- = NEW PIN PILES (2)

PROPOSED SQUARE FOOTAGE = 1269

NOTE:
71 SQFT REDUCTION. 2 PILE REDUCTION.

The landowner is proposing to replace the decking and fascia on the pier, repair timber piles, damaged finger pier, reconfigure the landward most slip, and remove the moorage cover on the property’s waterfront. The overwater coverage includes 1,340 square foot dock, 380 square-foot moorage cover, and 100 square-foot platform lift. The moorage cover fell in a storm and damaged a finger pier that will be repaired. See Appendix A - Sheets 2 and 4 of 10.

The project will overall have a net benefit to the nearshore environment by removing the 380 square foot moorage cover, 100 square foot platform lift, and reducing the dock by 71 square feet. In addition, Sunwalk grating will be used to replace the existing wood decking. The grated decking will reduce the effective overwater coverage by an additional 546 square feet. This grating will reduce the hard shadows favored by salmonid predators and increase productivity in waters under the pier. In addition, the pier will be raised by 7 inches which will naturally allow more light under the pier, further reducing impacts.

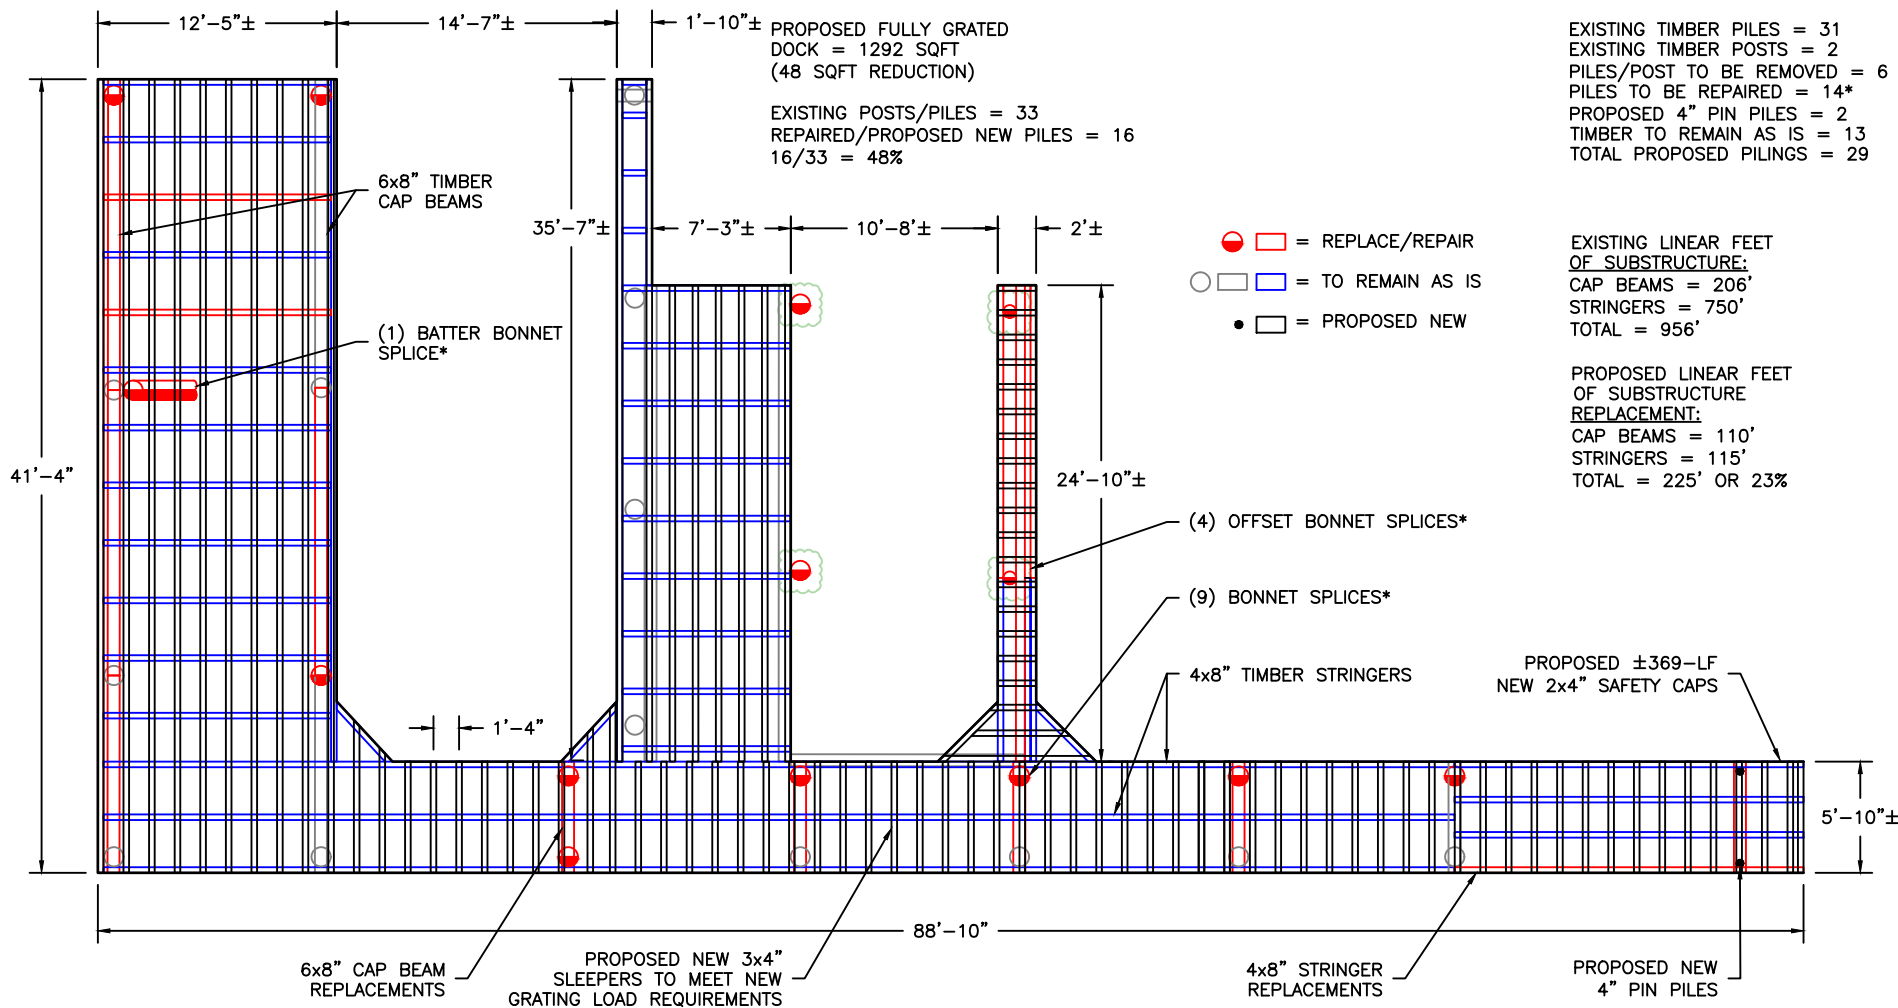
PROPOSED FULLY GRATED DOCK = 1292 SQFT (48 SQFT REDUCTION)
 EXISTING POSTS/PILES = 33
 REPAIRED/PROPOSED NEW PILES = 16
 16/33 = 48%

EXISTING TIMBER PILES = 31
 EXISTING TIMBER POSTS = 2
 PILES/POST TO BE REMOVED = 6
 PILES TO BE REPAIRED = 14*
 PROPOSED 4" PIN PILES = 2
 TIMBER TO REMAIN AS IS = 13
 TOTAL PROPOSED PILING = 29

EXISTING LINEAR FEET OF SUBSTRUCTURE:
 CAP BEAMS = 206'
 STRINGERS = 750'
 TOTAL = 956'
 PROPOSED LINEAR FEET OF SUBSTRUCTURE REPLACEMENT:
 CAP BEAMS = 110'
 STRINGERS = 115'
 TOTAL = 225' OR 23%

SUBSTRUCTURE REPAIRS:
 CAP BEAMS / STRINGERS = 23% OF 956 (23x956=219.88)
 PILING = 48% OF 33 (.48x33=15.84)
 (219.88+15.84) / (956+33) = 24% OF TOTAL SUBSTRUCTURE REPAIR

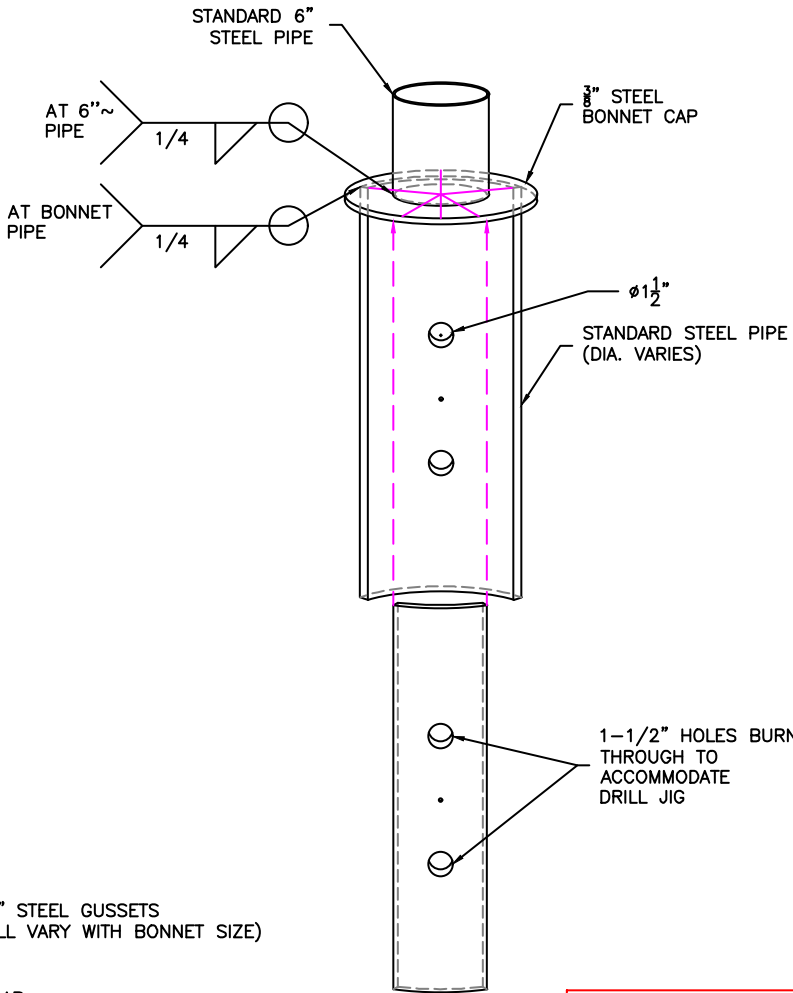
DETAIL 11-B

NOTE:
STEEL GUSSETS LEFT OUT OF DETAIL & SECTION VIEWS FOR CLARITY.

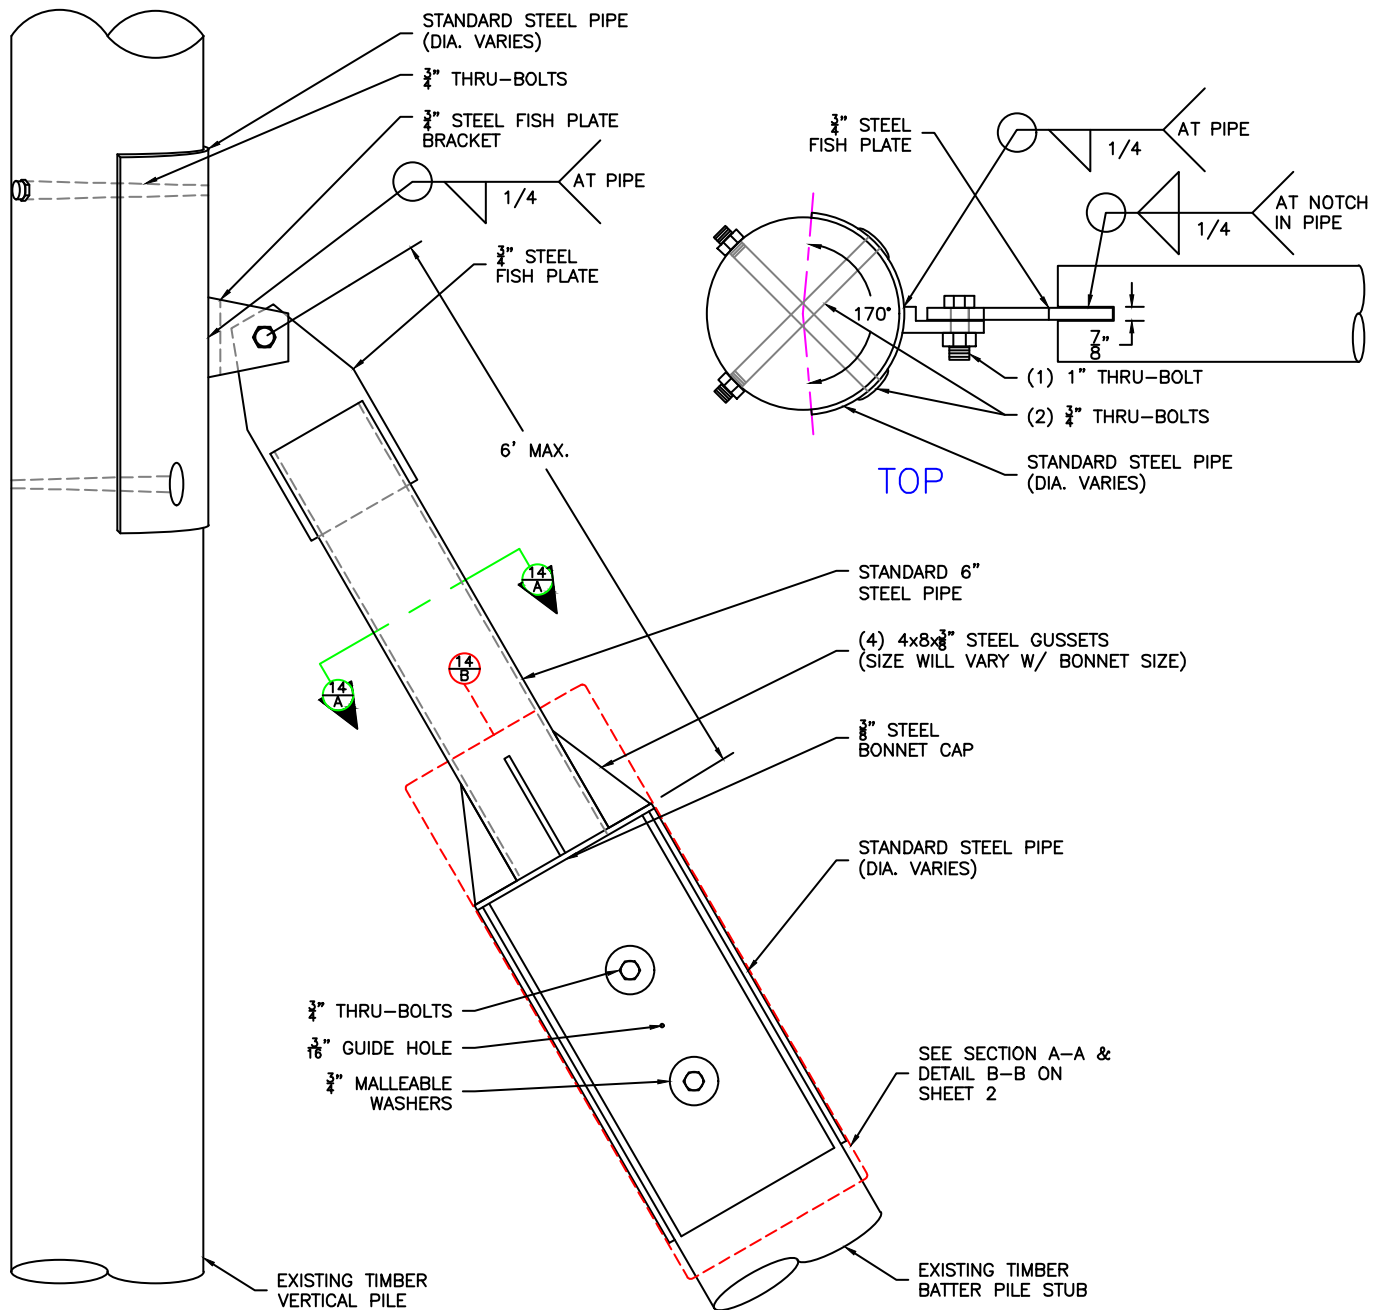
BATTER BONNET SPLICE

SIDE

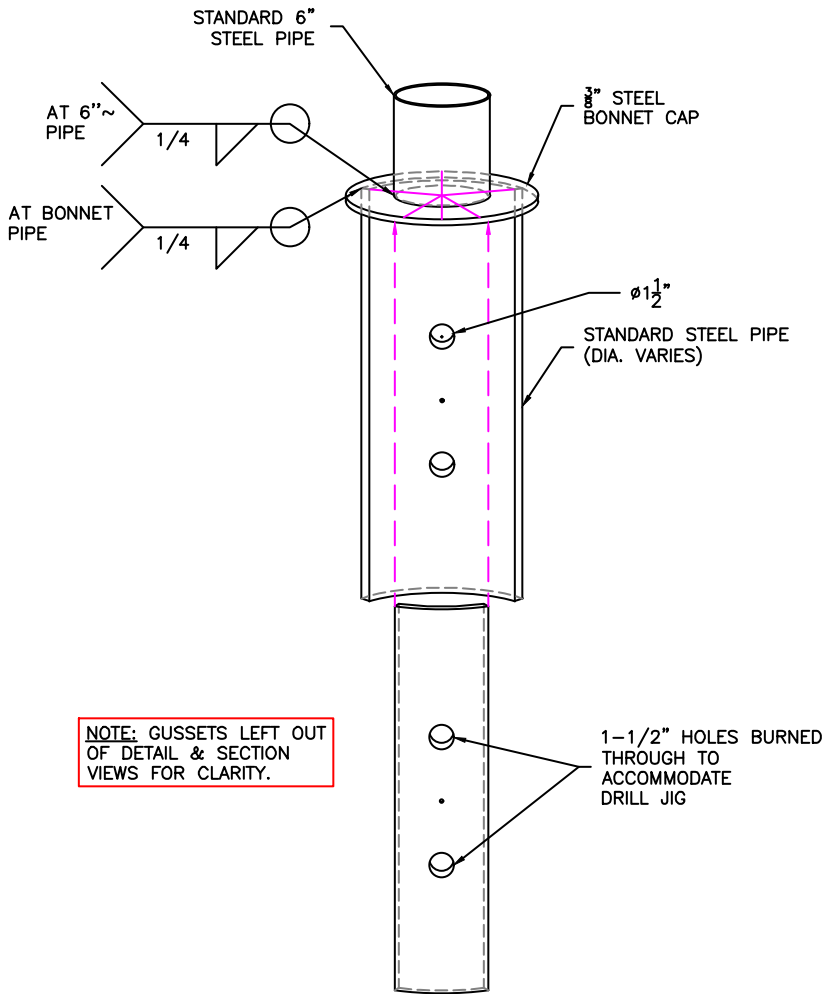
DETAIL 14-B

NOTE: GUSSETS LEFT OUT OF DETAIL & SECTION VIEWS FOR CLARITY.

1-1/2" HOLES BURNED THROUGH TO ACCOMMODATE DRILL JIG
