PROPOSED: PIER REPAIR
PURPOSE: RESTORE PIER INTEGRITY
DATUM: C.O.E. MLLW=0.0'

APPLICANT: DOUGLAS ROSEN
SITE ADD. 5995 SE 30TH STREET
 MERCER ISLAND, WA 98040
MAIL ADD. 5995 SE 30TH STREET
 MERCER ISLAND, WA 98040

DWG#: 19-31042-A13-1

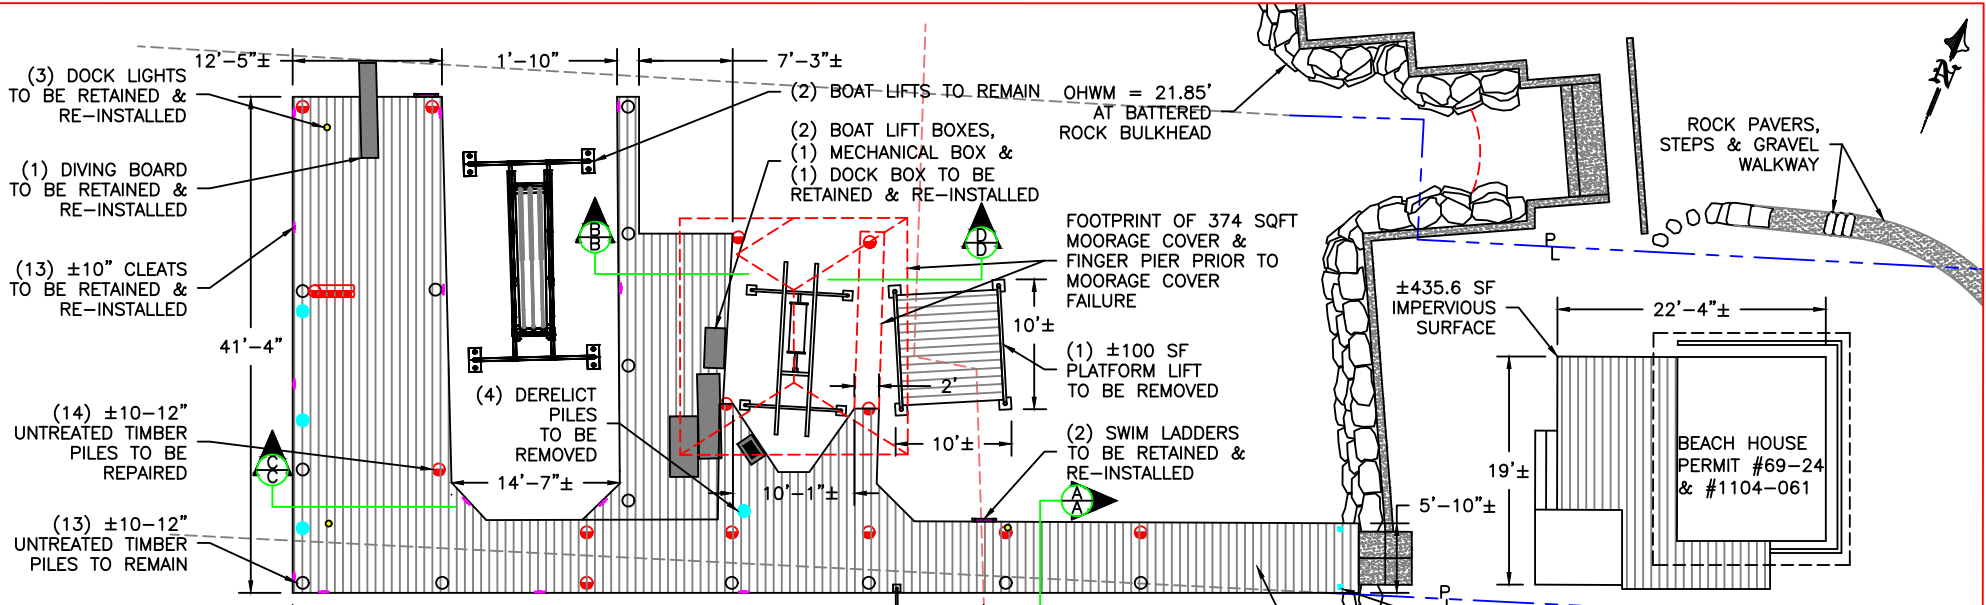
EXISTING DETAIL VIEW
SCALE: 1/16"=1'

EXISTING SQUARE FOOTAGE = 1340 SQFT
EXISTING TIMBER PILES/POSTS = 33

- = PILES TO REMAIN (13)
- = PILES TO REPAIR (14)
- = PILES TO REMOVE (4)
- = POSTS TO REMOVE (2)

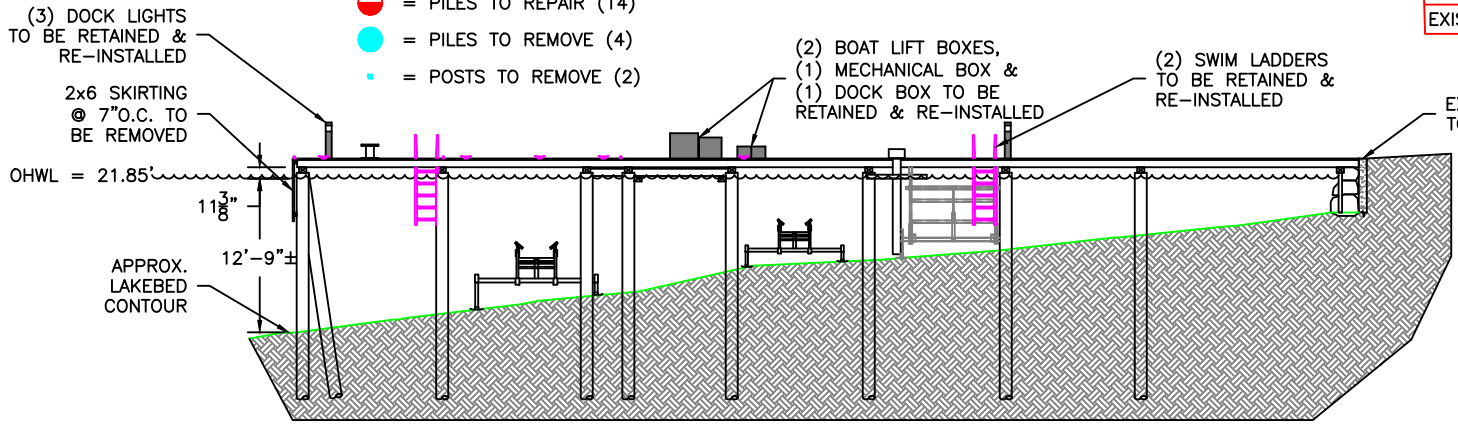
EXISTING ELEVATION VIEW
SCALE: 1/16"=1'

SEE SHEETS 9-14 FOR PILE REPAIR DETAILS.
SEE SHEETS 9-10 FOR SUBSTRUCTURE REPAIR DETAILS.

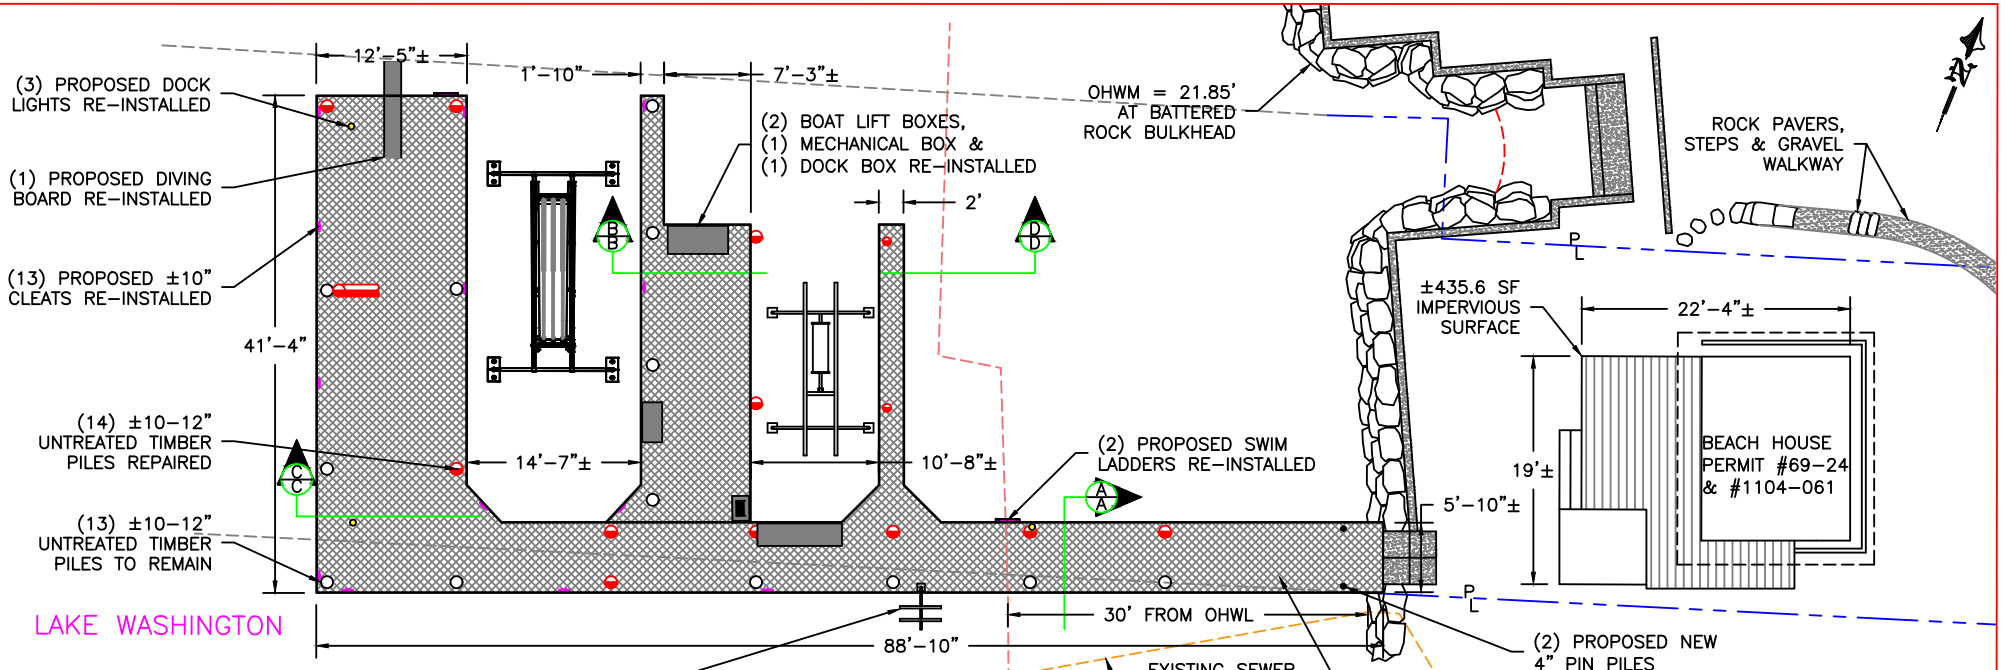
- (14) ±10-12" UNTREATED TIMBER PILES REPAIRED
- (3) DOCK LIGHTS TO BE RETAINED & RE-INSTALLED

- = PILES TO REMAIN (13)
- = PILES REPAIRED (14)
- = NEW PIN PILES (2)

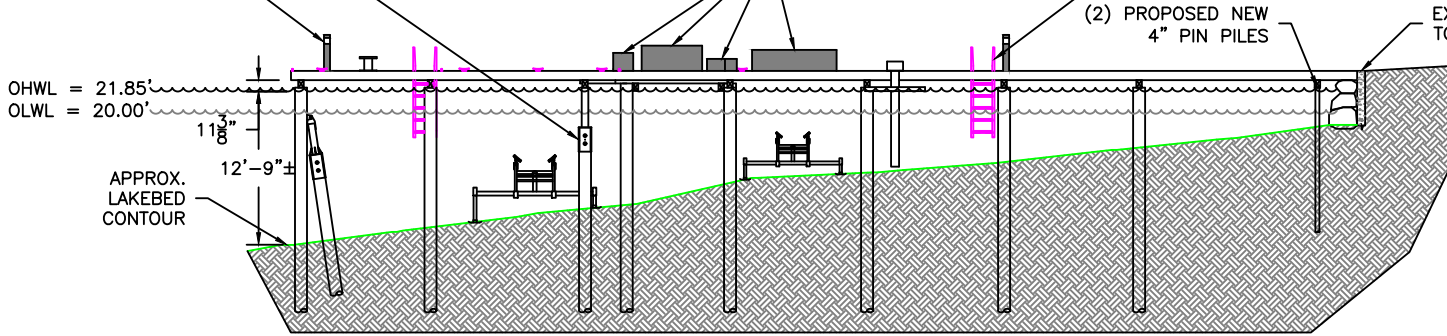
PROPOSED SQUARE FOOTAGE = 1269

NOTE:
71 SQFT REDUCTION. 2 PILE REDUCTION.

SEE SHEETS 9-14 FOR PILE REPAIR DETAILS.
SEE SHEETS 9-10 FOR SUBSTRUCTURE REPAIR DETAILS.

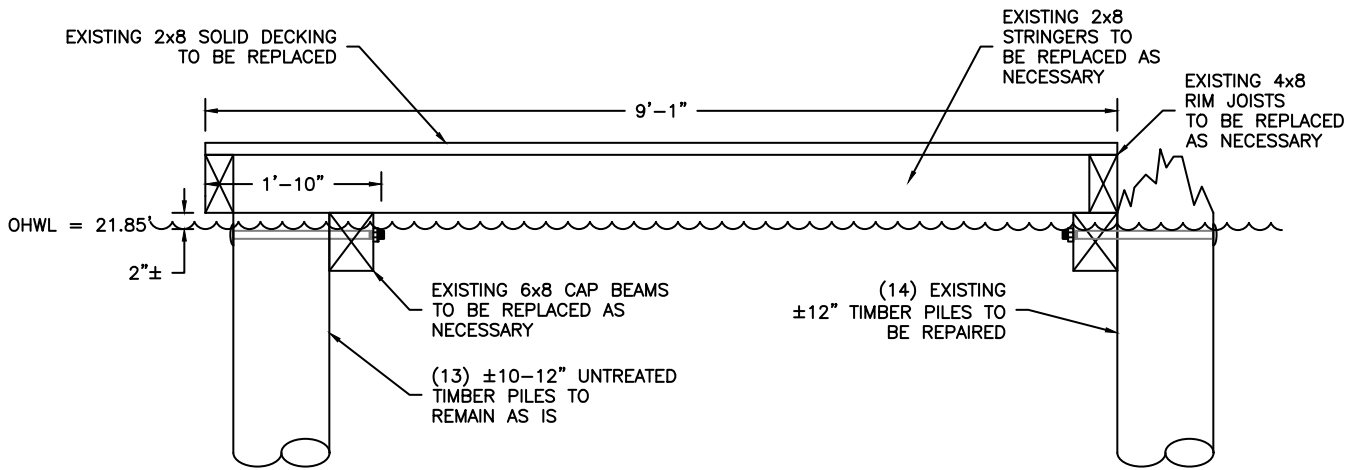
EXISTING SECTION B-B
SCALE: 1/2"=1'

SEE SHEETS 9-14 FOR PILE REPAIR DETAILS.
SEE SHEETS 9-10 FOR SUBSTRUCTURE REPAIR DETAILS.

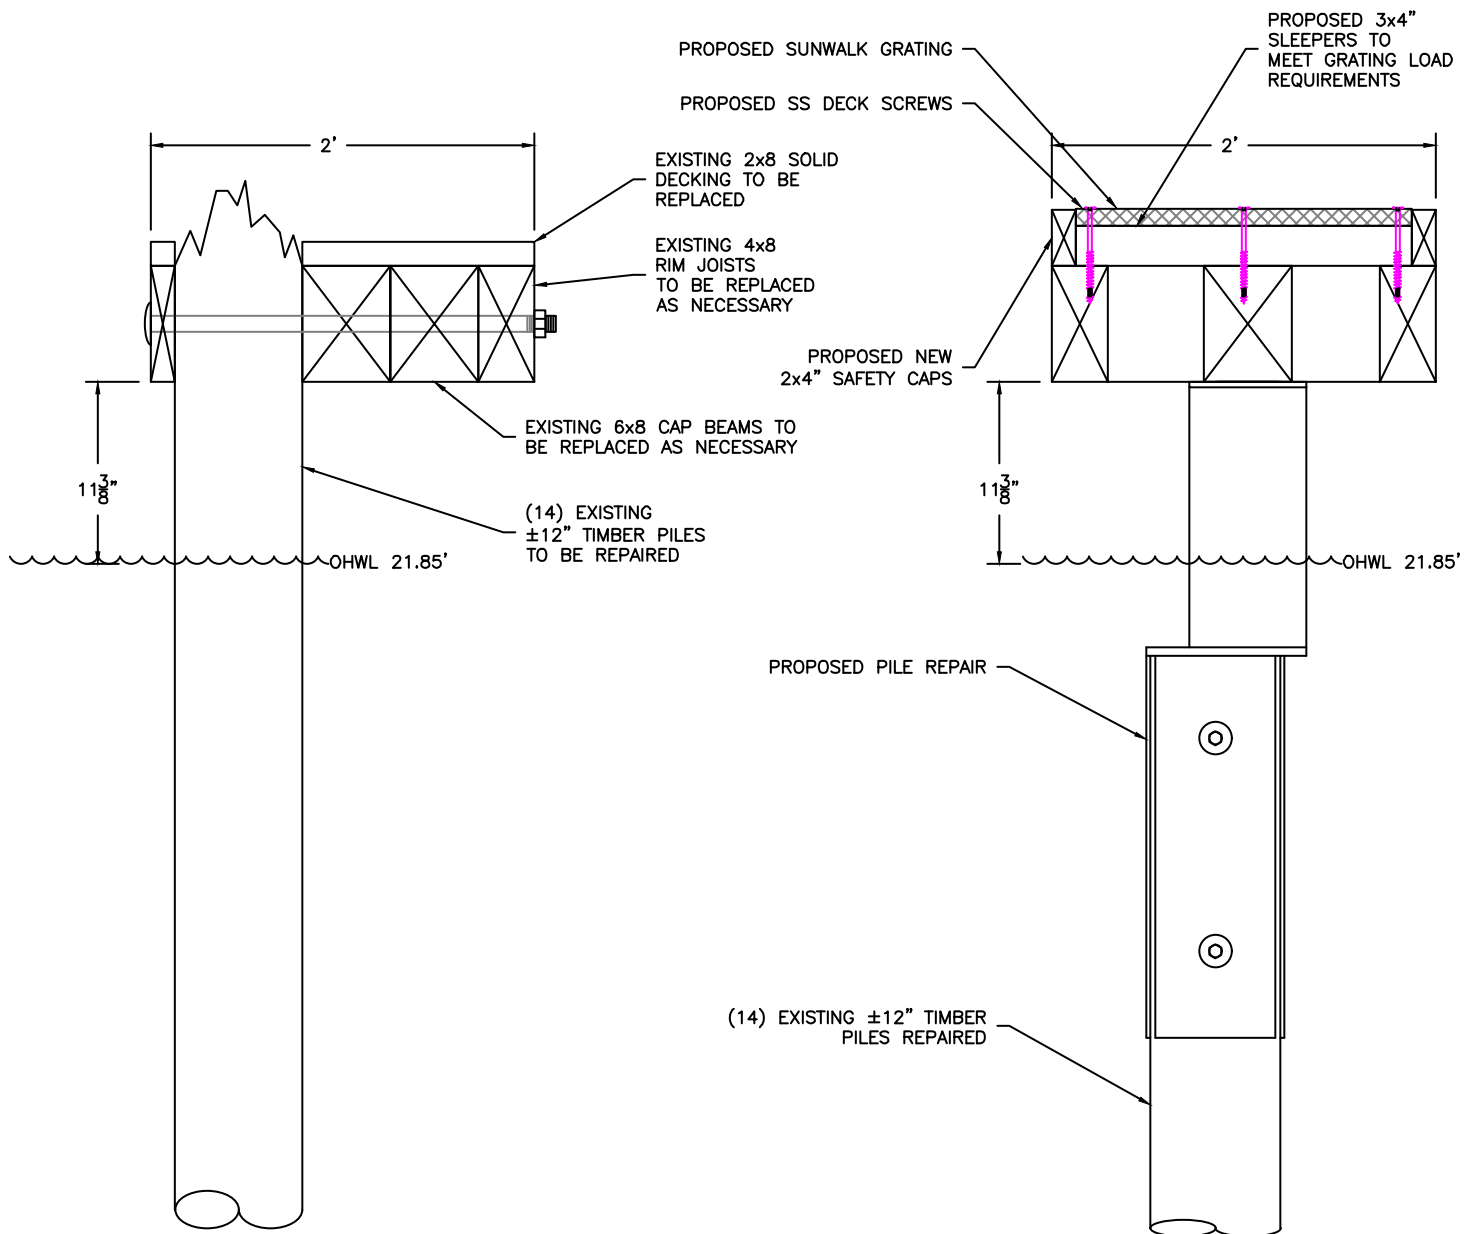
EXISTING SECTION D-D

PROPOSED SECTION D-D

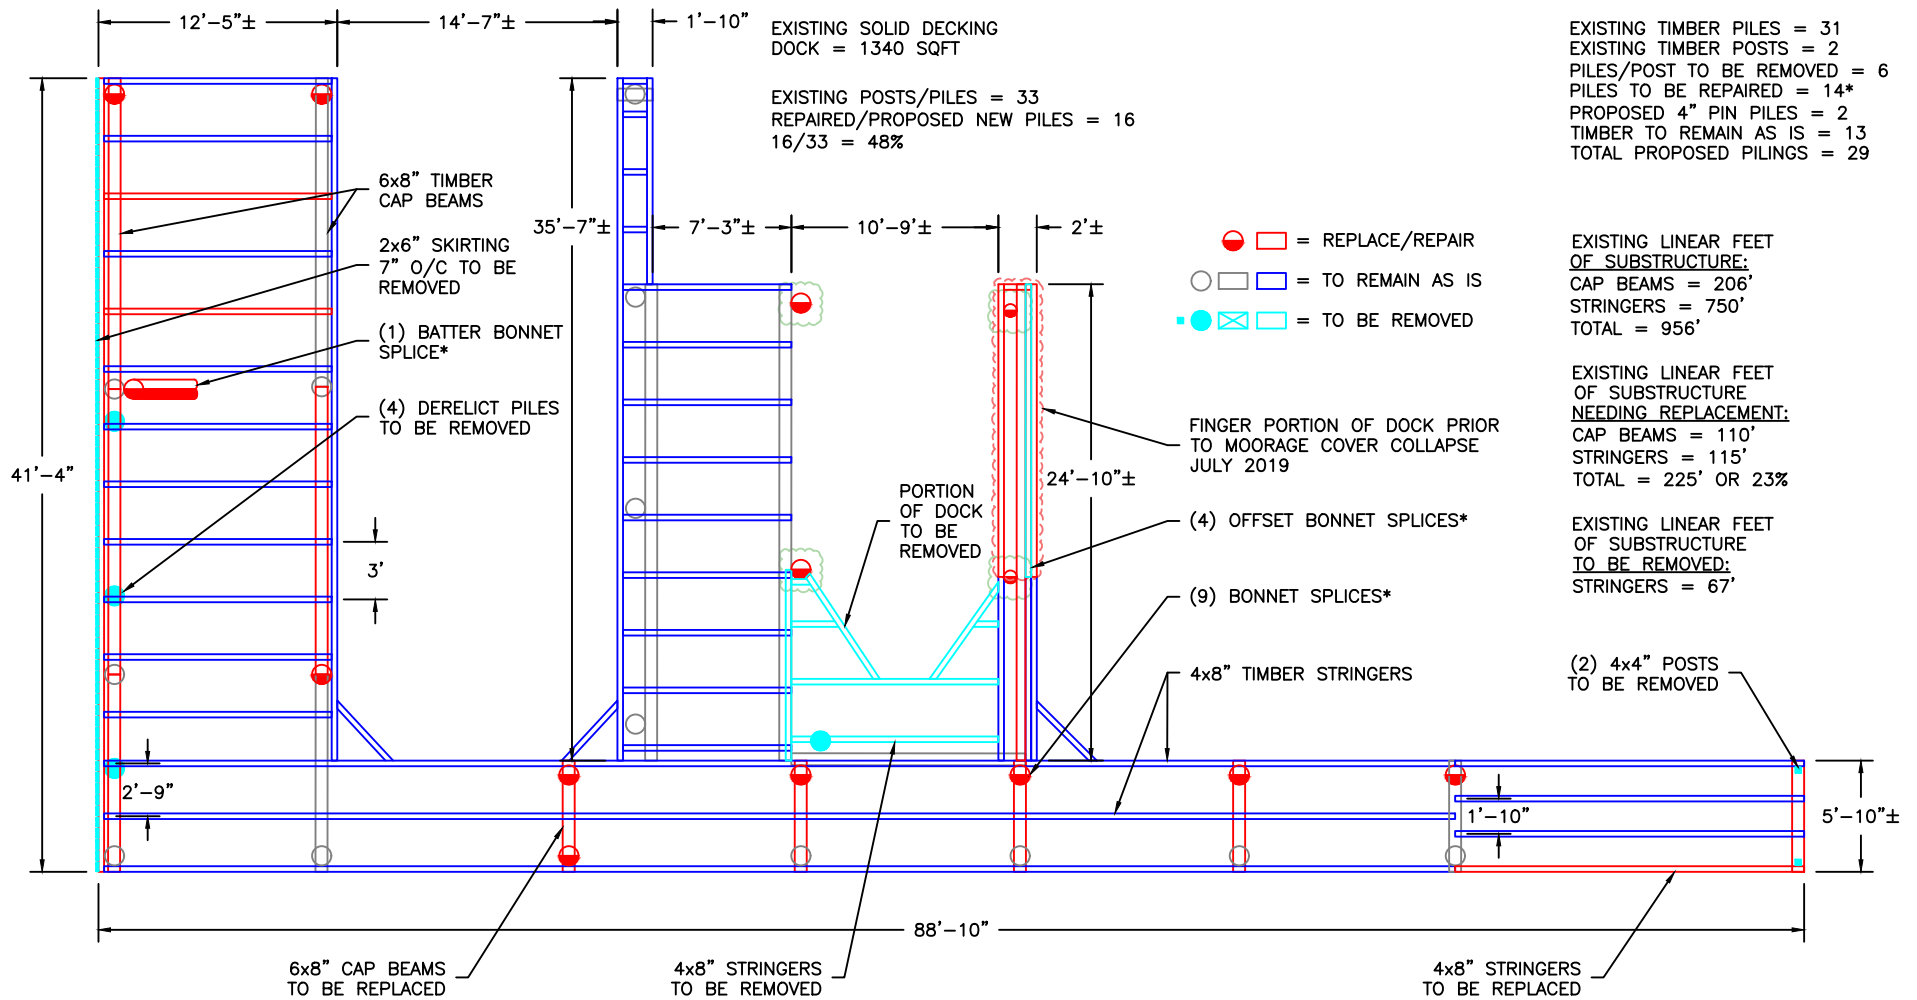
EXISTING FRAMING DETAIL PLAN VIEW

EXISTING TIMBER PILES = 31
 EXISTING TIMBER POSTS = 2
 PILES/POST TO BE REMOVED = 6
 PILES TO BE REPAIRED = 14*
 PROPOSED 4" PIN PILES = 2
 TIMBER TO REMAIN AS IS = 13
 TOTAL PROPOSED PILING = 29

EXISTING LINEAR FEET OF SUBSTRUCTURE:
 CAP BEAMS = 206'
 STRINGERS = 750'
 TOTAL = 956'

EXISTING LINEAR FEET OF SUBSTRUCTURE NEEDING REPLACEMENT:
 CAP BEAMS = 110'
 STRINGERS = 115'
 TOTAL = 225' OR 23%

EXISTING LINEAR FEET OF SUBSTRUCTURE TO BE REMOVED:
 STRINGERS = 67'

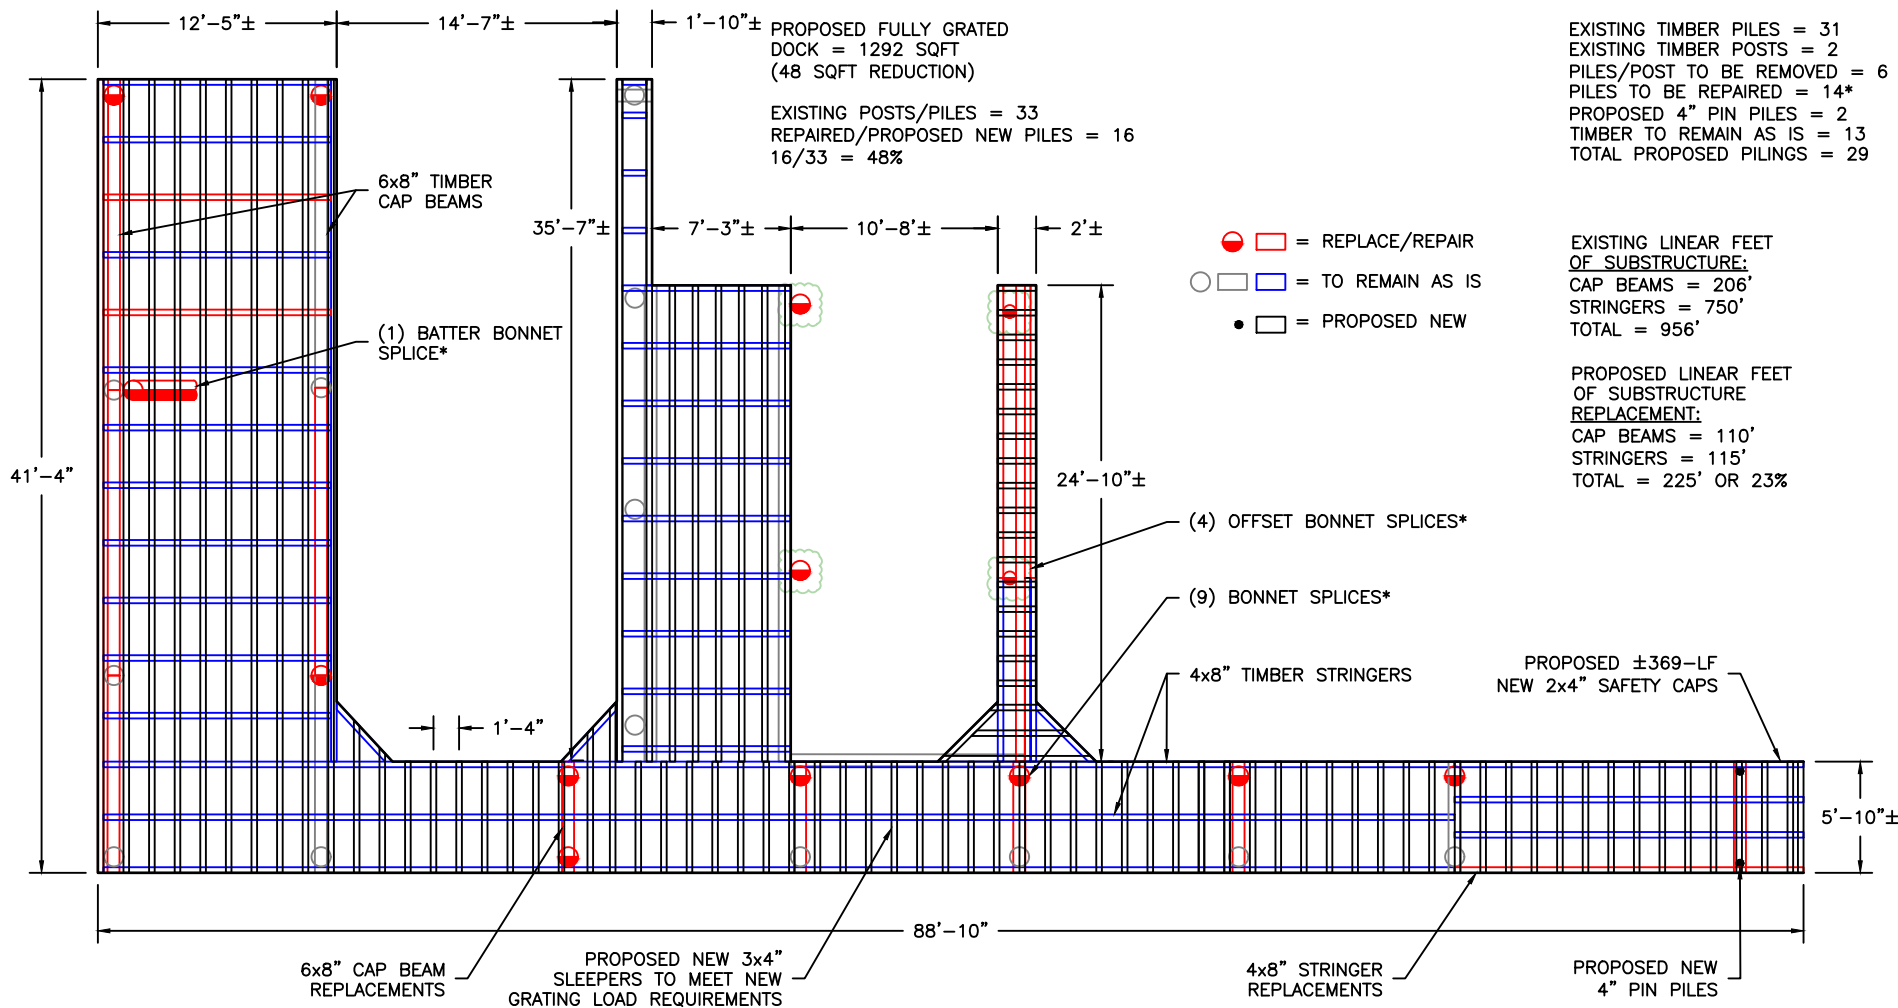
PROPOSED FRAMING DETAIL PLAN VIEW

SUBSTRUCTURE REPAIRS:
CAP BEAMS / STRINGERS = 23% OF 956 (23x956=219.88)
PILING = 48% OF 33 (.48x33=15.84)
(219.88+15.84) / (956+33) = 24% OF TOTAL SUBSTRUCTURE REPAIR

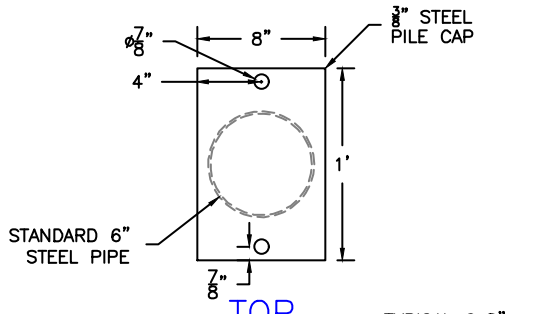
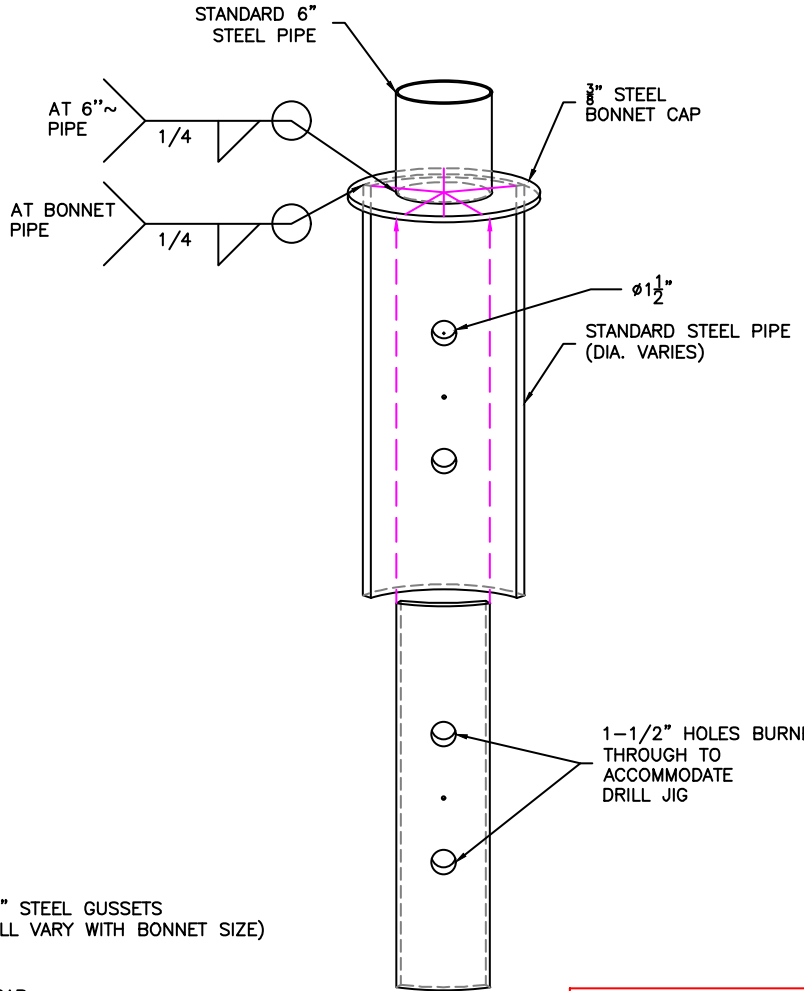
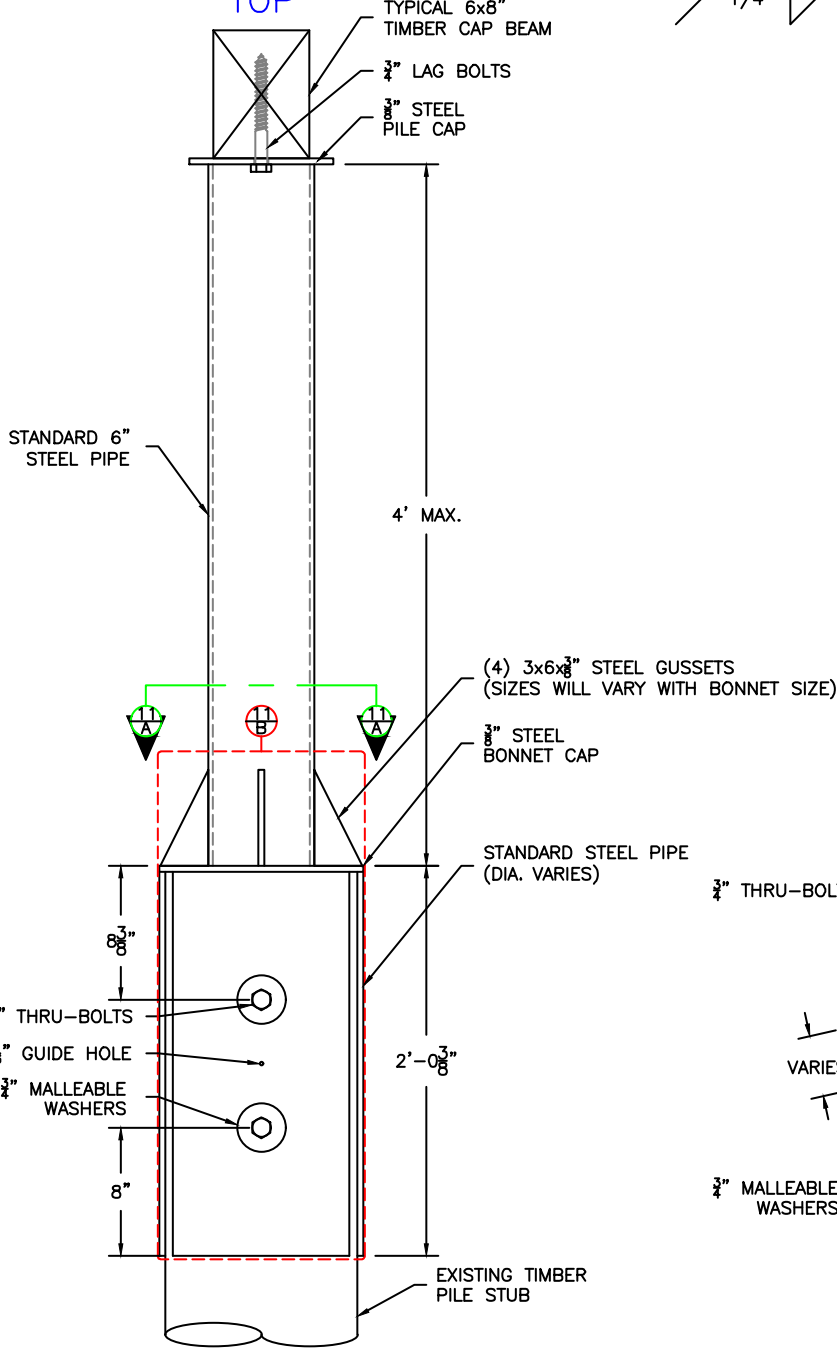
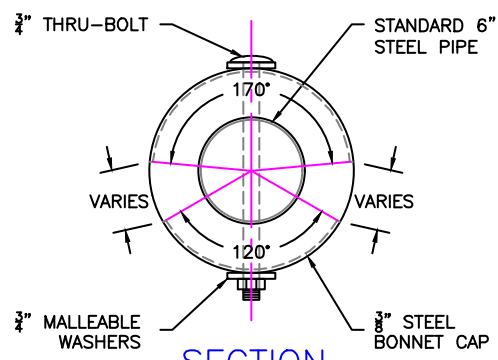
BONNET SPLICE

DETAIL 11-B

NOTE:
STEEL GUSSETS LEFT OUT OF DETAIL & SECTION VIEWS FOR CLARITY.

FRONT

SECTION 11-A

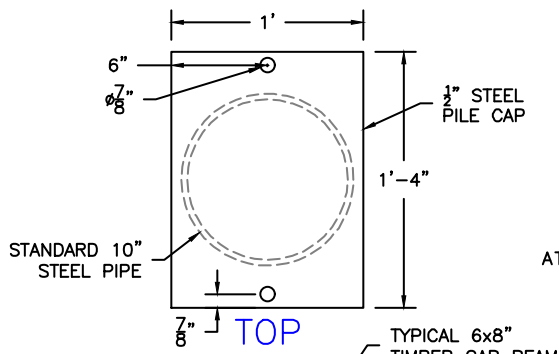
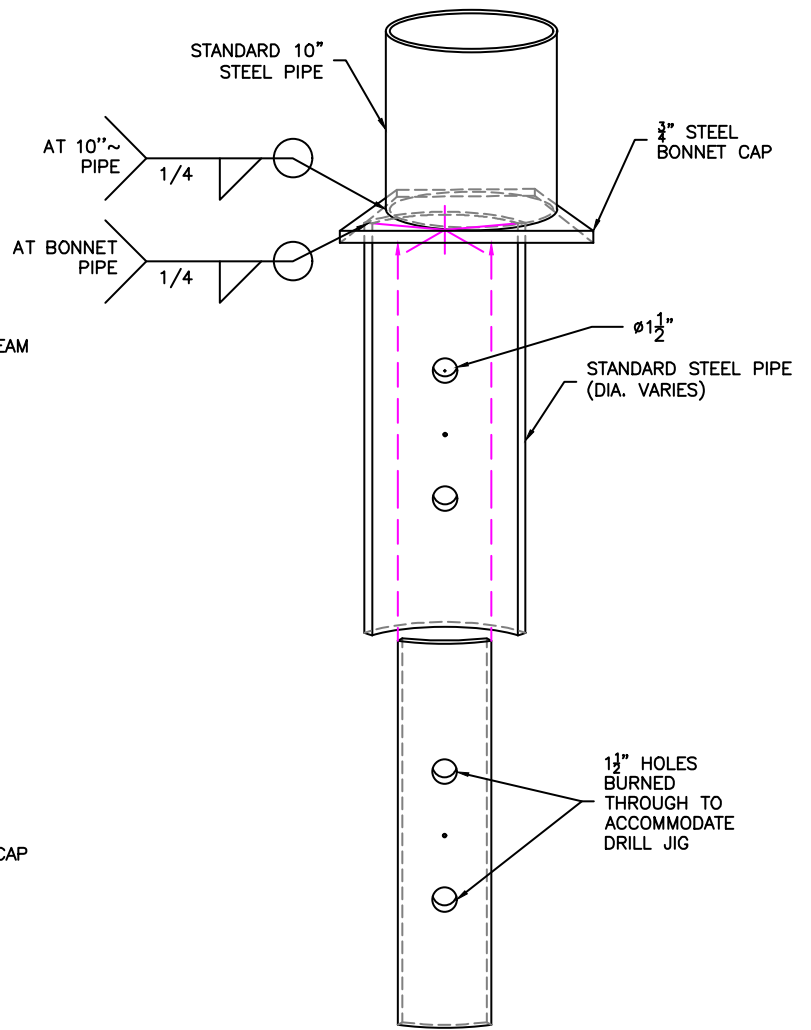
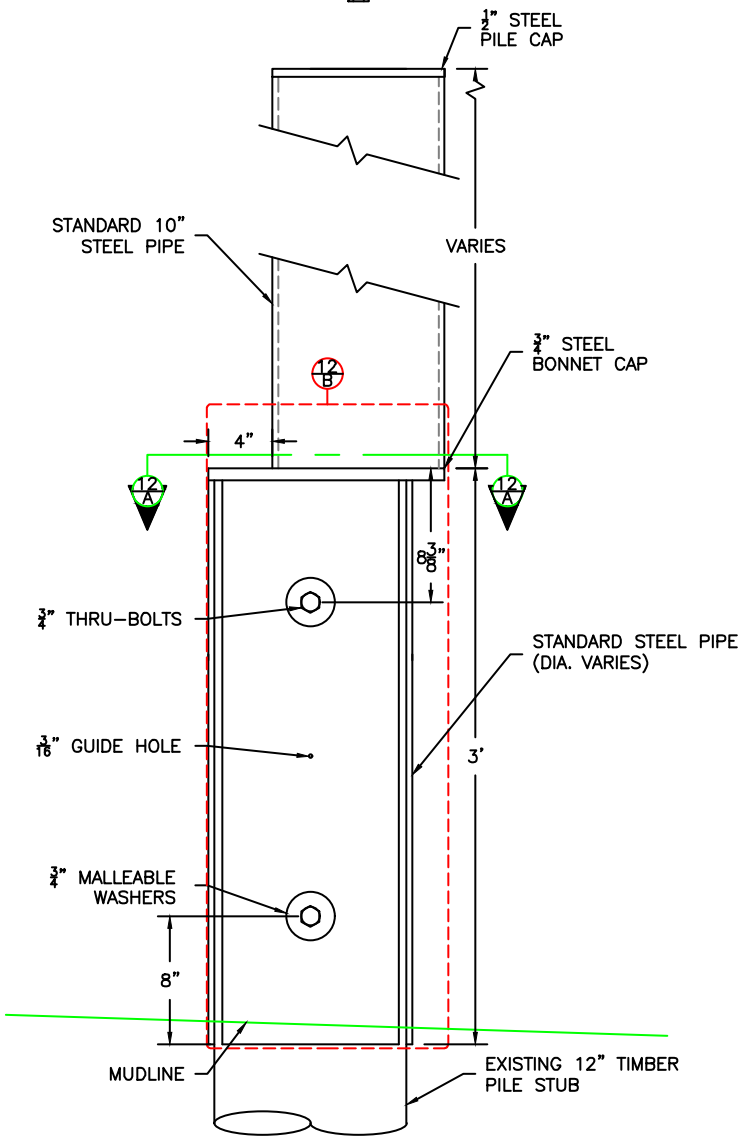
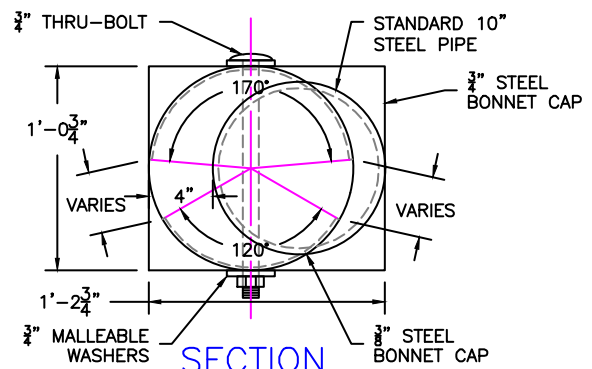
OFFSET BONNET SPLICE

TOP

DETAIL 12-B

FRONT

SECTION 12-A

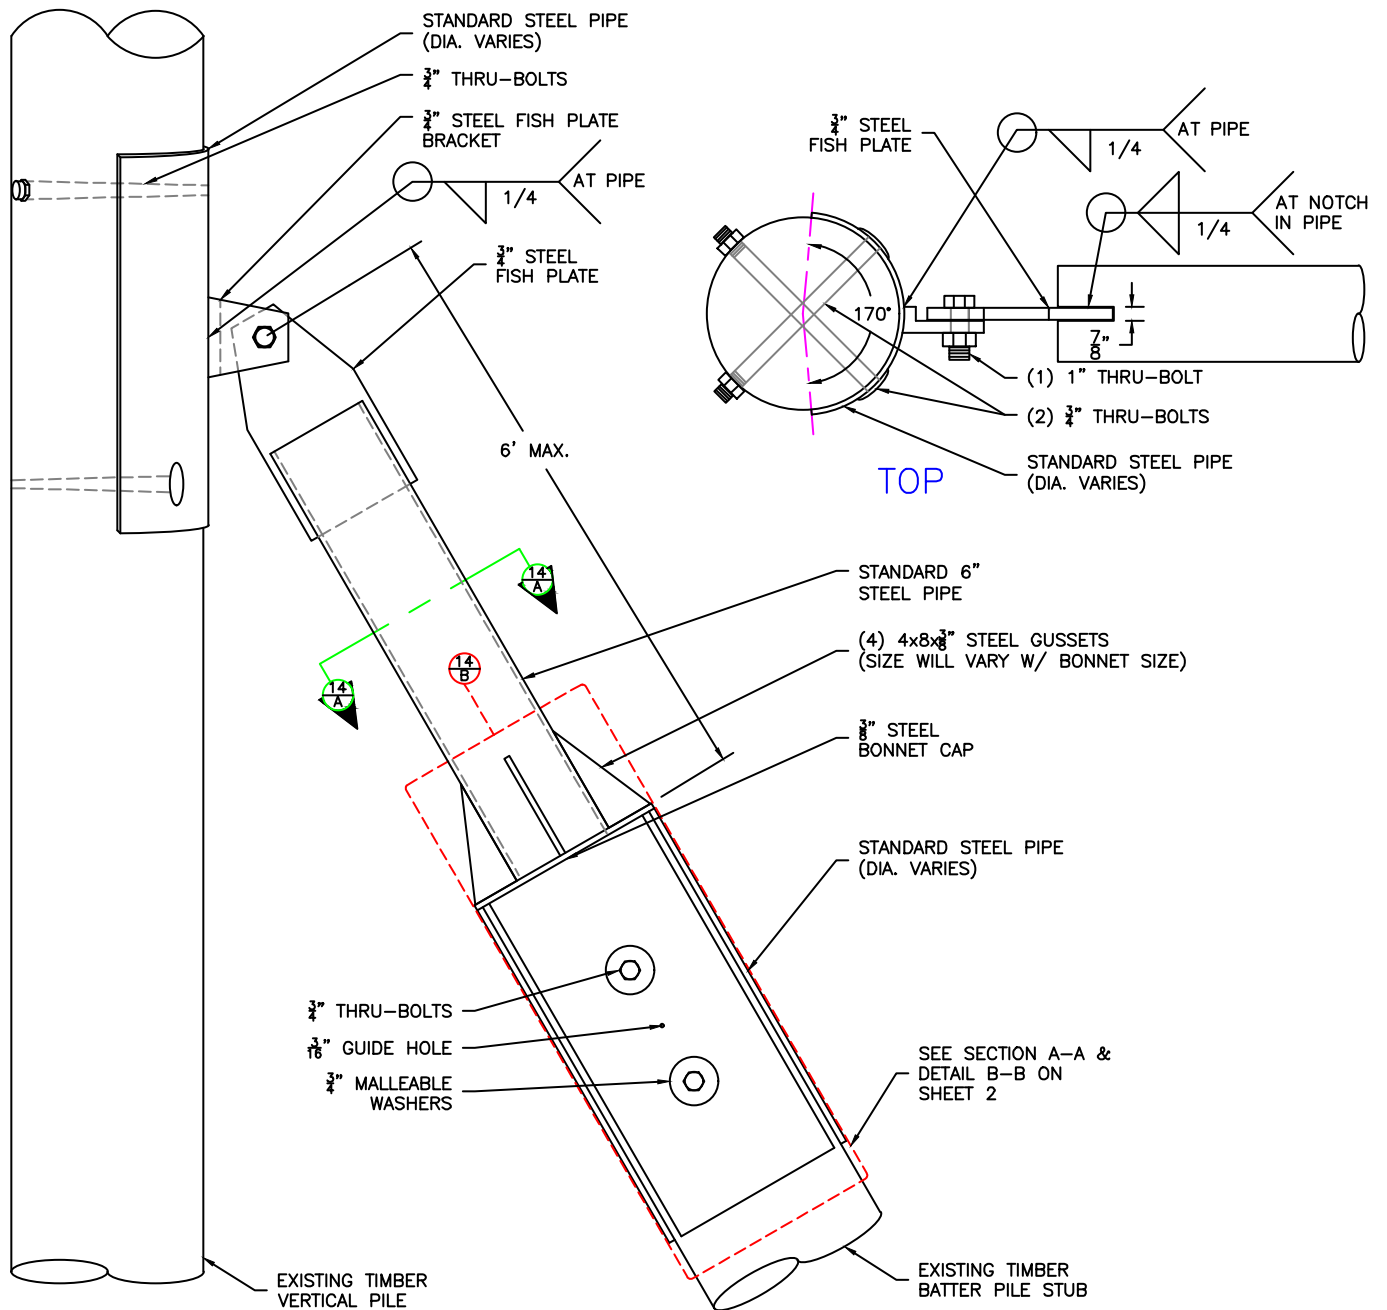
BATTER BONNET SPLICE

SIDE

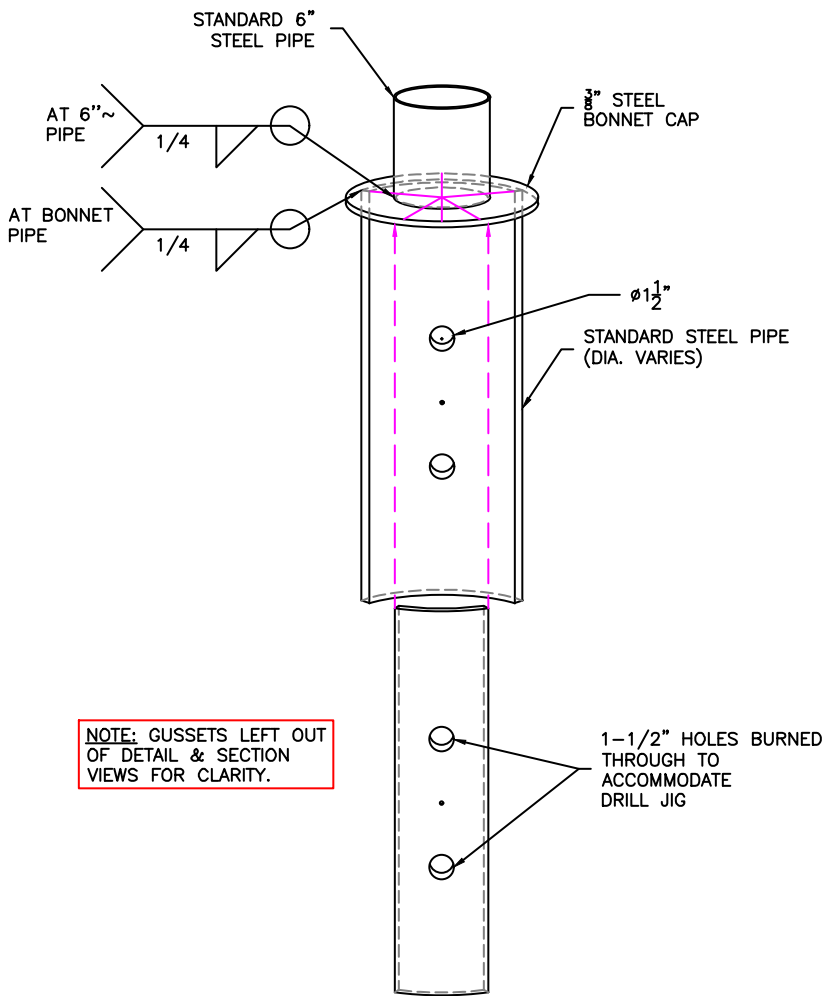
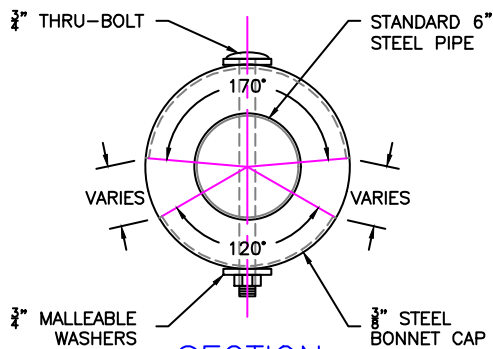
DETAIL
14-B

SECTION
14-A
