PROPOSED: PIER REPAIR

PURPOSE: RESTORE PIER INTEGRITY

DWG#: 19-31042-A14-1

REFERENCE #:		
APPLICANT: DOUGLAS ROSEN		
PROPOSED: PIER REPAIR		
SHEET: 3	OF: 18	NEAR/AT: MERCER ISLAND
DATE: 2-7-2020		DWG#: 19-31042-A14-3

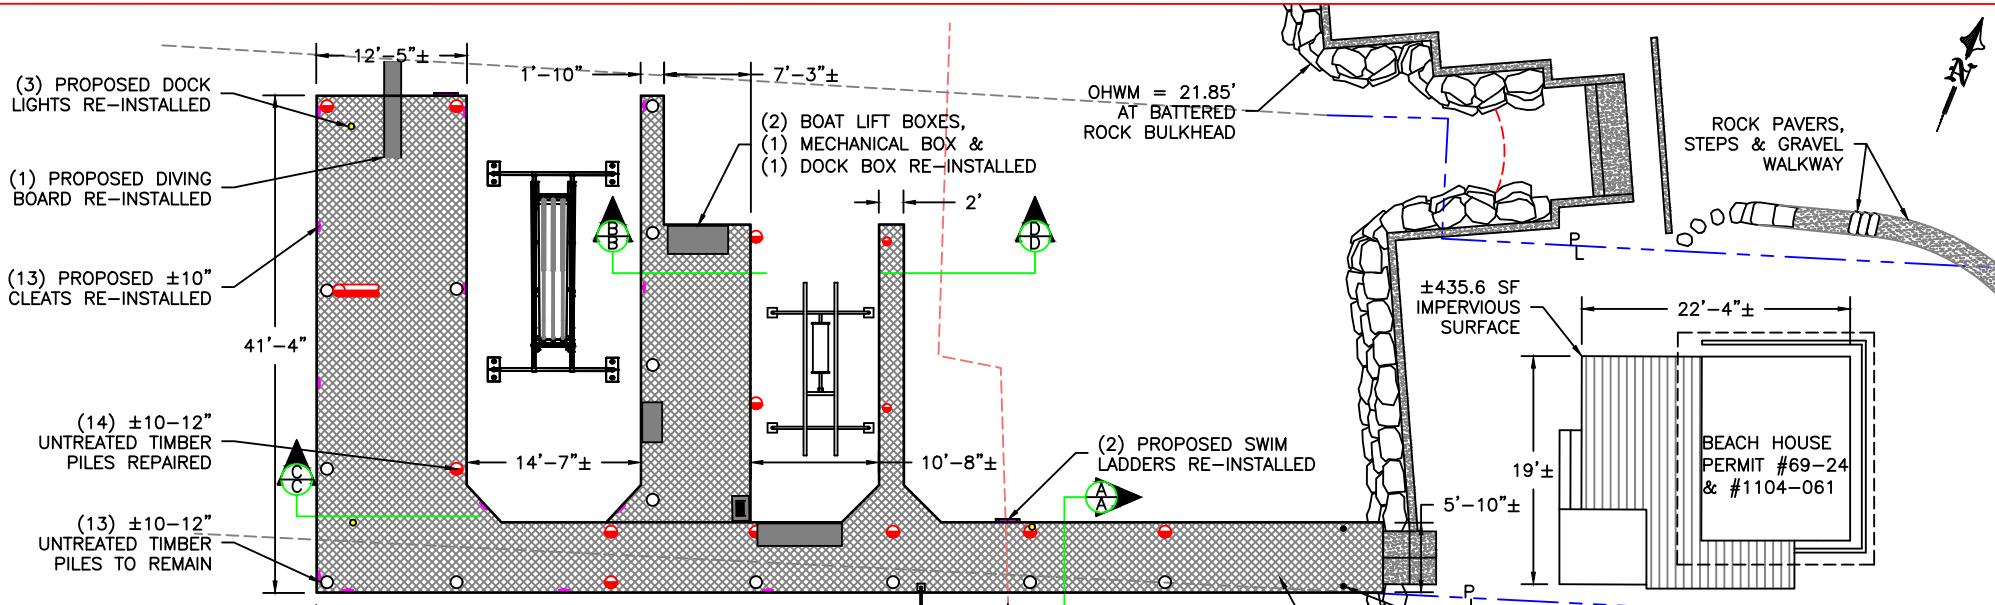
PROPOSED DETAIL VIEW
SCALE: 1/16"=1'

PROPOSED SQUARE FOOTAGE = 1269
NOTE: 71 SQFT REDUCTION. 2 PILE REDUCTION.

- (14) ±10-12" UNTREATED TIMBER PILES REPAIRED
- (3) DOCK LIGHTS TO BE RETAINED & RE-INSTALLED

- = PILES TO REMAIN (13)
- = PILES REPAIRED (14)
- = NEW PIN PILES (2)

- (2) BOAT LIFT BOXES, (1) MECHANICAL BOX & (1) DOCK BOX RE-INSTALLED
- (2) SWIM LADDERS TO BE RETAINED & RE-INSTALLED
- (2) PROPOSED NEW 4" PIN PILES

EXISTING BULKHEAD TO REMAIN AS IS

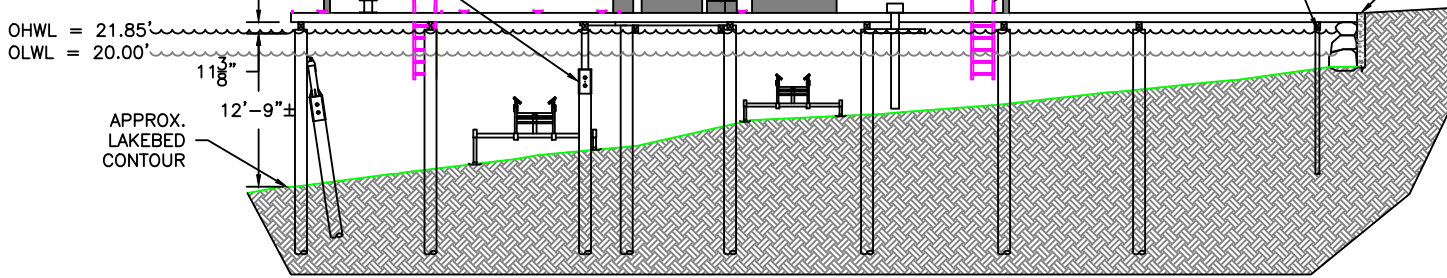
PROPOSED ELEVATION VIEW

SEE SHEETS 9-16 FOR PILE REPAIR DETAILS.
SEE SHEETS 9-10 FOR SUBSTRUCTURE REPAIR DETAILS.

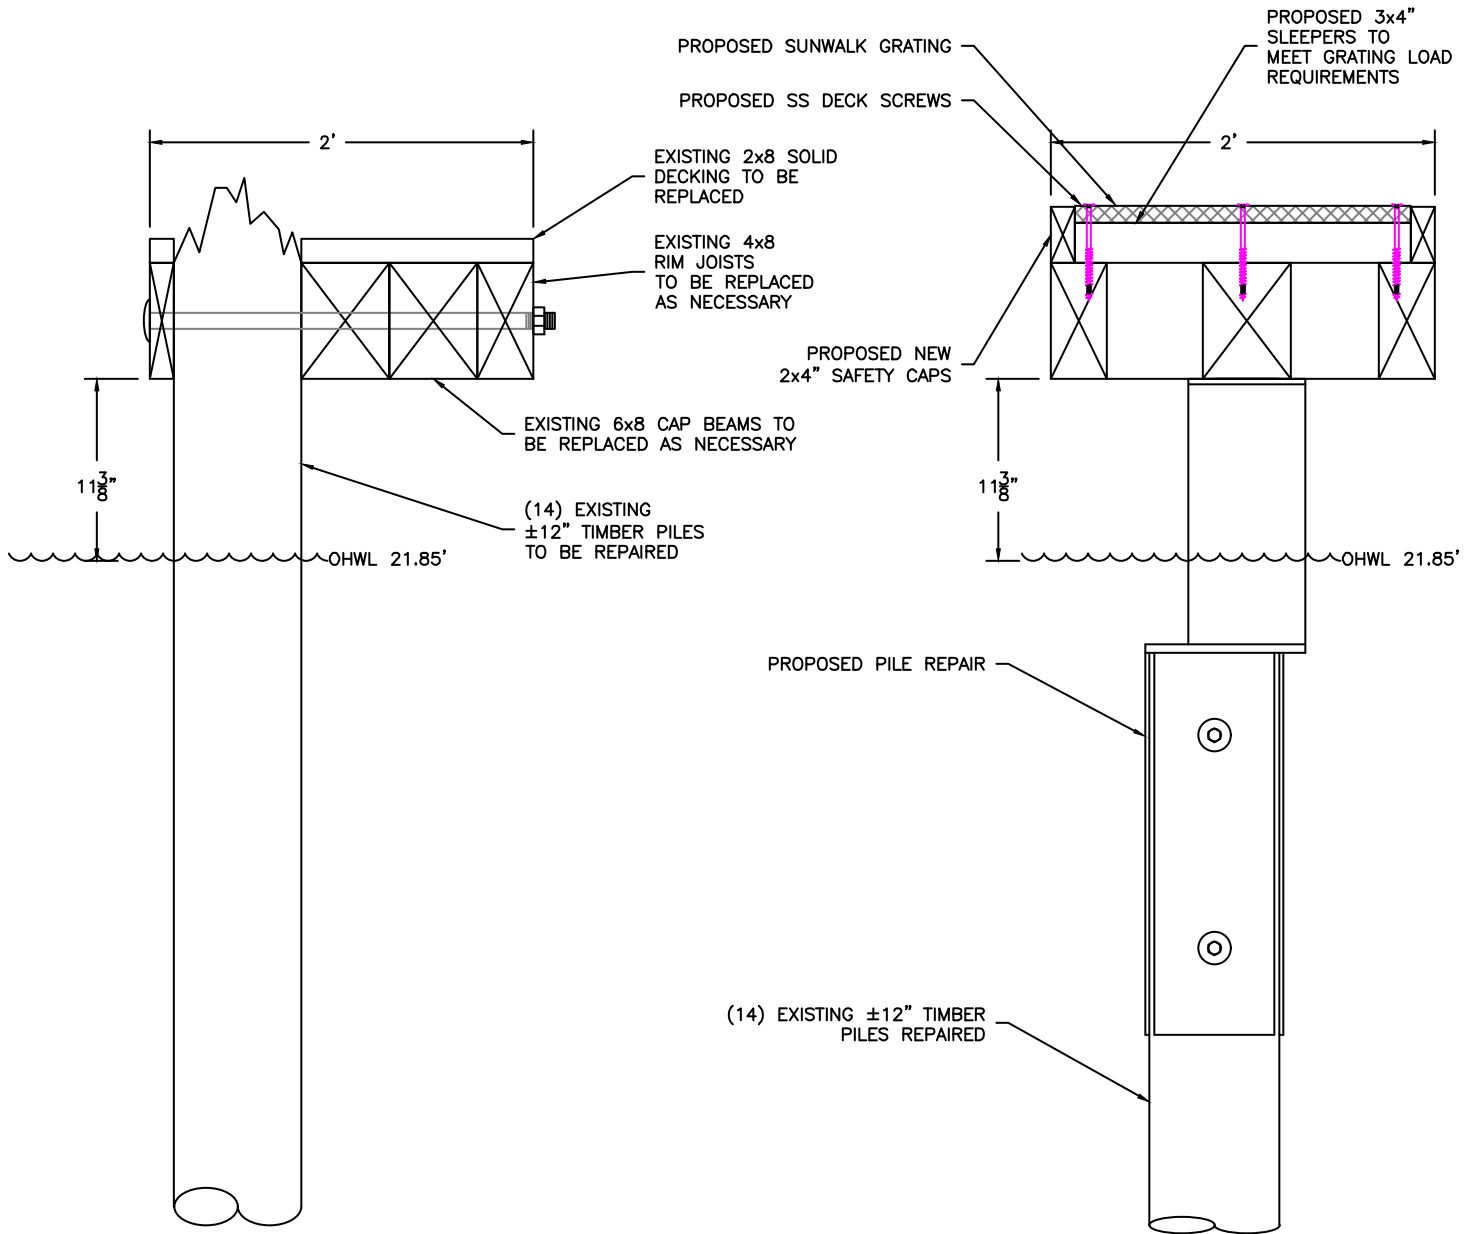
EXISTING SECTION D-D

PROPOSED SECTION D-D

SEE SHEETS 9-16 FOR PILE REPAIR DETAILS.
SEE SHEETS 9-10 FOR SUBSTRUCTURE REPAIR DETAILS.

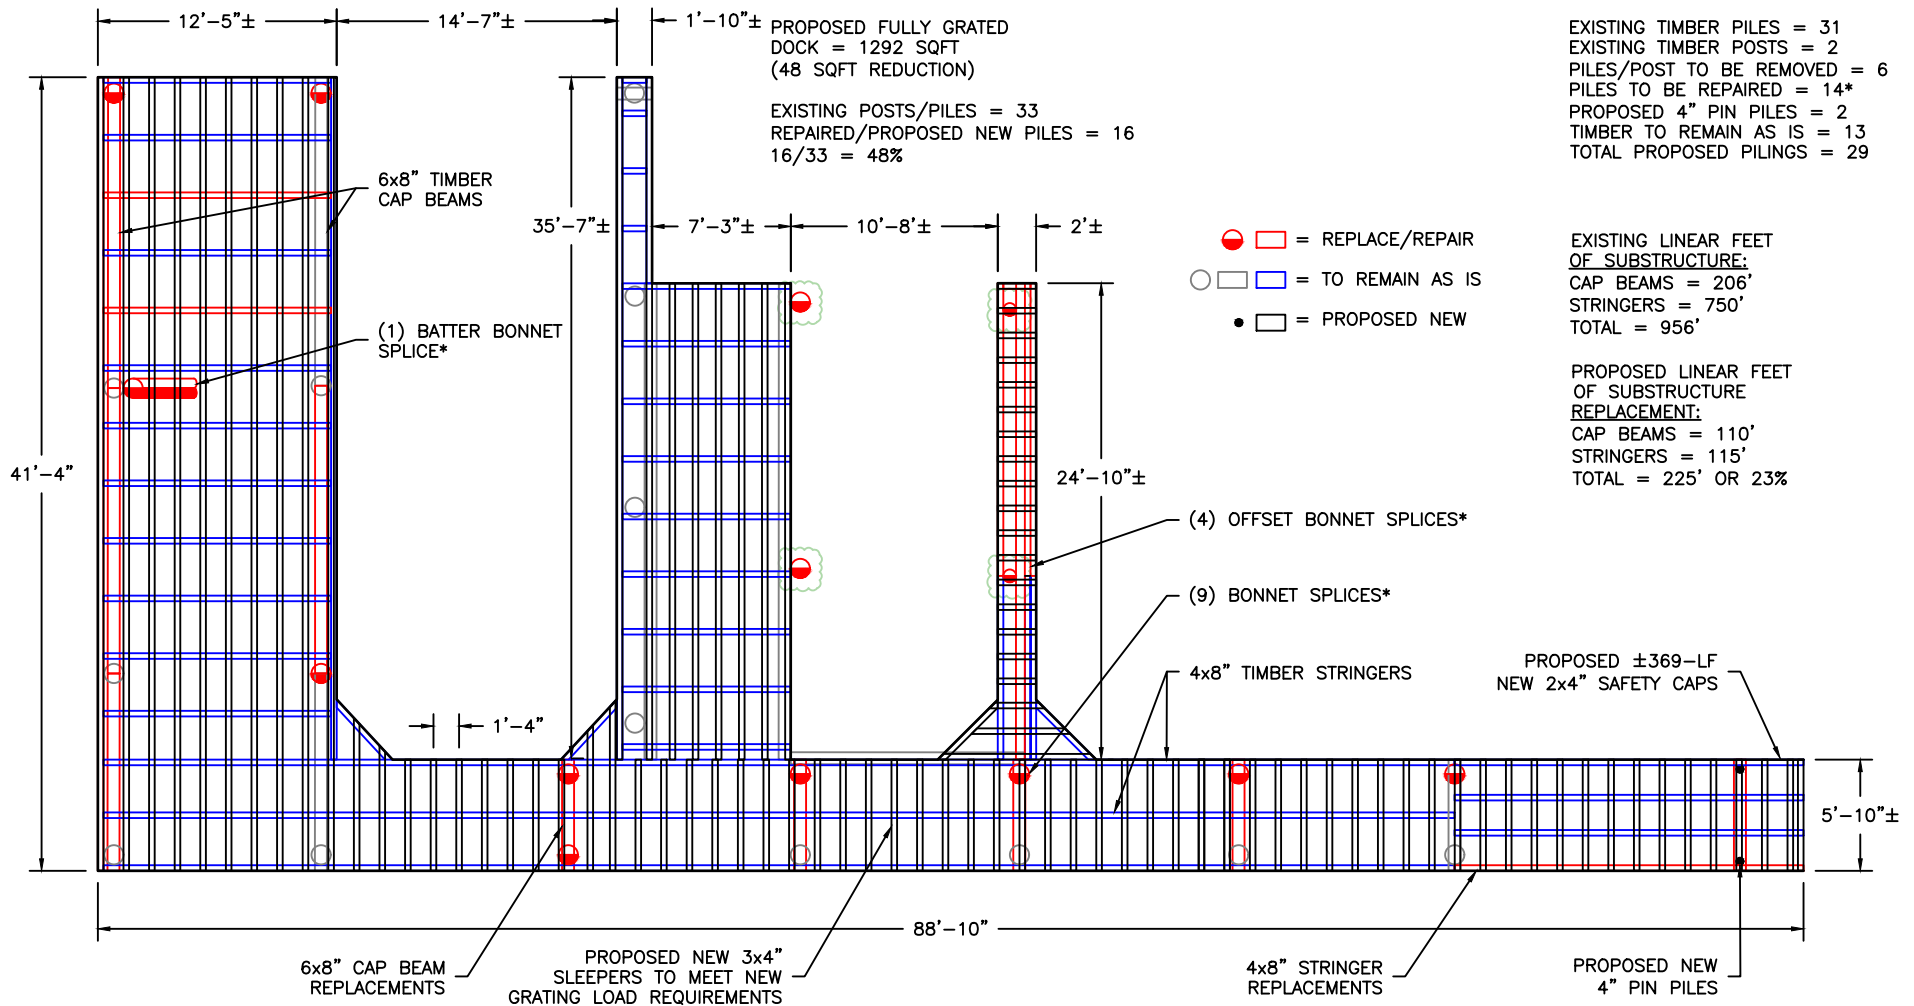
PROPOSED FRAMING DETAIL PLAN VIEW

PROPOSED FULLY GRATED DOCK = 1292 SQFT (48 SQFT REDUCTION)
 EXISTING POSTS/PILES = 33
 REPAIRED/PROPOSED NEW PILES = 16
 16/33 = 48%

EXISTING TIMBER PILES = 31
 EXISTING TIMBER POSTS = 2
 PILES/POST TO BE REMOVED = 6
 PILES TO BE REPAIRED = 14*
 PROPOSED 4" PIN PILES = 2
 TIMBER TO REMAIN AS IS = 13
 TOTAL PROPOSED PILING = 29

EXISTING LINEAR FEET OF SUBSTRUCTURE:
 CAP BEAMS = 206'
 STRINGERS = 750'
 TOTAL = 956'

PROPOSED LINEAR FEET OF SUBSTRUCTURE REPLACEMENT:
 CAP BEAMS = 110'
 STRINGERS = 115'
 TOTAL = 225' OR 23%

SUBSTRUCTURE REPAIRS:
 CAP BEAMS / STRINGERS = 23% OF 956 (23x956=219.88)
 PILING = 48% OF 33 (.48x33=15.84)
 (219.88+15.84) / (956+33) = 24% OF TOTAL SUBSTRUCTURE REPAIR

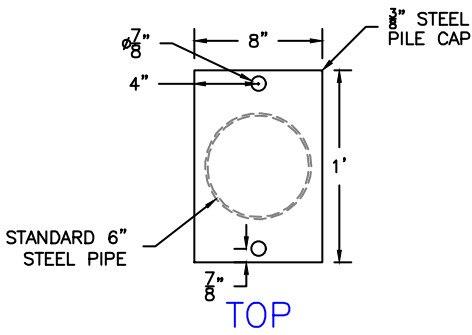
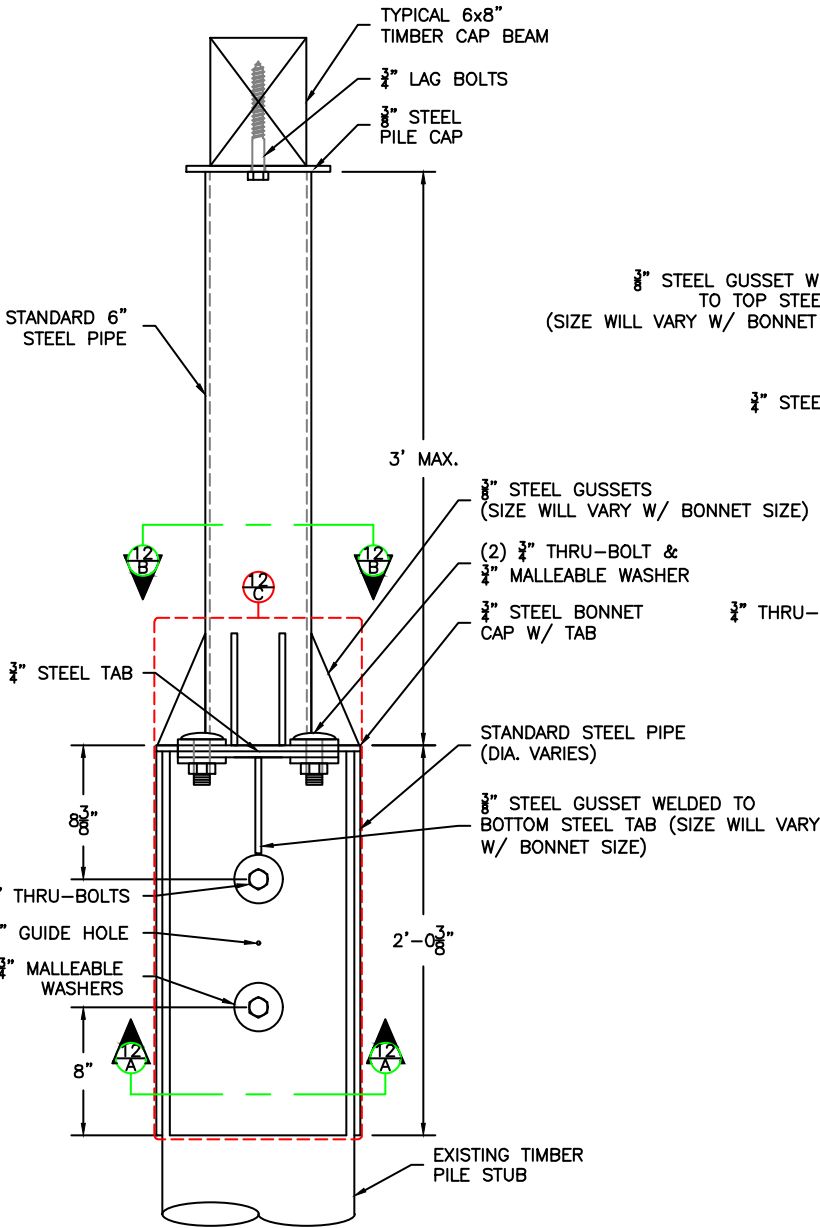
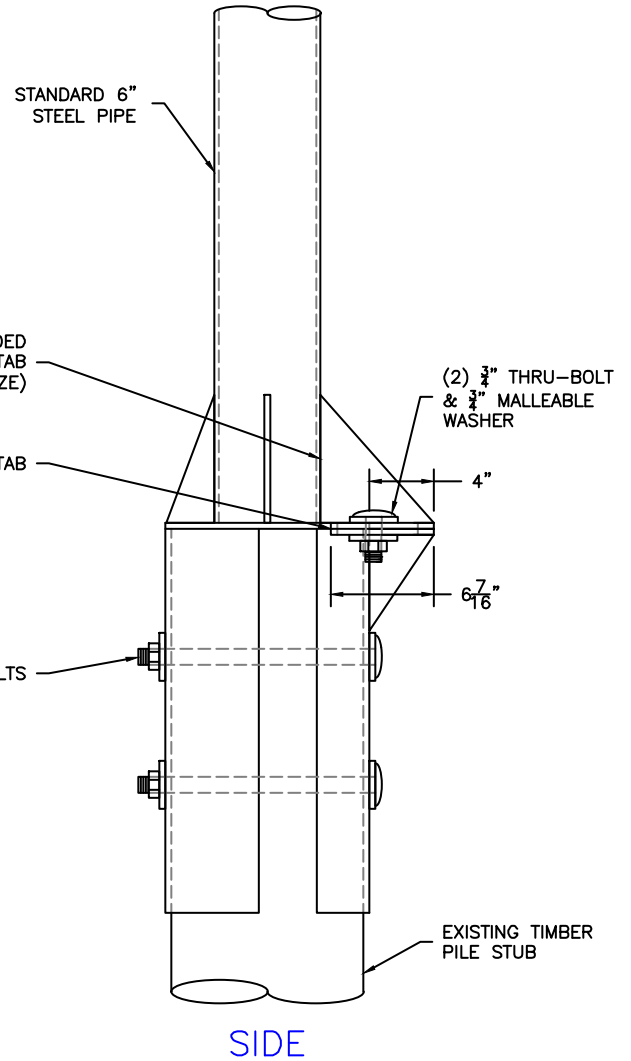
BONNET SPLICE

FRONT

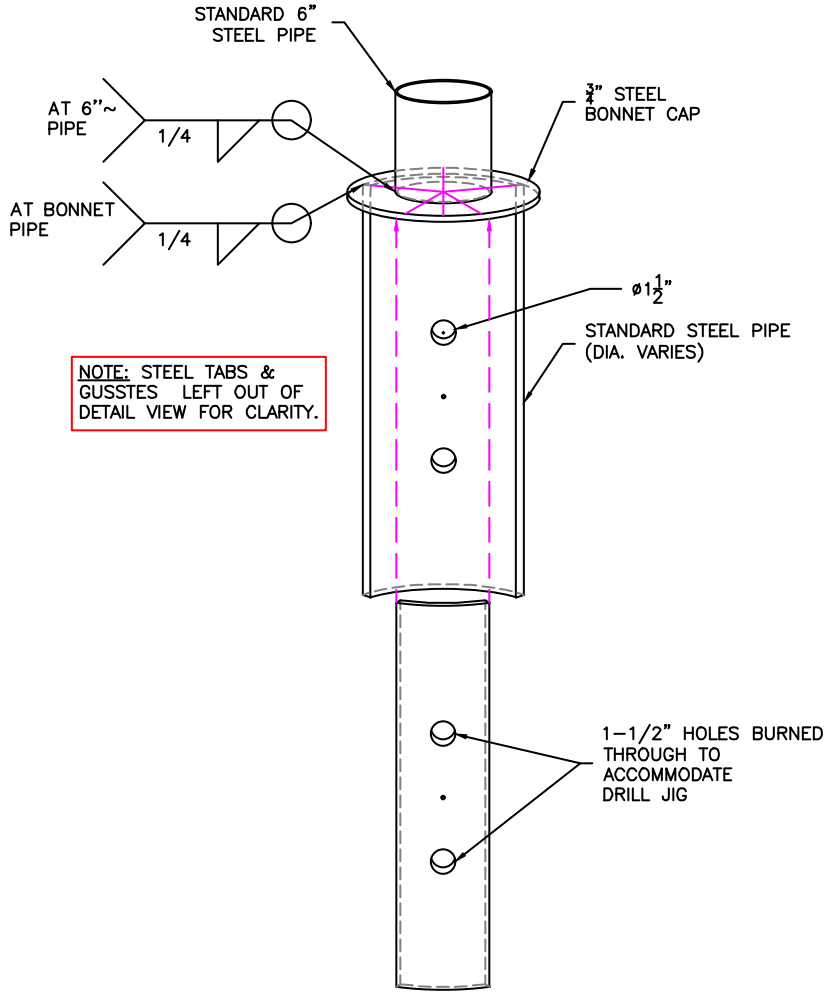
**DETAIL
12-C**

NOTE: STEEL TABS & GUSSETS LEFT OUT OF DETAIL VIEW FOR CLARITY.

BONNET SPLICE

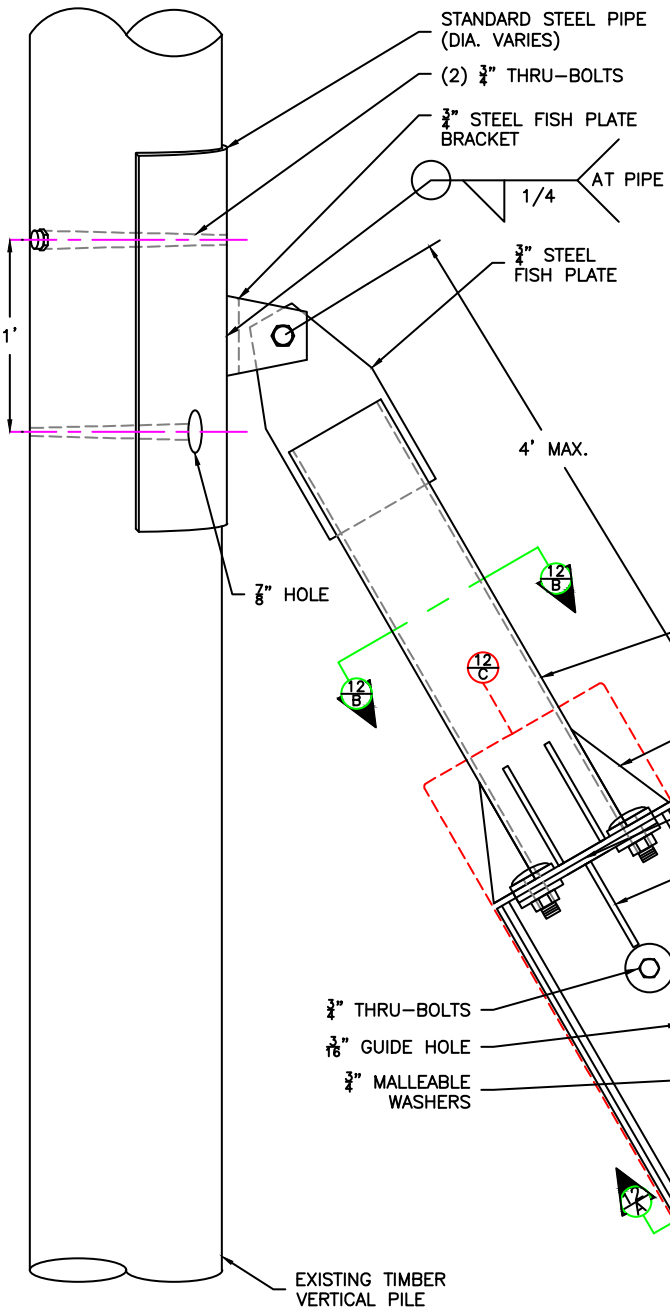
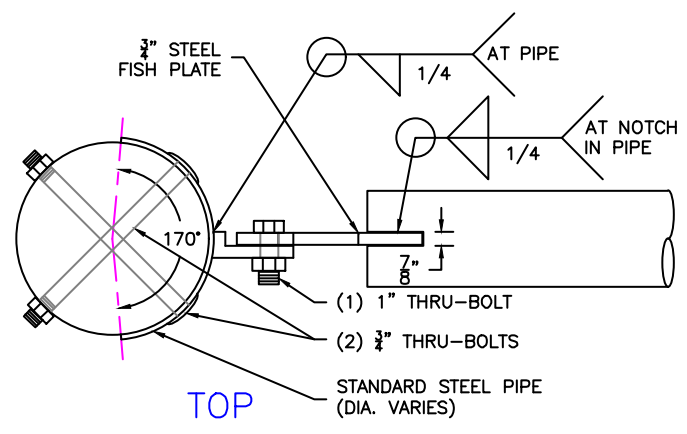
BATTER BONNET SPLICE

SEE SHEET 14 FOR FISH PLATE BRACKET DETAILS.

SIDE

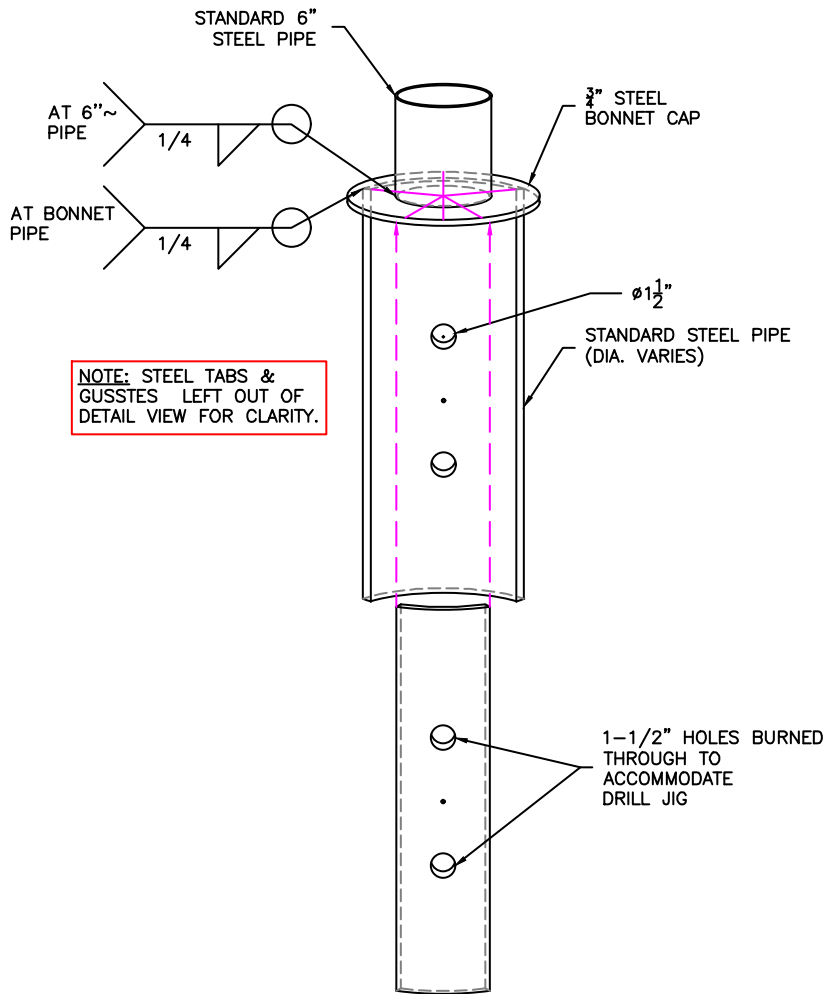
DETAIL 16-C

NOTE: STEEL TABS & GUSSETS LEFT OUT OF DETAIL VIEW FOR CLARITY.

OFFSET BONNET SPLICE

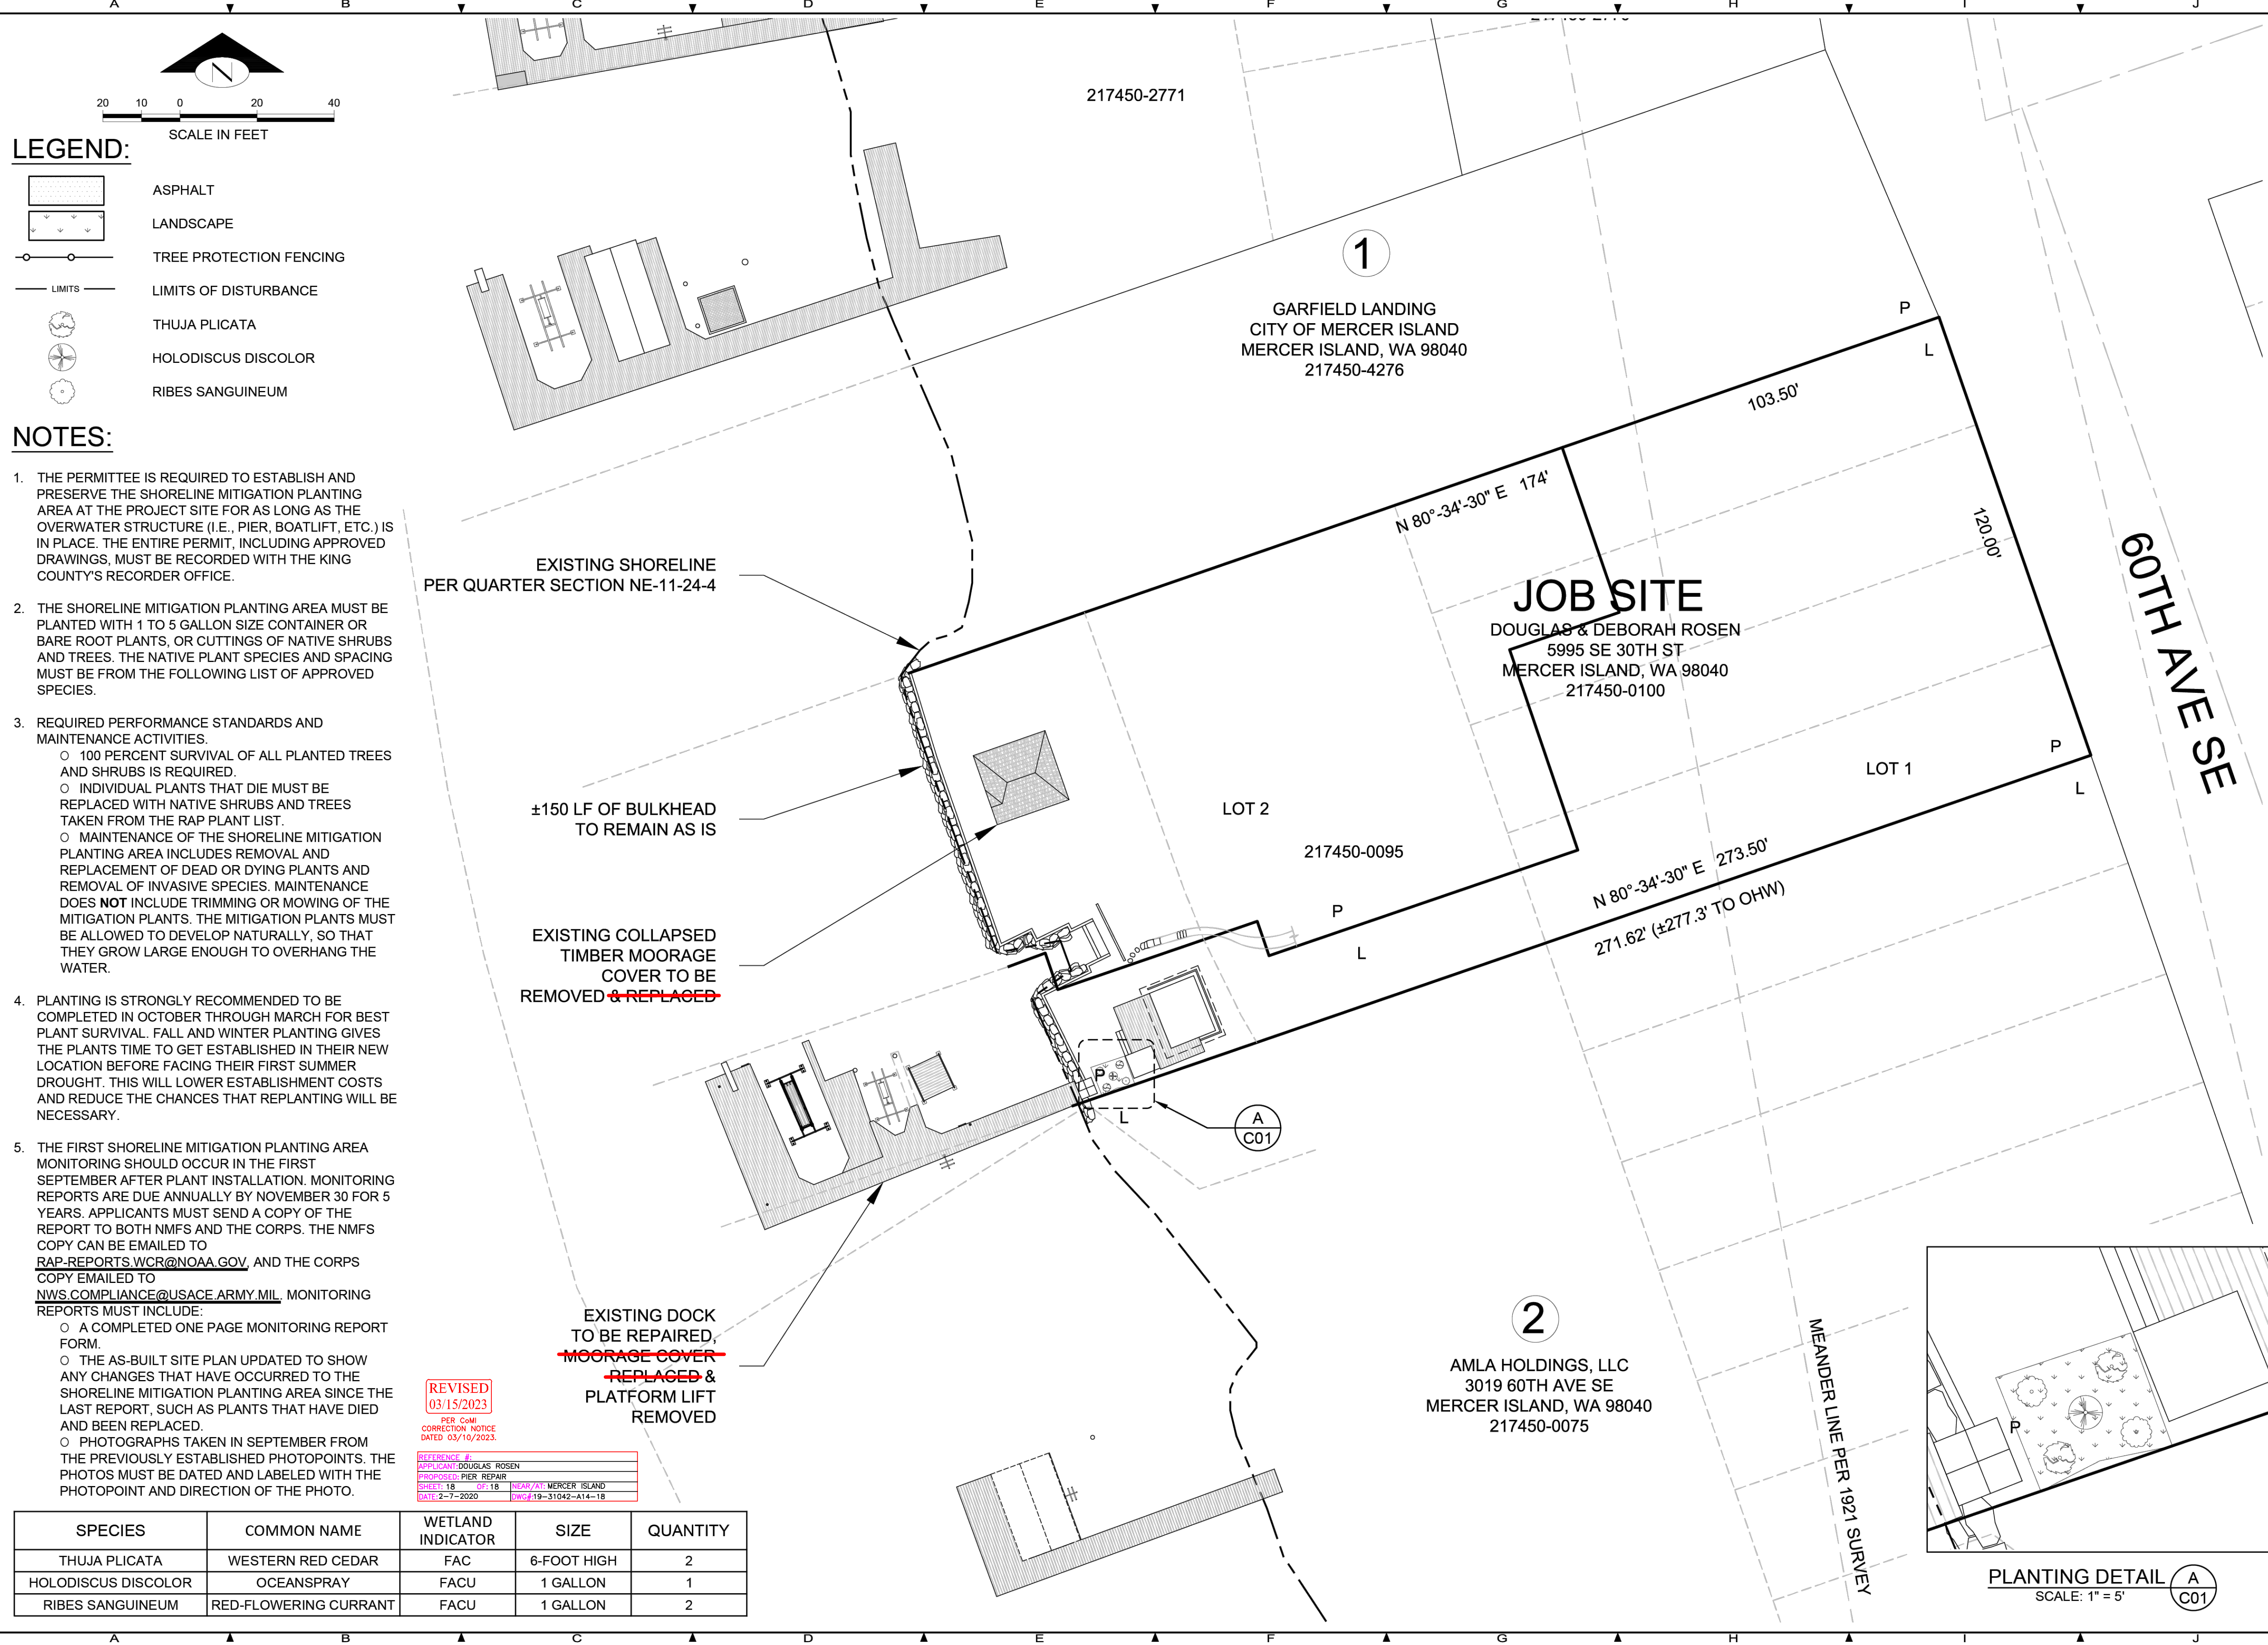
3. REQUIRED PERFORMANCE STANDARDS AND MAINTENANCE ACTIVITIES.
 - 100 PERCENT SURVIVAL OF ALL PLANTED TREES AND SHRUBS IS REQUIRED.
 - INDIVIDUAL PLANTS THAT DIE MUST BE REPLACED WITH NATIVE SHRUBS AND TREES TAKEN FROM THE RAP PLANT LIST.

- MAINTENANCE OF THE SHORELINE MITIGATION PLANTING AREA INCLUDES REMOVAL AND REPLACEMENT OF DEAD OR DYING PLANTS AND REMOVAL OF INVASIVE SPECIES. MAINTENANCE DOES NOT INCLUDE TRIMMING OR MOWING OF THE MITIGATION PLANTS. THE MITIGATION PLANTS MUST BE ALLOWED TO DEVELOP NATURALLY, SO THAT THEY GROW LARGE ENOUGH TO OVERHANG THE WATER.

4. PLANTING IS STRONGLY RECOMMENDED TO BE COMPLETED IN OCTOBER THROUGH MARCH FOR BEST PLANT SURVIVAL. FALL AND WINTER PLANTING GIVES THE PLANTS TIME TO GET ESTABLISHED IN THEIR NEW LOCATION BEFORE FACING THEIR FIRST SUMMER DROUGHT. THIS WILL LOWER ESTABLISHMENT COSTS AND REDUCE THE CHANCES THAT REPLANTING WILL BE NECESSARY.
