Office: 206-236-1700 ext. 3 www.seabornpiledriving.com Scope of Work: We propose to repair (10) piles and repair the dock with grated decking material.

# PIER DETAILS - EXISTING/PROPOSED

PROJECT: Kittilsby, Lisa 2025 W. Mercer Way Mercer Island, WA 98040 COUNTY: KING COUNTY IN: LAKE WASHINGTON

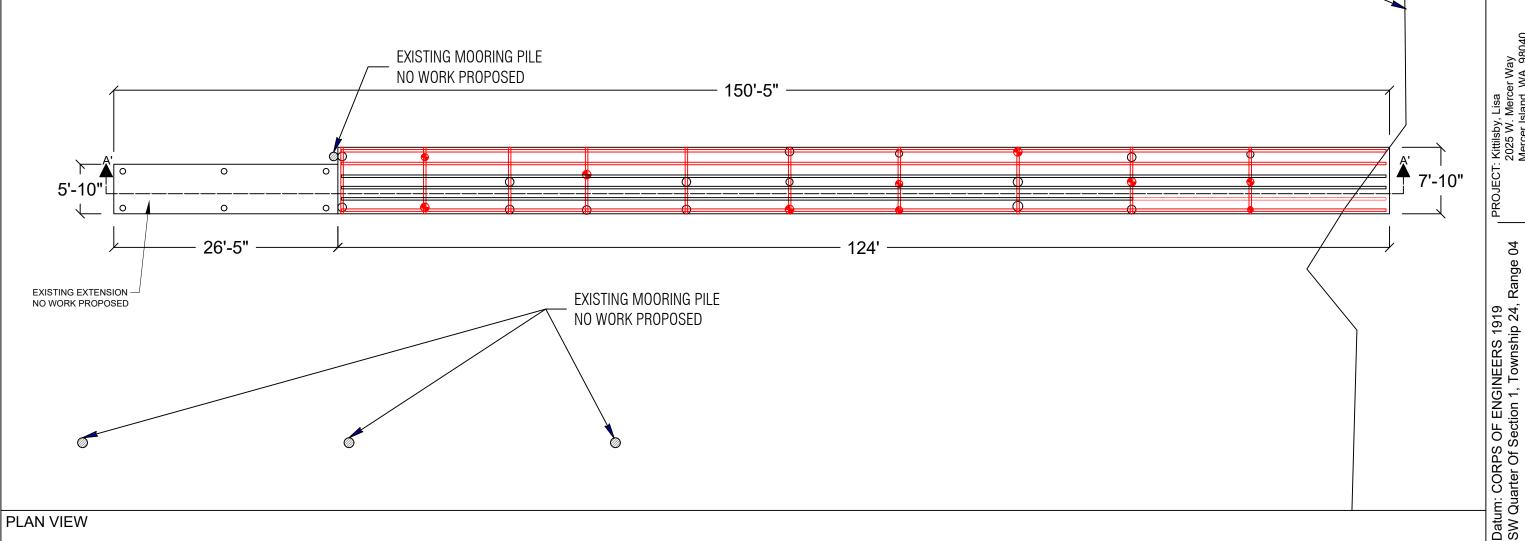
**PLAN VIEW**

## **EXISTING MEMBERS**

- (35) EXISTING PILES
- (10) EXISTING CAPS
- (60) EXISTING STRINGERS

(105) TOTAL EXISTING MEMBERS

## MEMBERS TO BE REPAIRED

- (10) EXISTING PILES TO BE REPAIRED
- (10) EXISTING CAPS TO BE REPAIRED
- (32) EXISTING STRINGERS TO BE REPAIRED
- (52) TOTAL EXISTING MEMBERS TO BE REPAIRED

105/52 = 49% OF EXISTING MEMBERS TO BE REPAIRED

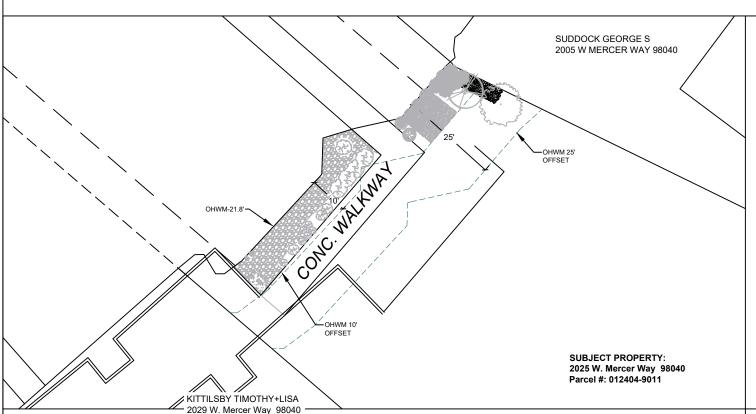
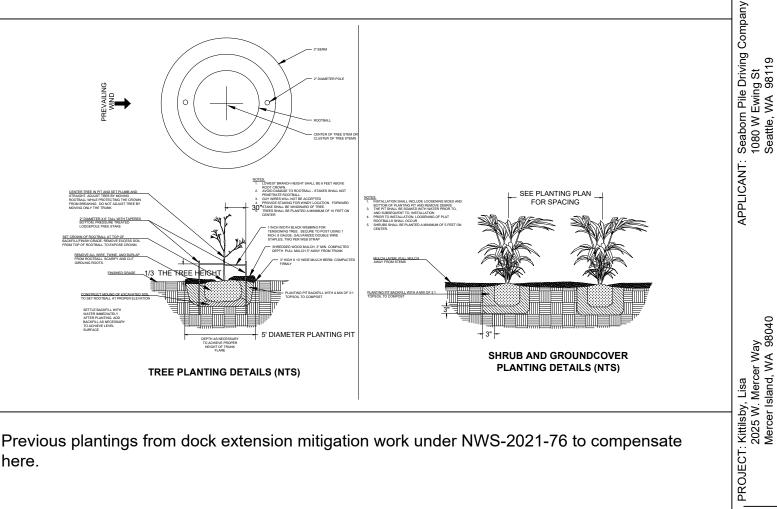
# MITIGATION PLAN

- 1. Shrubs are show, and shall be planted, at least five feet on center. Trees are show, and shall be planted, at least ten feet to center.
- 2. The property owner will implement and abide by the shoreline planting plan. The plants shall be installed before or concurrent with the work authorized by this permit. A report, as-built drawing and photographs demonstrating the plants have been installed or a report on the status of project construction will be submitted to the U.S. Army Corps of Engineers, Seattle District, Regulatory Branch, within 12 months from the date of permit issuance. This reporting requirement may be met by completing and submitting a U.S. Army Corps of Engineers approved Report for Mitigation Work Completion form.

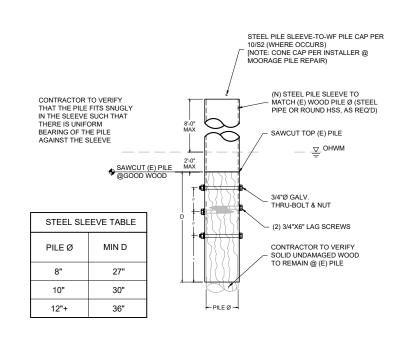
(S1) SLEEVE PILE REPAIR - TYP

Repair piles are done as a sleeve/strap method

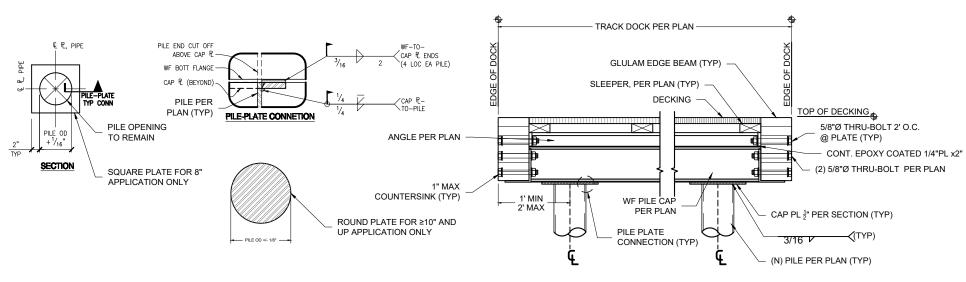
S3) I-BEAM CAP TO WOOD PILE - TYP

3" LAG SCREW ANGLE BEHIND EVERY 2' 1/4" CARRIAGE BOLT SLEEPER TO ANGLE SLEEPER PER PLAN AT EACH END SIDE PLATE **DECKING PER PLAN** WF PILE CROWN -TYP LAG BOLT 3/4" x 6" LAG . 0 (2) <sup>3</sup>/<sub>4</sub>"Ø THRUBOLT **EPOXY COATED** SIDE PL <sup>1</sup>/<sub>2</sub>"x4"x32" - TYP EACH SIDE **EXISTING WOOD** PILE - TYP

DOCK SECTION w/PILES - TYP (s1)
