SITE PLAN

Scope of Work: We propose to repair (14) dock piles, repair the 57 linear feet of existing rock bulkhead, remove approximately 214 sqft of hardscape, remove (6) dock piles & repair the existing decking with grated material.

Applicant: George Residence
9607 SE 72nd Street
Mercer Island, WA 98040

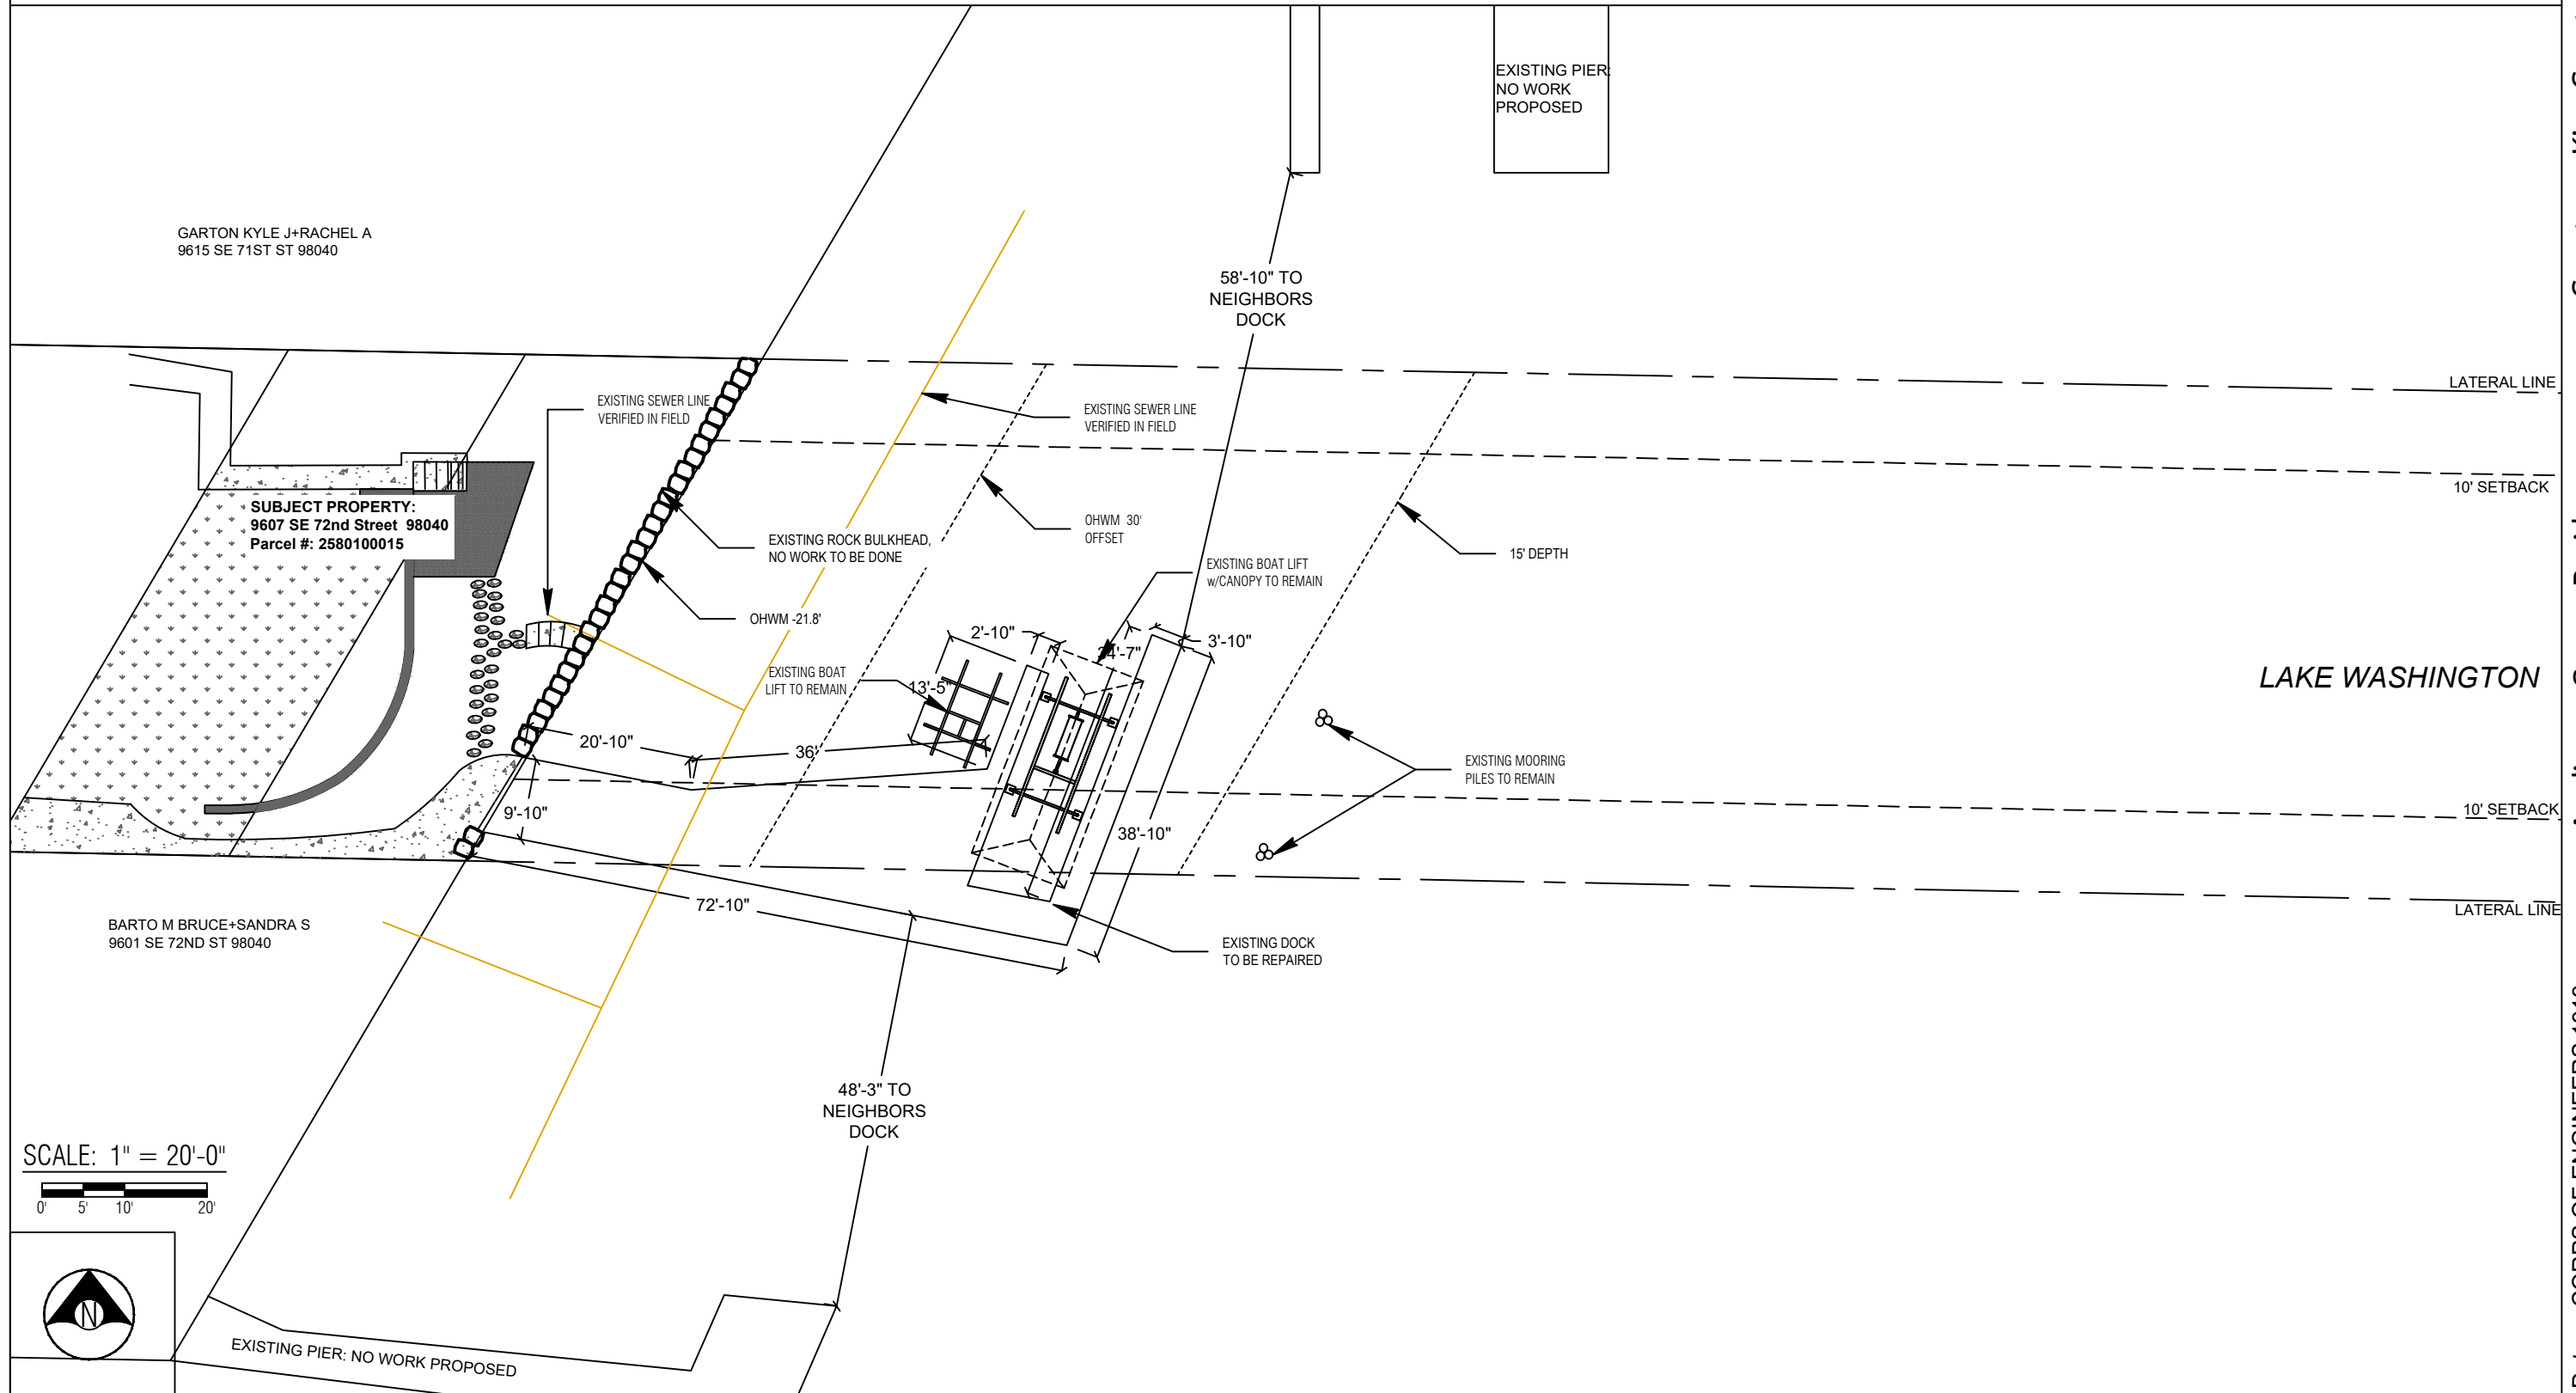
EXISTING CONDITIONS

****CLEAN UP LAKE AROUND PROJECT****

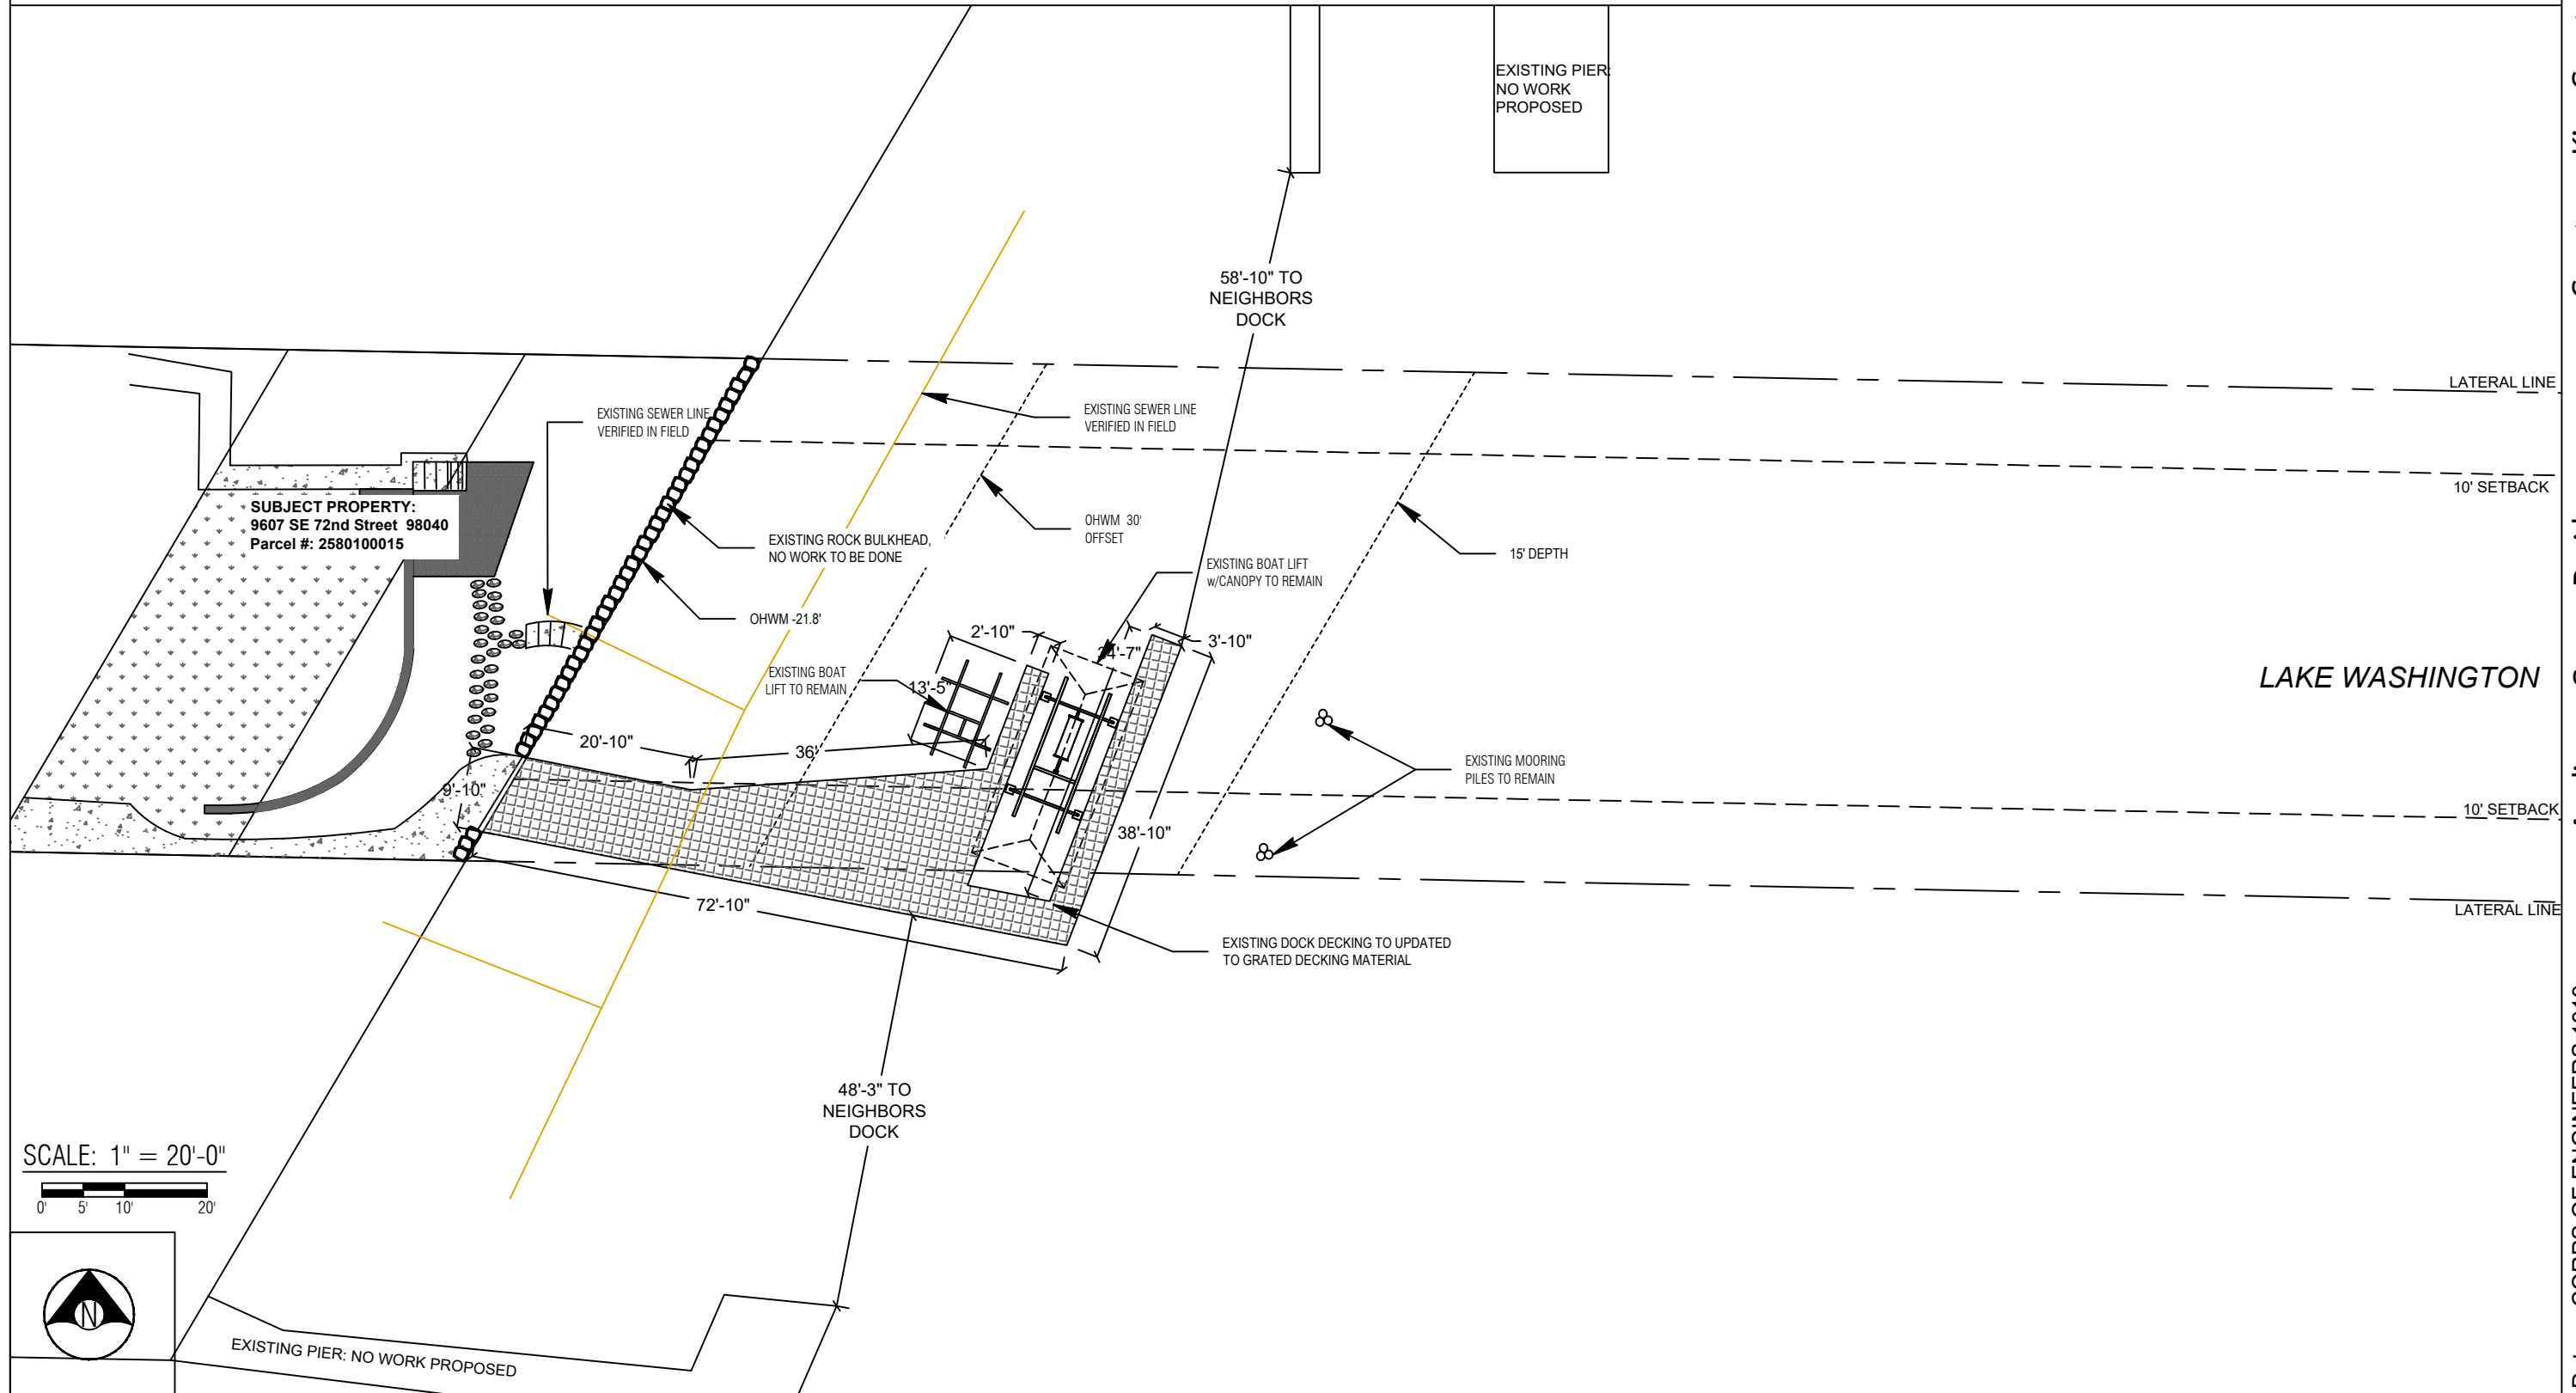
PROPOSED CONDITIONS

****CLEAN UP LAKE AROUND PROJECT****

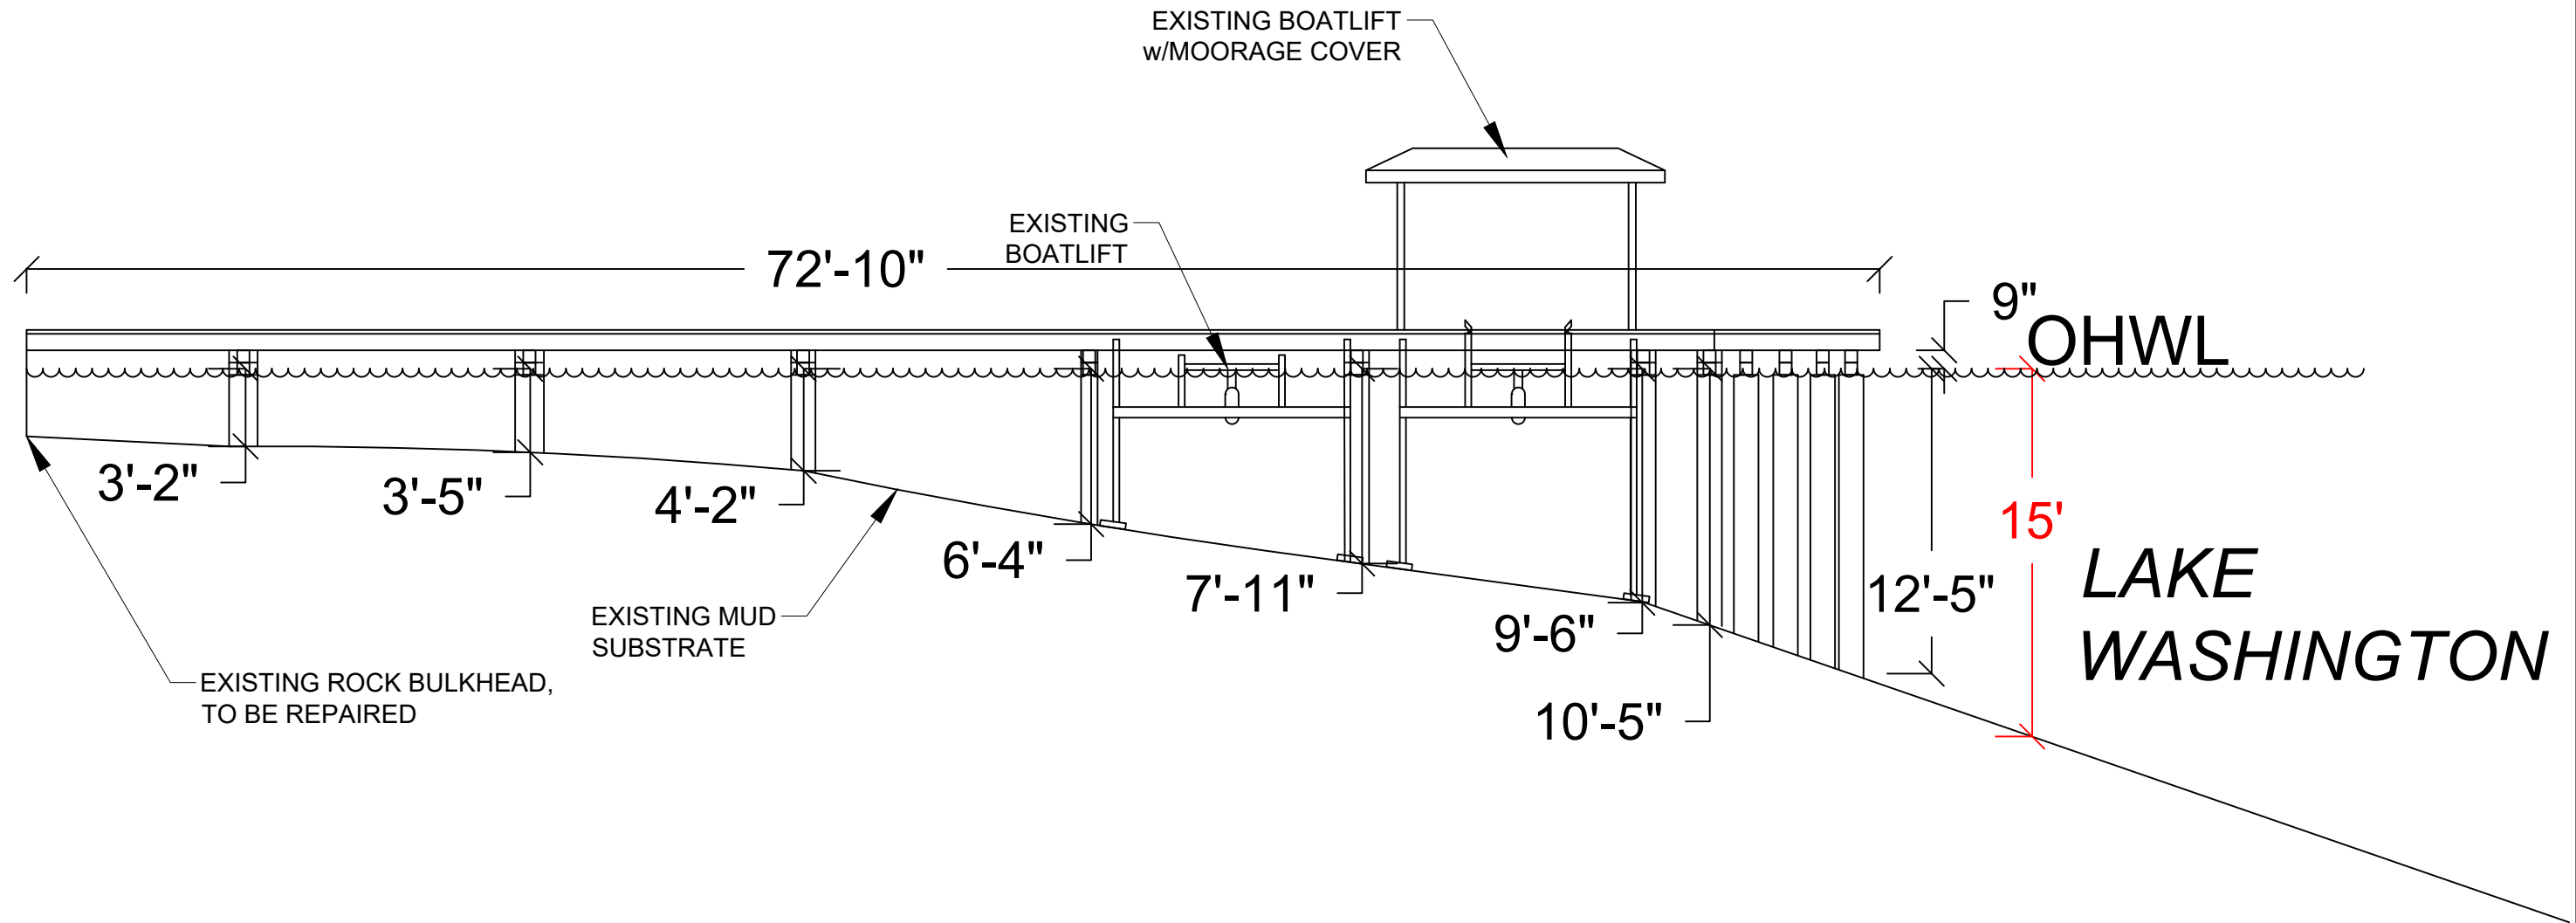
PIER DETAILS EXISTING/PROPOSED

SECTION VIEW: A'-A'

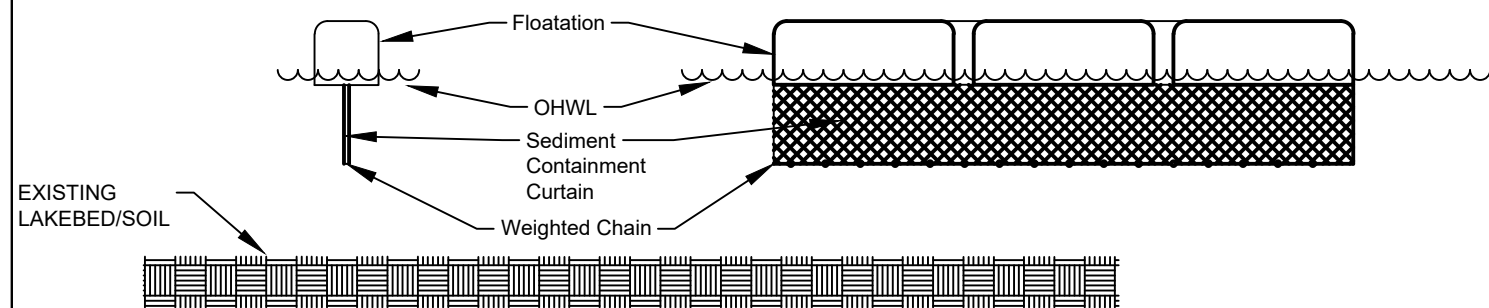
DETAIL 1.1 & 1.2

DETAIL 1.1

DETAIL 1.2

9. When removing piles, no actions shall be taken that would cause adhering sediments to return to lake waters.
 10. Above-water containment shall be installed around removed piles to prevent sediment laden waters from returning to lake waters.

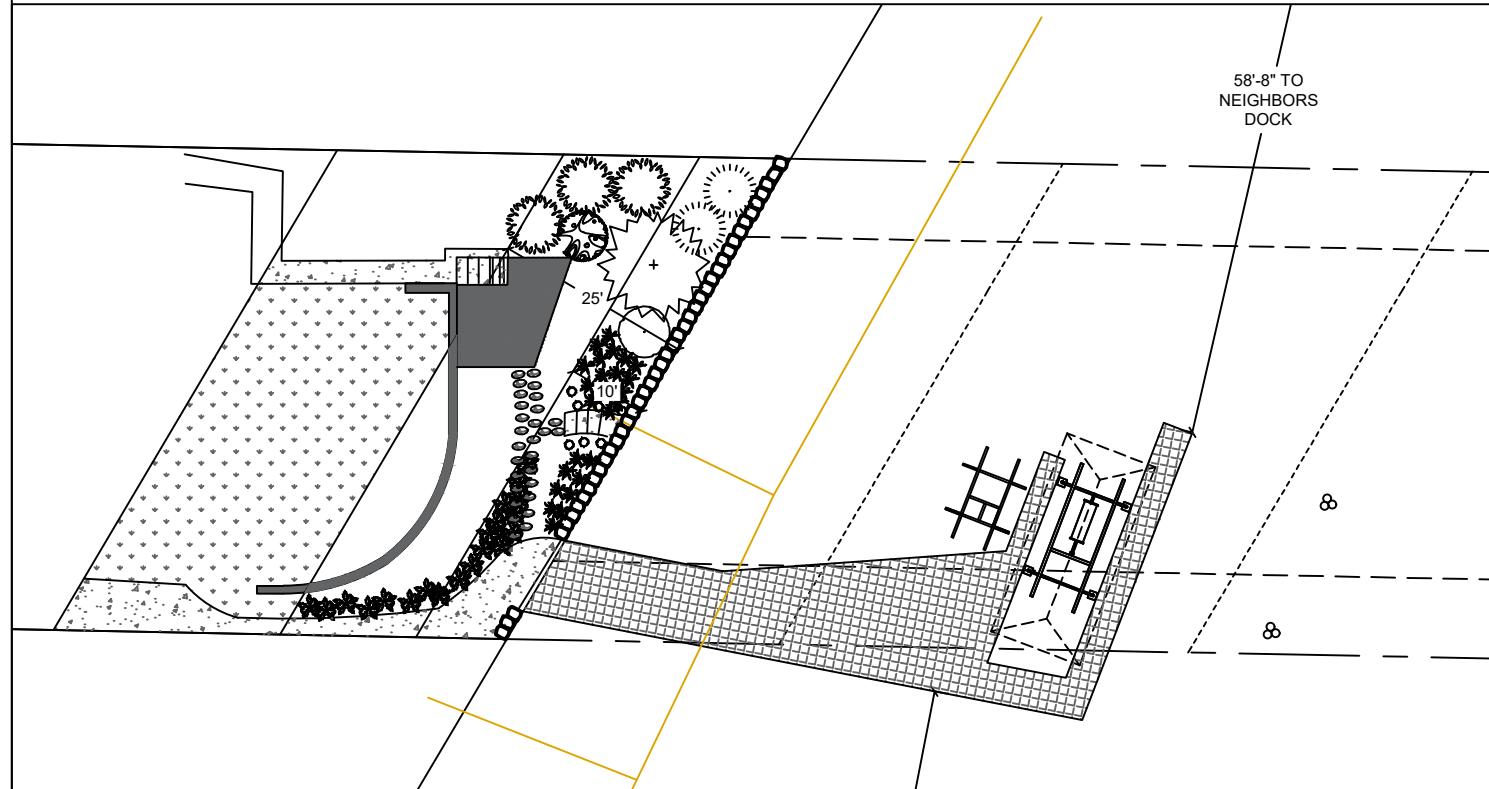
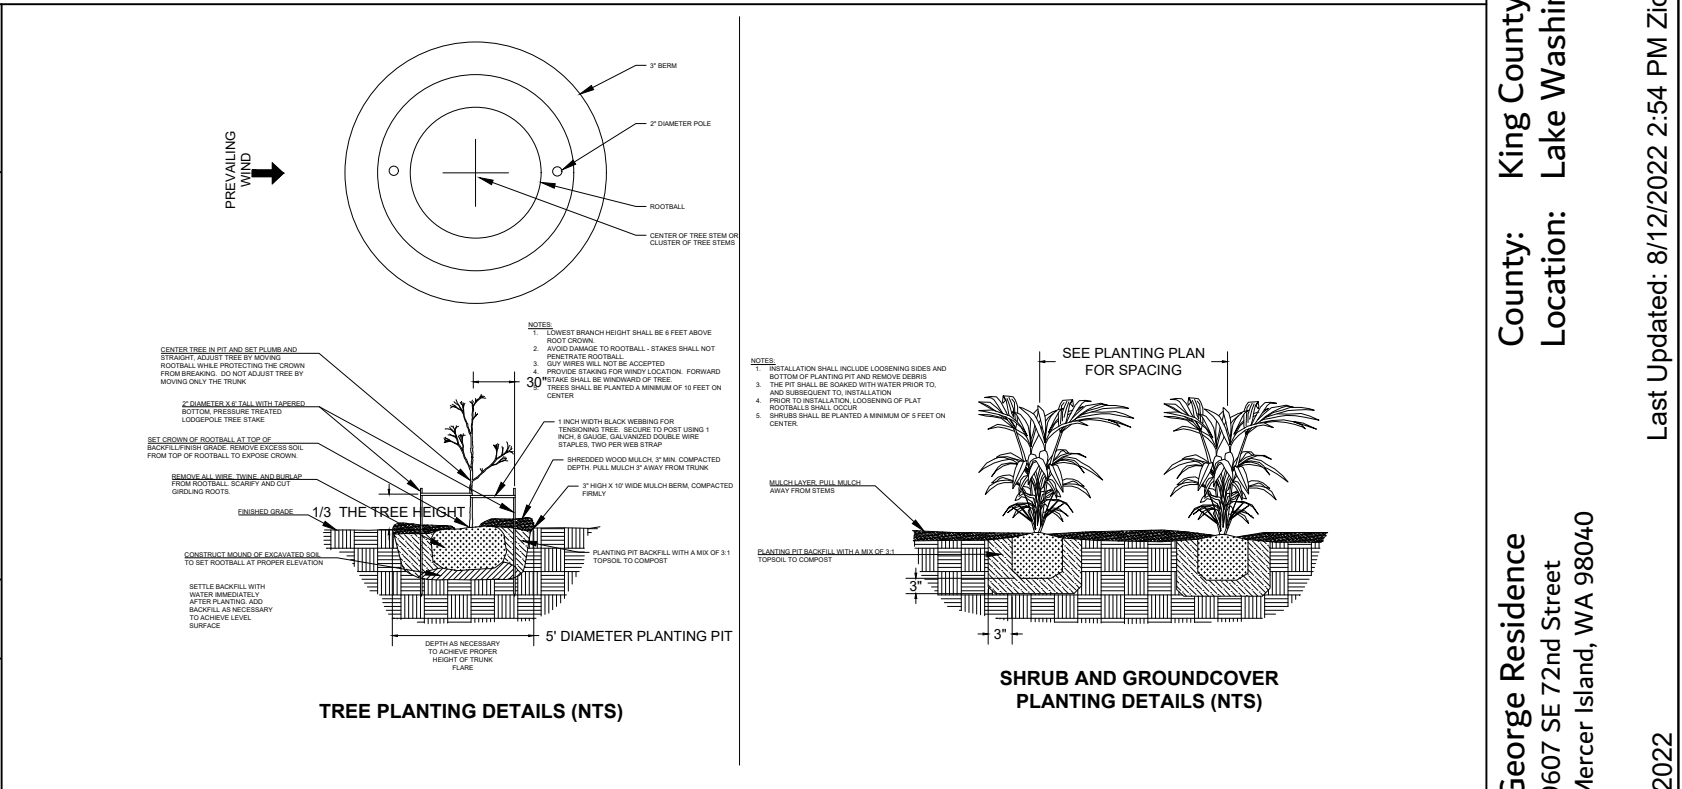
MITIGATION PLAN

1. Shrubs are show, and shall be planted, at least five feet on center. Trees are show, and shall be planted, at least ten feet to center.
2. The property owner will implement and abide by the shoreline planting plan. The plants shall be installed before or concurrent with the work authorized by this permit. A report, as-built drawing and photographs demonstrating the plants have been installed or a report on the status of project construction will be submitted to the U.S. Army Corps of Engineers, Seattle District, Regulatory Branch, within 12 months from the date of permit issuance. This reporting requirement may be met by completing and submitting a U.S. Army Corps of Engineers approved Report for Mitigation Work Completion form.

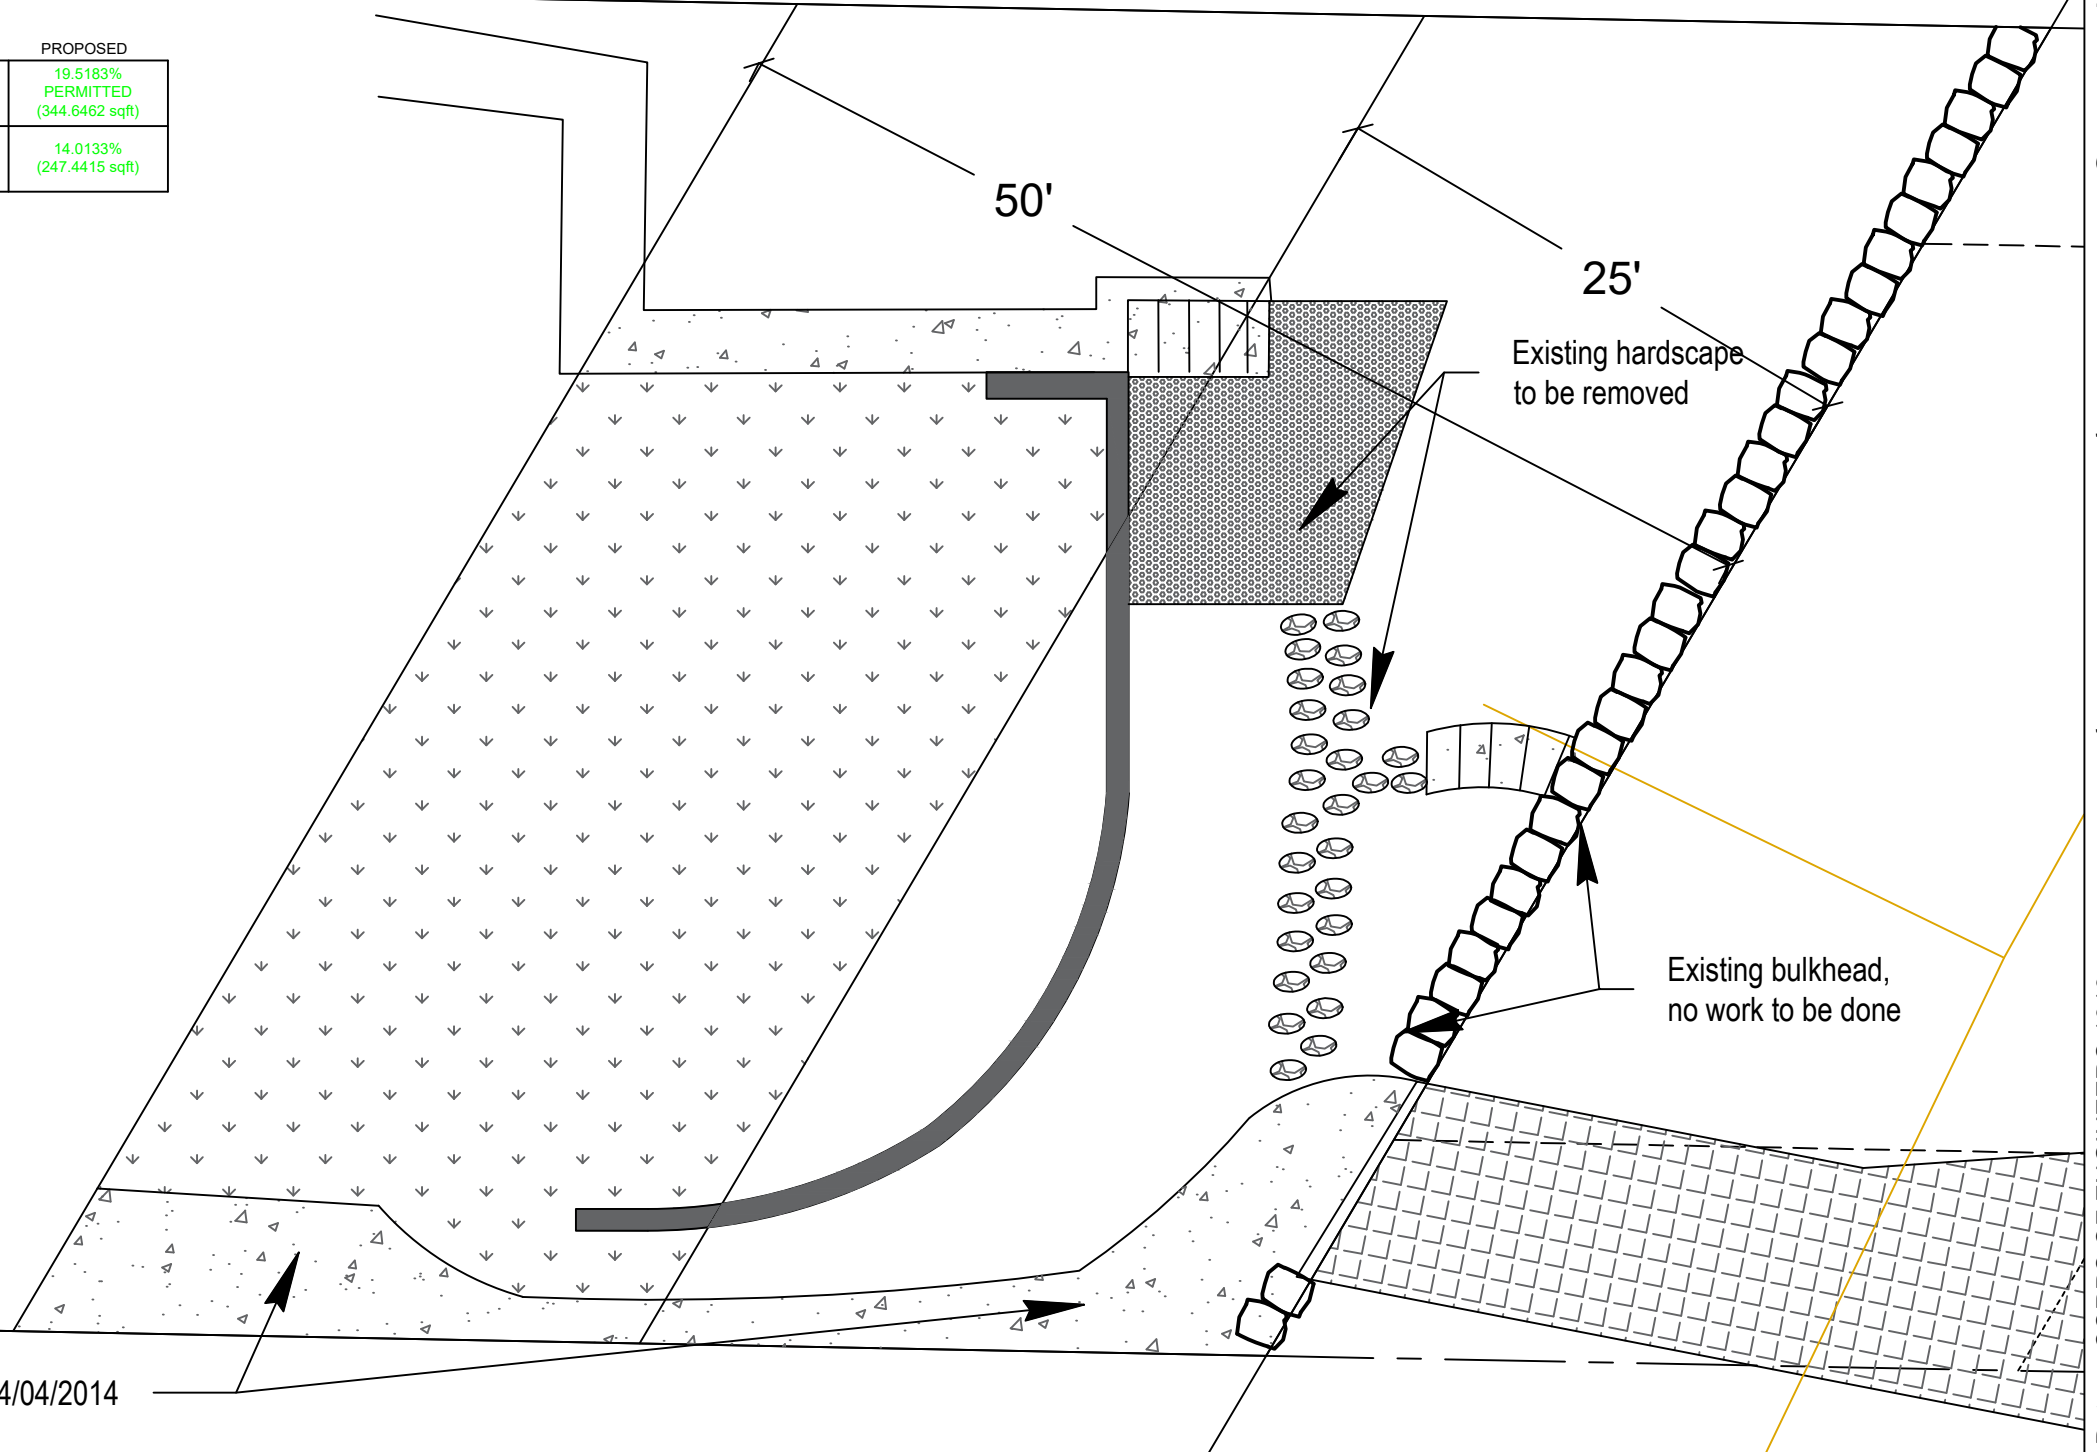
LEGEND - MATERIAL UPDATE 25' SETBACK

DESCRIPTION	AREA	HATCH
PATIO - GRAVEL TO WOOD CHIPS 25FT SETBACK	145.7603 sqft	
28 STONE STEP PADS TO WOOD CHIPS 25FT SETBACK	28 sqft	
57 L.F BULKHEAD (PERMITTED) 25FT SETBACK	114 sqft (2' W BULKHEAD)

PATH PERMITTED 04/04/2014

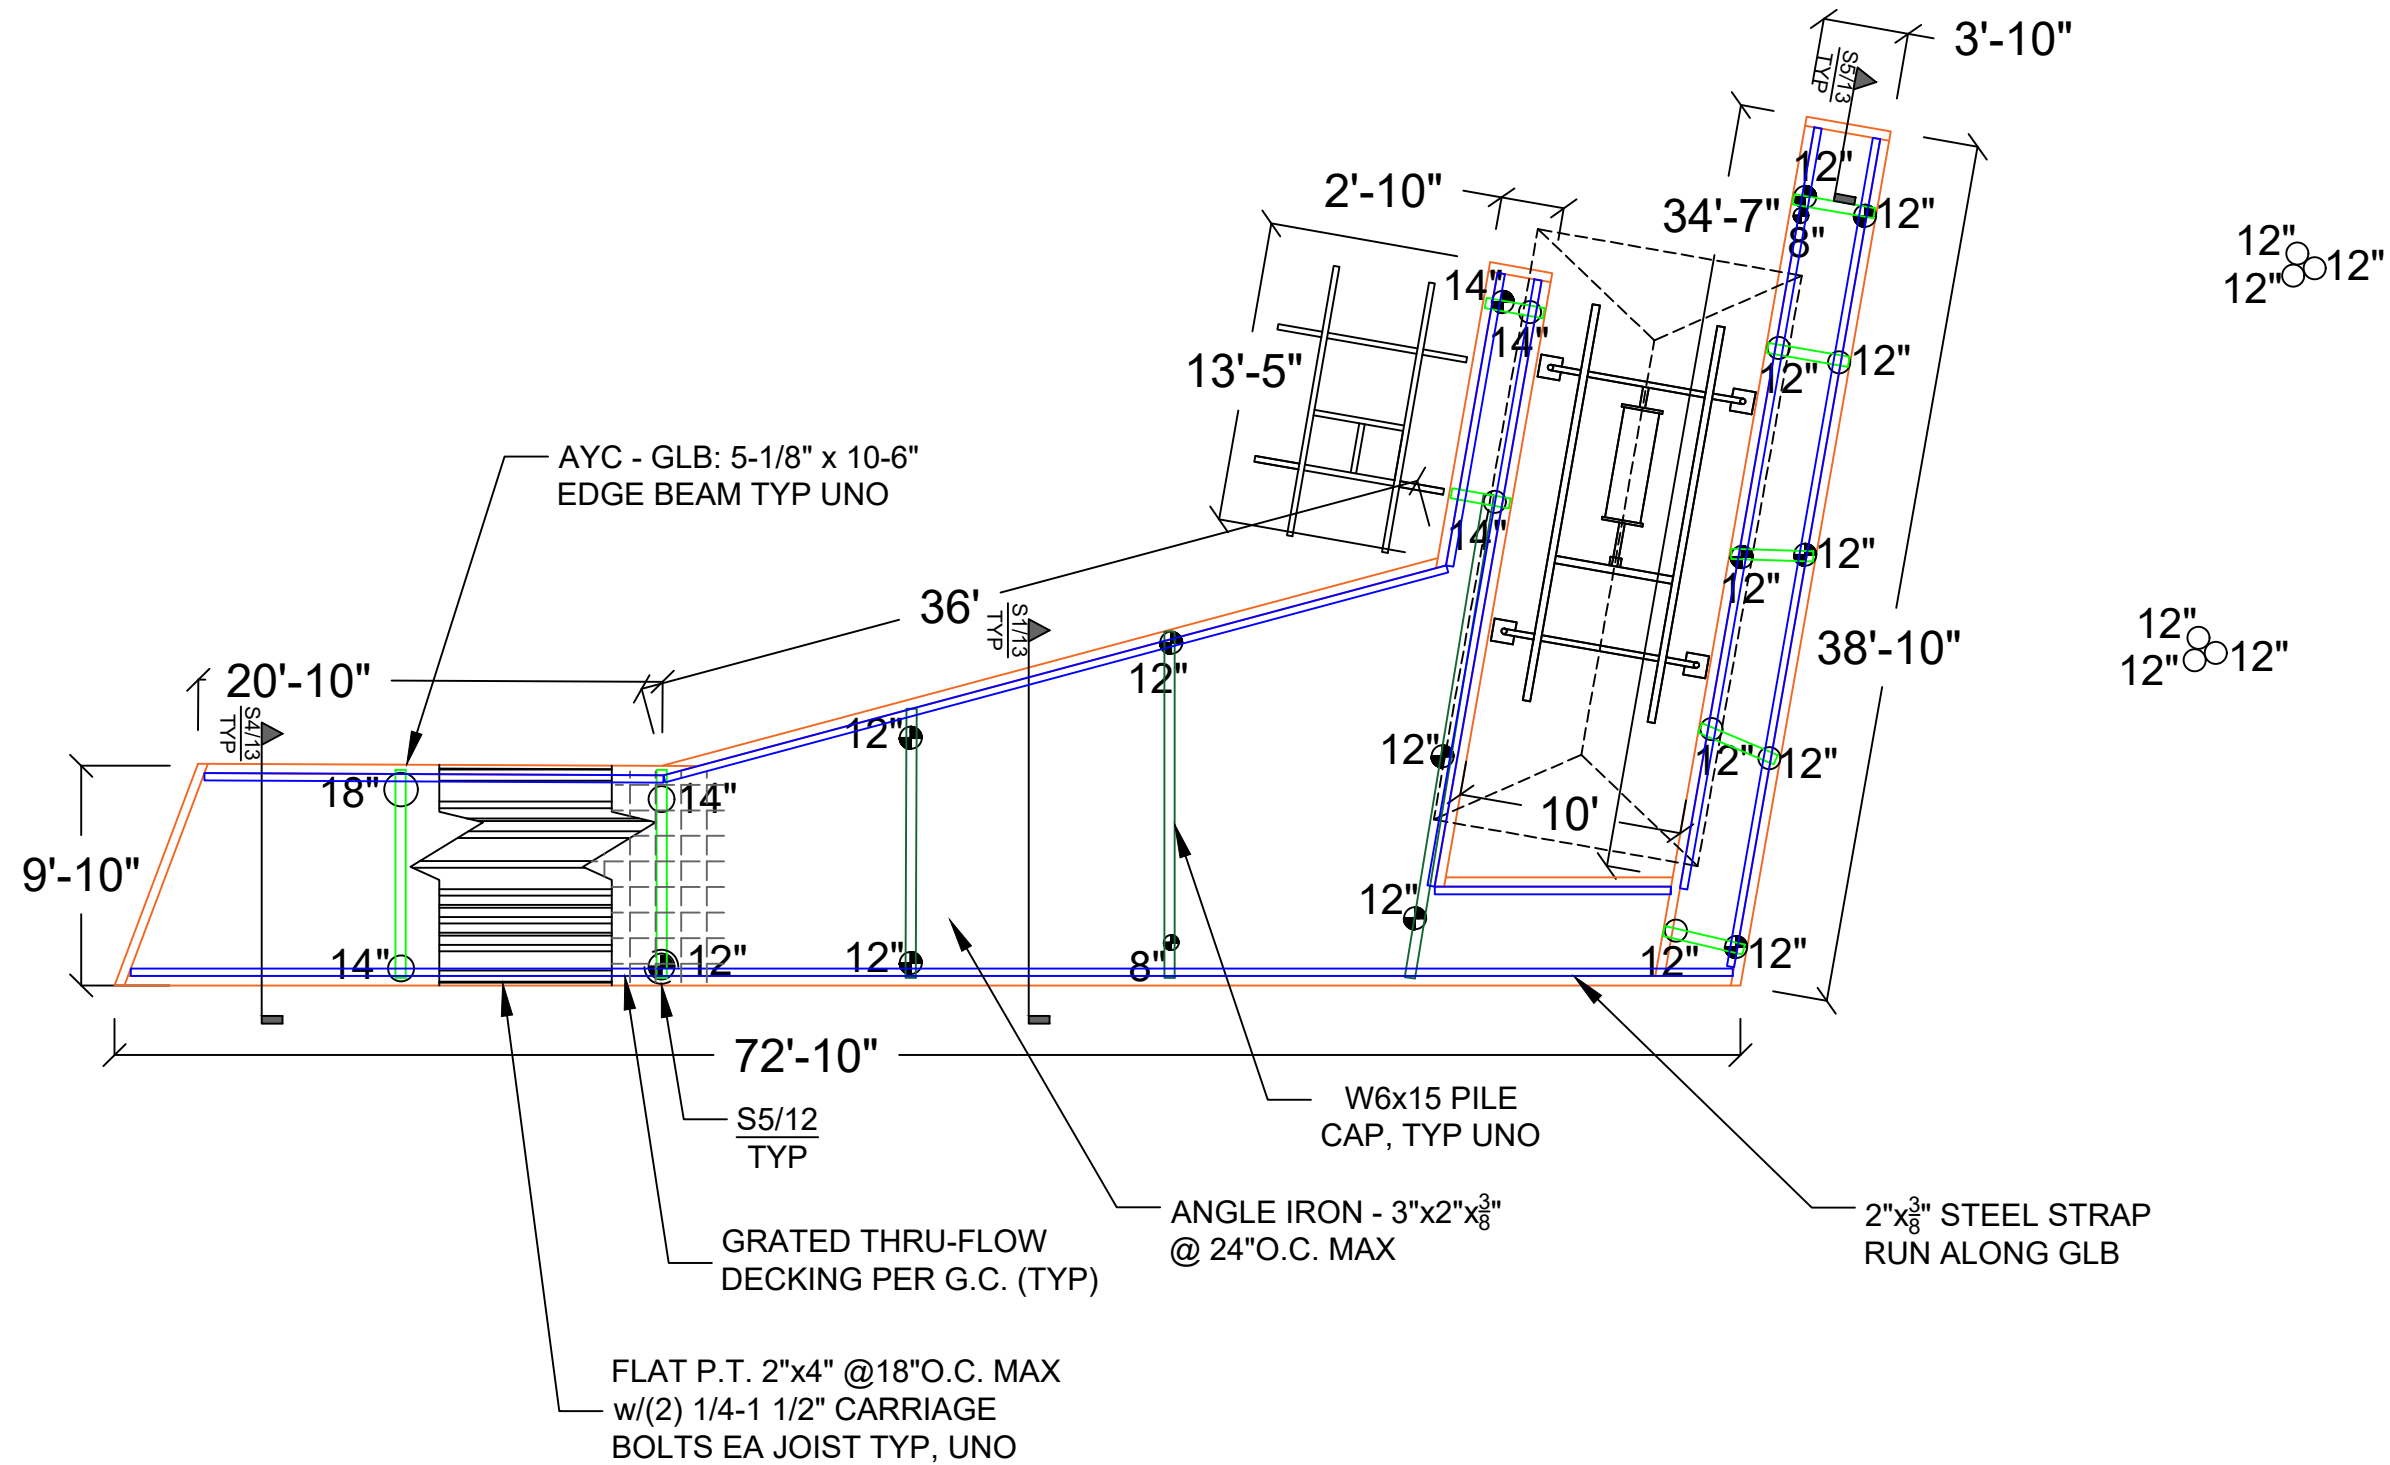
FRAMING LAYOUT

TAKEOFF LAYOUT

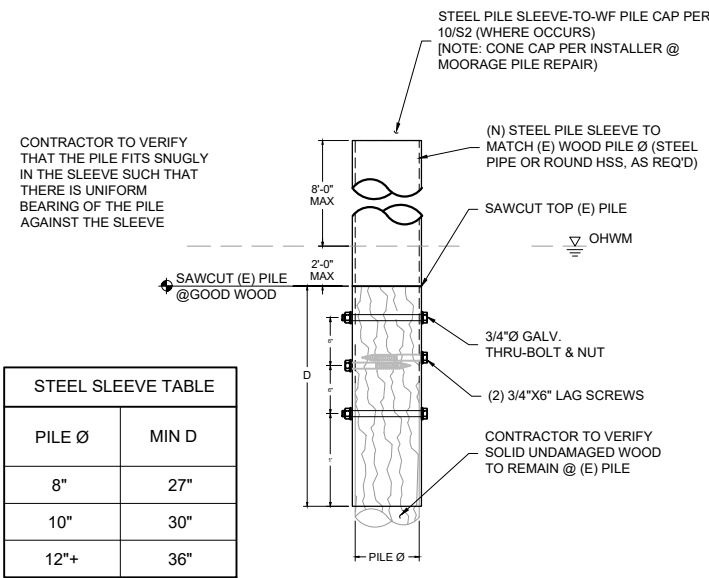
S1 SLEEVE PILE REPAIR - TYP
SCALE: 1/2" = 1'

STEEL SLEEVE TABLE	
PILE Ø	MIN D
8"	27"
10"	30"
12"+	36"

- NOTES:
- 1) MAX PILE LOAD = 1,200 # / PILE (BOAT LOAD PARALLEL TO DOCK). CONTACT ENGINEERING IF BOAT SIZE EXCEEDS GENERAL NOTES MAXIMUM ALLOWABLE.
 - 2) MINIMUM BOLT SPACING = 3"
 - 3) STRAP AXIS SHALL BE ORIENTED PERPENDICULAR TO LONGITUDINAL AXIS OF DOCK.

PILES:
 * Repair piles are done as a sleeve/strap method

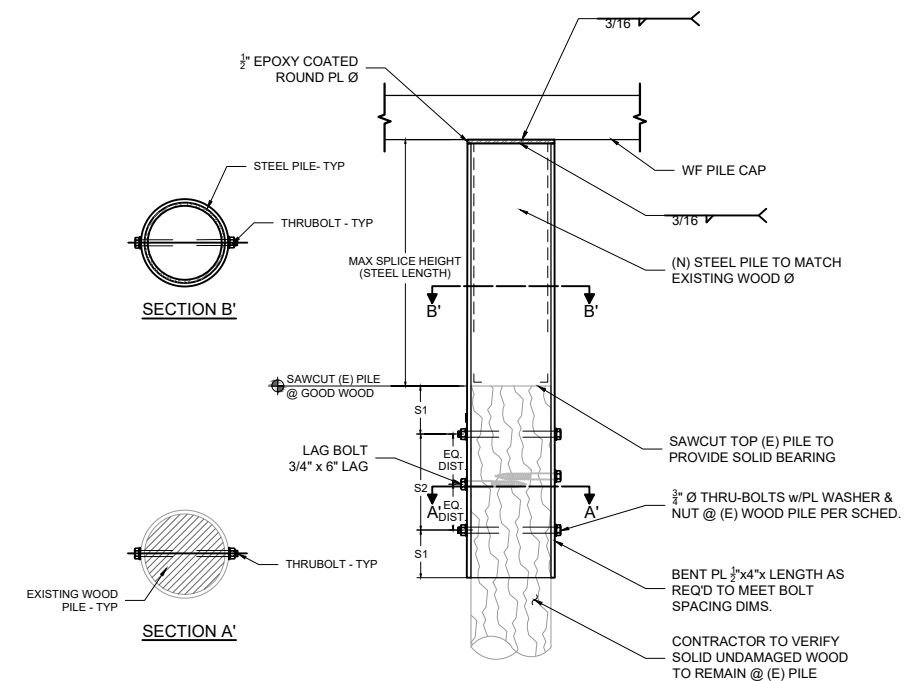
S5 SPLICE PILE REPAIR - TYP
SCALE: 1/2" = 1'

STEEL SLEEVE TABLE				
PILE Ø	MAX SPLICE HEIGHT	S1	S2	S3
9"	15"	6"	12"	3"
12"+	28"	6"	12"	3"
