SITE PLAN

Scope of Work: We propose to repair (14) dock piles, repair the 57 linear feet of existing rock bulkhead, remove approximately 214 sqft of hardscape, remove (6) dock piles & repair the existing decking with grated material.

**SHEET
A1.0**

NWS-2022-432
PAGE 1 OF 13

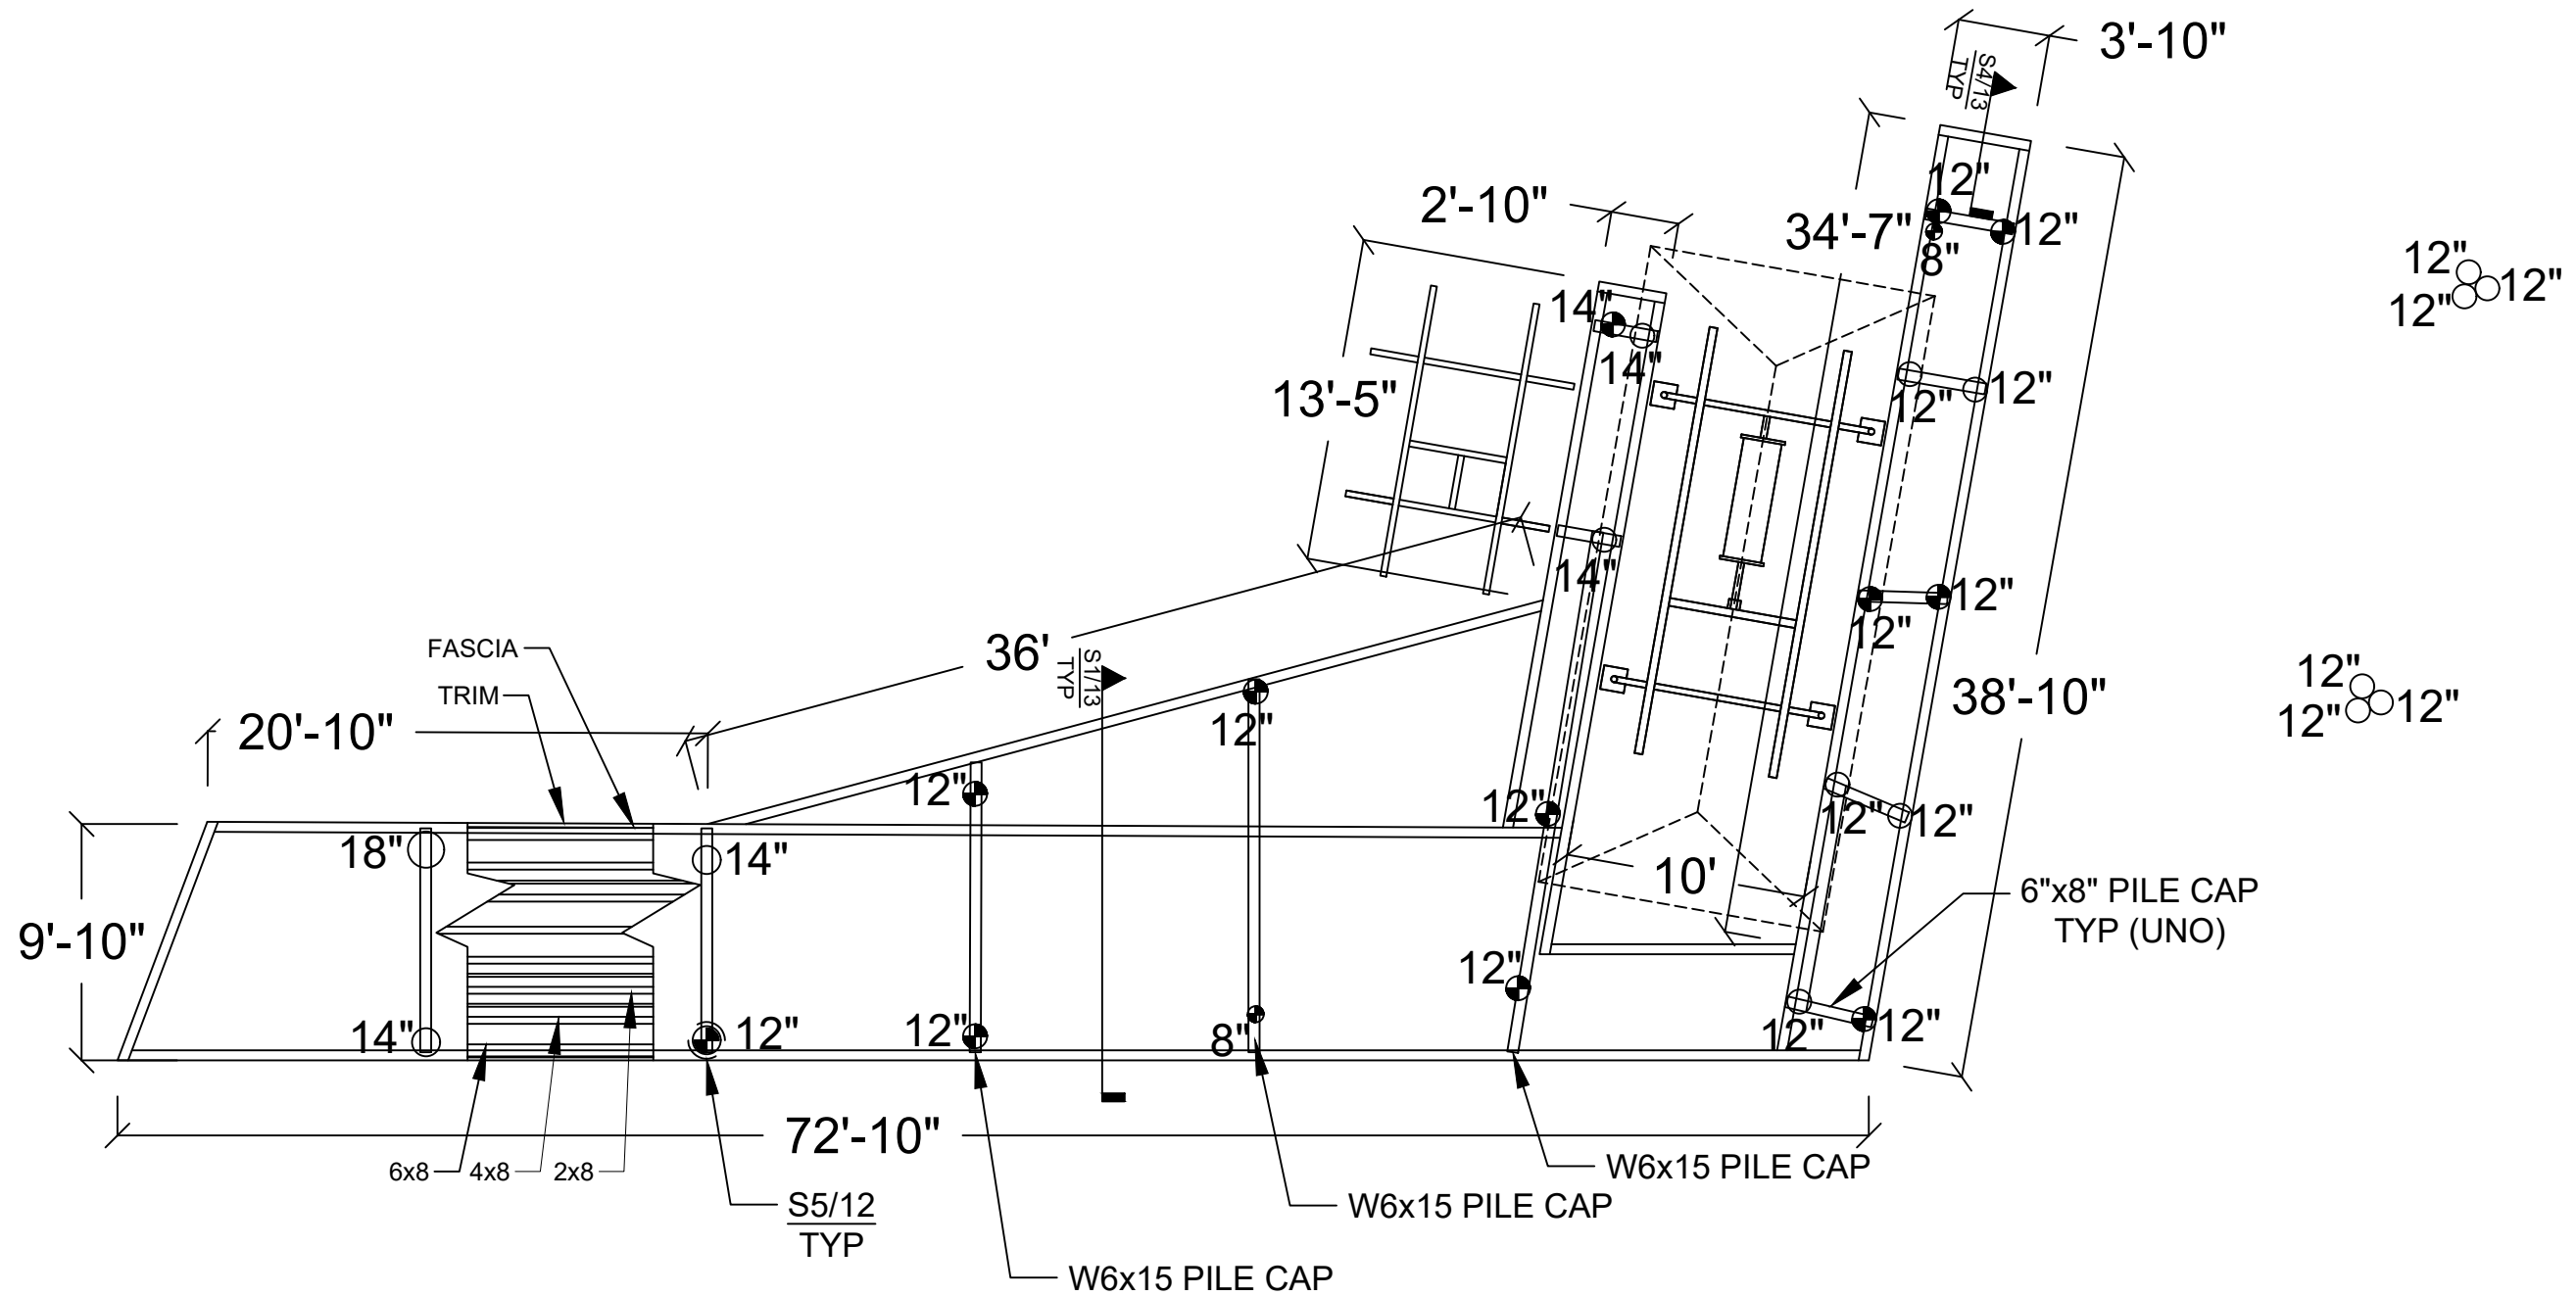
TAKEOFF LAYOUT

FRAMING LAYOUT
