PIER DETAILS - EXISTING/PROPOSED

Scope of Work: We propose to repair (8) piles, repair the existing deck, stairs, and dock with grated decking material, and permitting the relocation of one lift.

Rosato Residence 5652 E. Mercer Way Mercer Island, WA 98040

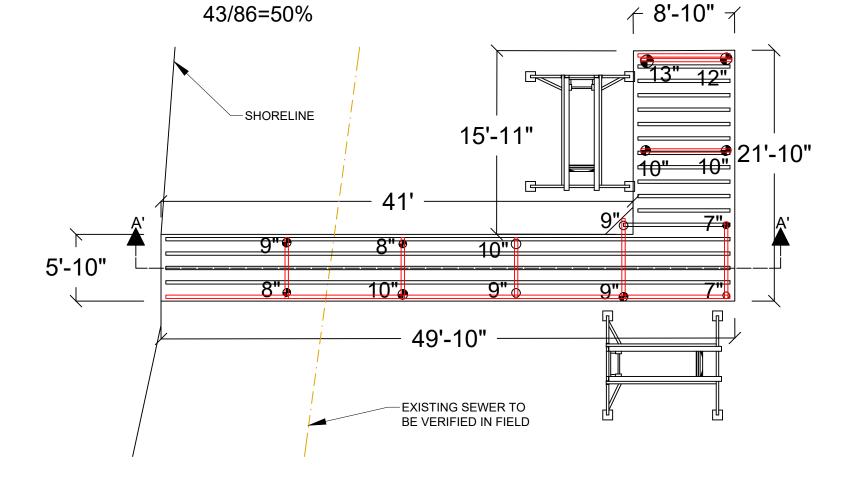
PLAN VIEW

- (10) EXISTING PILES TO BE REPAIRED
- (4) EXISTING PILES NO WORK TO BE DONE
- (2) EXISTING MOORING PILE NO WORK TO BE DONE

Area: 432 sqft (new grated decking)

**Grated decking material is 43% light permeable

- (14) EXISTING PILES
- (7) EXISTING CAPS
- (37) EXISTING STRINGERS
- (28) EXISTING BRACKETS
- (86) TOTAL MEMBERS

- (7) CAPS
- (6) STRINGERS
- (20) BRACKETS
- (43) MEMBER REPAIRS

No more than 50% of the structure will be repaired, please see Sheet A6.0.

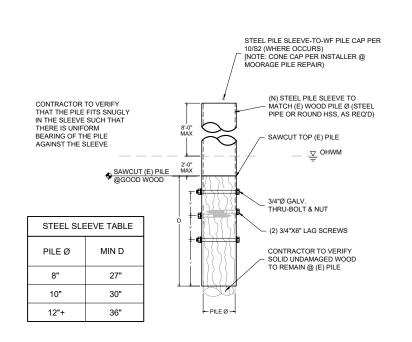
SLEEVE PILE REPAIR - TYP (S1)

STEEL SLEEVE TABLE							
PILE Ø	MAX SPLICE HEIGHT	S1	S2	S 3			
9"	15"	6"	12"	3"			
12"+	28"	6"	12"	3"

- MAX PILE LOAD = 1,200 # / PILE (BOAT LOAD PARALLEL TO DOCK).
- CONTACT ENGINEERING IF BOAT SIZE EXCEEDS GENERAL NOTES MAXIMUM ALLOWABLE
- MINIMUM BOLT SPACING = 3"
- STRAP AXIS SHALL BE ORIENTED PERPENDICULAR TO LONGITUDINAL AXIS OF DOCK.

* Repair piles are done as a sleeve/strap method

Piles will be repaired with epoxy coated steel.
