BUILT BY	Seaborn Pile Driving 1080 W Ewing St Seattle, WA 98119	Scope of Work: We propose to repair (12) existing piles and replace the existing 115'- 9" wood rock.
SEABORT · ESTD 1947 ·	Office: 206-236-1700 ext. 3 www.seabornpiledriving.com

PIER DETAILS - EXISTING/PROPOSED

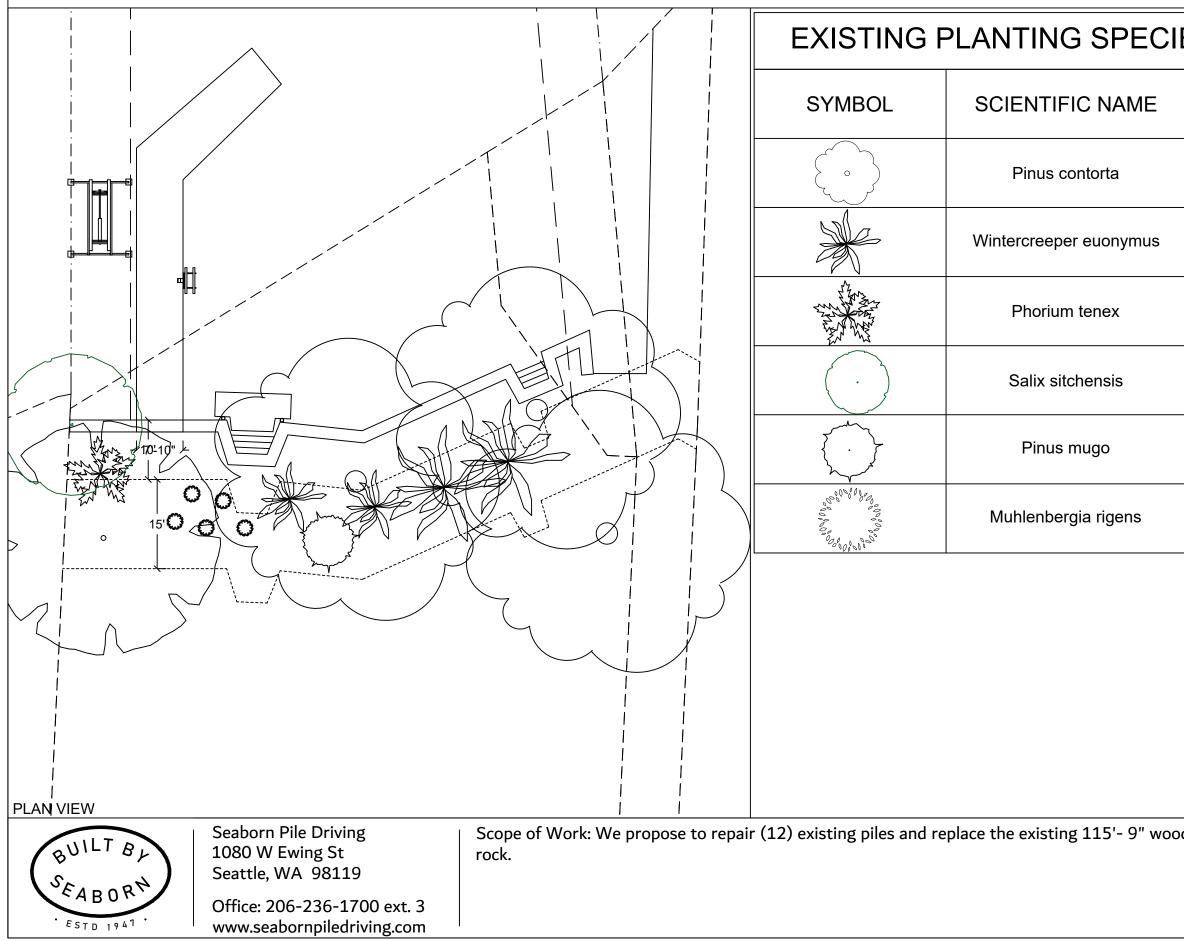
EXISTING PLANT PLAN

y ington	ion		
E	ES/QUANT	King County Lake Washington	3:01 PM Z				
	COMMON NAME	QTY	SIZE		ast Updated: 9/16/2022 3:01 PM Zion-		
	Lodgepole Pine	3	~30'	County: Location:	st Updated:		
	Fortune's spindle	4	varies	e 140	La:		
	New Zealand flax	1	~5'	Skinner Residence 7601 W. Mercer Way Mercer Island, WA 98040			
	Sitka Willow	1	~15'		25/22		
	Dwarf Mugo Pine	1	~8'	Applicant:	Created: 03/25/22		
	Deergrass	6	~3'	nge 04	AS E JR NAY 98040		
				F ENGINEERS stion 25, Town rs:			
Datum: CORPS OF E SW Quarter Of Sectic Adjacent Owners							
C	l bulkhead and stai	SHEET A8.0					
				NWS-2022-76 PAGE 8 OF 1

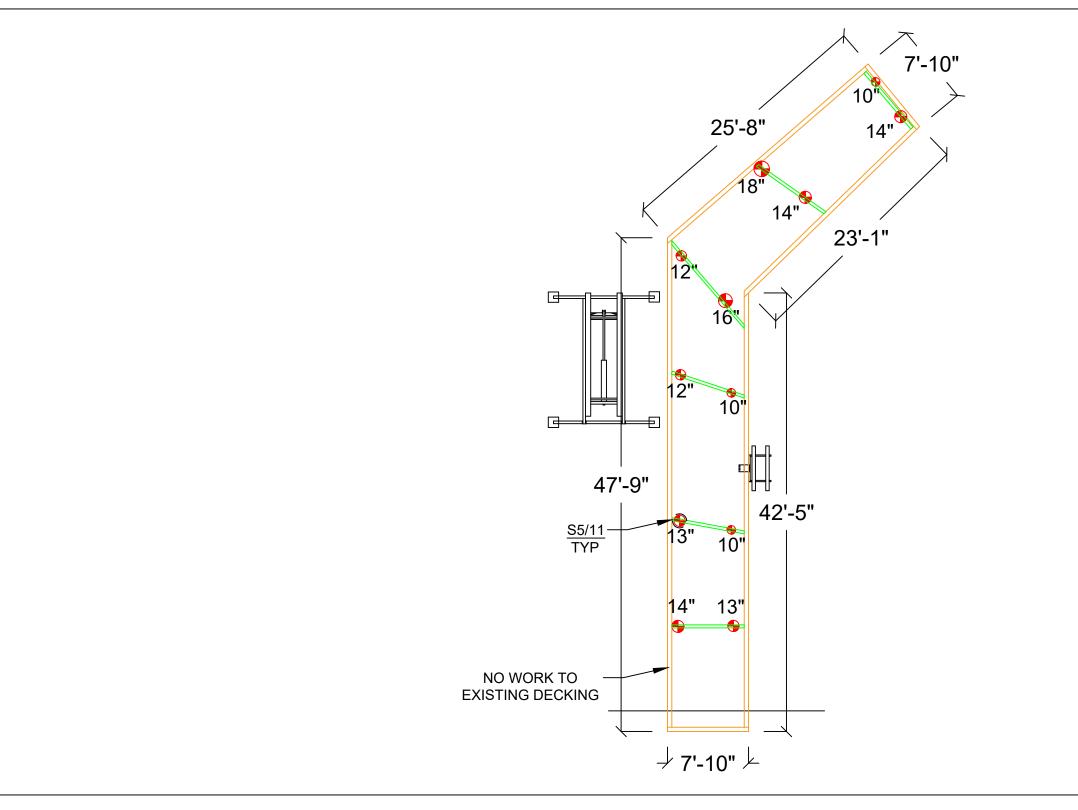
DETAILS - REPAIR

S1 DETAIL NOT IN USE		Sz		IOT IN USE	<u> </u>				S3 DETAIL NOT IN USE
				STEE	EL SLEEVE	E TABLE]	
			PILE Ø	MAX SPLICE HEIGHT	S1	S2	S3		2" EPOXY COATEL ROUND PL &
			9"	15"	6"	12"	3"	-	/ STEEL PILE- TYP
			12"+ <u>NOTES:</u>	28"	6"	12"	3"		THRUBOLT -
			2) MINIMUN	E LOAD = 1,200 # / T ENGINEERING IF 1 BOLT SPACING = XIS SHALL BE ORI	F BOAT SIZE EX(= 3"	CEEDS GENERAL	NOTES MAXIMUM		SECTION B'
									LAG BO 3/4" x 6" L4
									EXISTING WOOD
									PILE - TYP
S4 DETAIL NOT IN USE		S	SLEEVE I	PILE REPA	IR - TYP				
BUILT BY	Seaborn Pile Driving 1080 W Ewing St Seattle, WA 98119	Scope rock.	of Work: V	We propo	se to rep	air (12) e	xisting pil	es and replace tl	ne existing 115'- 9" woo
SEABORN · ESTD 1941 ·	Office: 206-236-1700 ext. 3 www.seabornpiledriving.com

NWS-202 PAGE 11 C	
	SHEET	
d bulkhead and stairs with new granite	E o.	
TYP SAWCUT TOP (E) PILE TO PROVIDE SOLID BEARING ADDIT SOLID VOOD PILE PER SCHED. BENT PL ¹ / ₂ ×4*x LENGTH AS RECO TO MEET BOLT SPACING DIMS. CONTRACTOR TO VERIFY SOLID UNDAMAGED WOOD TO REMAIN @ (E) PILE	Datum: CORPS OF ENGINEERS 1919 SW Quarter Of Section 25, Township 24, Rai	Adjacent Owners: INKROCK HOLDING LIMITED 7617 W MERCER WAY 98040
TYP WF PILE CAP 3/16 P (N) STEEL PILE TO MATCH EXISTING WOOD Ø B' B' B'	EERS 1919 ownship 24, Range 04	BASSETT DOUGLAS E JR 7455 W MERCER WAY 98040
	Applicant: Skinner Residence 7601 W. Mercer Way Mercer Island, WA 98040	Created: 03/25/22
	County: H Location: I	Last Updated: 9/16/2022 3:01 PM Zion
	King County Lake Washington	22 3:01 PM Zion

* Repair piles are done as a sleeve/strap method

Piles are being repaired with epoxy coated steel.
