Ecological No Net Loss Assessment Report

**Eckhard Evers Residence
4456 Ferncroft Road
Mercer Island, WA 98040**

Permits are being applied for a dock repair and reconfiguration and removal of existing boat lifts.

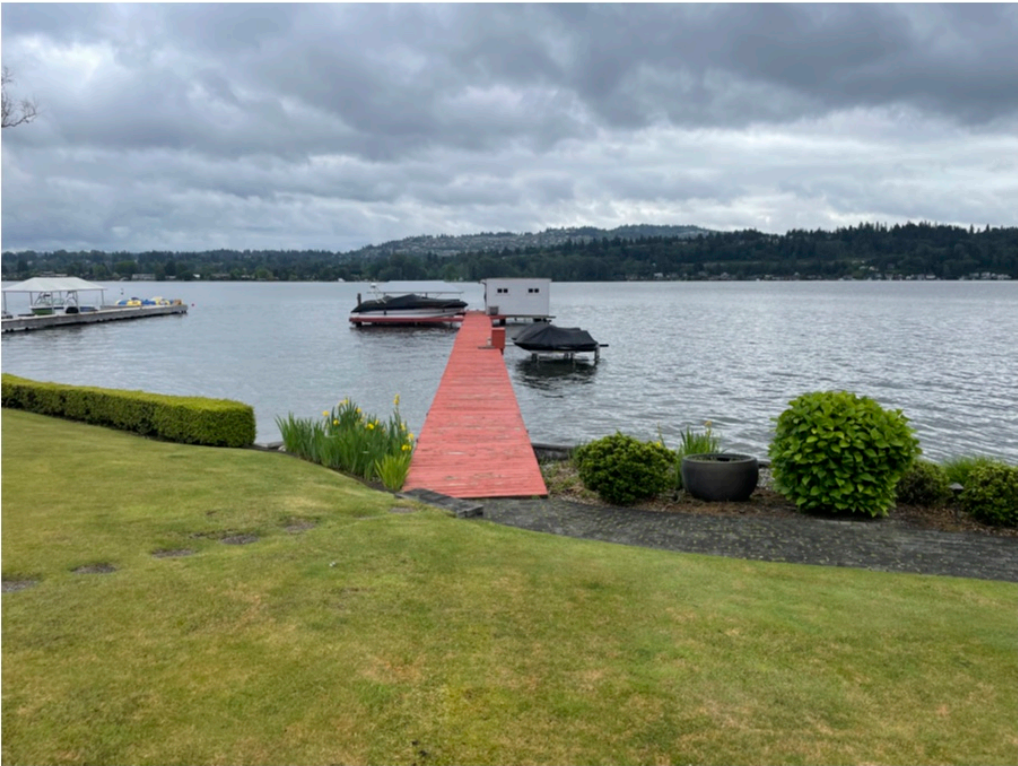
Photo 1 - Existing dock looking waterward.

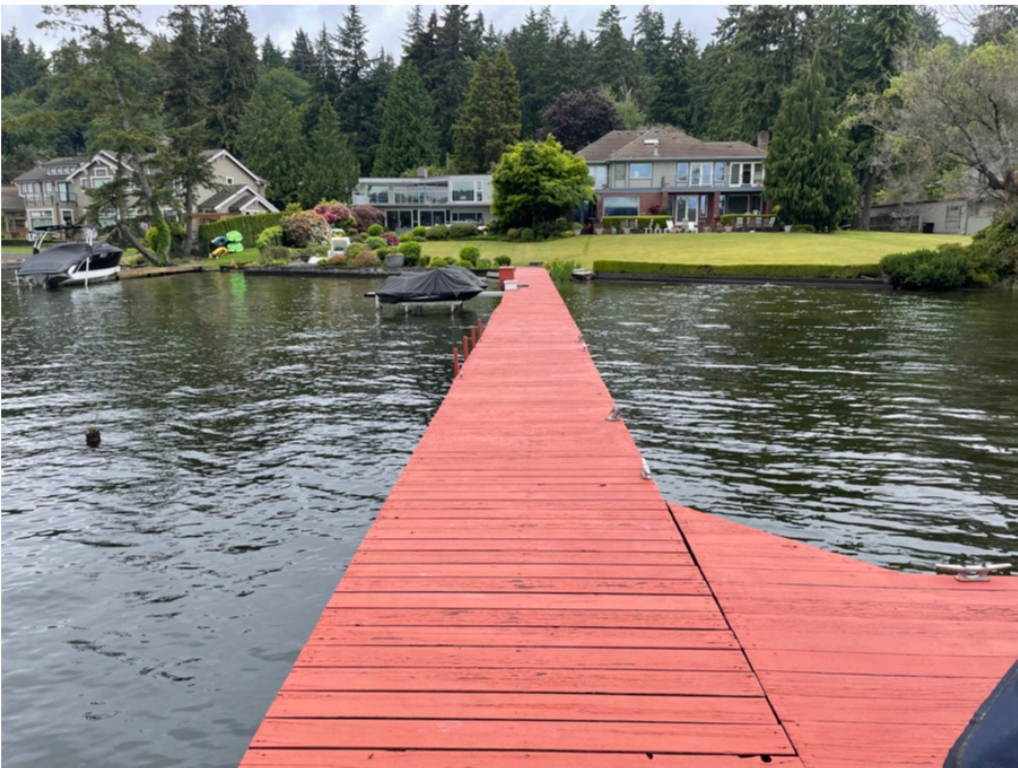
Photo 2 - Existing dock looking landward.

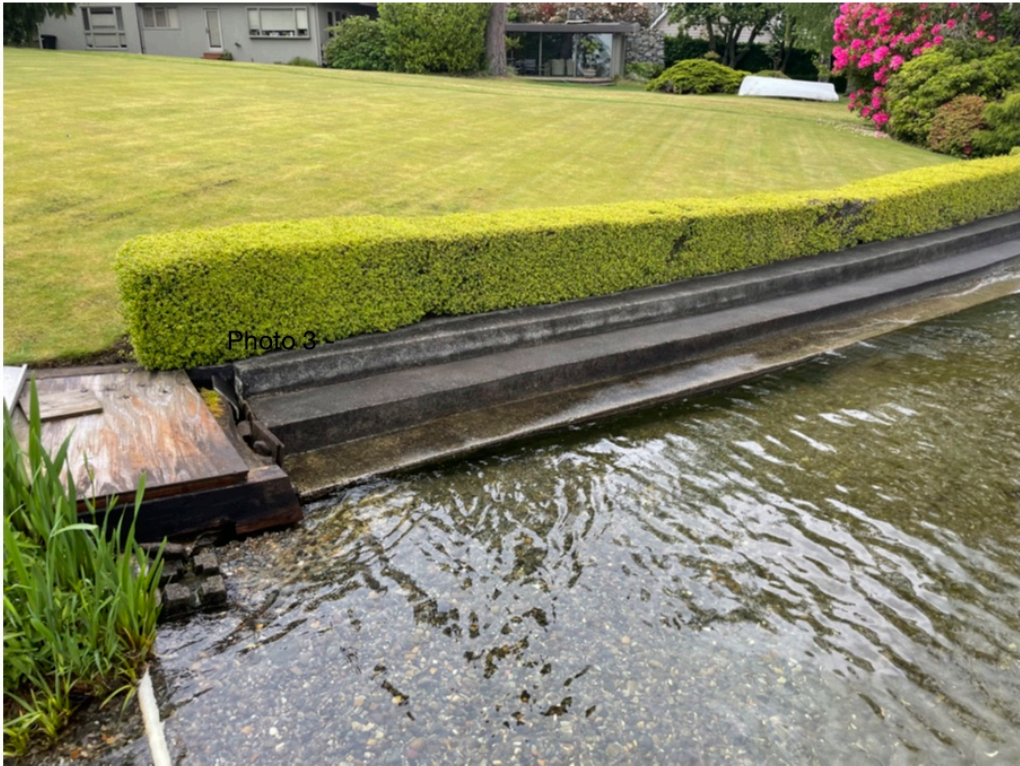
Photo 3 - Shoreline conditions north of dock

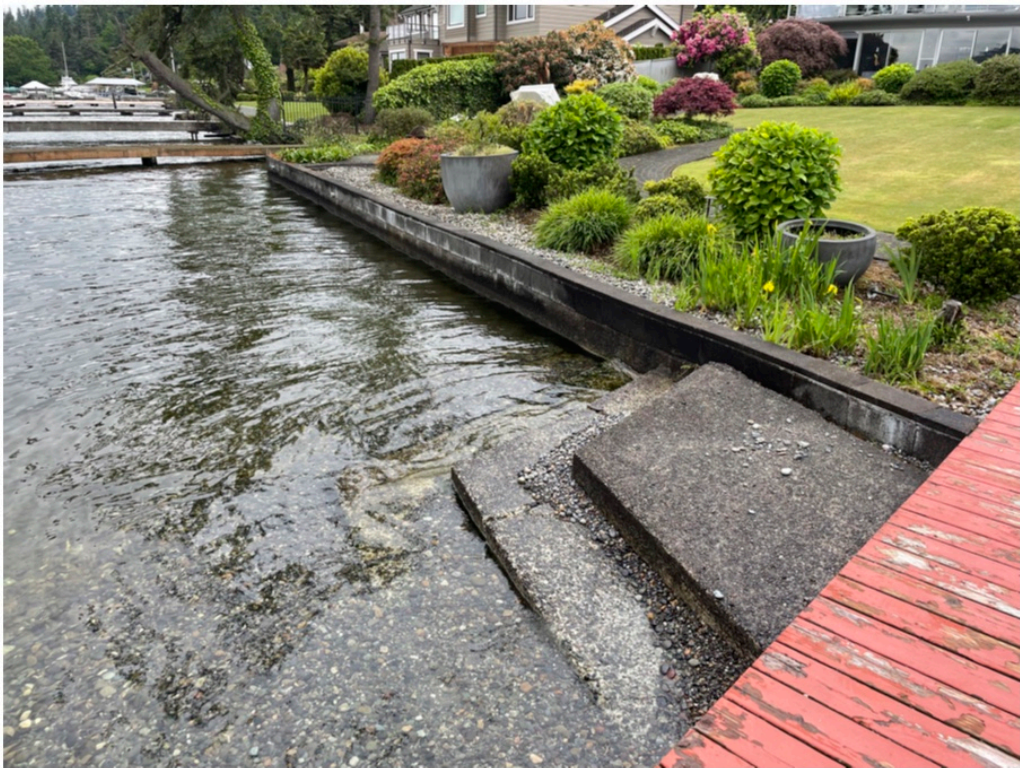
Photo 4 - Shoreline conditions south of dock. Note concrete stairs to be removed.

The reconfiguration in the first 30 feet of the shoreline will include removal of existing concrete stairs and concrete groin as mitigation. The existing wood decking will be replaced with thruflow grated decking on existing and new decked areas. Project drawings are included in Attachment A.

There will be temporary impacts from noise and disturbed sediments during construction. The project will improve shoreline conditions by removing approximately 115 (SF) of concrete from the shoreline. The concrete groin modifies beach flows and acts as a barrier to juvenile fish migration. The reconfiguration of the dock will result in a decrease in overwater coverage by 60 square feet, in addition narrowing the dock within 30 feet of shore may reduce the occurrence of

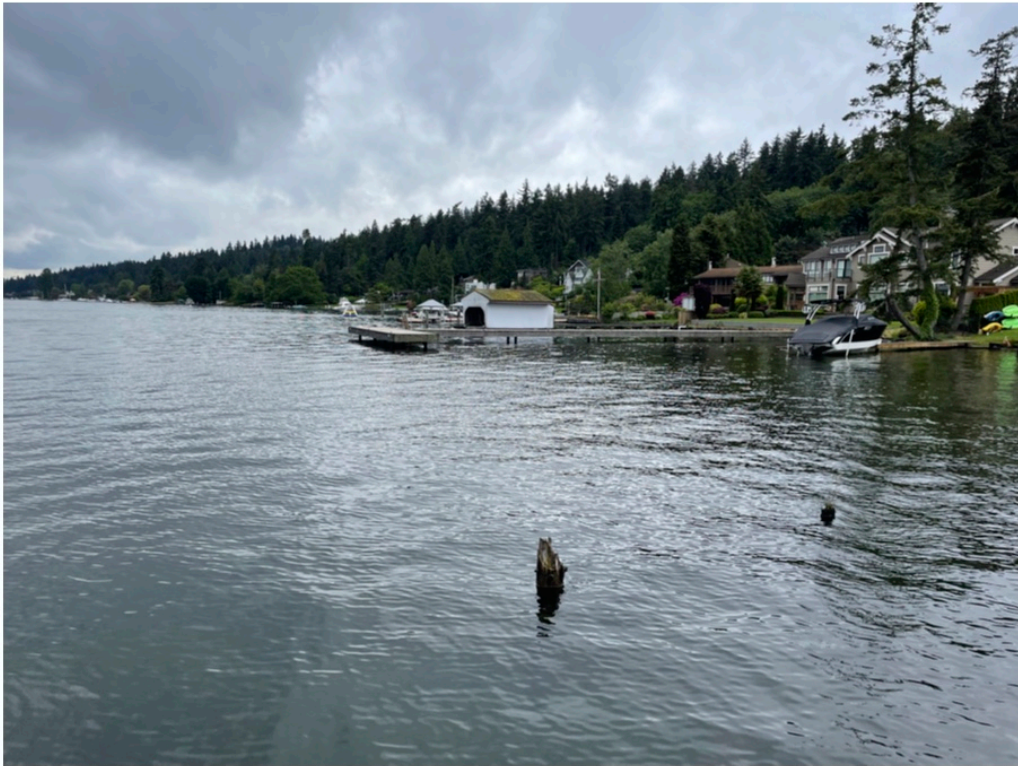
Photo 5 - Shoreline conditions south of the site. Note broken mooring piles to be removed.

The work on the dock will include repairing and reconfiguring the existing dock and pile repair. The existing dock will be removed and reconstructed. The work will include narrowing the dock within the first 30 feet from 6 feet wide to 4 feet wide. The finger pier and ell will be removed on the north side of the dock and the two existing boat lifts removed. A new finger pier and access pier will be constructed on the south side of the dock. The existing moorage cover and shed will remain and one of the existing lifts. Thirty-seven of the existing timber piles will be replaced with 20 new 8-inch steel piles and 2 4-inch pin piles. Two approximately 12-inch timber mooring piles will be removed and replaced with two 10-inch steel mooring piles.

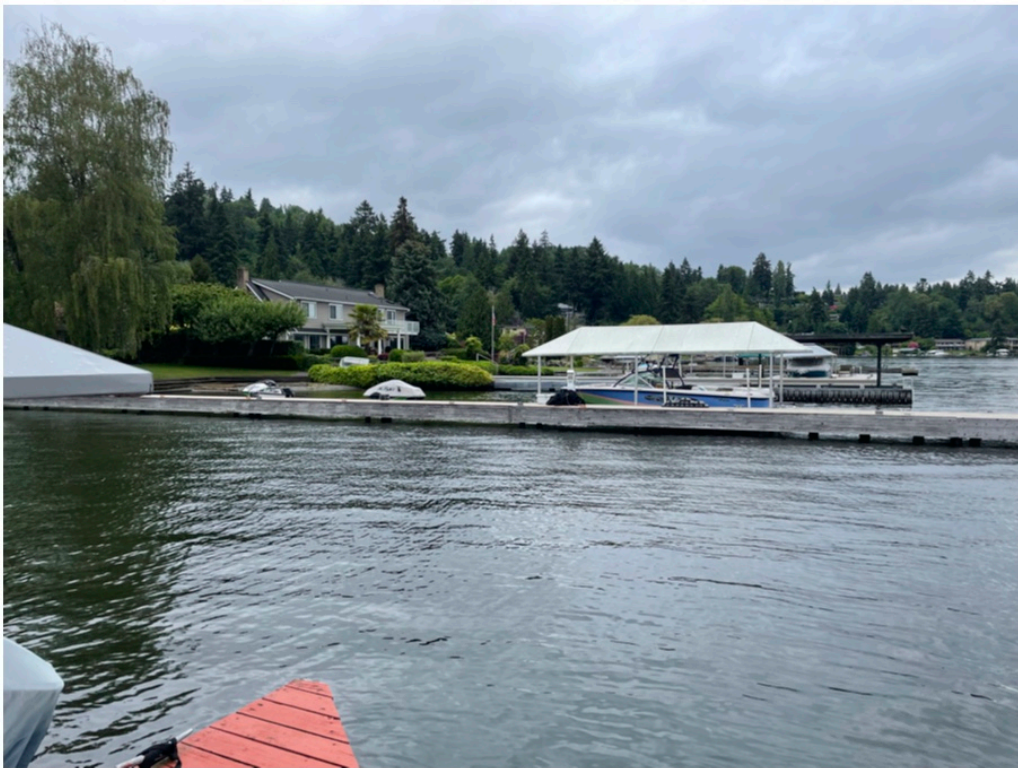
Photo 6 - Shoreline conditions north of the site.
