SITE PLAN

Scope of Work: We propose to repair (14) piles of the east dock, set back 6" and repair 107 lft of existing bulkhead, replace 4 lft of existing rock bulkhead with stairs, raise the existing east dock 1', and repair the existing east dock with (415 sqft) grated decking material.

County: King County
Location: Lake Washington

Applicant: Thomas Residence
8149 W Mercer Way
Mercer Island, Washington 98040

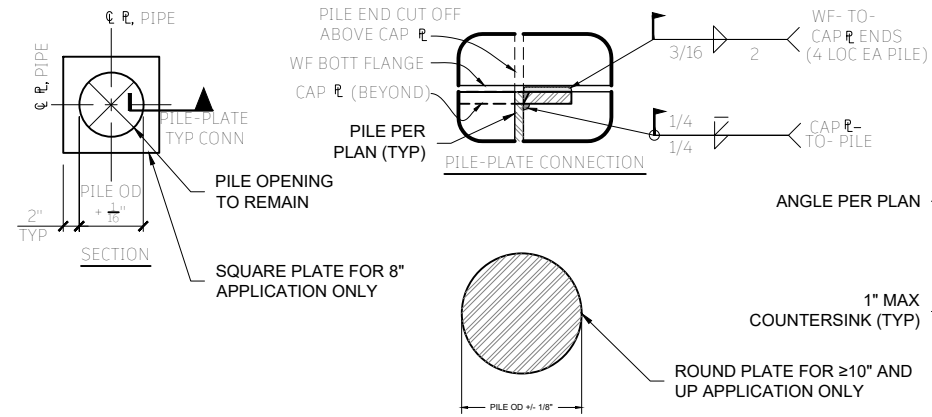
S1 DOCK SECTION w/PILES - TYP
SCALE: 1" = 1"

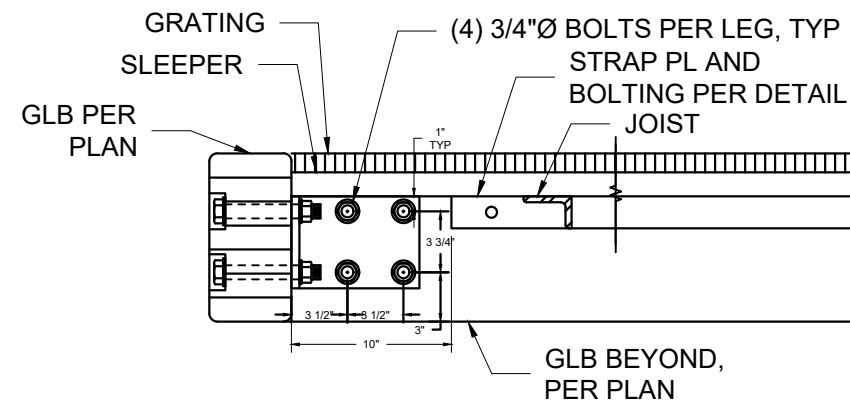
S4 HEAVY DUTY BRACKET DETAIL
SCALE: 1" = 1"

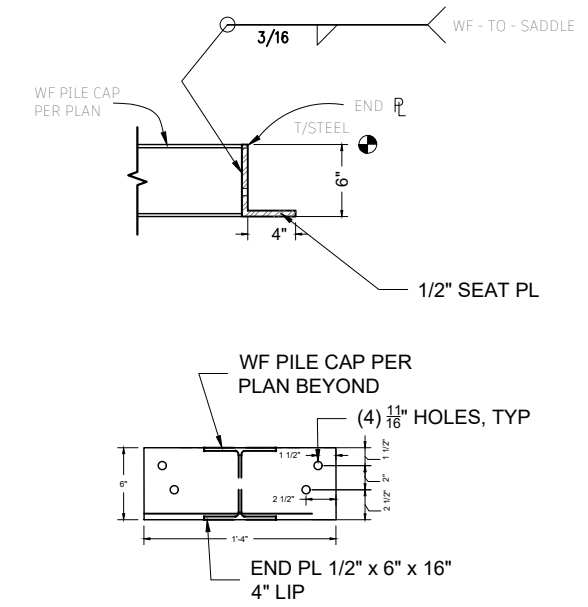
S2 ANGLE TO PLATE - TYP
SCALE: 1" = 1"

S3 BEAM SADDLE BRACKET
SCALE: 3/4" = 1"

S4 FILLET CONNECTION DETAIL
SCALE: 1" = 1"
