# SITE PLAN

Scope of Work: We propose to repair (14) piles of the east dock, set back 6" and repair 107 lft of existing bulkhead, replace 4 lft of existing rock bulkhead with stairs, raise the existing east dock 1', and repair the existing east dock with (415 sqft) grated decking material.

County: King County  
Location: Lake Washington  
Applicant: Thomas Residence  
8149 W Mercer Way  
Mercer Island, Washington 98040  
Datum: CORPS OF ENGINEERS 1919  
NE Quarter Of Section 36, Township 24, Range 04  
Adjacent Owners:  
KIVIAI MARK DAVID  
8137 W MERCER WAY 98040  
MCMILLAN COREY TYLER+VICTOR  
8153 W MERCER WAY 98040  
Last Updated: 11/17/2023 3:31 PM Shop  
Created: 07/17/23

**SHEET**  
**1.0**  
NWS-2023-XXX  
PAGE 1 OF 15

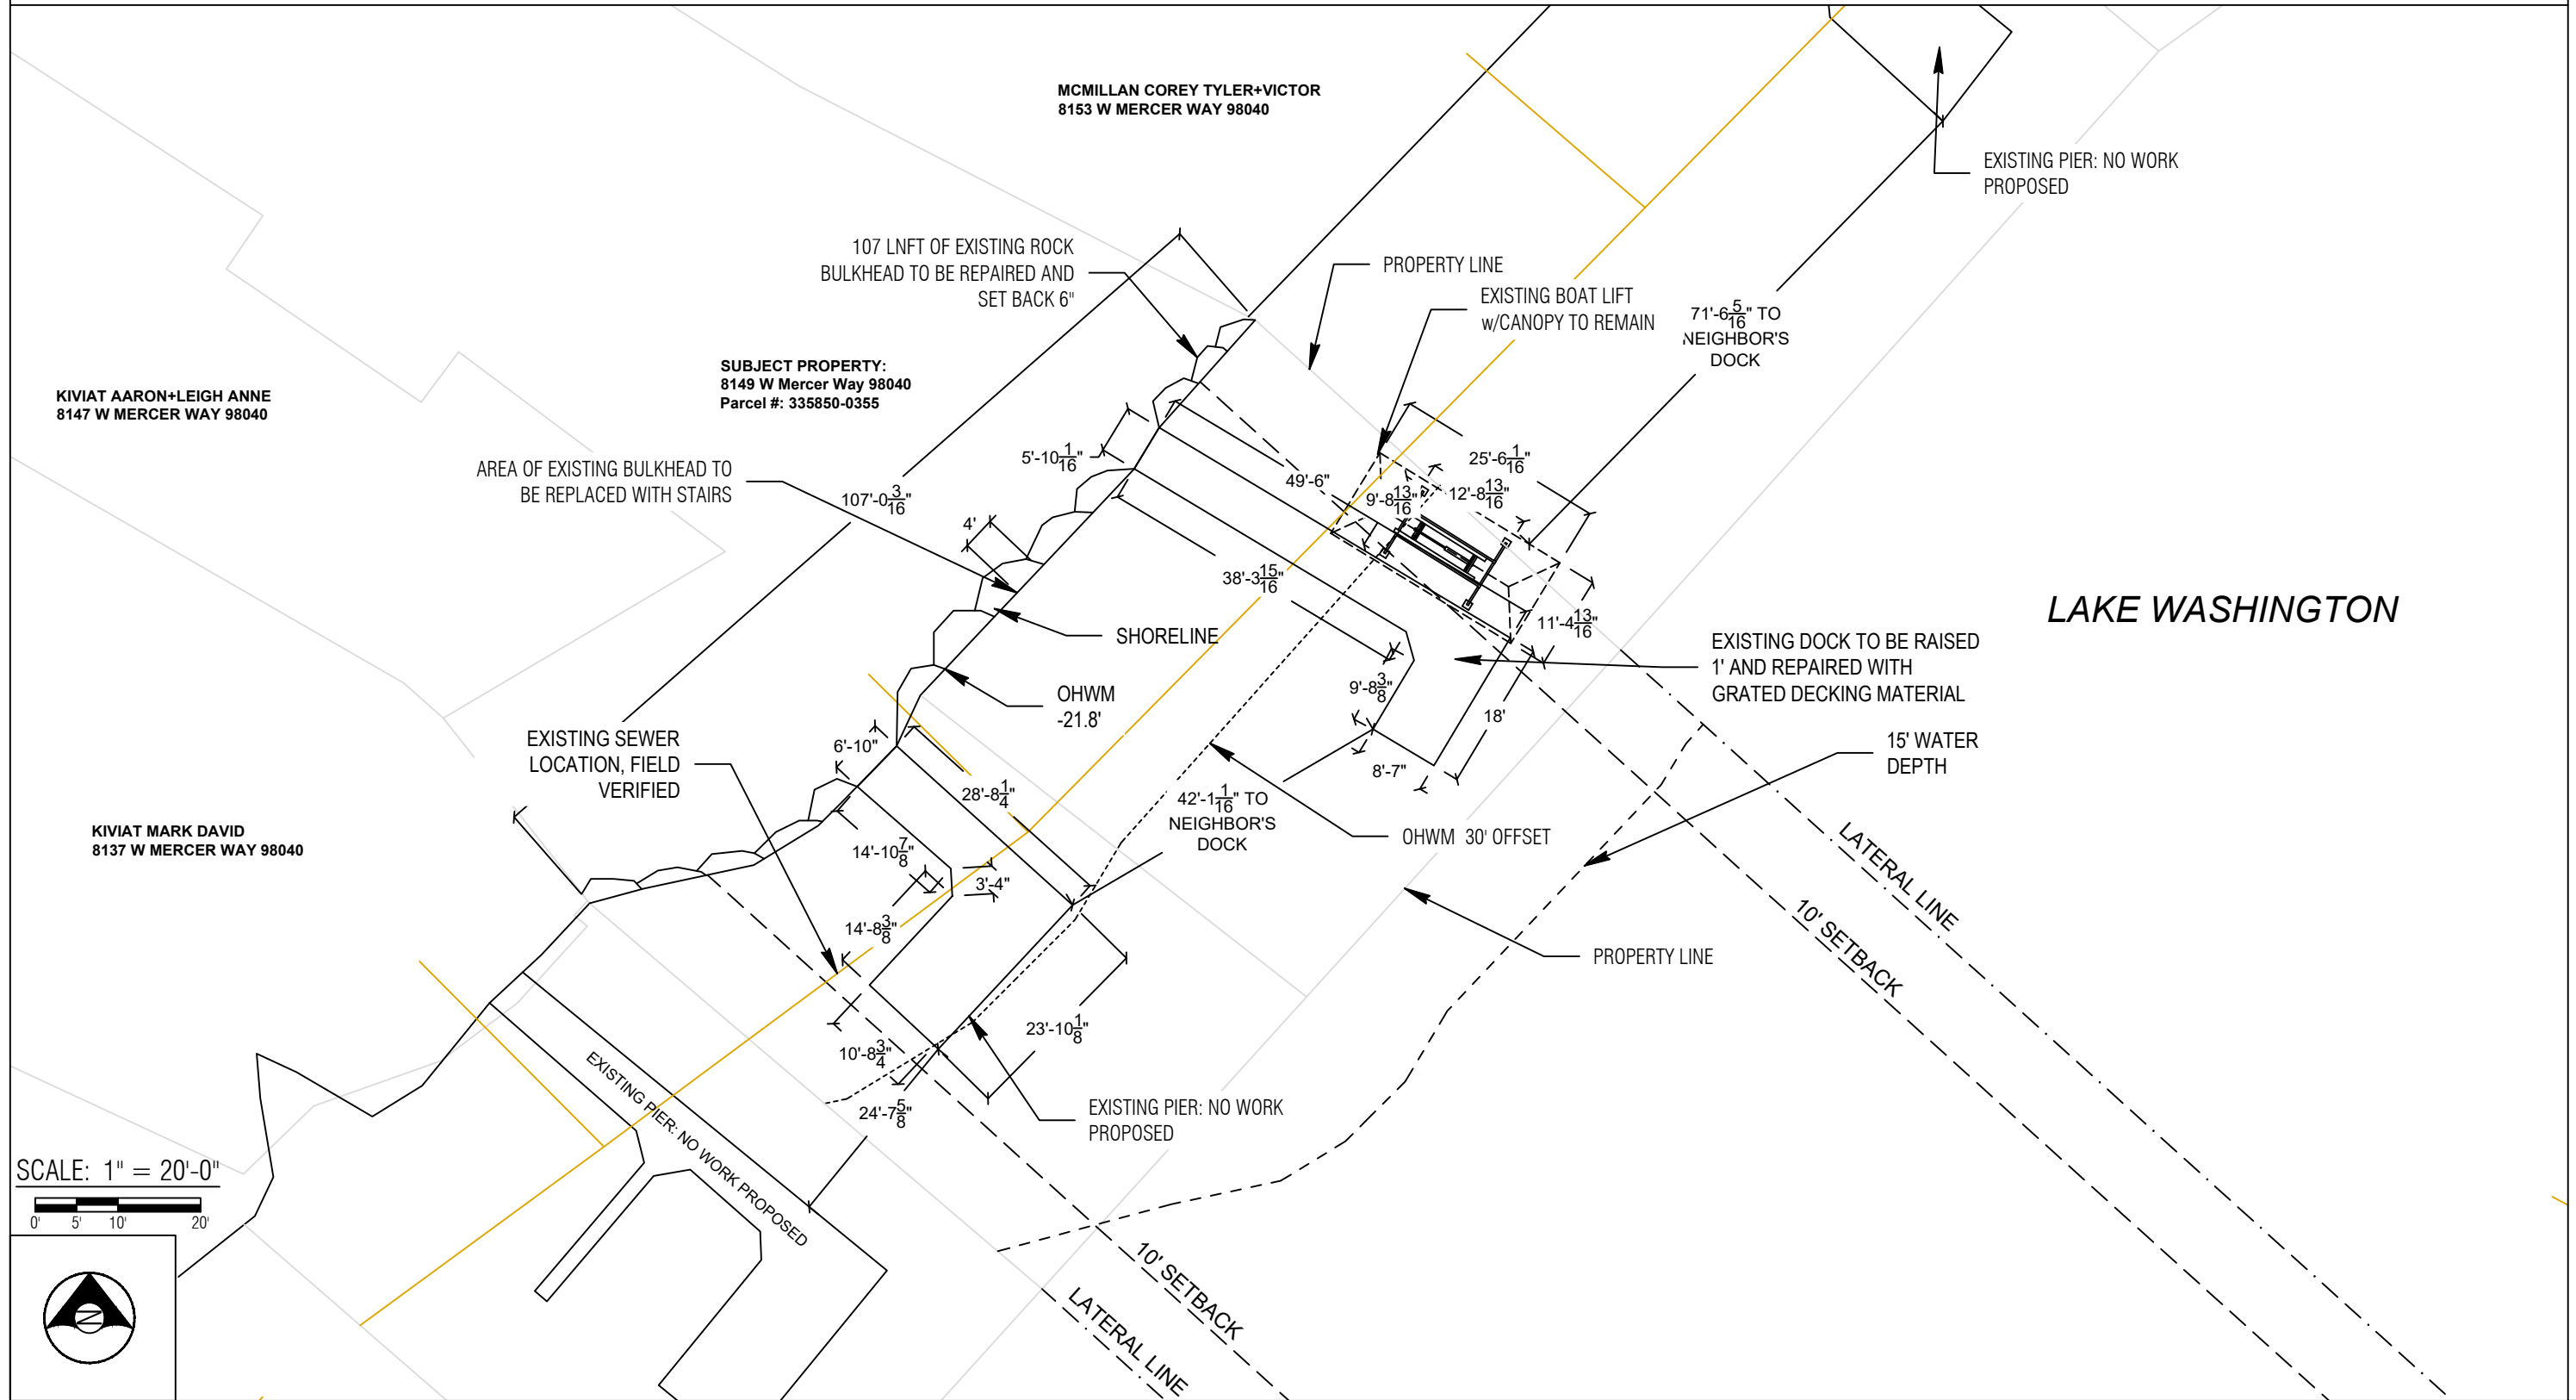
# EXISTING CONDITIONS

SCALE: 1" = 20'-0"

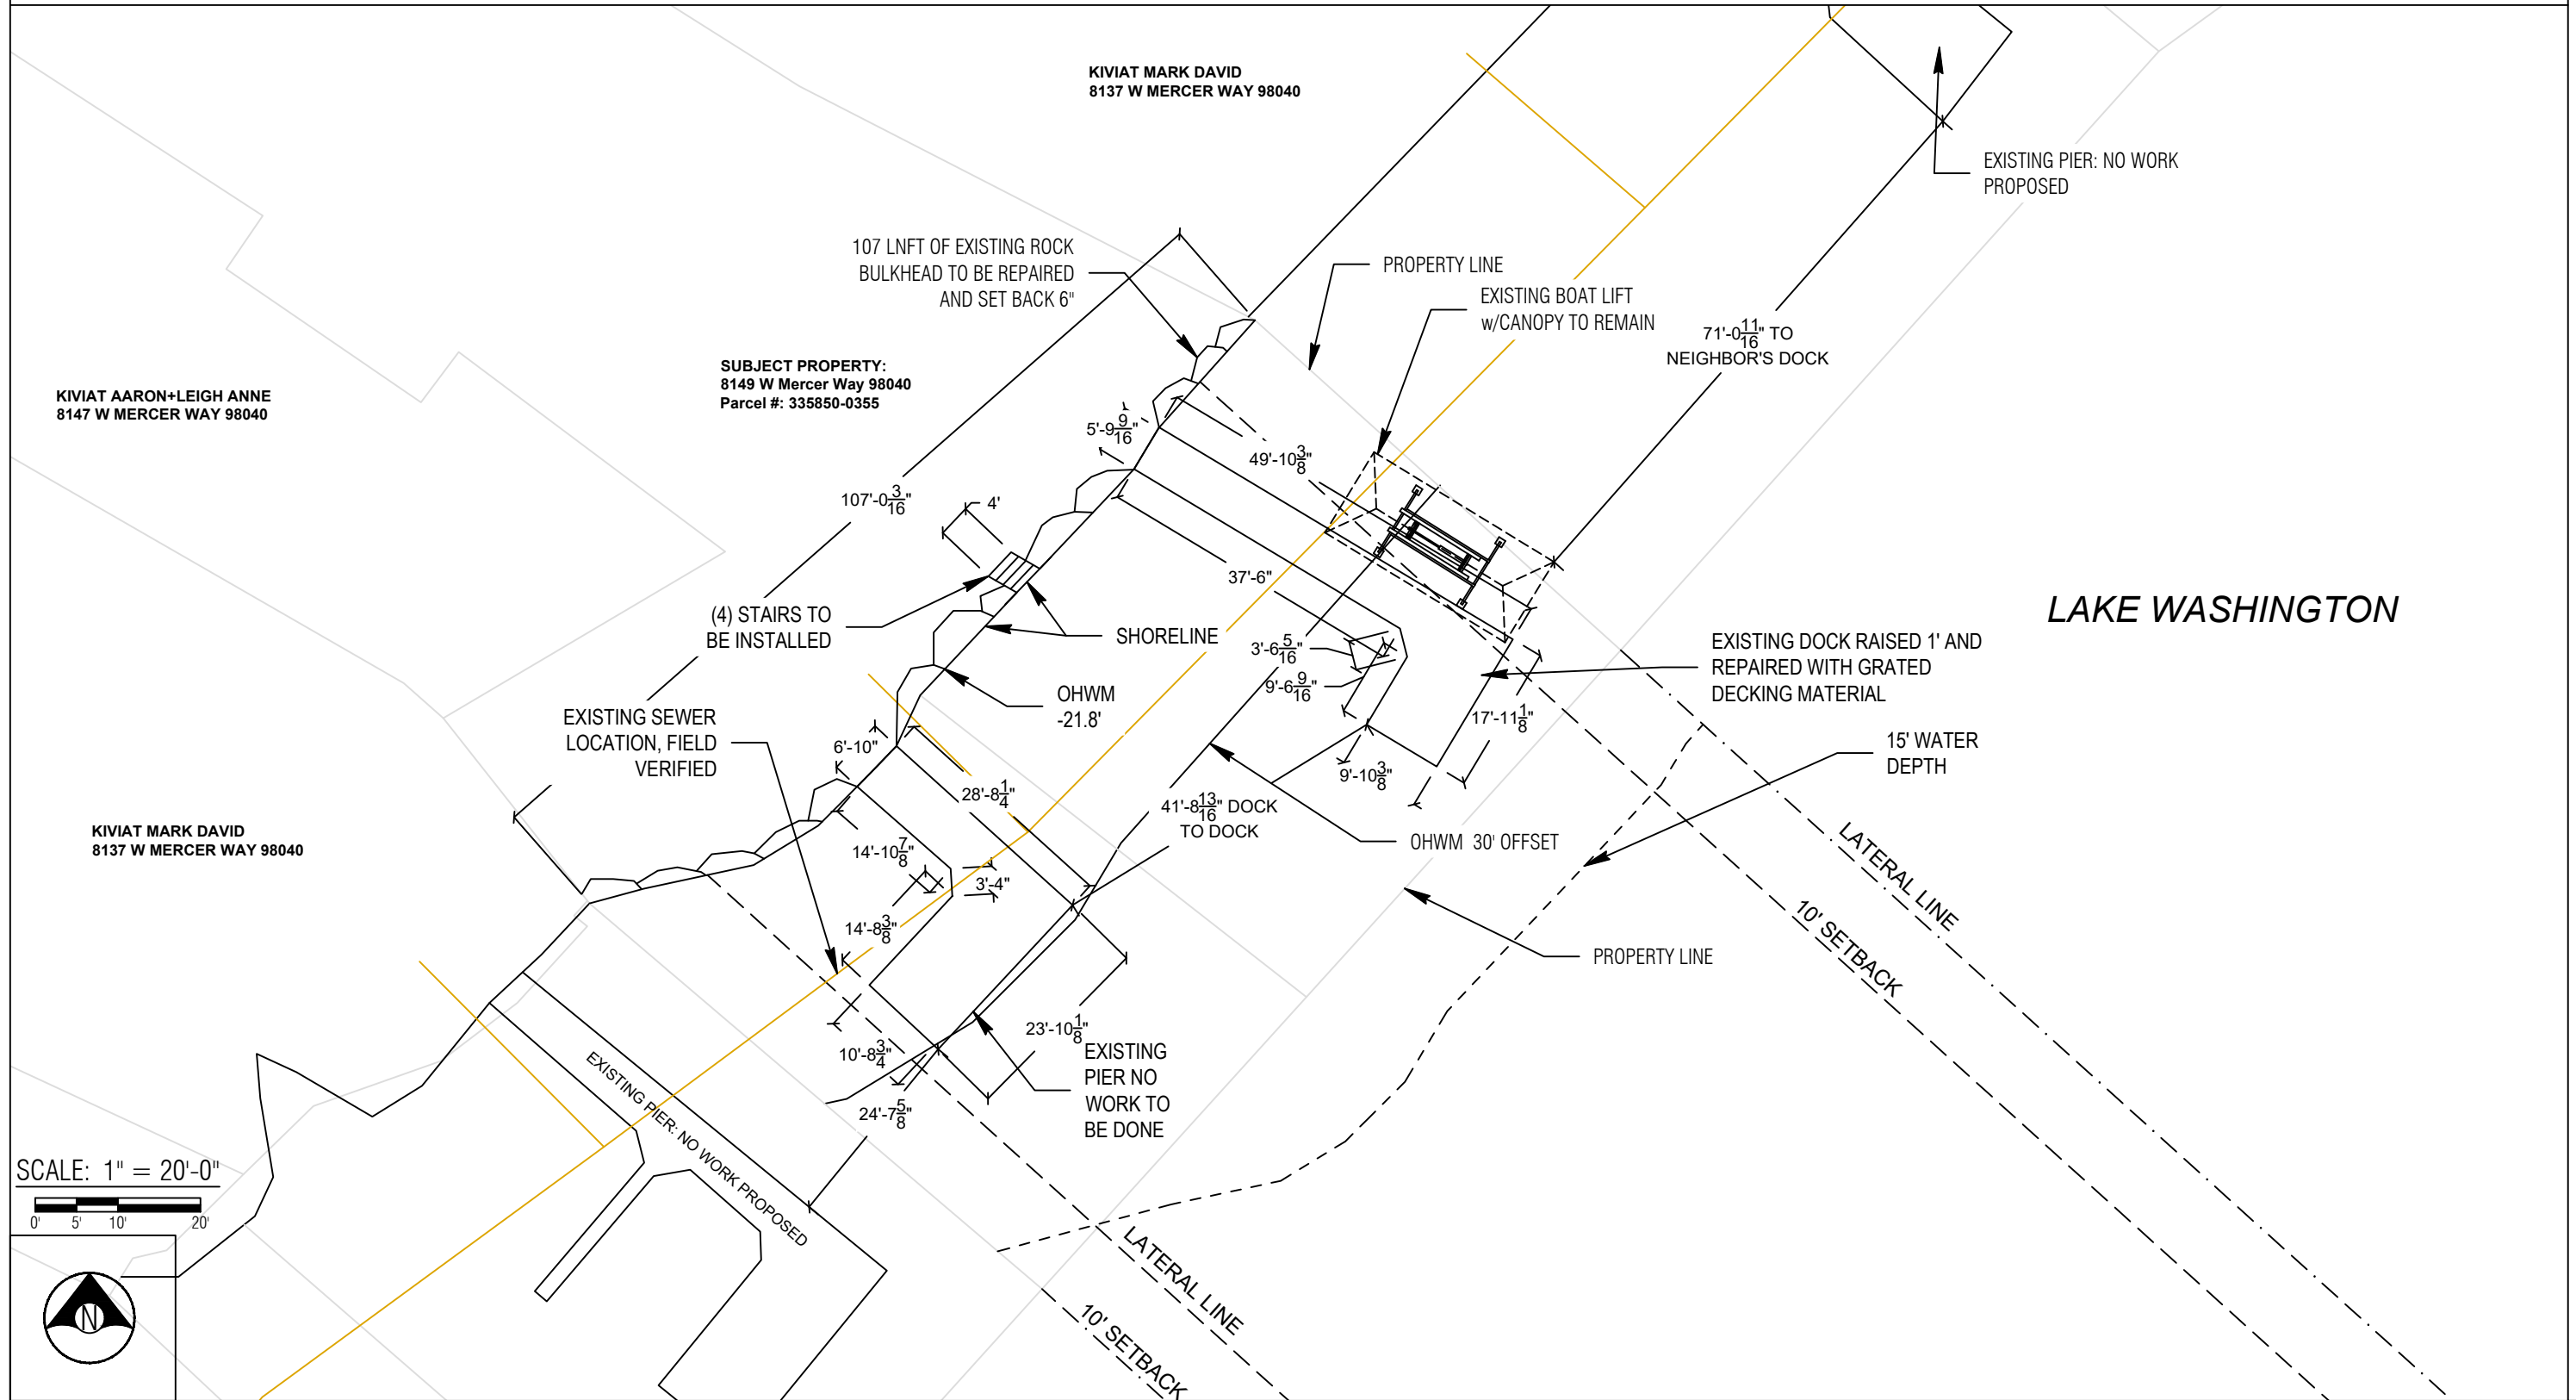
# PROPOSED CONDITIONS

SCALE: 1" = 20'-0"

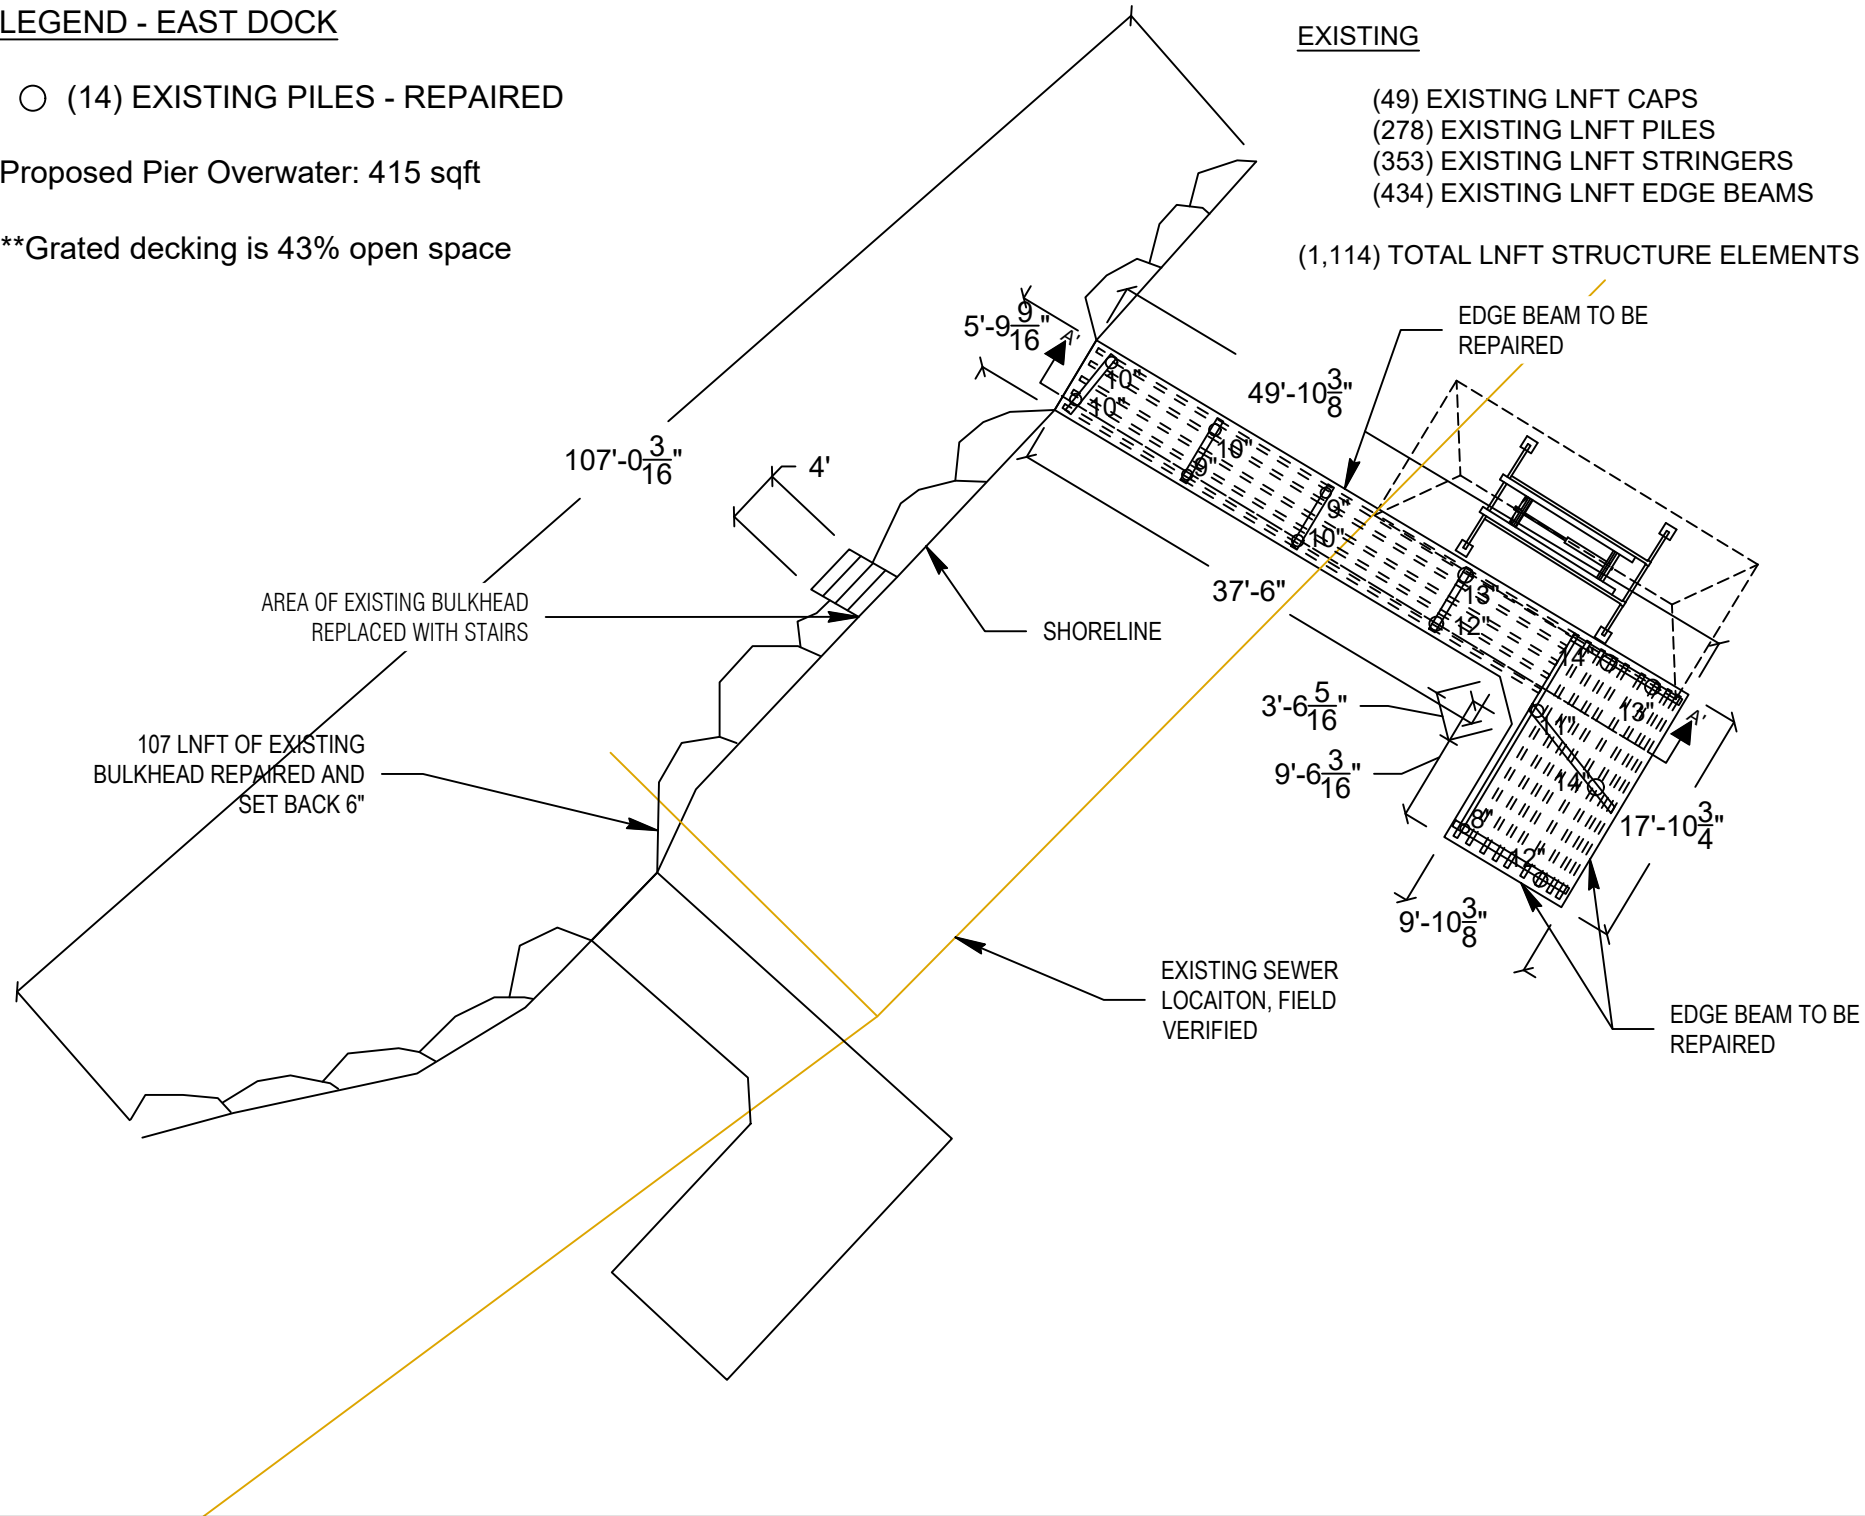
○ (14) EXISTING PILES - REPAIRED

Proposed Pier Overwater: 415 sqft

\*\*Grated decking is 43% open space

### EXISTING

- (49) EXISTING LNFT CAPS
- (278) EXISTING LNFT PILES
- (353) EXISTING LNFT STRINGERS
- (434) EXISTING LNFT EDGE BEAMS

### TO BE REPAIRED

- (0) EXISTING LNFT CAPS TO BE REPAIRED
- (63) EXISTING LNFT PILES TO BE REPAIRED
- ▭ (215) EXISTING LNFT STRINGERS TO BE REPAIRED w/ ANGLE IRON
- ▭ (78) EXISTING LNFT EDGE BEAMS TO BE REPAIRED

(356) TOTAL LNFT STRUCTURE ELEMENTS TO BE REPAIRED

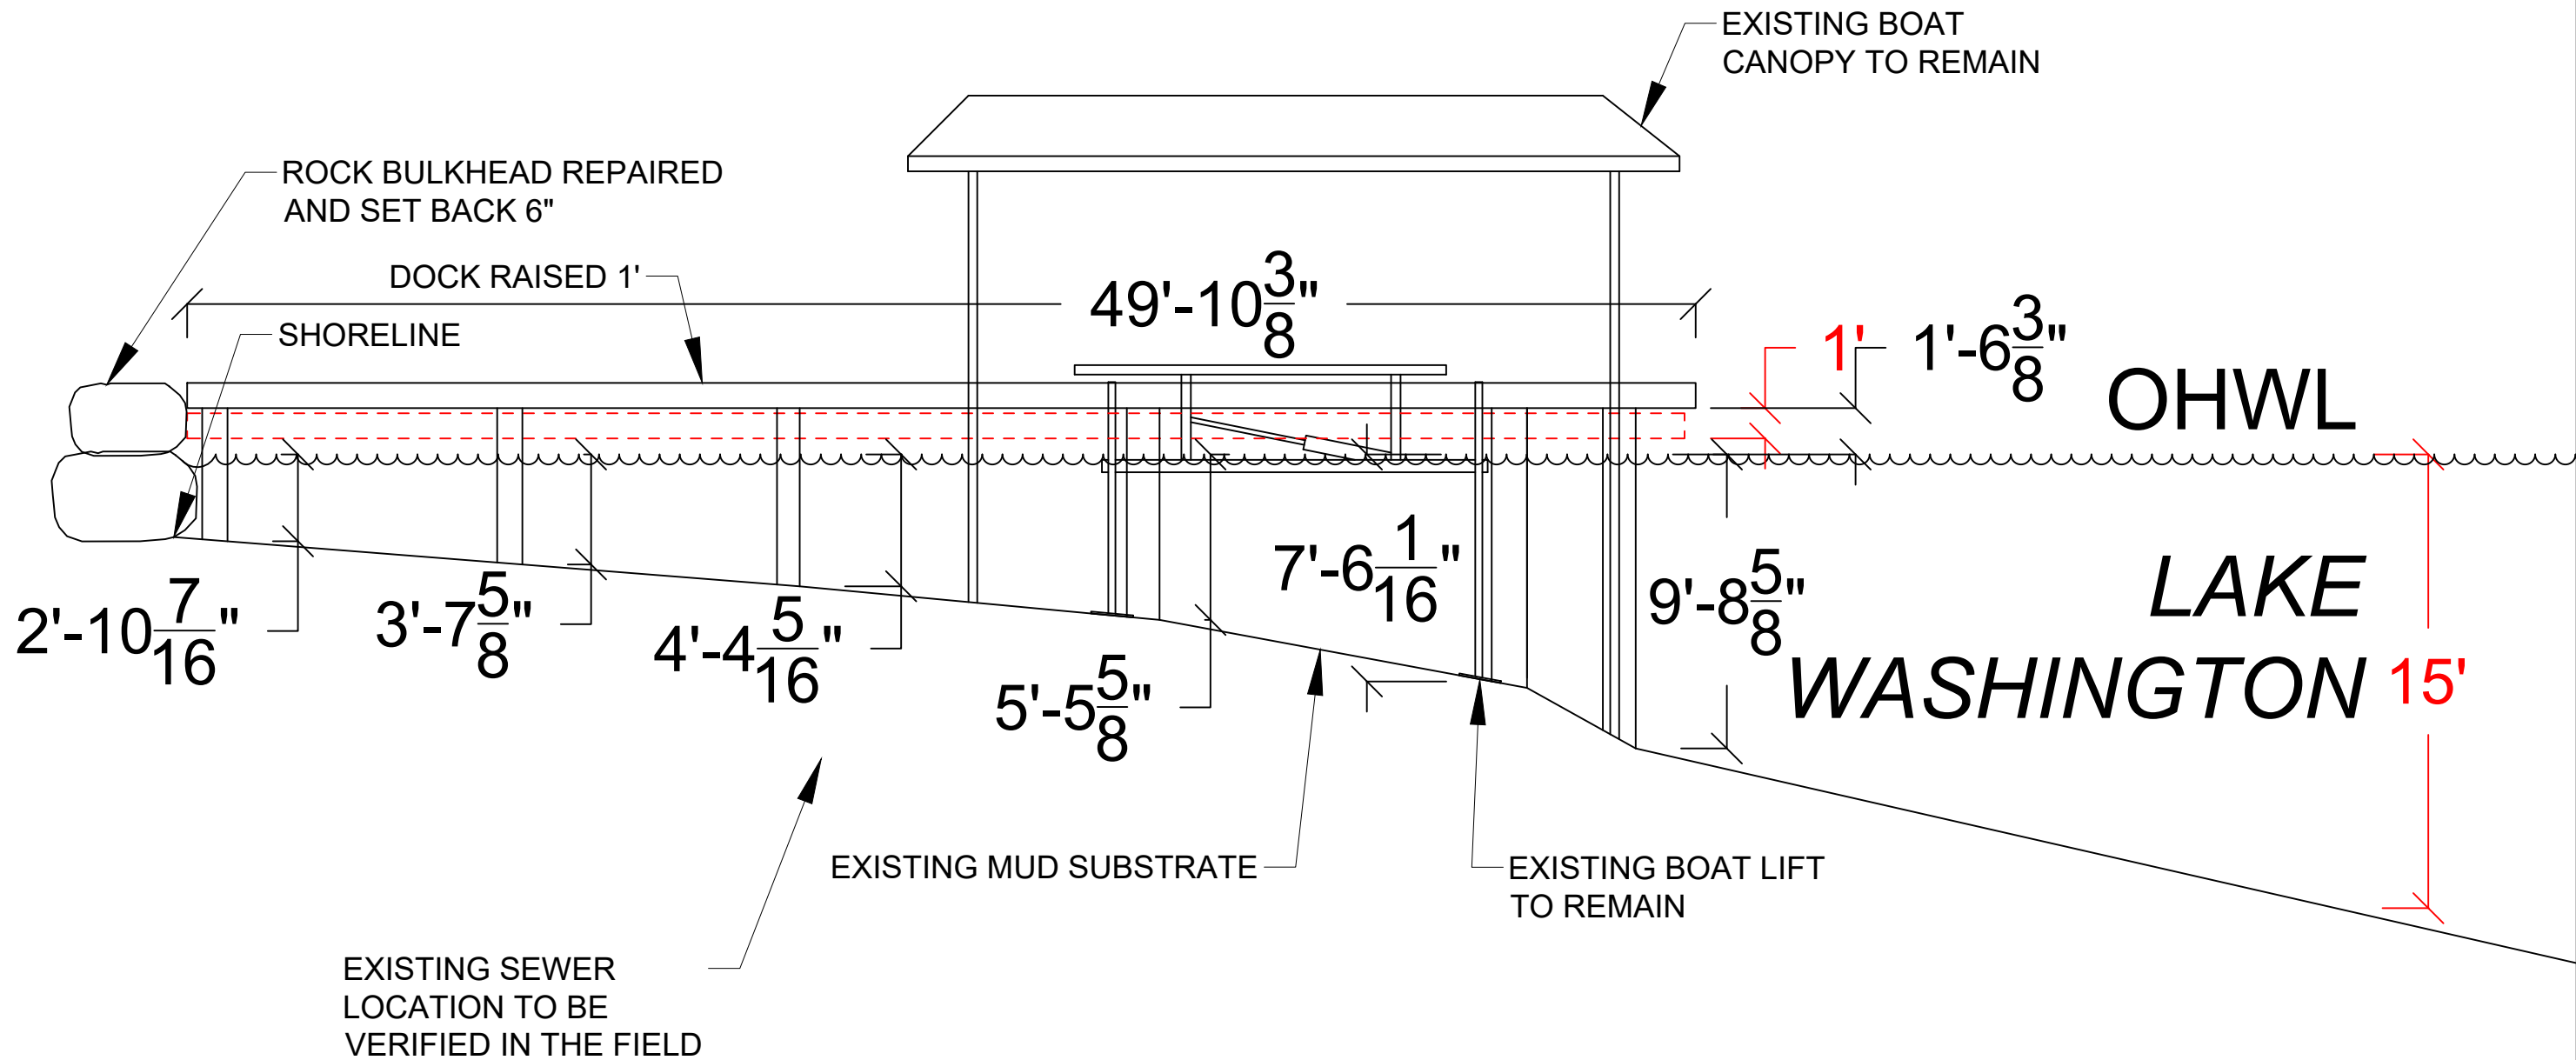
# PIER DETAILS PROPOSED - SECTION VIEW

SECTION VIEW: A'-A'

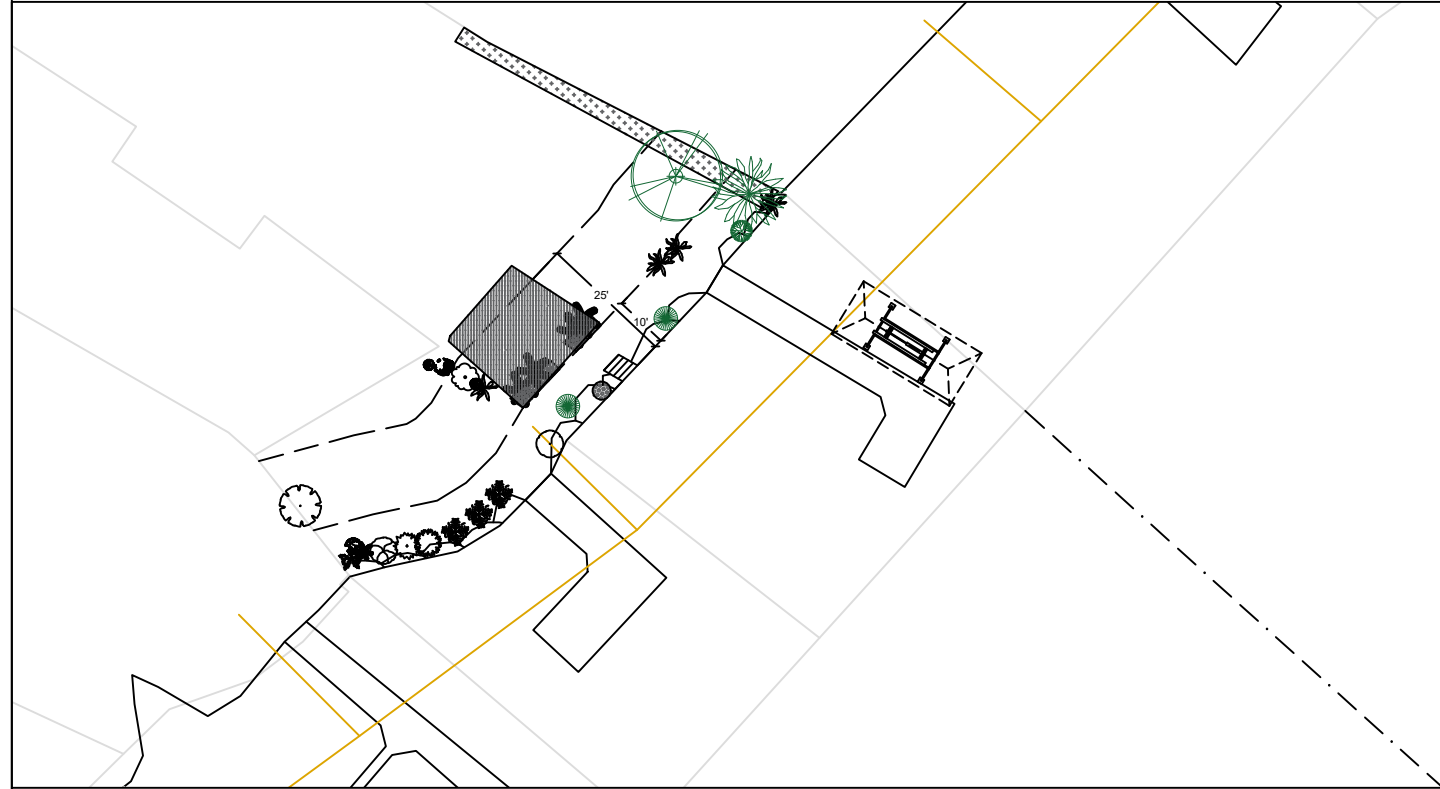
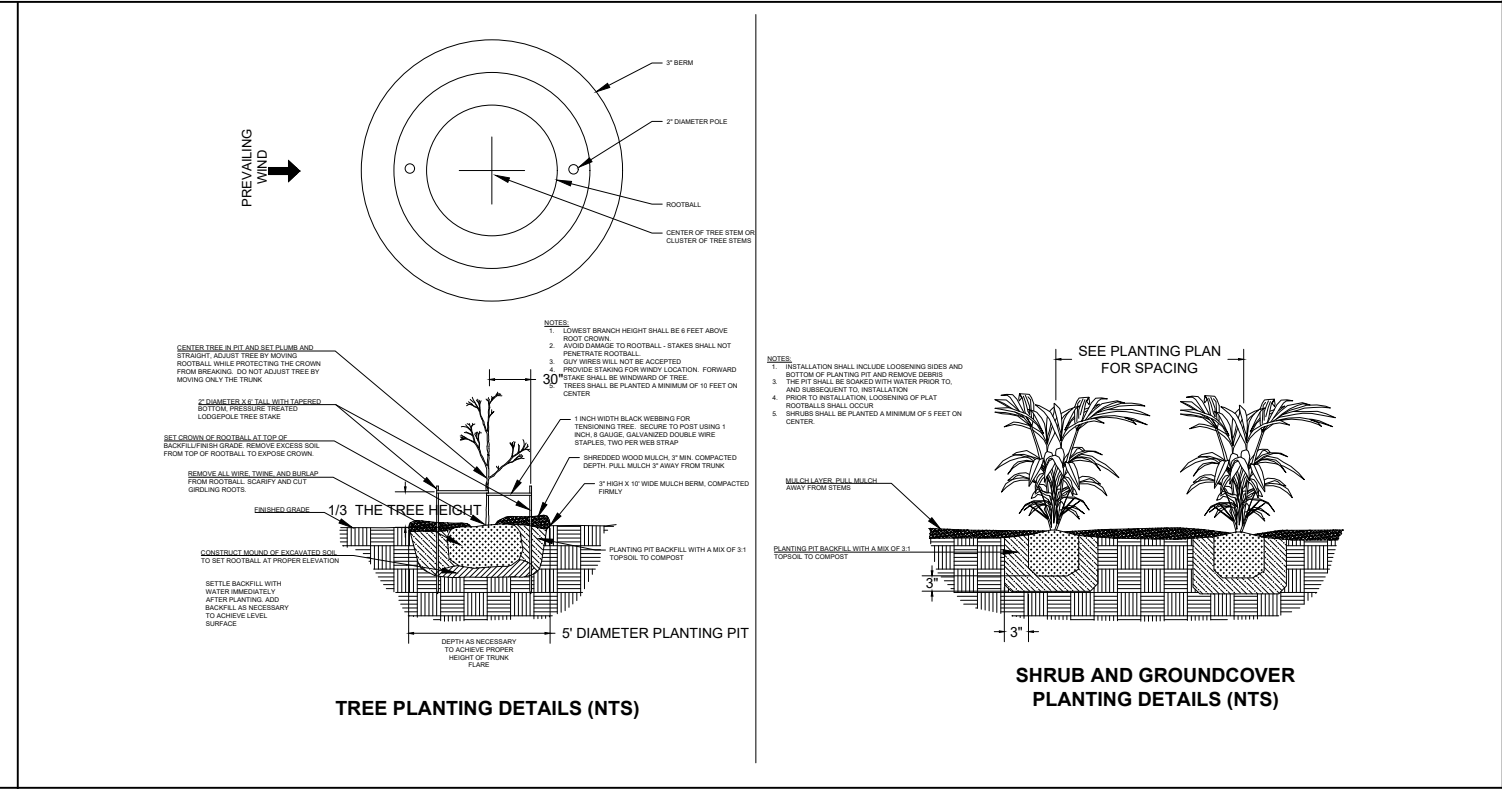
# MITIGATION PLAN

1. Shrubs are shown, and shall be planted, at least five feet on center. Trees are shown, and shall be planted, at least ten feet to center.
2. The property owner will implement and abide by the shoreline planting plan. The plants shall be installed before or concurrent with the work authorized by this permit. A report, as-built drawing and photographs demonstrating the plants have been installed or a report on the status of project construction will be submitted to the U.S. Army Corps of Engineers, Seattle District, Regulatory Branch, within 12 months from the date of permit issuance. This reporting requirement may be met by completing and submitting a U.S. Army Corps of Engineers approved Report for Mitigation Work Completion form.

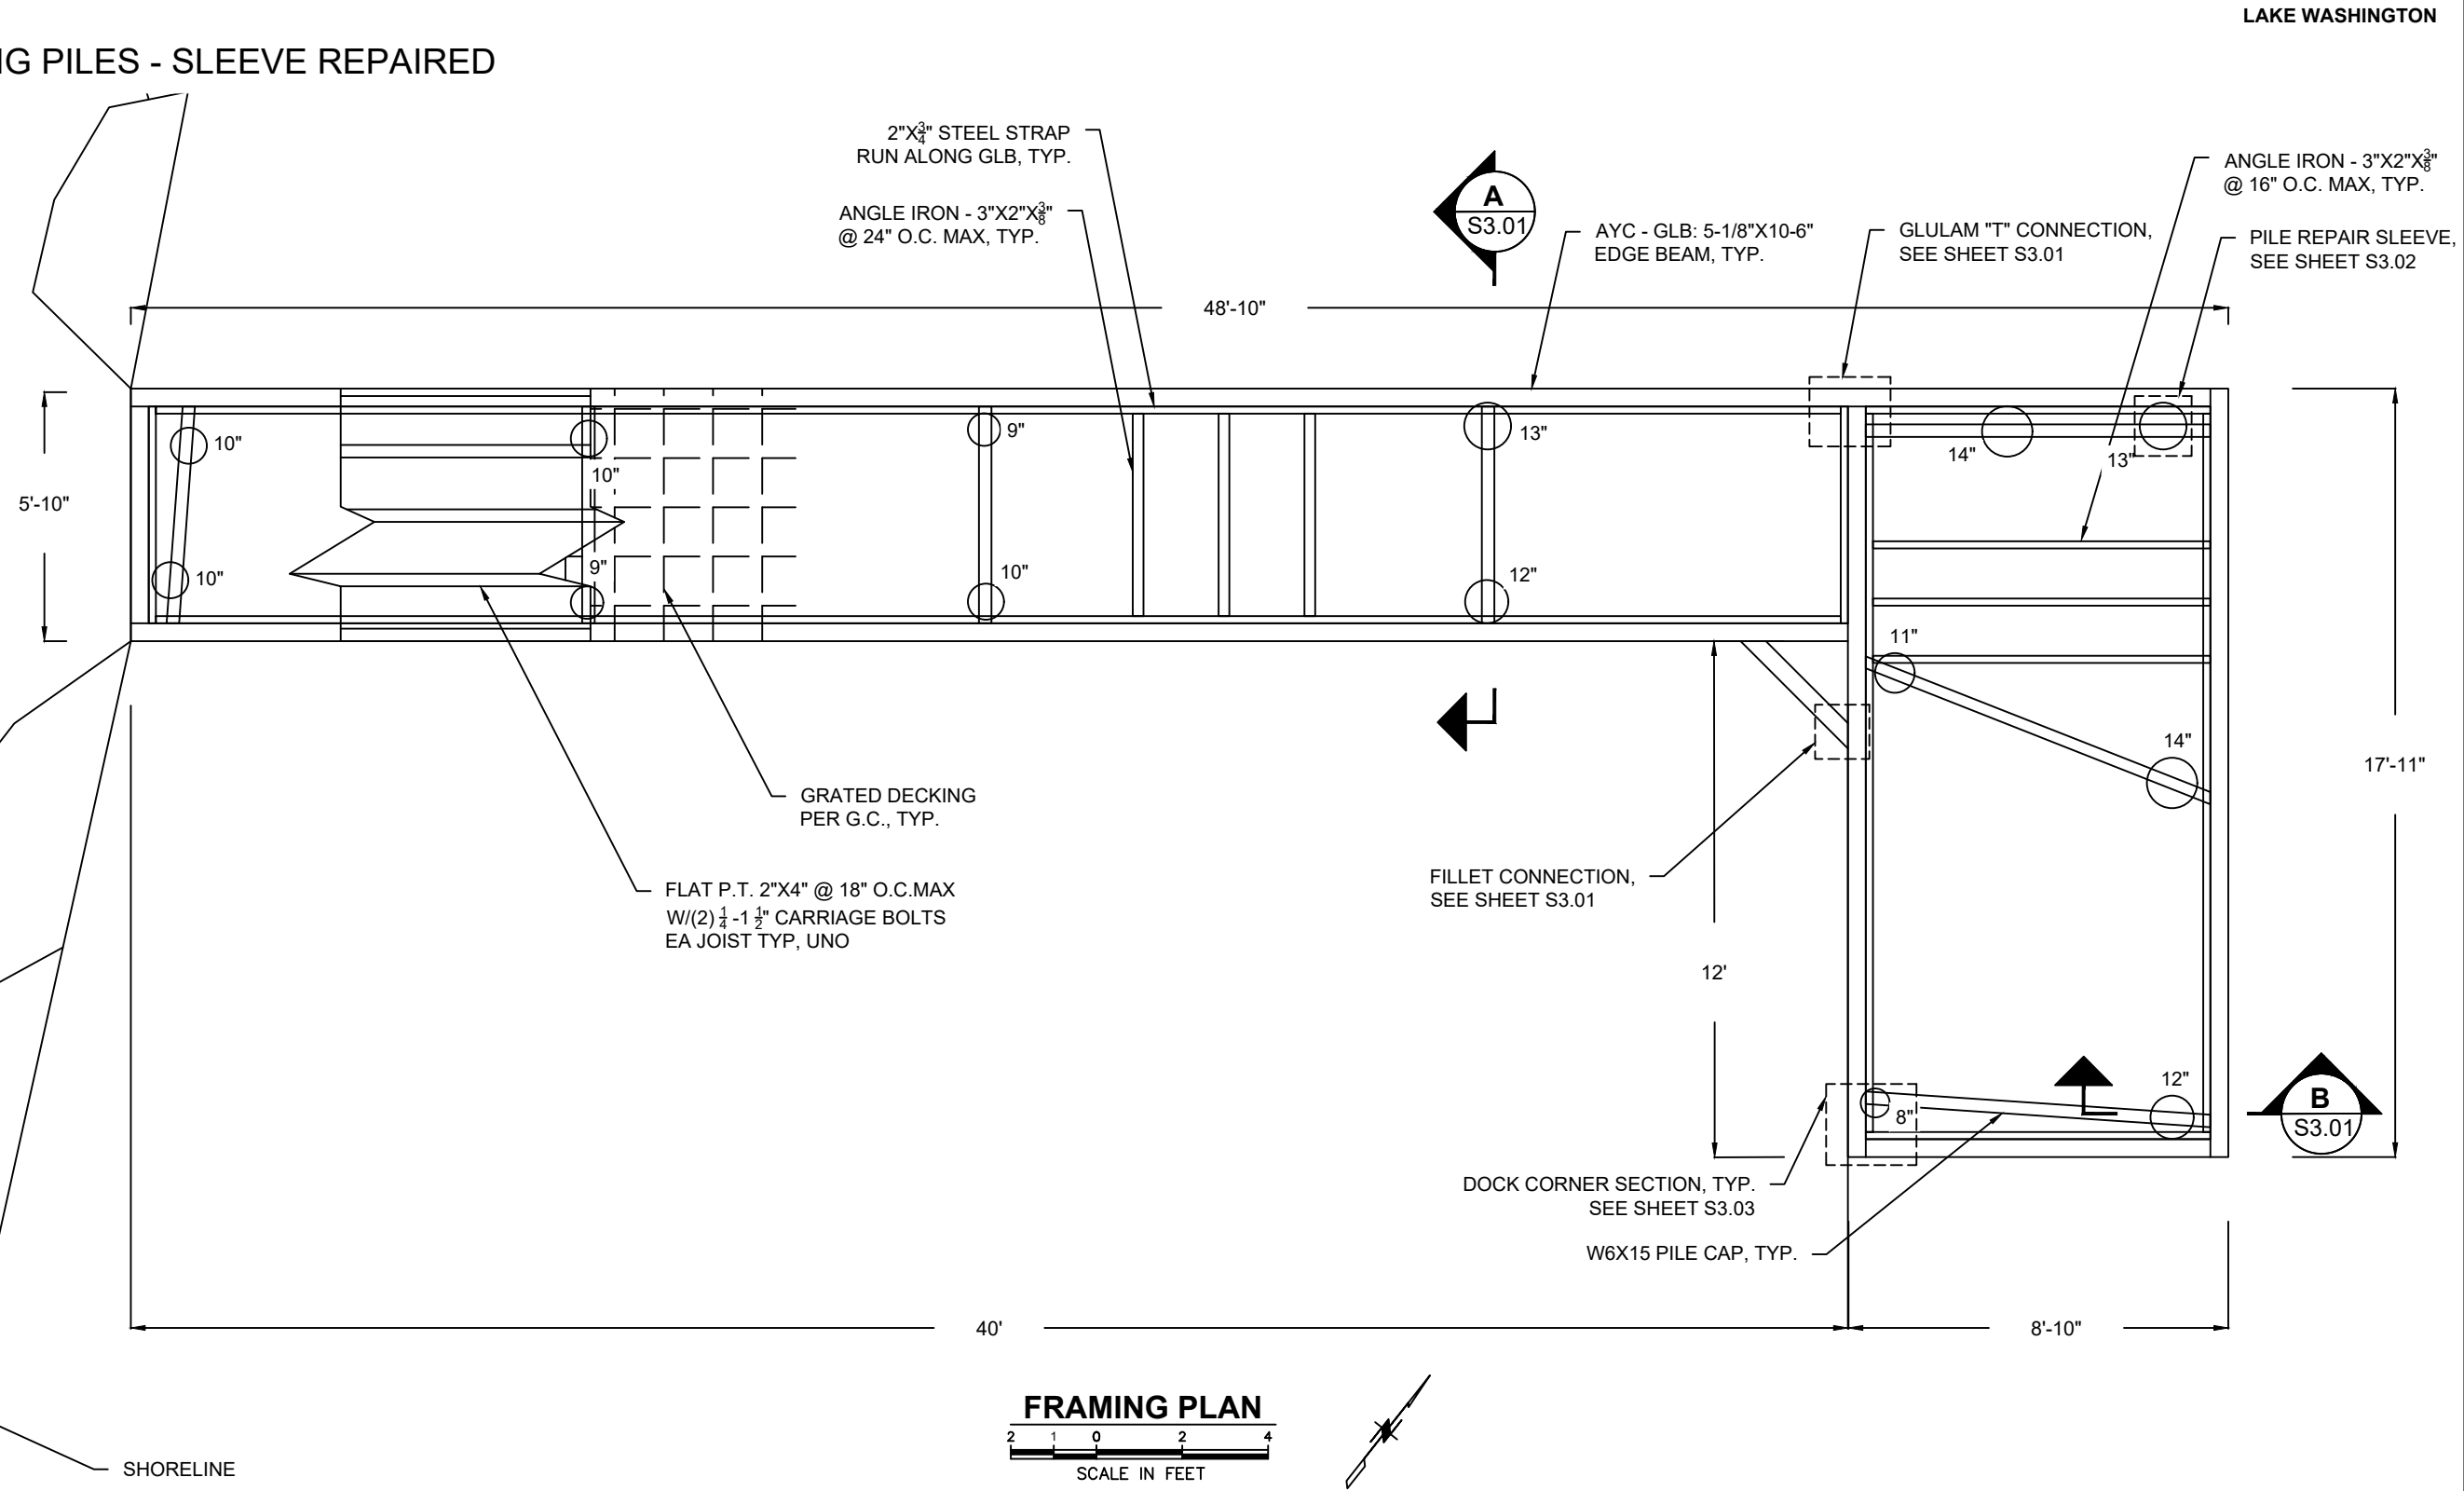
**FRAMING PLAN**  
SCALE IN FEET

**LEGEND - EAST DOCK**

○ (14) EXISTING PILES - SLEEVE REPAIRED

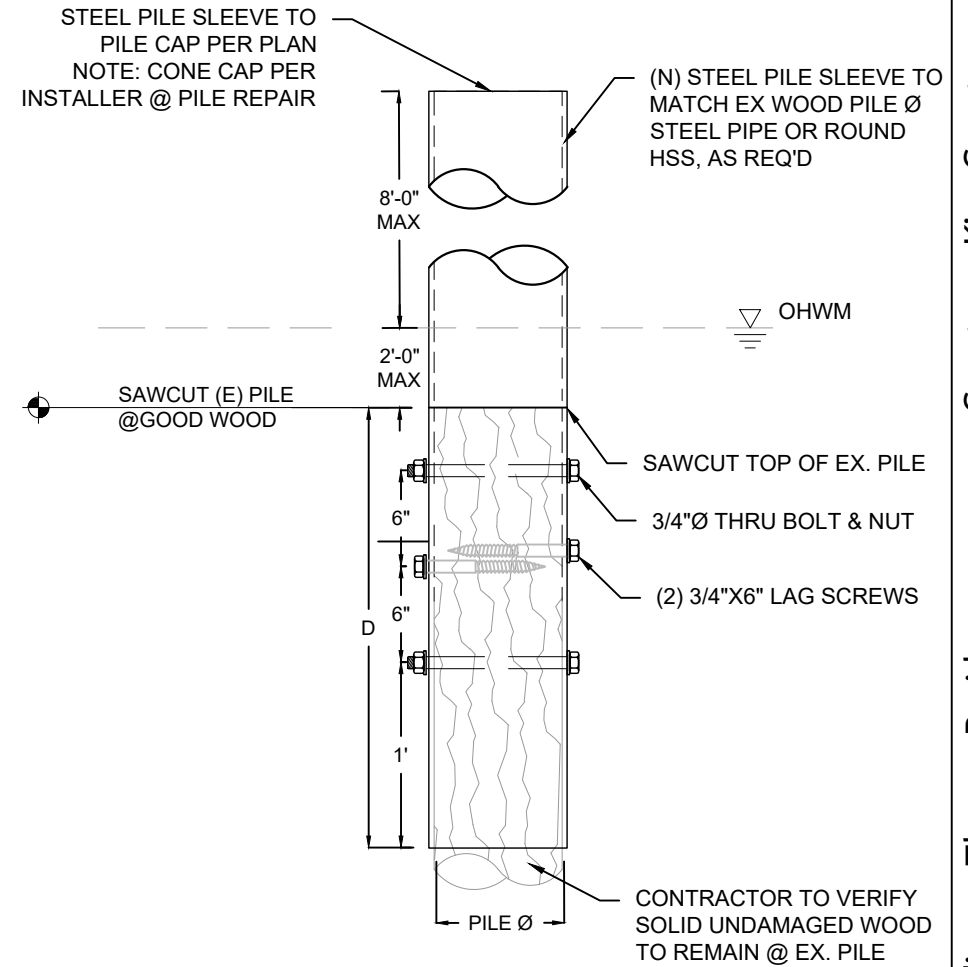
**SHEET S3.01**

STEEL SLEEVE TABLE	
PILE Ø	MIN D
8"	27"
10"	30"
12"+	36"

CONTRACTOR TO VERIFY THAT THE PILE FITS SNUGLY IN THE SLEEVE SUCH THAT THERE IS UNIFORM BEARING OF THE PILE AGAINST THE SLEEVE
