# SITE PLAN

Scope of Work: We propose to repair (14) piles of the east dock, set back 6" and repair 107 lft of existing bulkhead, replace 4 lft of existing rock bulkhead with stairs, raise the existing east dock 1', and repair the existing east dock with (415 sqft) grated decking material.

County: King County  
Location: Lake Washington  
Applicant: Thomas Residence  
8149 W Mercer Way  
Mercer Island, Washington 98040  
Datum: CORPS OF ENGINEERS 1919  
NE Quarter Of Section 36, Township 24, Range 04  
Adjacent Owners:  
KIVIAI MARK DAVID  
8137 W MERCER WAY 98040  
MCMILLAN COREY TYLER+VICTOR  
8153 W MERCER WAY 98040  
Last Updated: 11/17/2023 3:31 PM Shop  
Created: 07/17/23

**SHEET**  
**1.0**  
NWS-2023-XXX  
PAGE 1 OF 15

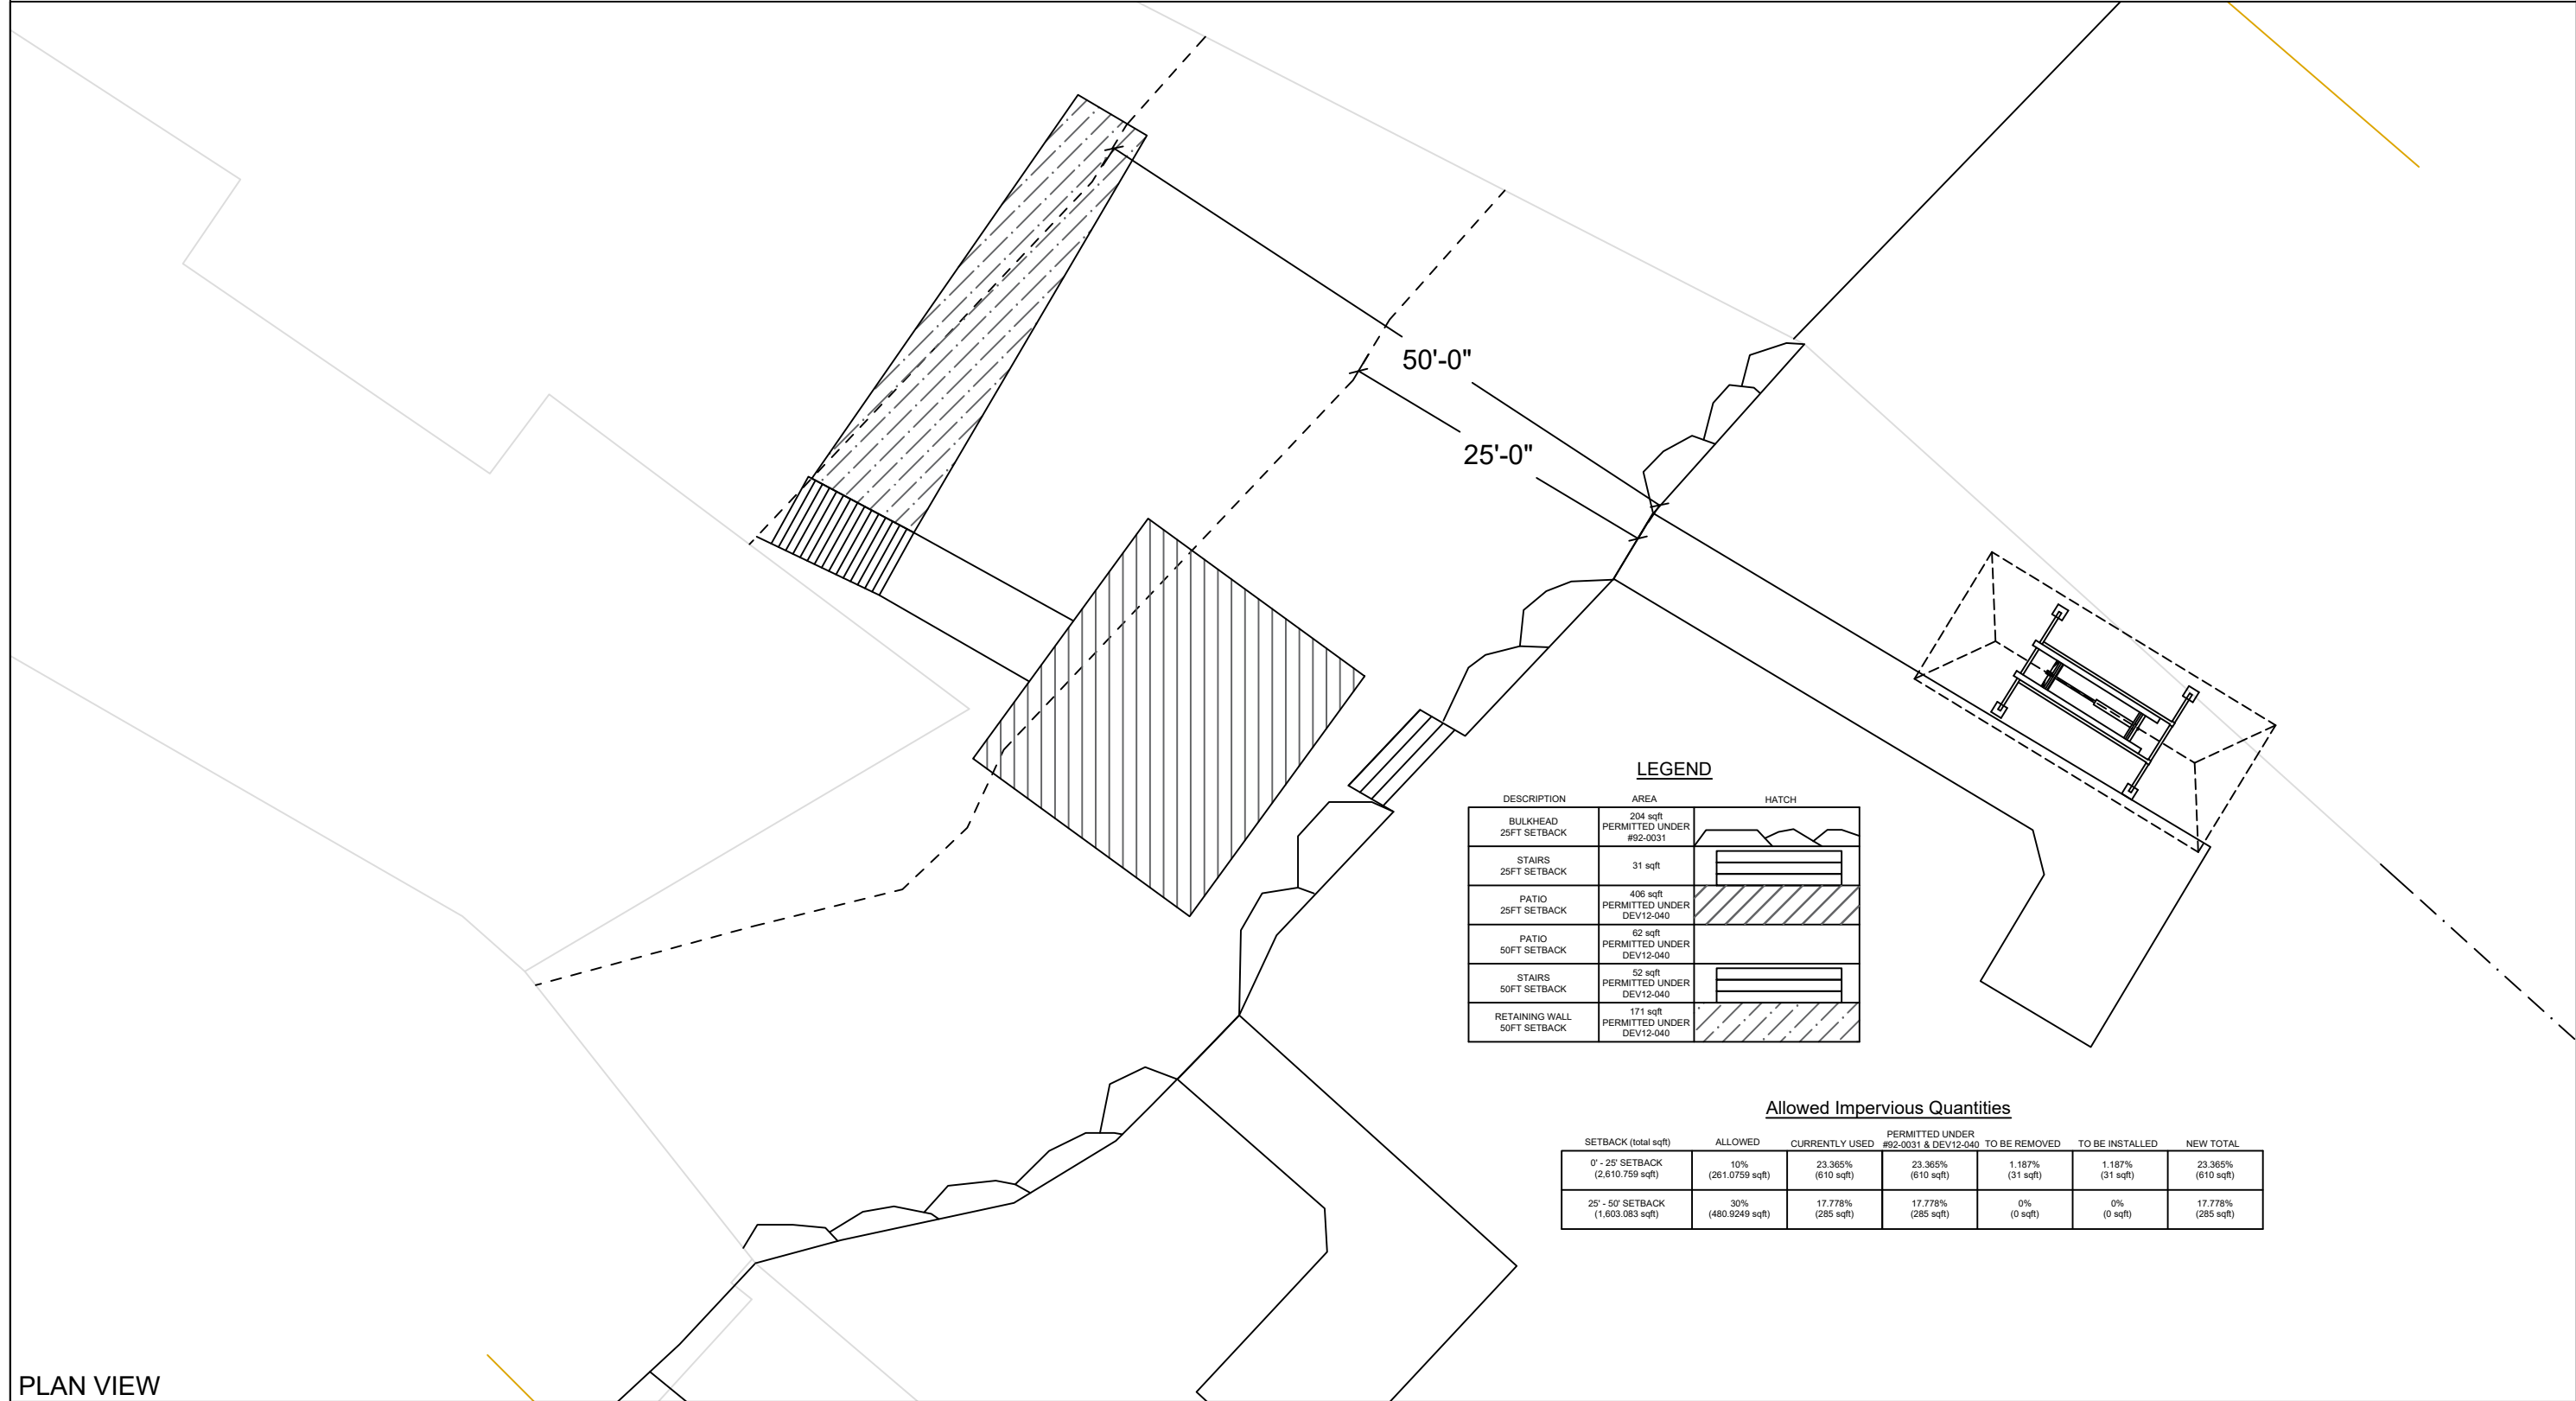
# HARDSCAPE CALCULATION

PLAN VIEW
