Ecological No Net Loss Assessment Report

Wellmon Residence
6333 77th Ave SE
Mercer Island, WA 98040

Permits are being applied for a dock repairs and associated moorage improvements.

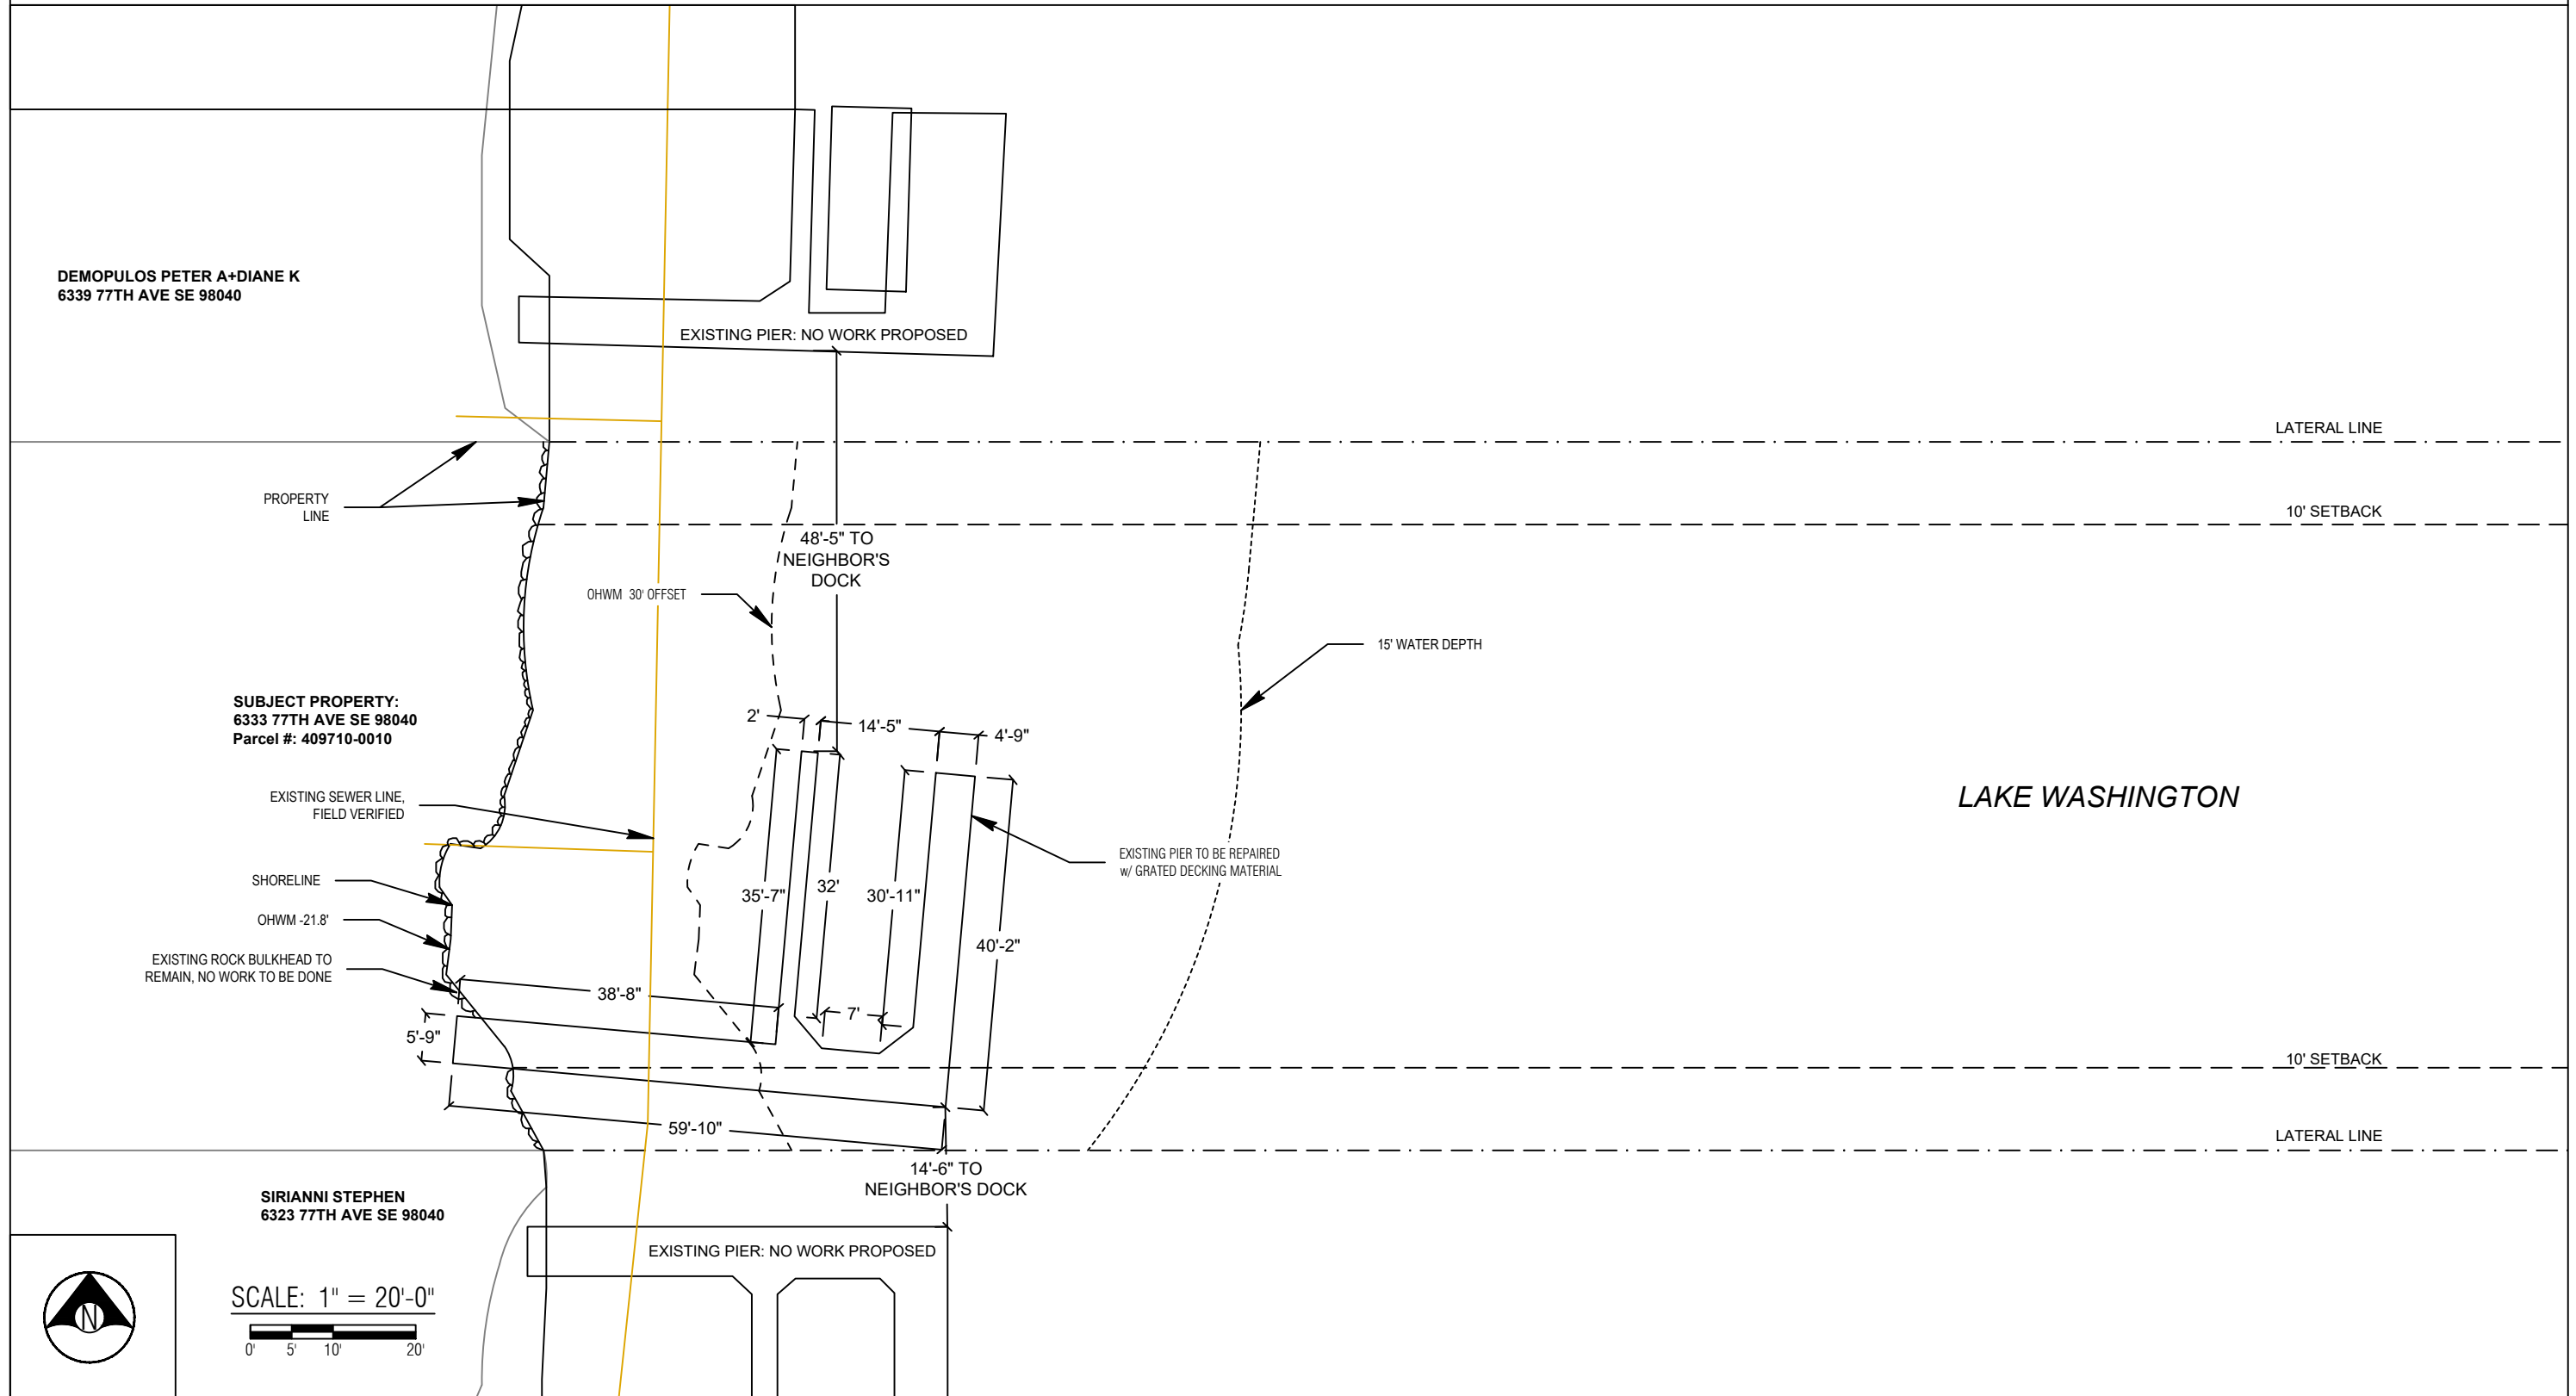
EXISTING CONDITIONS

Scope of Work: We propose to repair (11) existing piles, repair (1) existing brace pile, repair the existing dock, and install a platform lift.

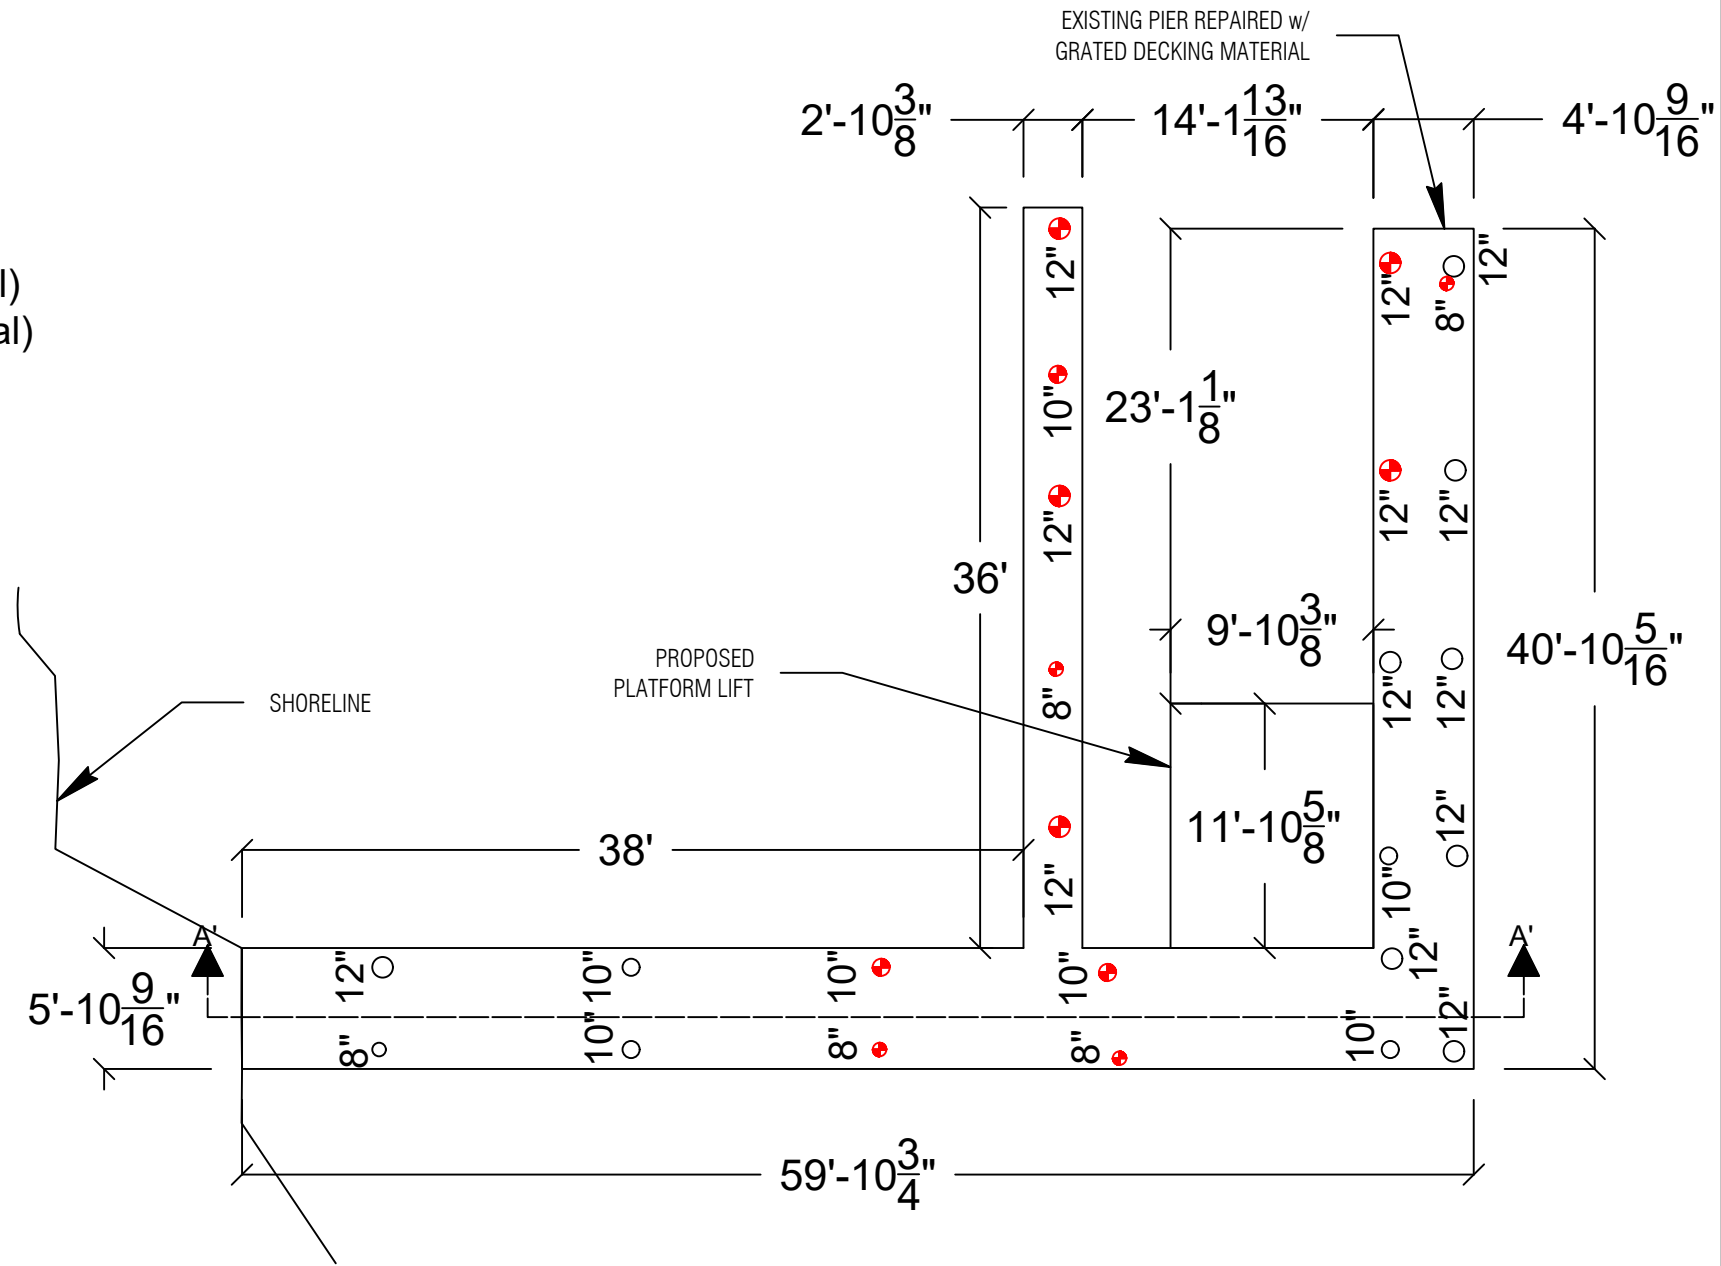
PLAN VIEW

- ⊕ (11) EXISTING PILES - TO BE REPAIRED
- ⊕ (1) EXISTING BRACE PILE - TO BE REPAIRED
- (13) EXISTING PILES - NO WORK TO BE DONE

Existing Pier Total: 592 sqft (to be repaired with grated decking material)
 Existing Overwater: 592 sqft (to be repaired with grated decking material)

Proposed Platform Lift: 117 sqft (grated decking material)
 New Pier Total: 627 sqft (grated decking material)
 New Overwater Total: 744 sqft (grated decking material)

**Grated decking is 43% light permeable

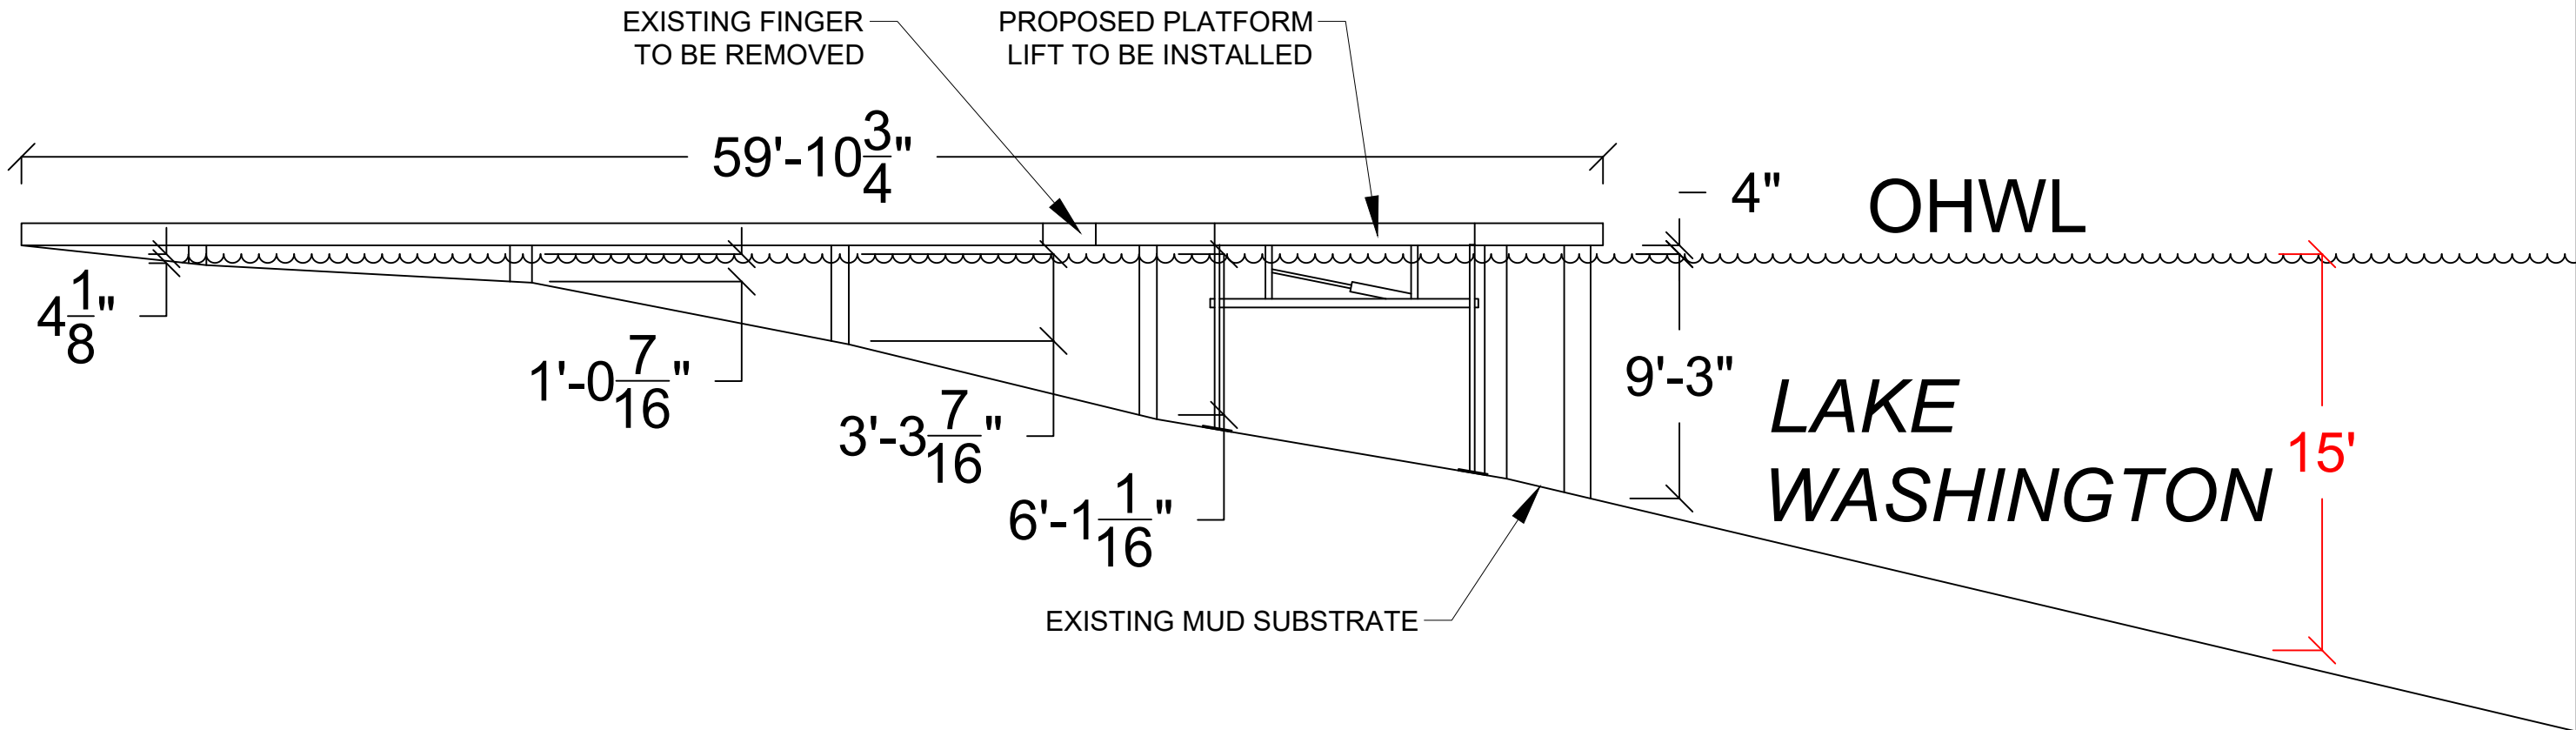
PIER DETAILS EXISTING/PROPOSED - SECTION VIEW

SECTION VIEW: A'-A'

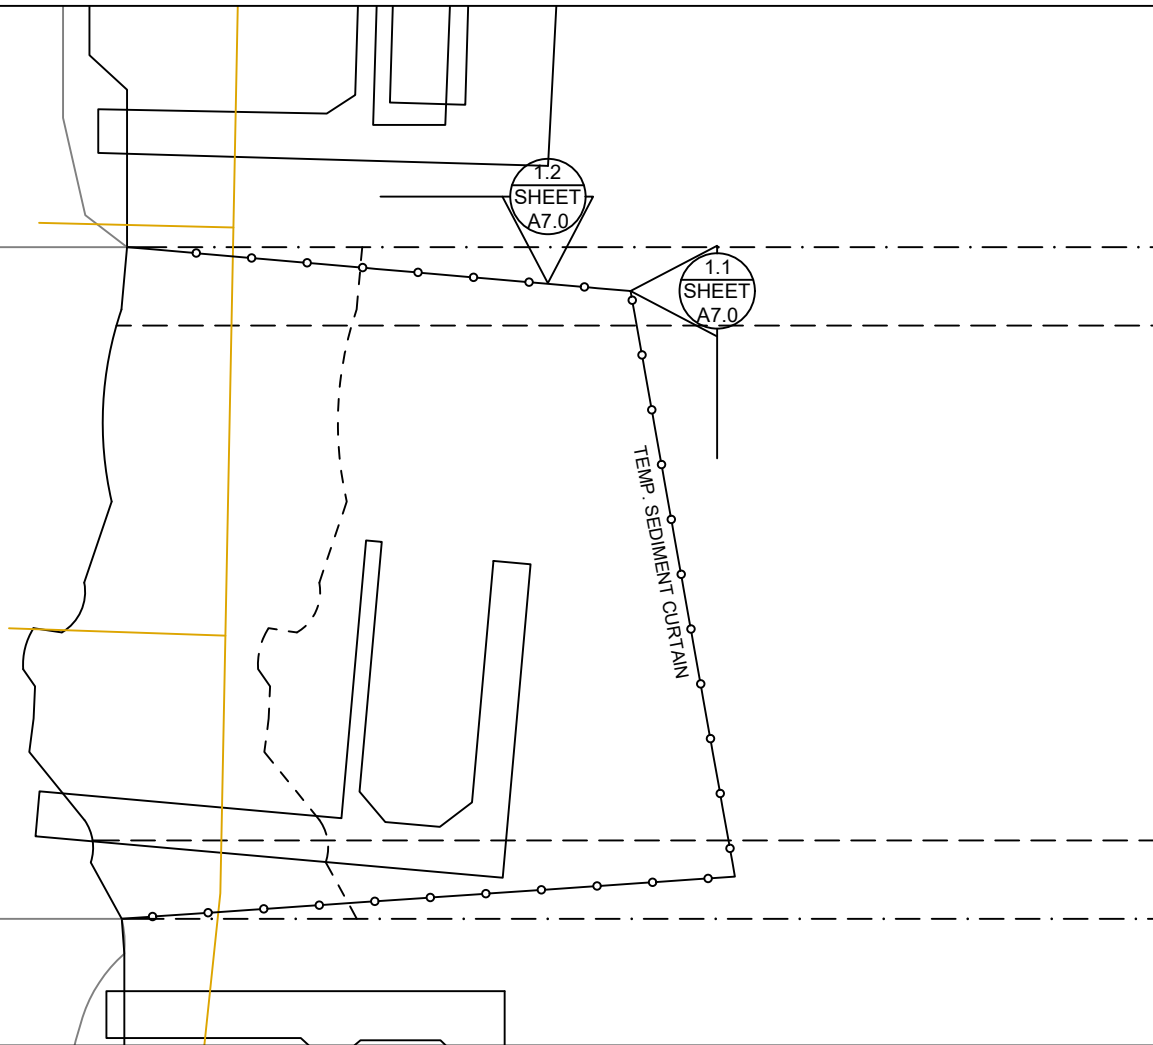
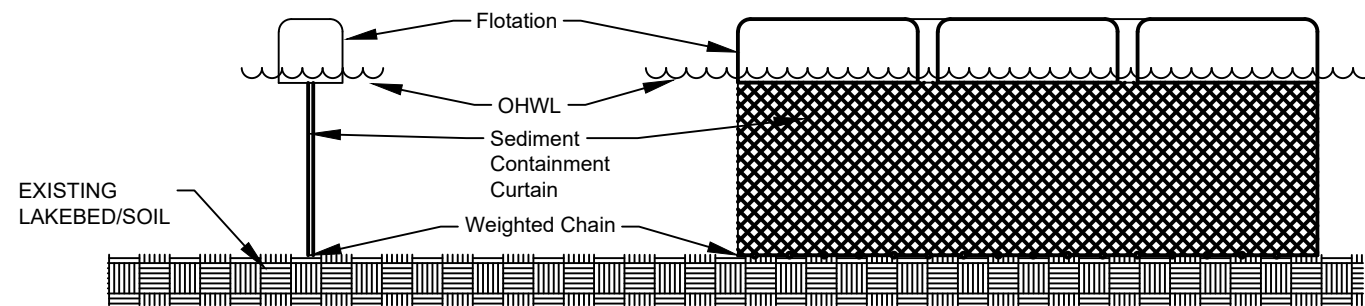
BMP INFORMATION

9. When removing piles, no actions shall be taken that would cause adhering sediments to return to lake waters.
 10. Above-water containment shall be installed around removed piles to prevent sediment laden waters from returning to lake waters.

During construction, a floating boom will surround the work barge and dock. (See Appendix A – Sheets A7.0)

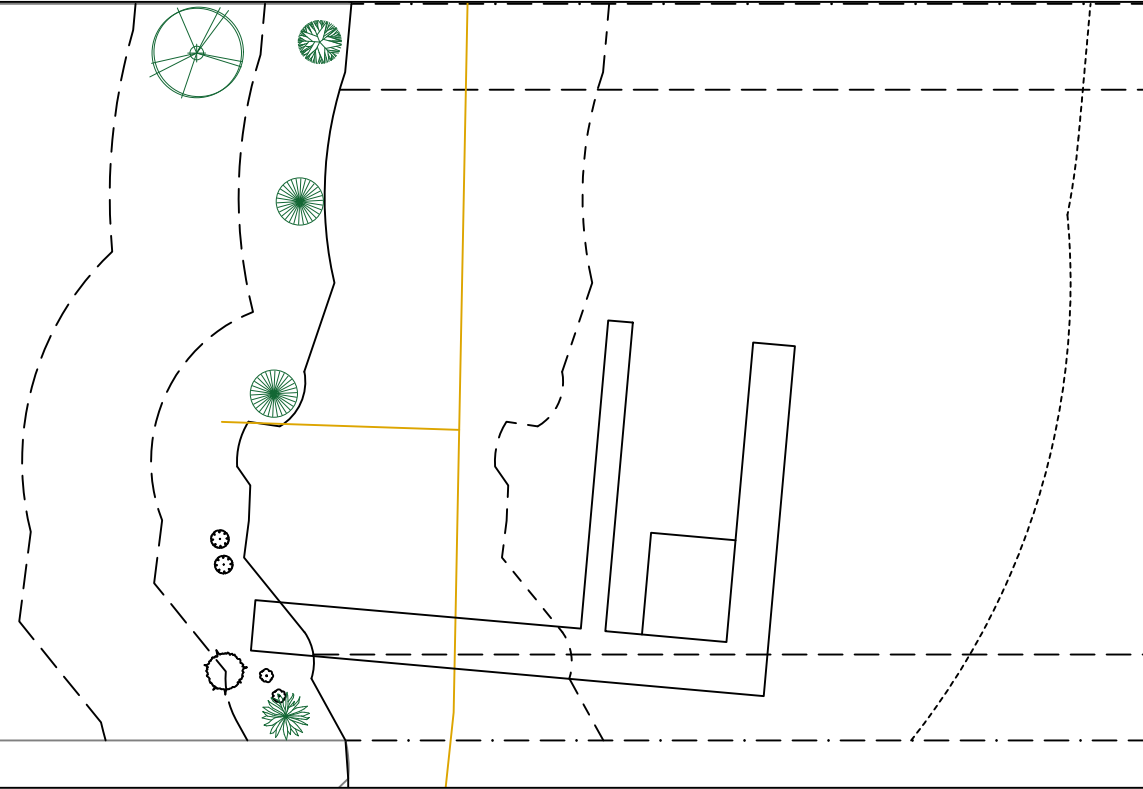
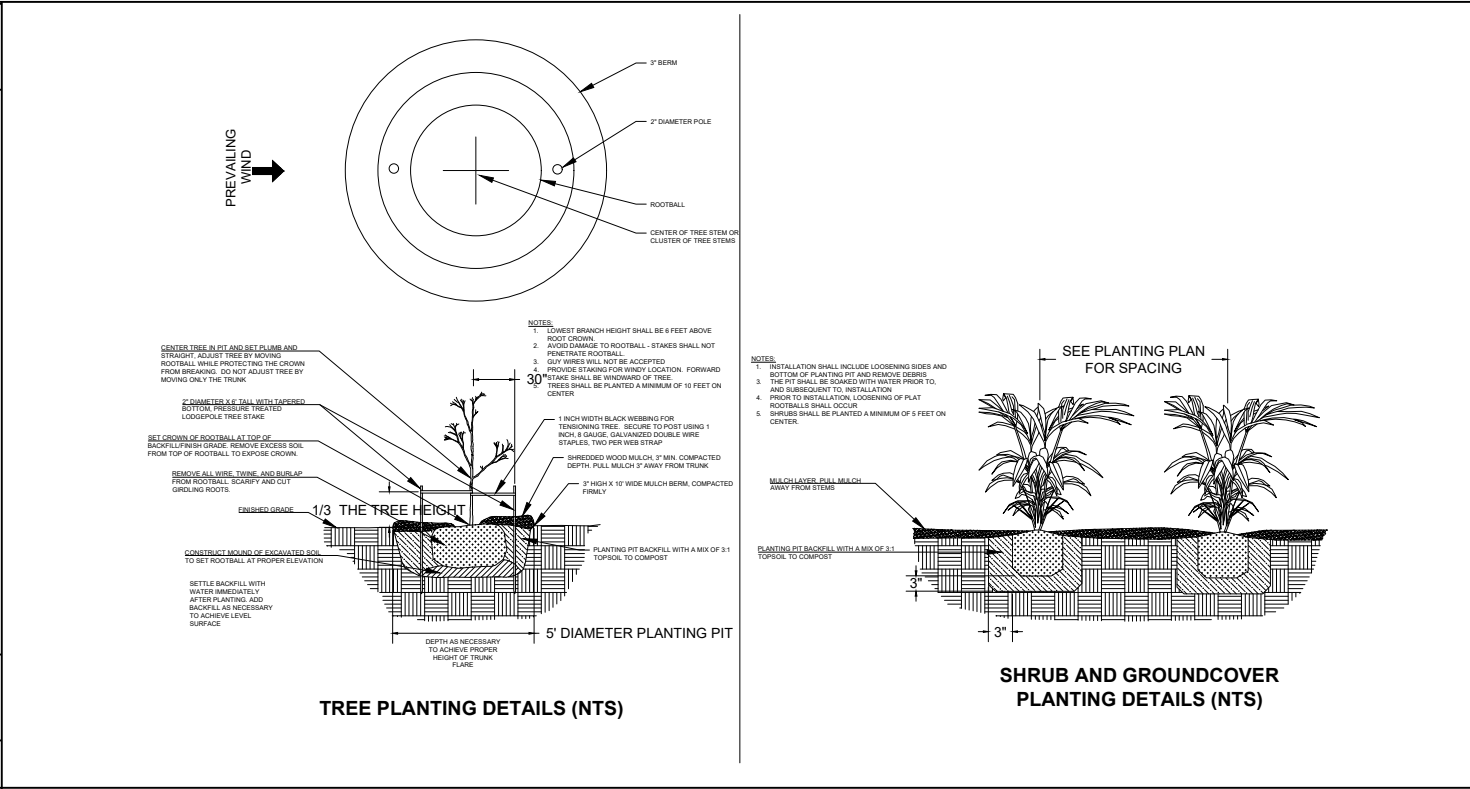
MITIGATION PLAN

1. Shrubs are show, and shall be planted, at least five feet on center. Trees are show, and shall be planted, at least ten feet to center.
2. The property owner will implement and abide by the shoreline planting plan. The plants shall be installed before or concurrent with the work authorized by this permit. A report, as-built drawing and photographs demonstrating the plants have been installed or a report on the status of project construction will be submitted to the U.S. Army Corps of Engineers, Seattle District, Regulatory Branch, within 12 months from the date of permit issuance. This reporting requirement may be met by completing and submitting a U.S. Army Corps of Engineers approved Report for Mitigation Work Completion form.

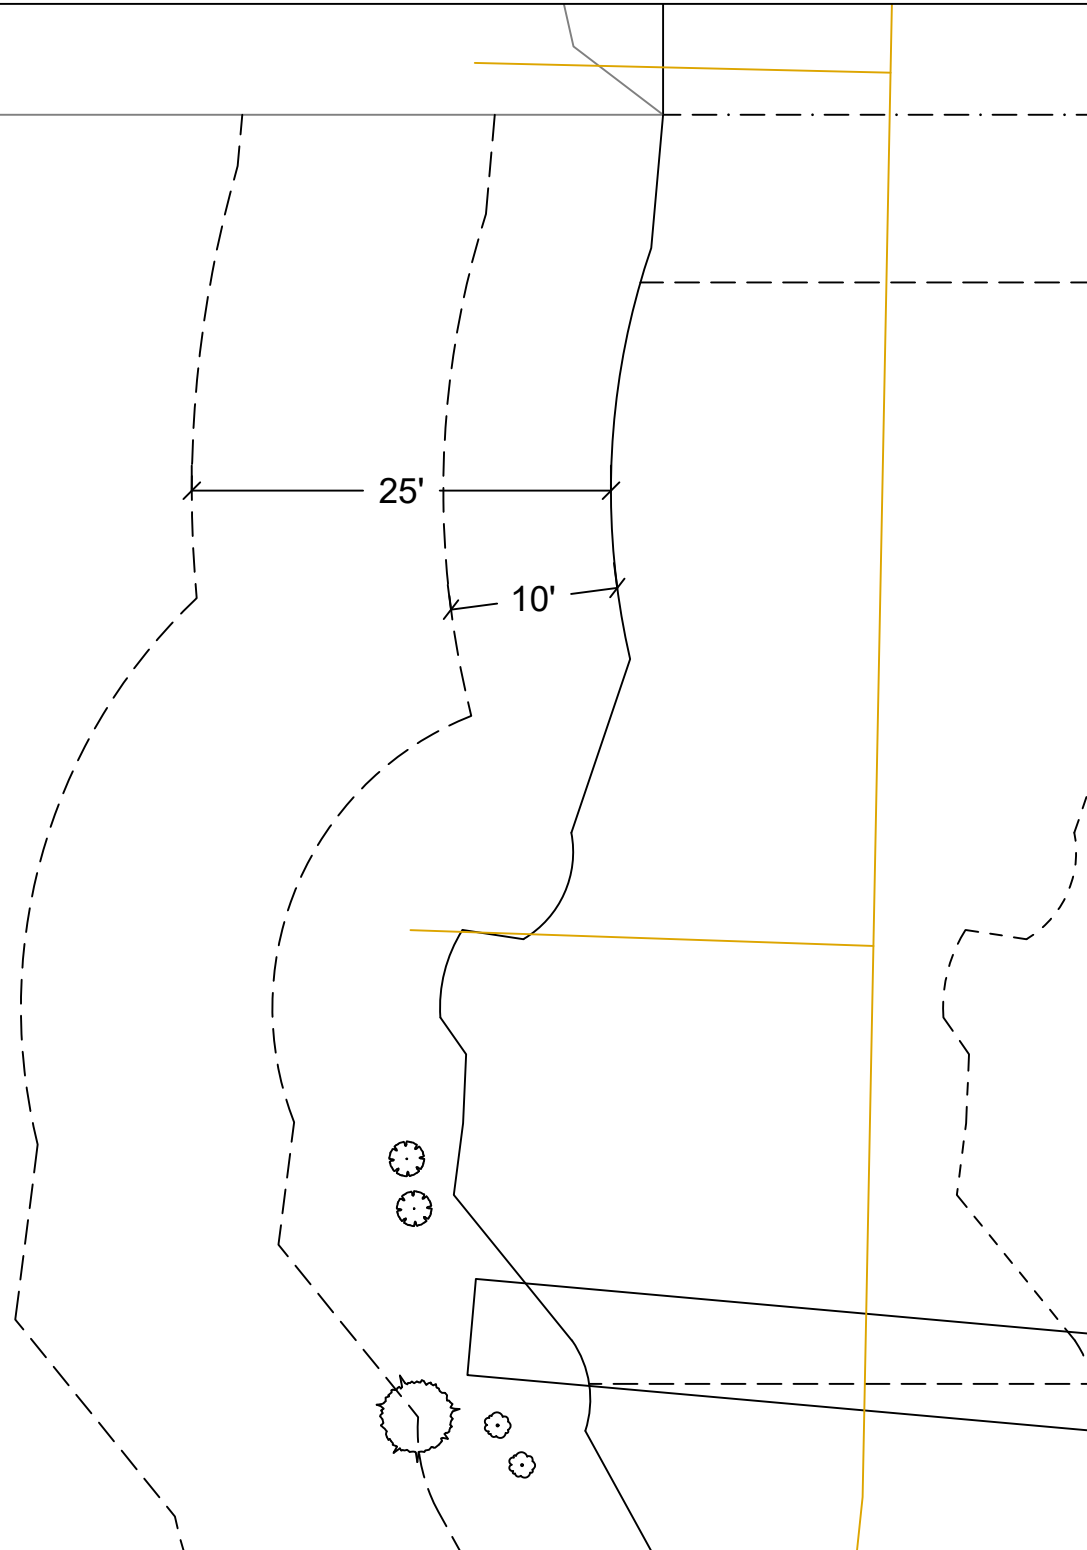
EXISTING PLANT PLAN

SYMBOL	SCIENTIFIC NAME	COMMON NAME	QTY	SIZE
	<i>Pyrus communis</i>	Common Pear	1	~5'
	<i>Sonchus oleraceus</i>	Common Sowthistle	2	~2ft
	<i>Leucanthemum maximum</i>	Shasta Daisy	2	~ 2ft

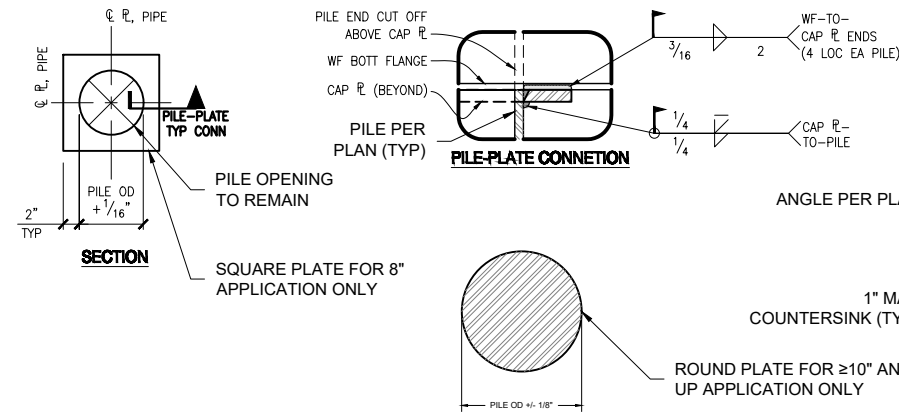
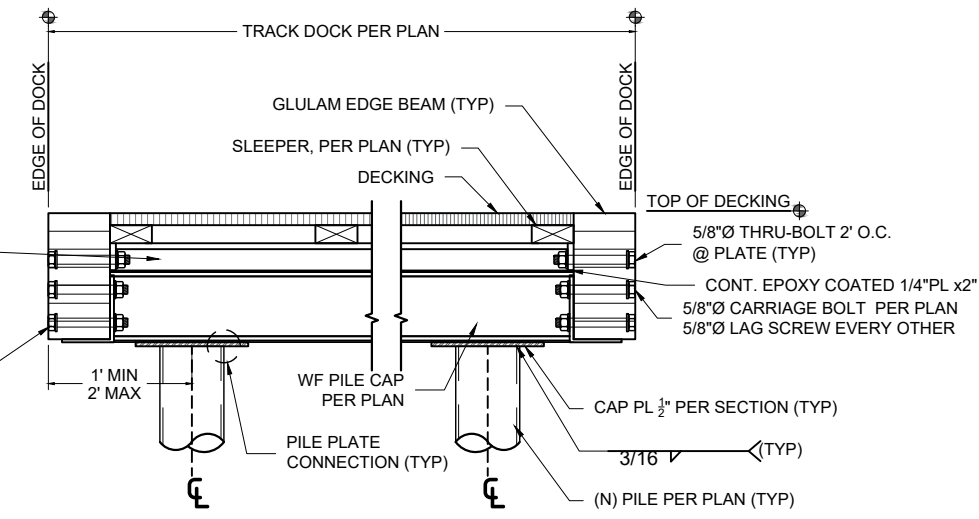
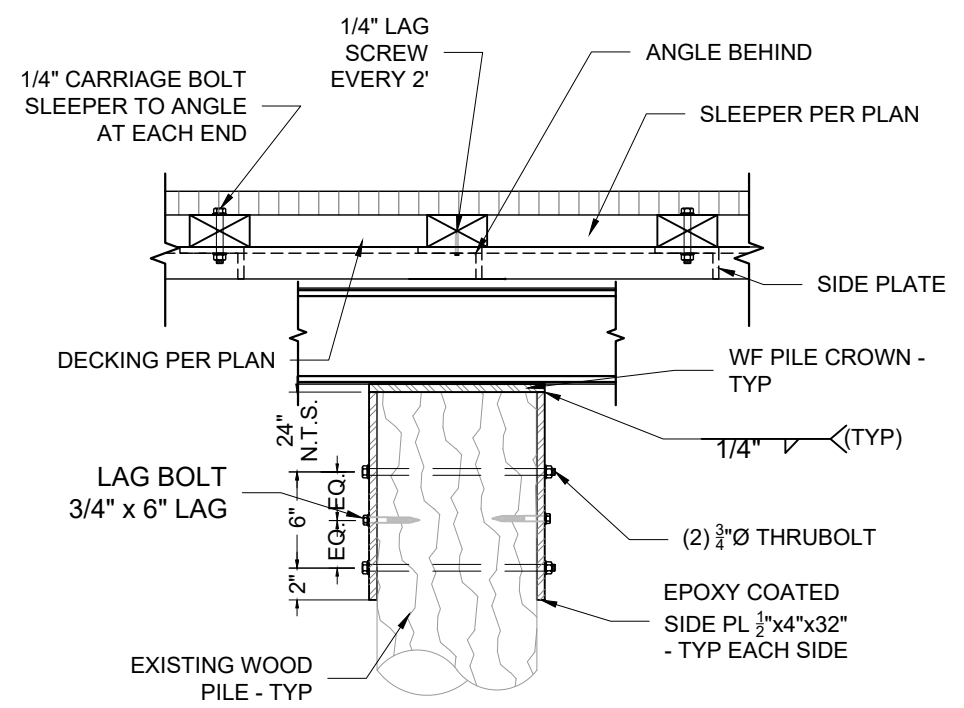
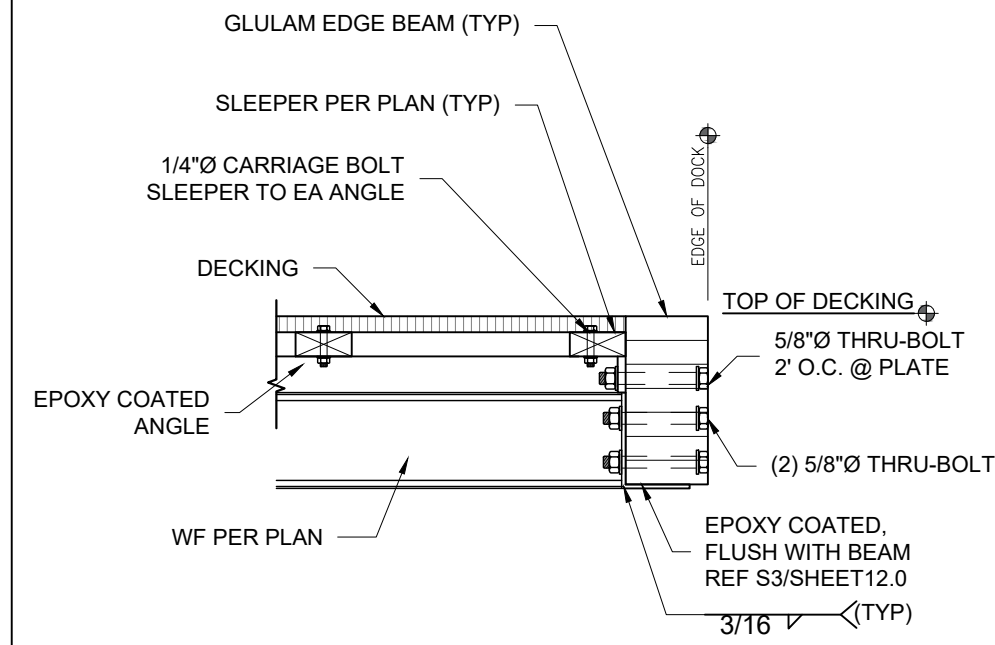
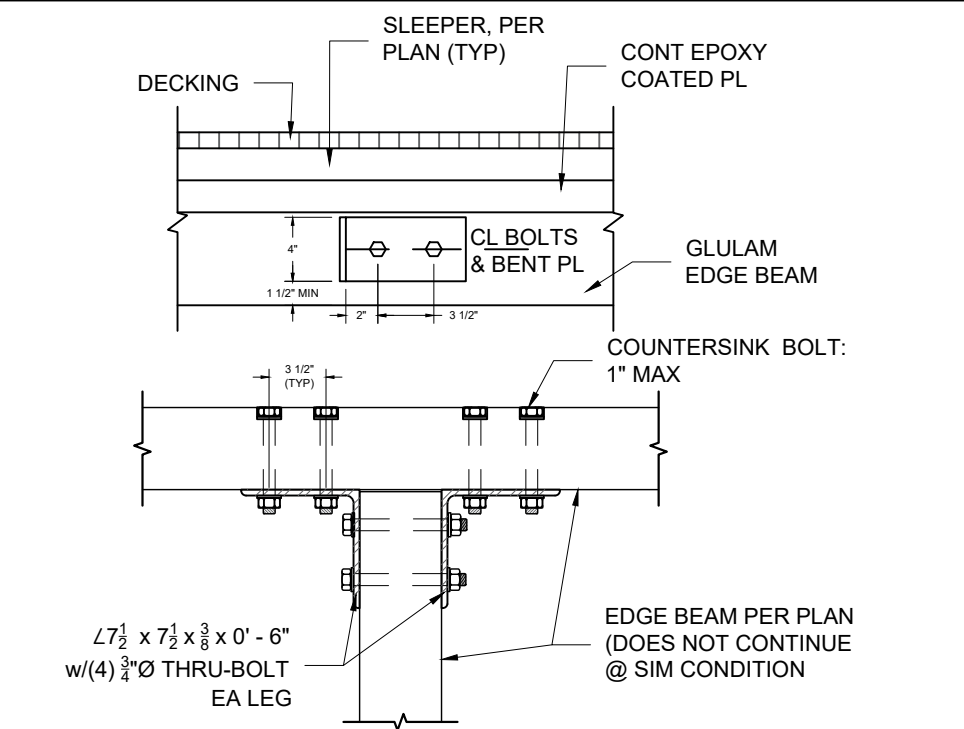
DETAILS - TRACK

PILE Ø	MIN D
8"	27"
10"	30"
12"+	36"

S1 DOCK SECTION w/PILES - TYP
SCALE: 1" = 1'

S3 I-BEAM CAP TO WOOD PILE - TYP
SCALE: 1" = 1'

S4 SLEEVE PILE REPAIR
SCALE: 1/2" = 1'

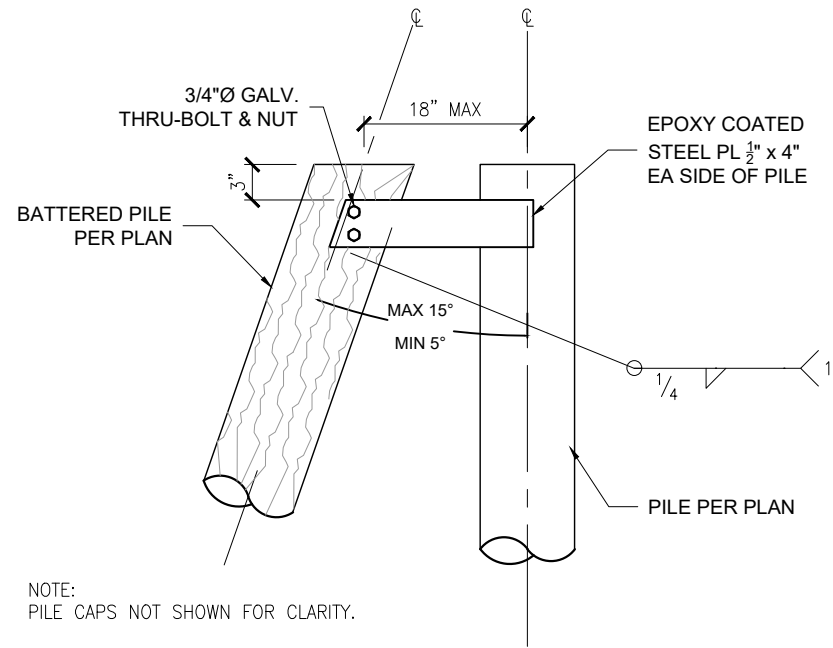
S1 BRACE PILES - TYP
SCALE: 3/4" - 1"

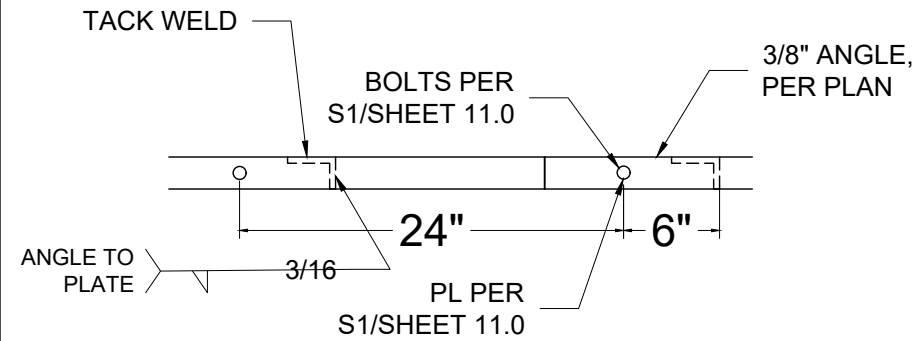
S2 ANGLE TO PLATE - TYP
SCALE: 1" - 1"

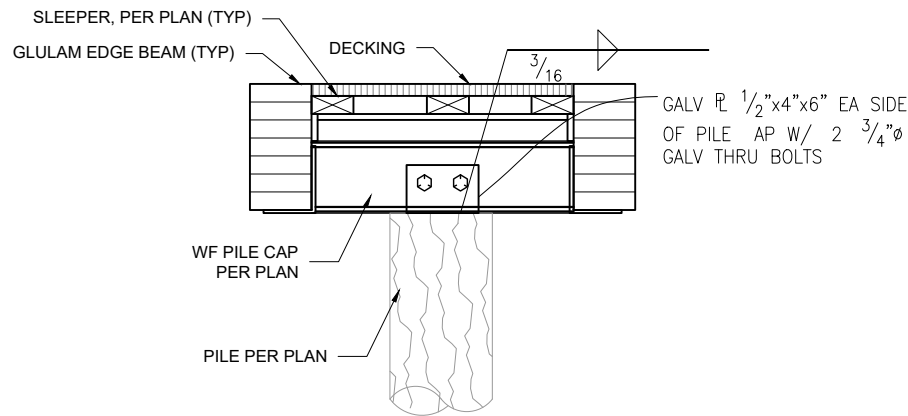
S4 DOCK SECTION AT SINGLE WOOD PILE
SCALE: 3/4" - 1"

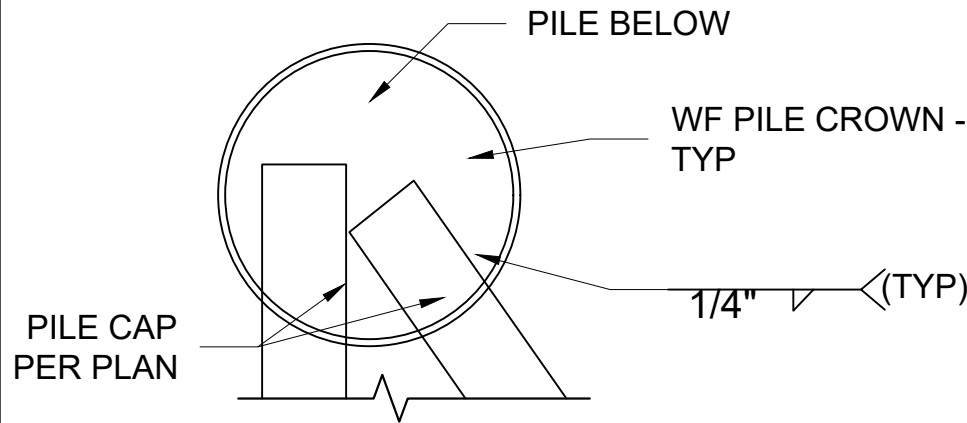
S5 DOUBLE I-BEAM CAP TO WOOD PILE
SCALE: 1-1/2" - 1"

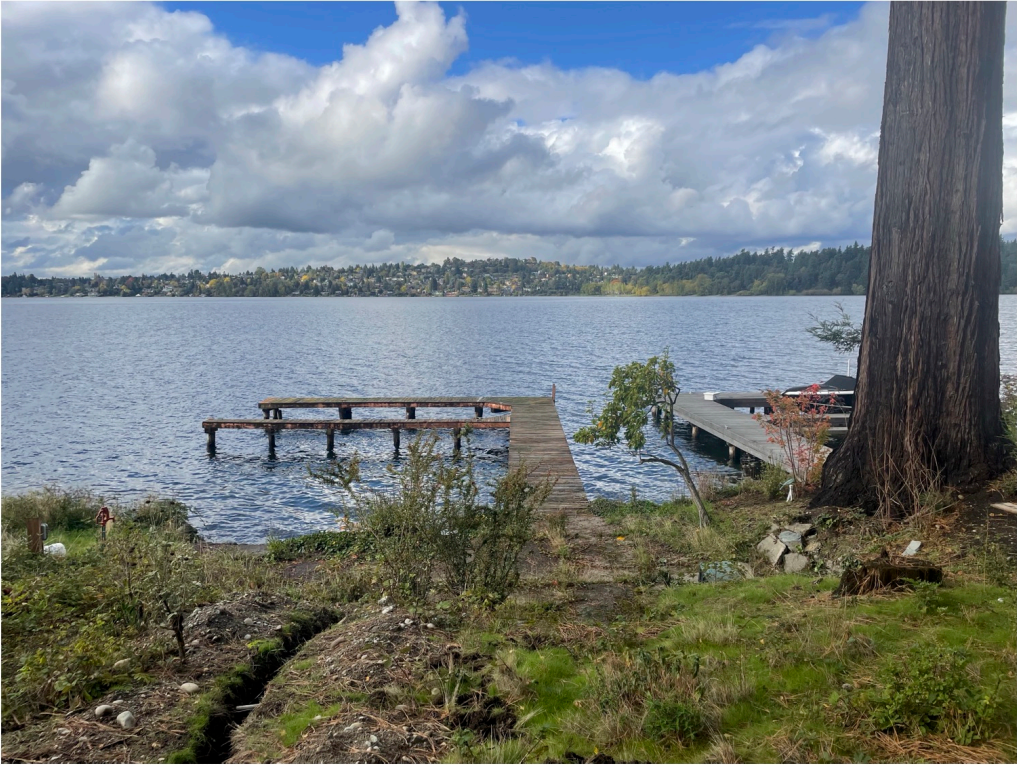
Photo 1 - Existing dock looking waterward.

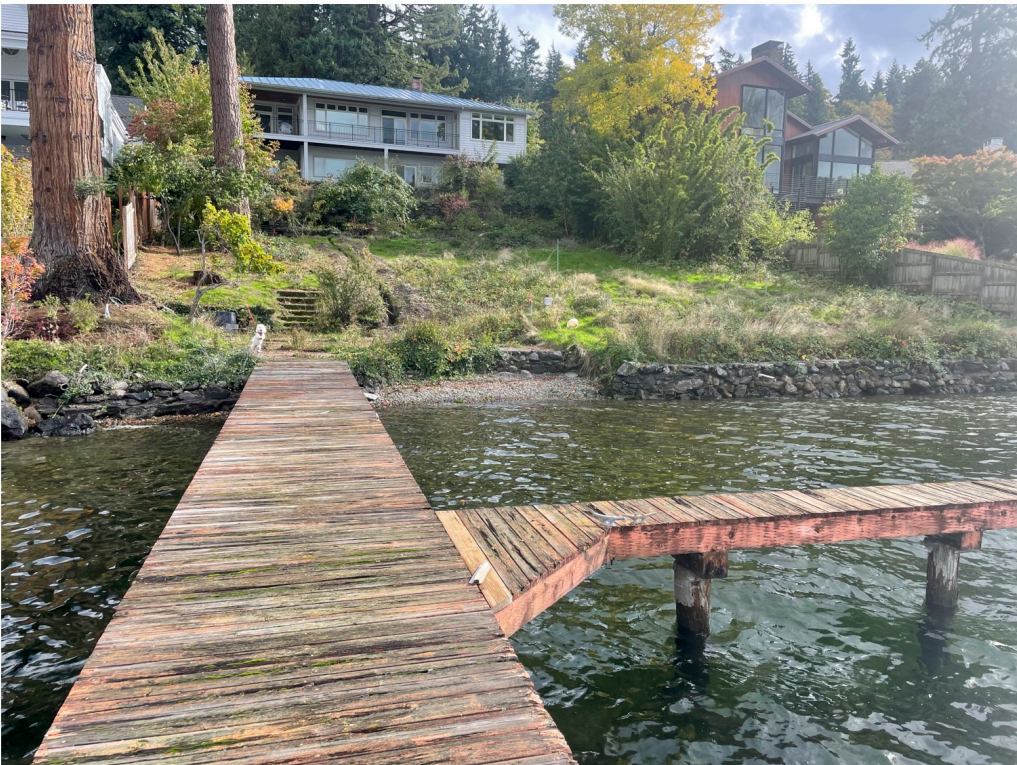
Photo 2 - Existing dock looking landward.
