# PROJECT INFORMATION

**APPLICANT:**  
MERCERWOOD SHORE CLUB

**PROJECT DESCRIPTION:**  
REPAIR TWO EXISTING PIER BY SLEEVING PILES, RE-FRAMING, AND RE-DECKING WITH GRATED DECKING. A SECTION OF ONE PIER (PIER A) HAS ALREADY BEEN REPAIRED AND THE REMAINING SECTION IS TO BE REPAIRED. INSTALL CONCRETE PANELS FOR AN EXISTING BOAT LAUNCH.

Repair Piers  
**IN:** Lake Washington  
**NEAR/AT:** Mercer Island  
**COUNTY:** King **STATE:** WA

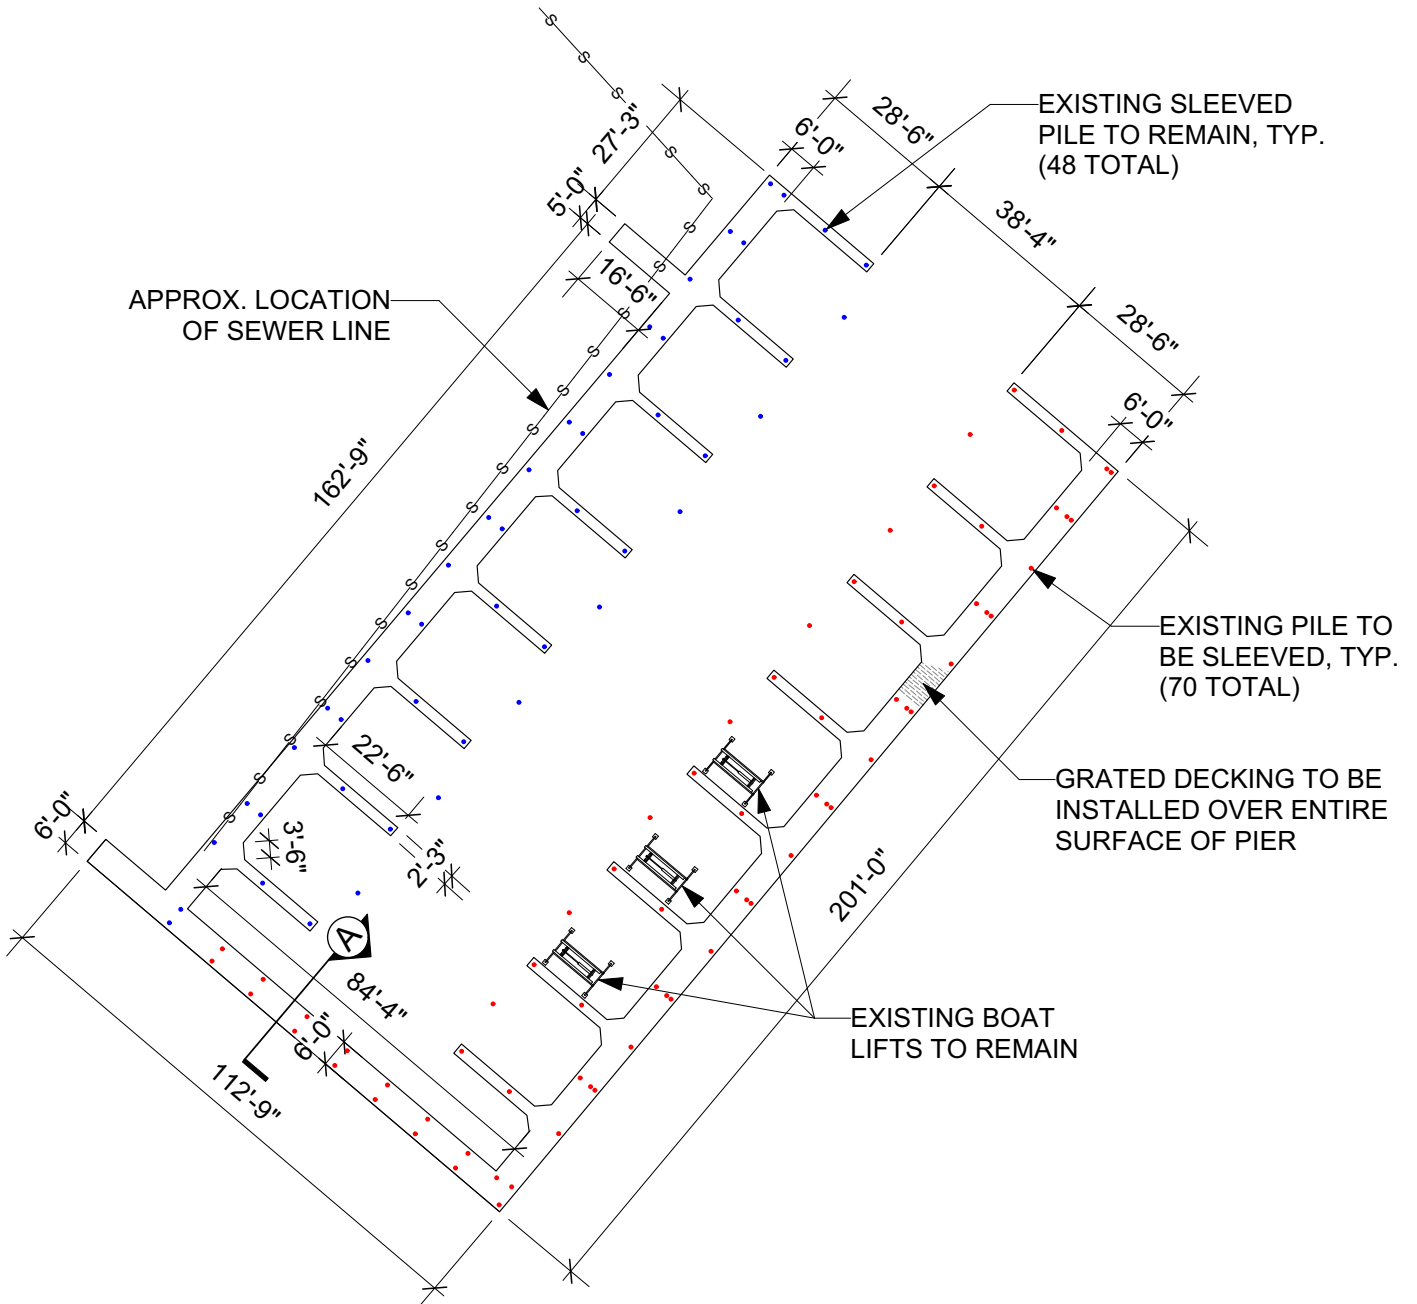
**PIER A - PILE PLAN**

**PIER A:**

- 63 - PILES TO BE REPAIRED WITH THE PILE AS DETAILED
- 7 - MOORING PILE TO BE REPAIRED WITH THE PILE AS DETAILED
- 41 - EXISTING REPAIRED PILES TO REMAIN (NO WORK)
- 7 - EXISTING REPAIRED MOORING PILES TO REMAIN (NO WORK)
- 3,958 SQ FT - EXISTING OVER WATER COVERAGE

**SKIRTING**

EXISTING SKIRTING IS ALONG THE SOUTHEAST (201') & SOUTHWEST (109.5') WALKWAYS  
201' + 95.5' = 296.5 LINEAR FEET OF SKIRTING TO BE REMOVED

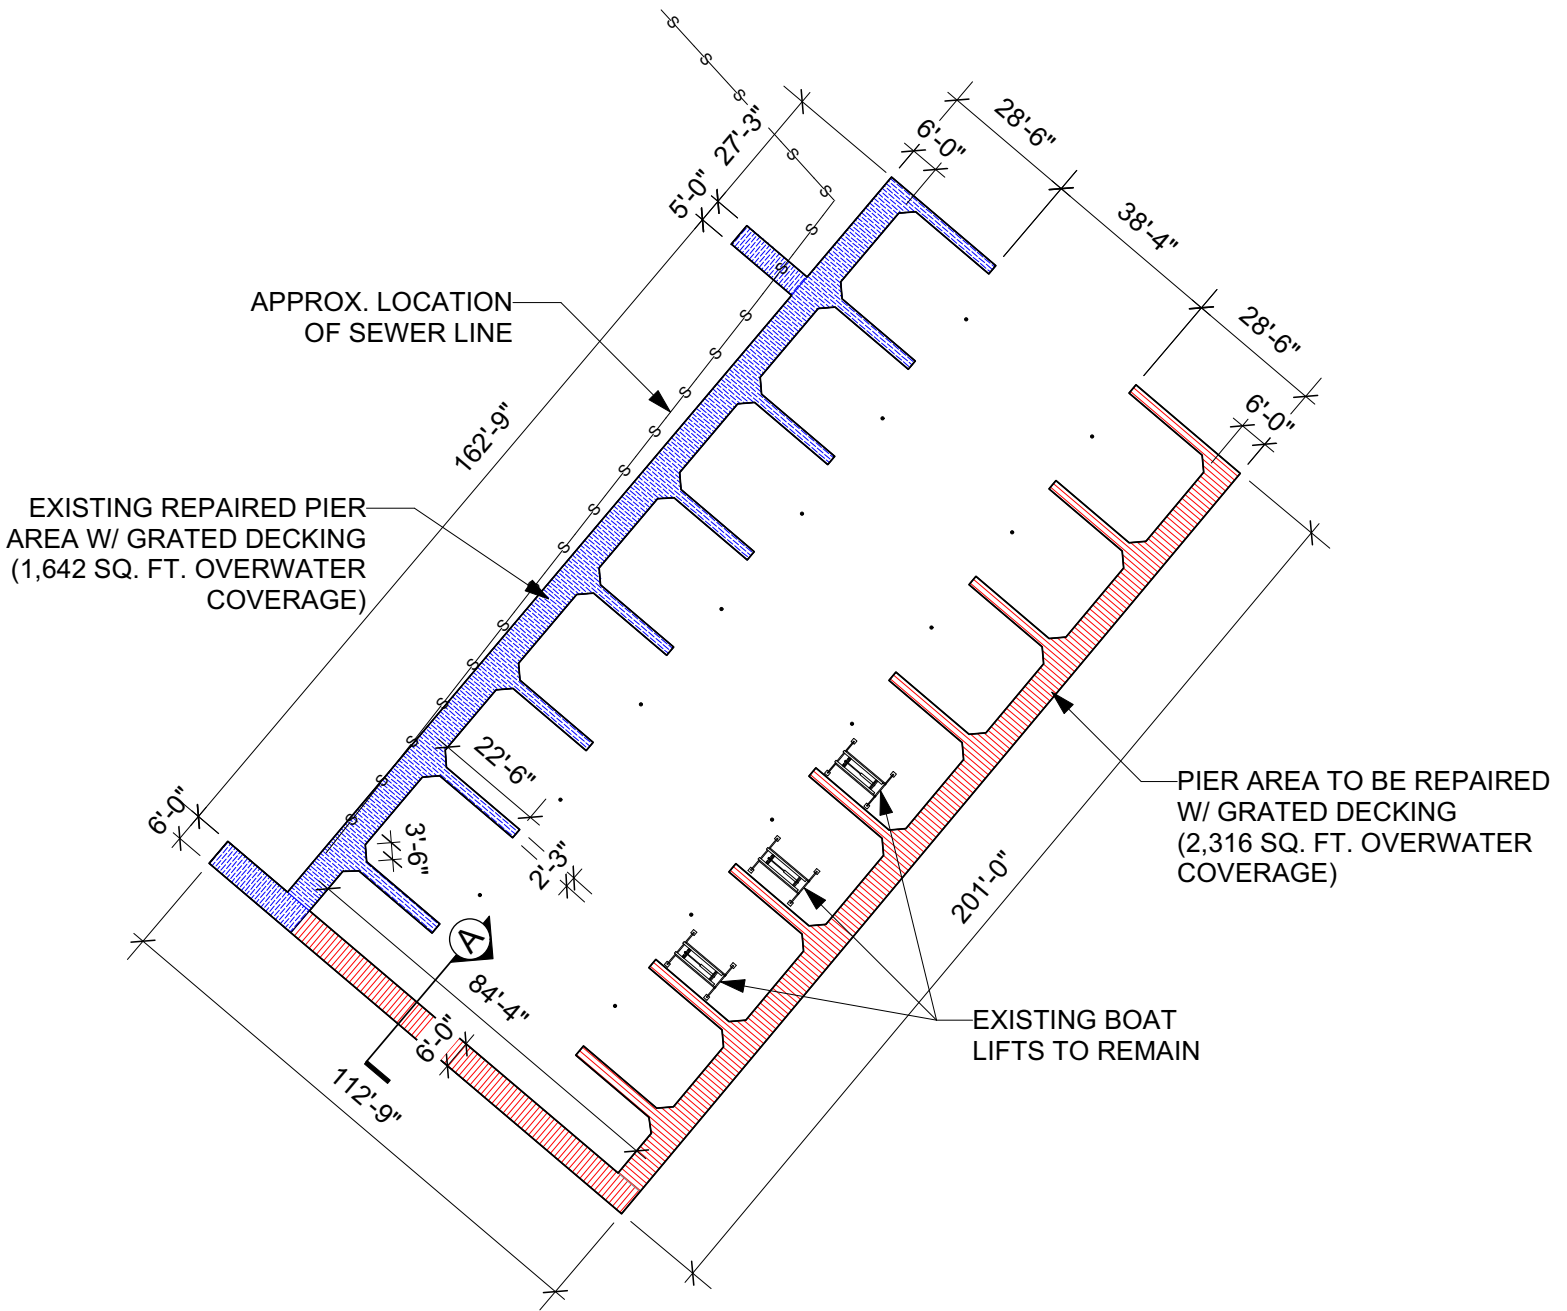
**PIER A - REPAIR PLAN**

SECTION OF PIER THAT HAS ALREADY BEEN REPAIRED WITH GRATED DECKING
-

SECTION OF PIER TO BE REPAIRED

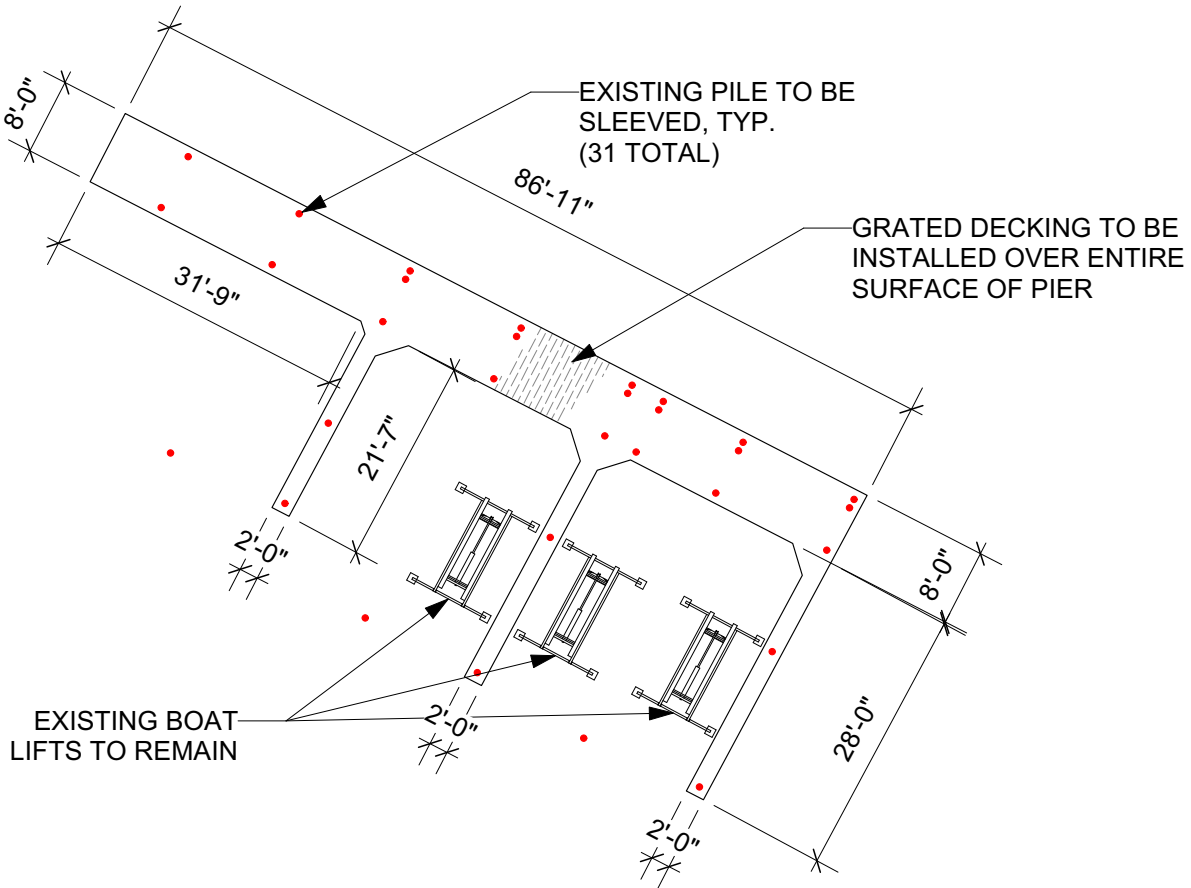
**PIER B - PILE PLAN**

**PIER B:**

28 - PILES TO BE REPAIRED AS DETAILED

3 - MOORING PILE TO BE REPAIRED AS DETAILED

867 SQ FT - EXISTING OVER WATER COVERAGE
