TECHNICAL INFORMATION REPORT CITY OF MERCER ISLAND

**93rd Ave SE Short Plat
7216 93rd Avenue SE
Mercer Island, WA 98040**

May 4, 2022

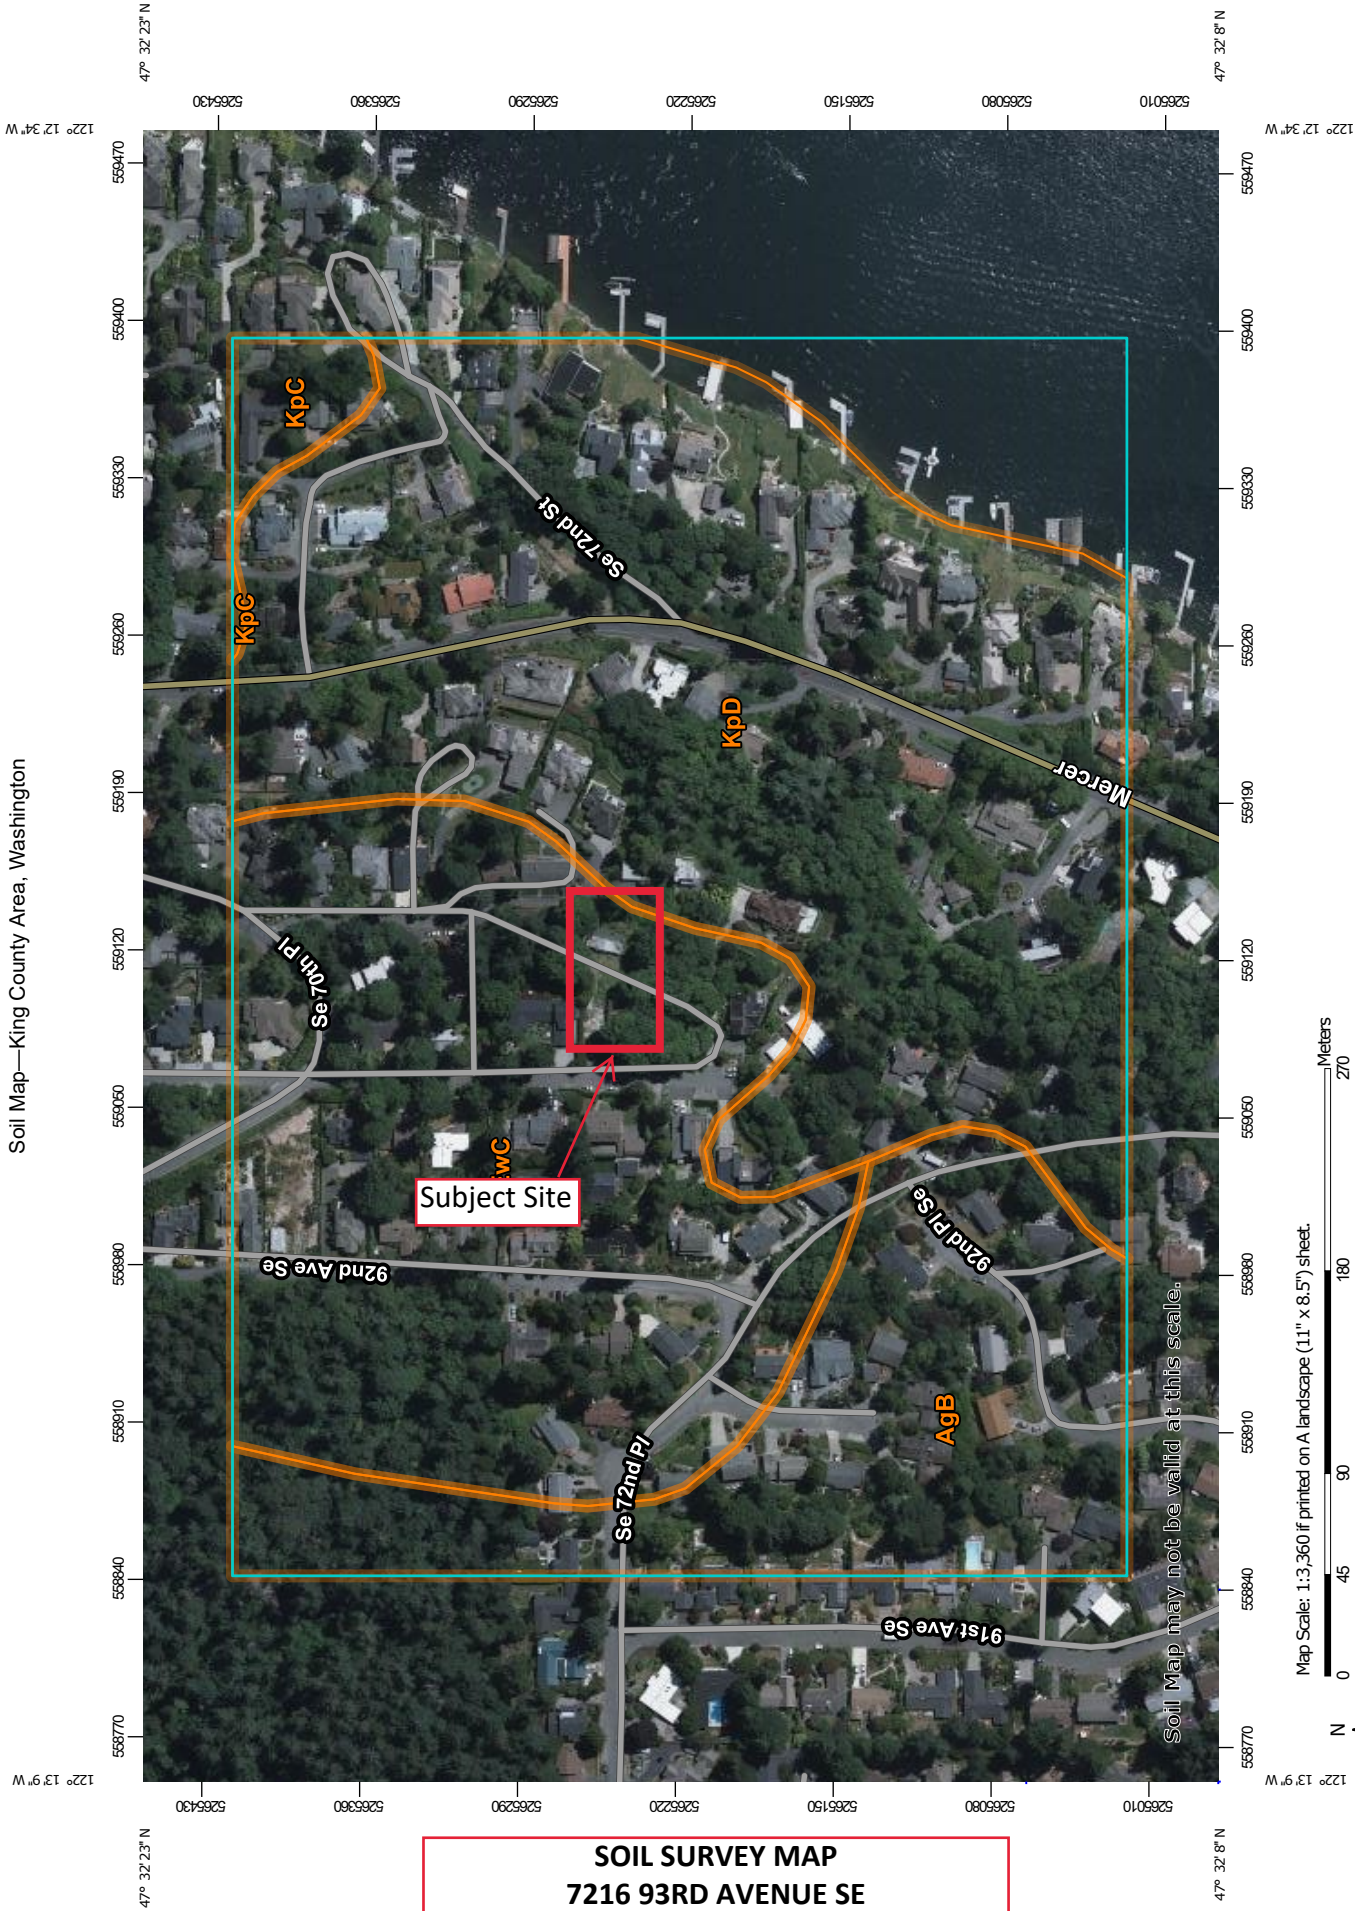
J-0165 FIGURE 9

**SOIL SURVEY MAP
7216 93RD AVENUE SE
MERCER ISLAND, WASHINGTON**
