<b>Project 4833 MI_4 - Lot Short Plat</b>  <b>Trees Protection Plan</b>	<b>PACIFIC LAND ENGINEERING</b> <small>Civil Engineering, Development Services, Land Use Consulting, Inspection Services, Expert Witness          Bellevue, WA - www.pacificlandeng.com          info@pacificlandeng.com (425) 475-8100</small>	<b>MATEW S. HAIDER</b> <small>STATE OF WASHINGTON</small> <b>REGISTERED ENGINEER</b> <small>36034</small>	Revisions <table border="1" style="width: 100%; border-collapse: collapse;"> <tr> <th>No.</th> <th>Date</th> <th>By</th> </tr> <tr> <td> </td> <td> </td> <td> </td> </tr> </table>	No.	Date	By			
No.	Date	By							
Plan Plotted For: <b>Initial Submittal</b>		Date: 11/01/2022 STAMP IS NOT VALID UNLESS SIGNED AND DATED							
Job Number: 220520 - PLE - 2211		DWG Date: 11/01/2022							
Sheet No. <b>C - 3.0</b> OF <b>C - 6.0</b>		Call 48 HOURS BEFORE YOU DIG <b>811</b> Call 800.424.5555

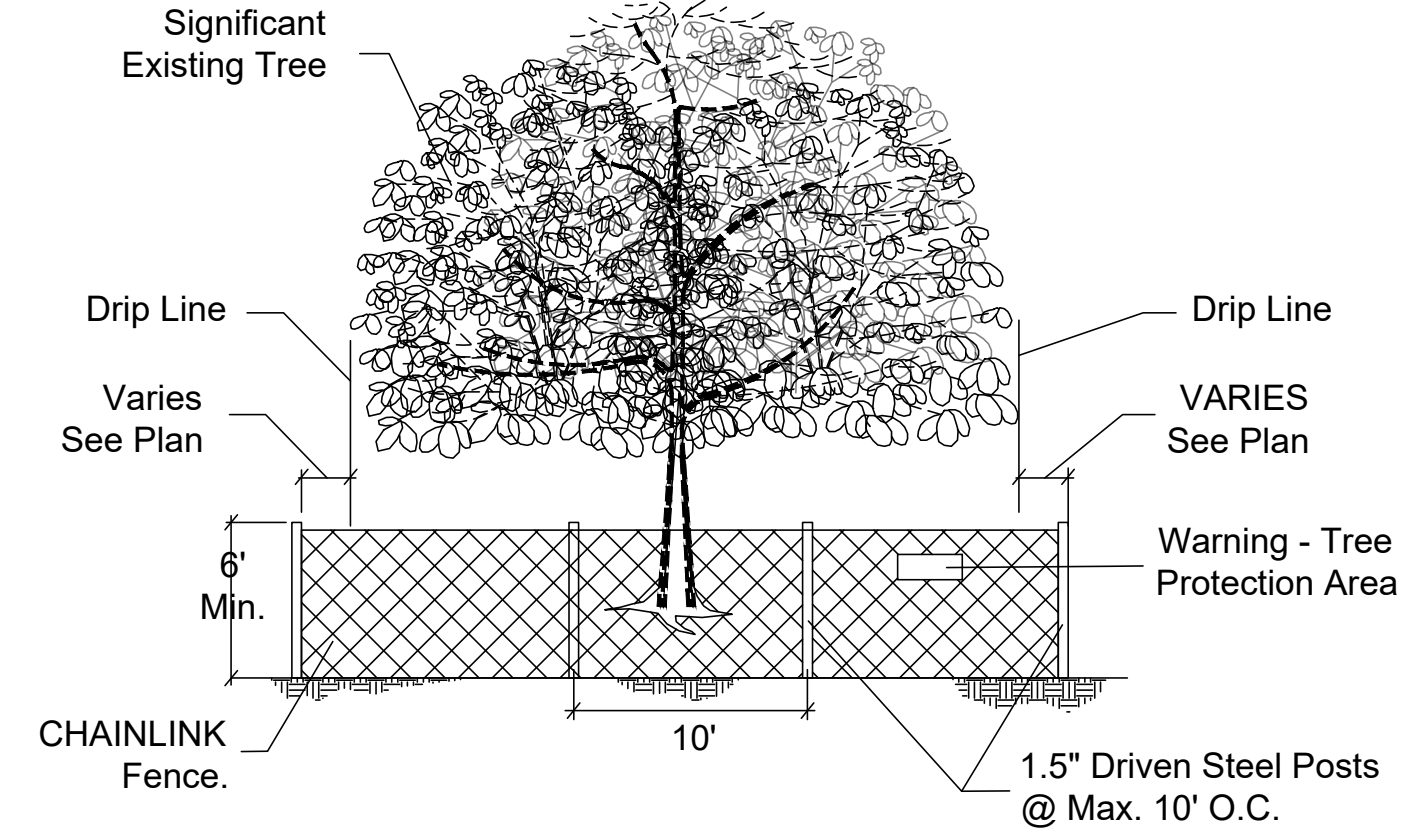
**Tree Protection Detail**  
N.T.S.

- NOTES:**
- MINIMUM SIX (6) FOOT HIGH TEMPORARY CHAINLINK FENCE SHALL BE PLACED AT DISTANCE OF GENERALLY TWO (2) FEET OUTSIDE THE DRIP LINE OF THE SIGNIFICANT TREE(S). FENCE SHALL COMPLETELY ENCIRCLE TREE(S). INSTALL POSTS USING 1.5-INCH STEEL POSTS DRIVEN 2- FEET INTO THE GROUND.

- MOVABLE BARRIERS OF CHAIN LINK FENCING SECURED TO THE CEMENT BLOCKS MAY BE SUBSTITUTED FOR "FIXED" FENCING IF THE PROJECT ARBORIST AND CITY STAFF AGREE THAT THE FENCING WILL HAVE TO BE MOVED TO ACCOMMODATE CERTAIN PHASES OF THE CONSTRUCTION. MODIFICATIONS TO FENCING MATERIAL AND LOCATION MUST BE APPROVED BY PLANNING OFFICIAL AND PROJECT ARBORIST.

- THE FENCING CAN BE MOVED WITHIN THE DRIP LINE OF THE TREE IF AUTHORIZED BY THE CLEARING AND GRADING INSPECTOR AND THE PROJECT ARBORIST BUT NOT CLOSER THAN 2' FROM THE TRUNK OF THE TREE. ONLY EXCAVATION BY HAND OR COMPRESSED AIR SHALL BE ALLOWED WITHIN THE DRIP LINE OF THE TREES. MACHINE TRENCHING SHALL BE ALLOWED.

- TREATMENT OF ROOTS EXPOSED DURING CONSTRUCTION: FOR ROOTS OVER TWO (2) INCH IN DIAMETER DAMAGED DURING CONSTRUCTION, MAKE A CLEAN STRAIGHT CUT TO REMOVE DAMAGED PORTION OF THE ROOT. ALL EXPOSED ROOTS SHALL BE TEMPORARY COVERED WITH DAMP BURLAP TO PREVENT DRYING AND COVERED WITH SOIL AS SOON AS POSSIBLE.

- NO STOCKING OF MATERIALS, VEHICULAR TRAFFIC, OR STORAGE OF EQUIPMENT OR MACHINERY SHALL BE ALLOWED WITHIN THE LIMIT OF THE FENCING. WORK WITHIN PROTECTION FENCE SHALL BE DONE MANUALLY UNDER THE SUPERVISION OF THE ON-SITE ARBORIST AND WITH PRIOR APPROVAL BY THE CITY PLANNING OFFICIAL.

- FENCING SIGNAGE AS DETAILED ABOVE MUST BE POSTED EVERY FIFTEEN ALONG THE FENCE. THE SIGN SHALL BE MINIMUM OF 8.5-INCHES BY 11-INCHES.
