GOVERNING AGENCY

PROJECT INFORMATION:

SEARS SHORT PLAT

A PLAT COMMUNITY A PORTION OF THE NW 1/4, OF THE SE 1/4, SECTION 25, TOWNSHIP 24 NORTH, RANGE 4 EAST, W.M. CITY OF MERCER ISLAND KING COUNTY, WASHINGTON

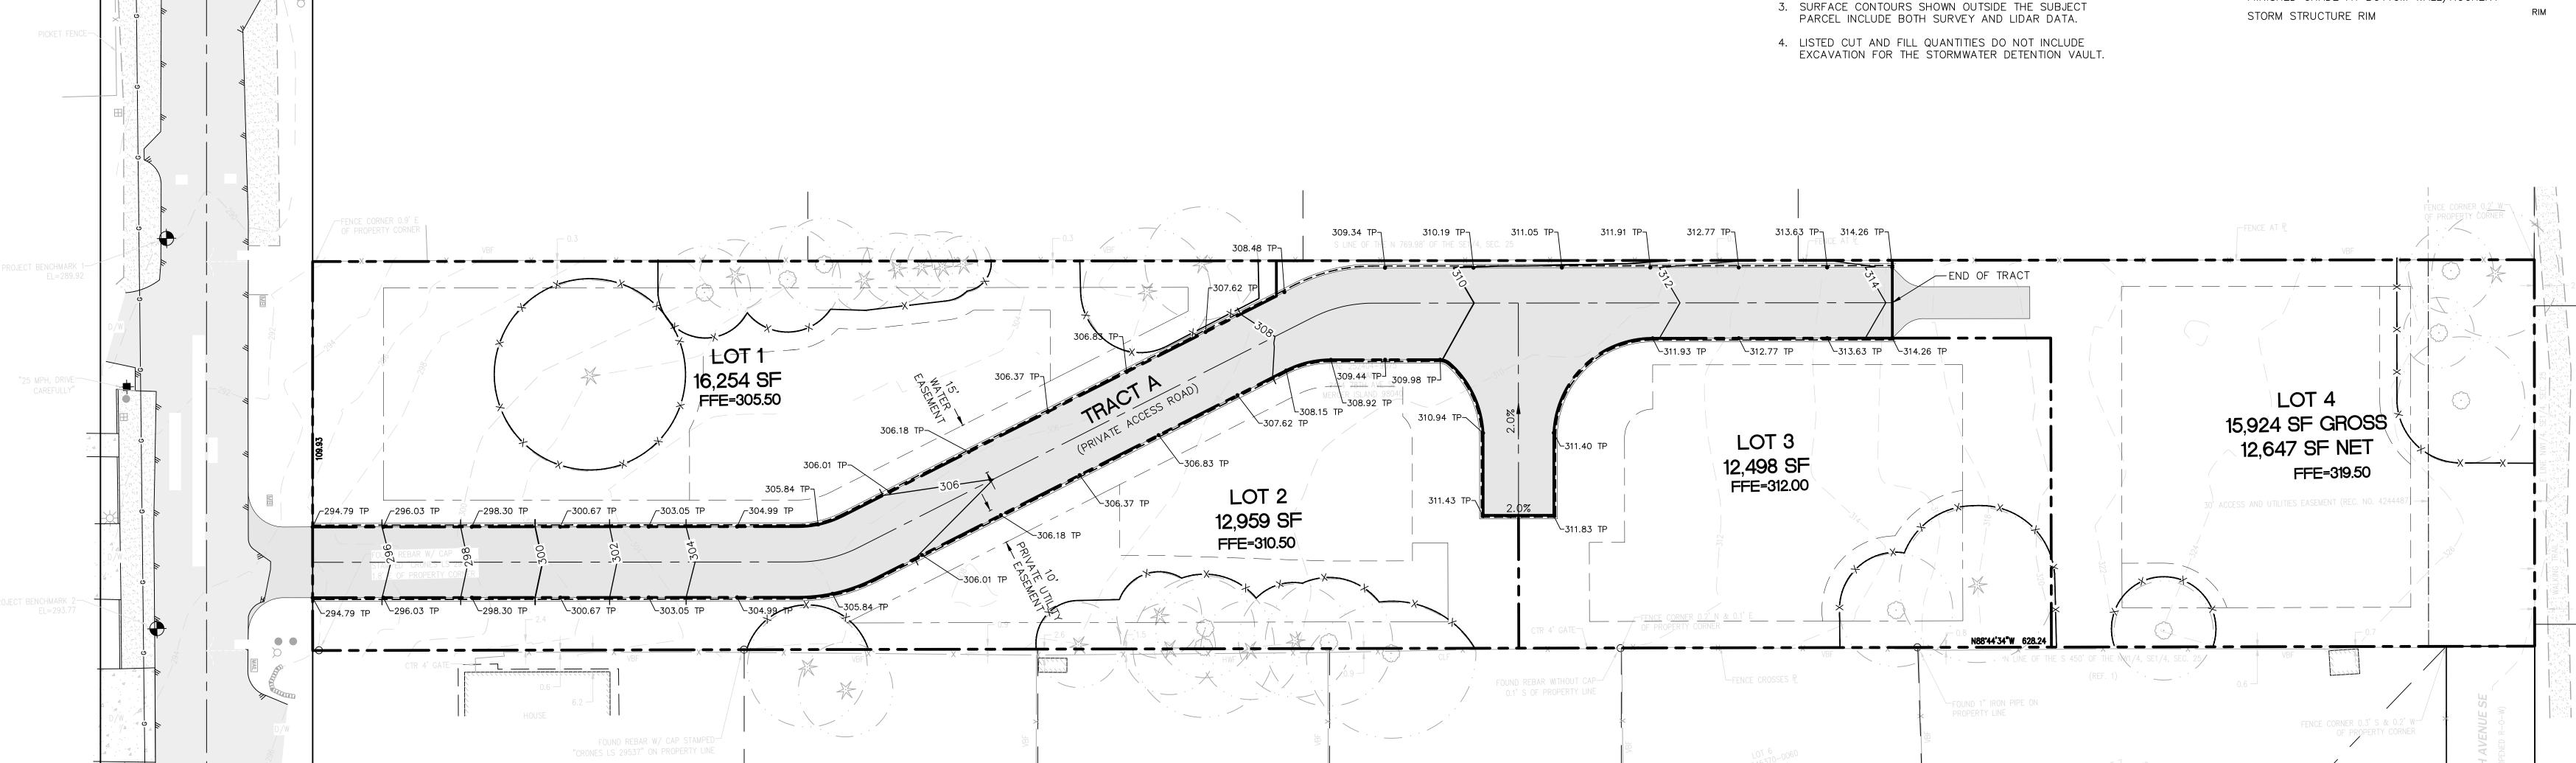
FIRE DEPT. HAMMERHEAD TURN AROUND ROAD SECTION

26' PRIVATE ACCESS ROAD

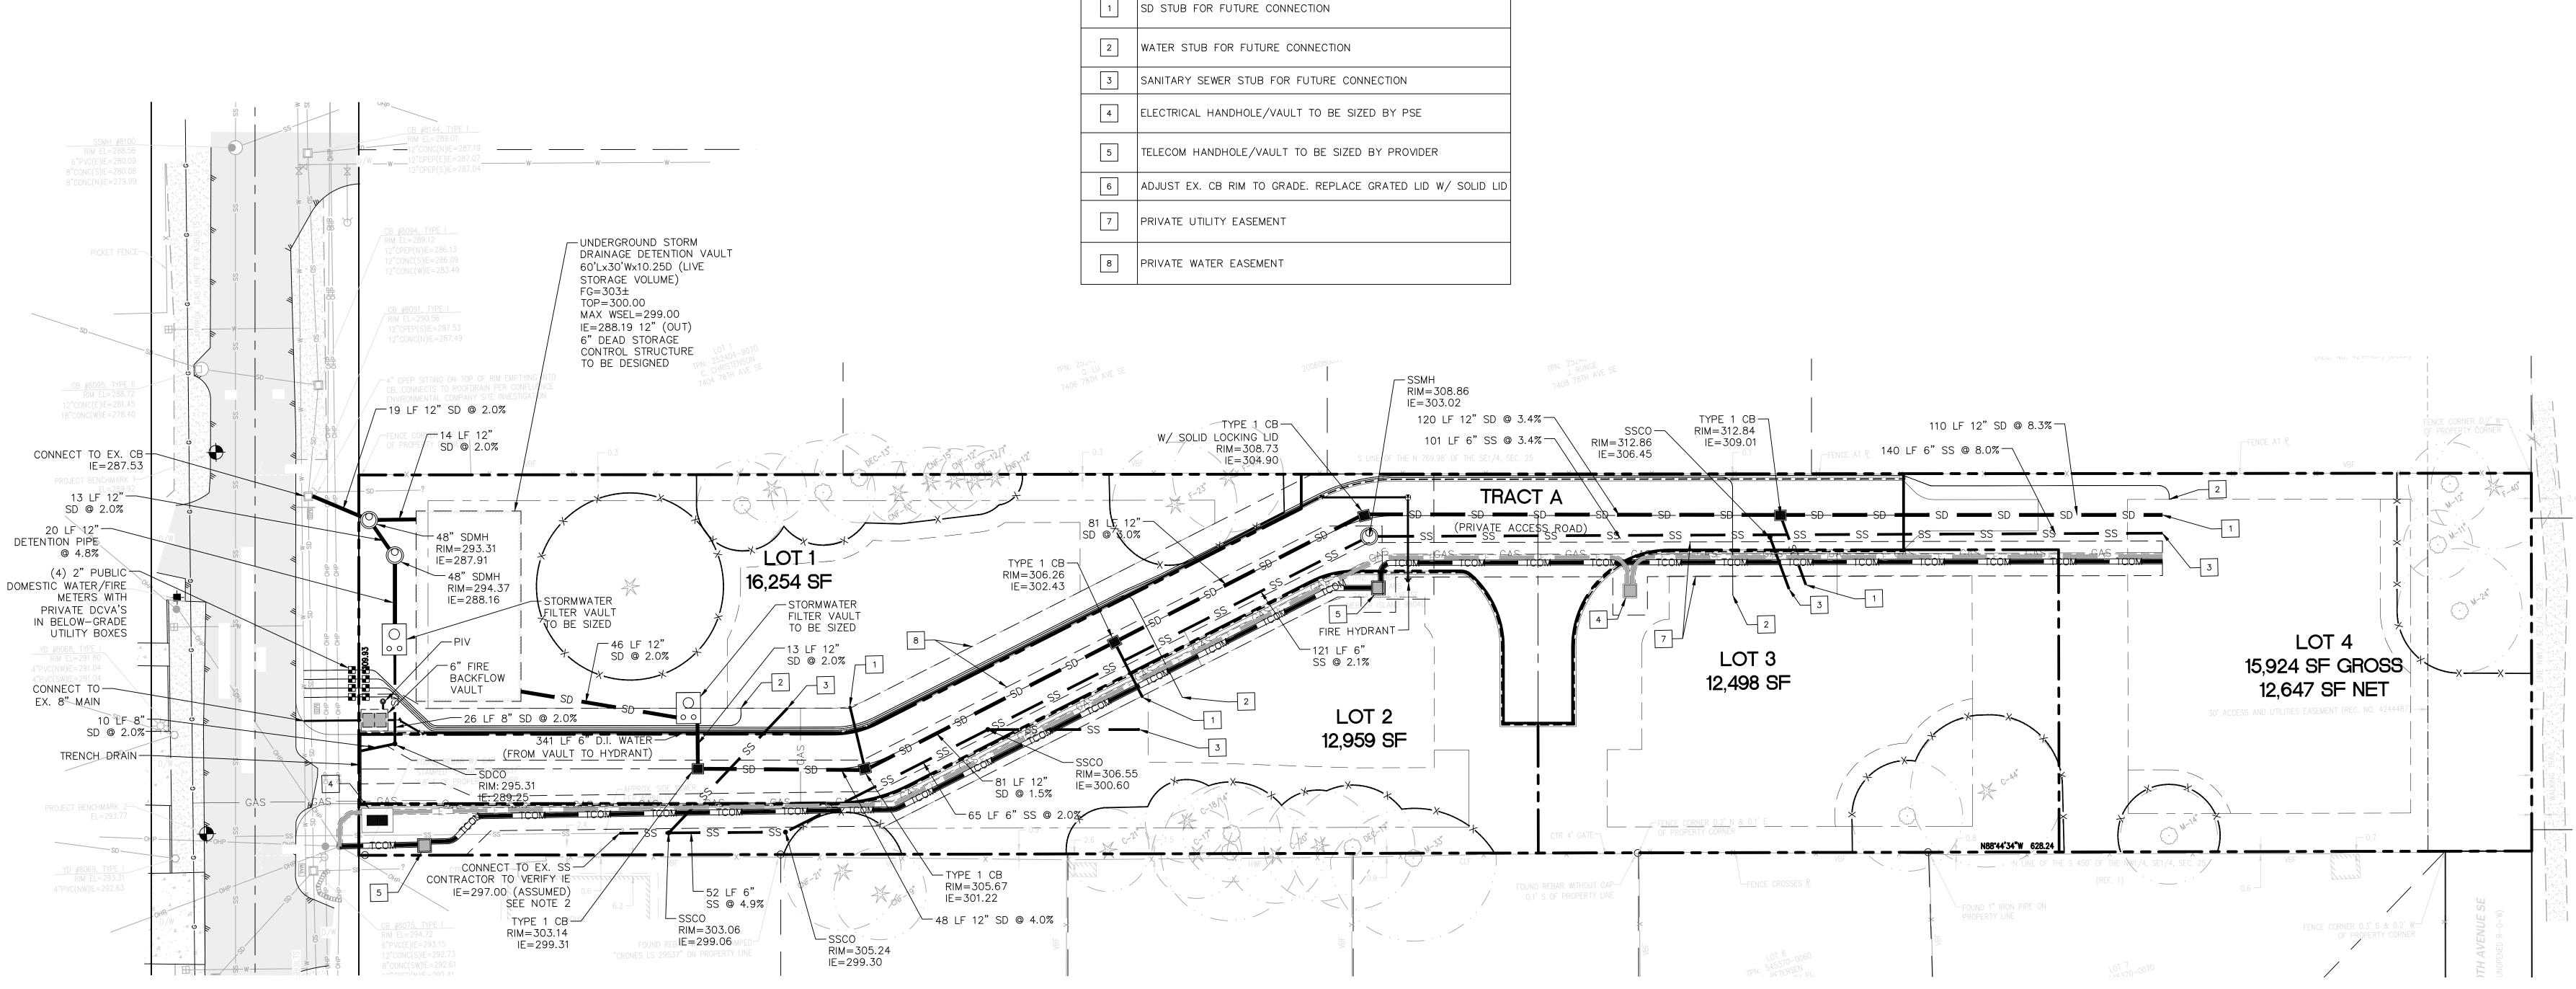
CONCEPTUAL **UTILITY PLAN**

- 1. THE DESIGN FOR THE STORM, SEWER, AND WATER UTILITIES ARE PRELIMINARY ONLY. THE DETAILED DESIGN WILL BE REVIEWED DURING THE SITE DEVELOPMENT PERMIT PHASE AFTER THE PRELIMINARY SHORT PLAT IS APPROVED.
- 2. THE CONDITION AND SIZE OF THE EXISTING SIDE SEWER WILL NEED TO BE VERIFIED DURING THE SITE DEVELOPMENT PERMIT AFTER THE PRELIMINARY SHORT PLAT IS APPROVED.
