DRS DR. STRONG D.R. STRONG CONSULTING ENGINEERS ENGINEERS PLANNERS SURVEYORS 620 - 7th AVENUE KIRKLAND, WA 98033 0 425.827.3063 F 425.827.2423								
LORENZINI SP	TITLE SHEET	4719 86TH AVENUE SE MERCER ISLAND, WASHINGTON PARCEL NO. 7598100420						
TODD SHERMAN DESIGN BUILT HOMES		11400 SE 8TH STREET, SUITE 415 BELLEVUE, WASHINGTON 98004 206-909-8187						
	A START AND A STAR							
DATE REVISION APR 12.09.22 REVS. PER AGENCY COMMENTS MAJ								
DRAFTED DESIGNED PROJECT DATE: 1 PROJECT DRAWING: SHEET:	BY: JS ENGINEE 2.20.21 NO.: 2 C1	5E TR: MAJ 1071

DRS D.R. STRONG CONSULTING ENGINEERS ENGINEERS PLANNERS SURVEYORS 620 - 7th AVENUE KIRKLAND, WA 98033 0 425.827.3063 F 425.827.2423							
LORENZINI SP	SITE PLAN 4719 86TH AVENUE SE MERCER ISLAND, WASHINGTON PARCEL NO. 7598100420						
TODD SHERMAN DESIGN BUILT HOMES	11400 SE 8TH STREET, SUITE 415 BELLEVUE, WASHINGTON 98004 206-909-8187						
	A STATE AND A STAT						
DATE REVISION APR 12.09.22 REVS. PER AGENCY COMMENTS MAJ							
PROJECT DATE: ;	BY: <b>JSE</b> ENGINEER: <b>MAJ</b> 1 <b>2.20.21</b> NO.: <b>21071</b>

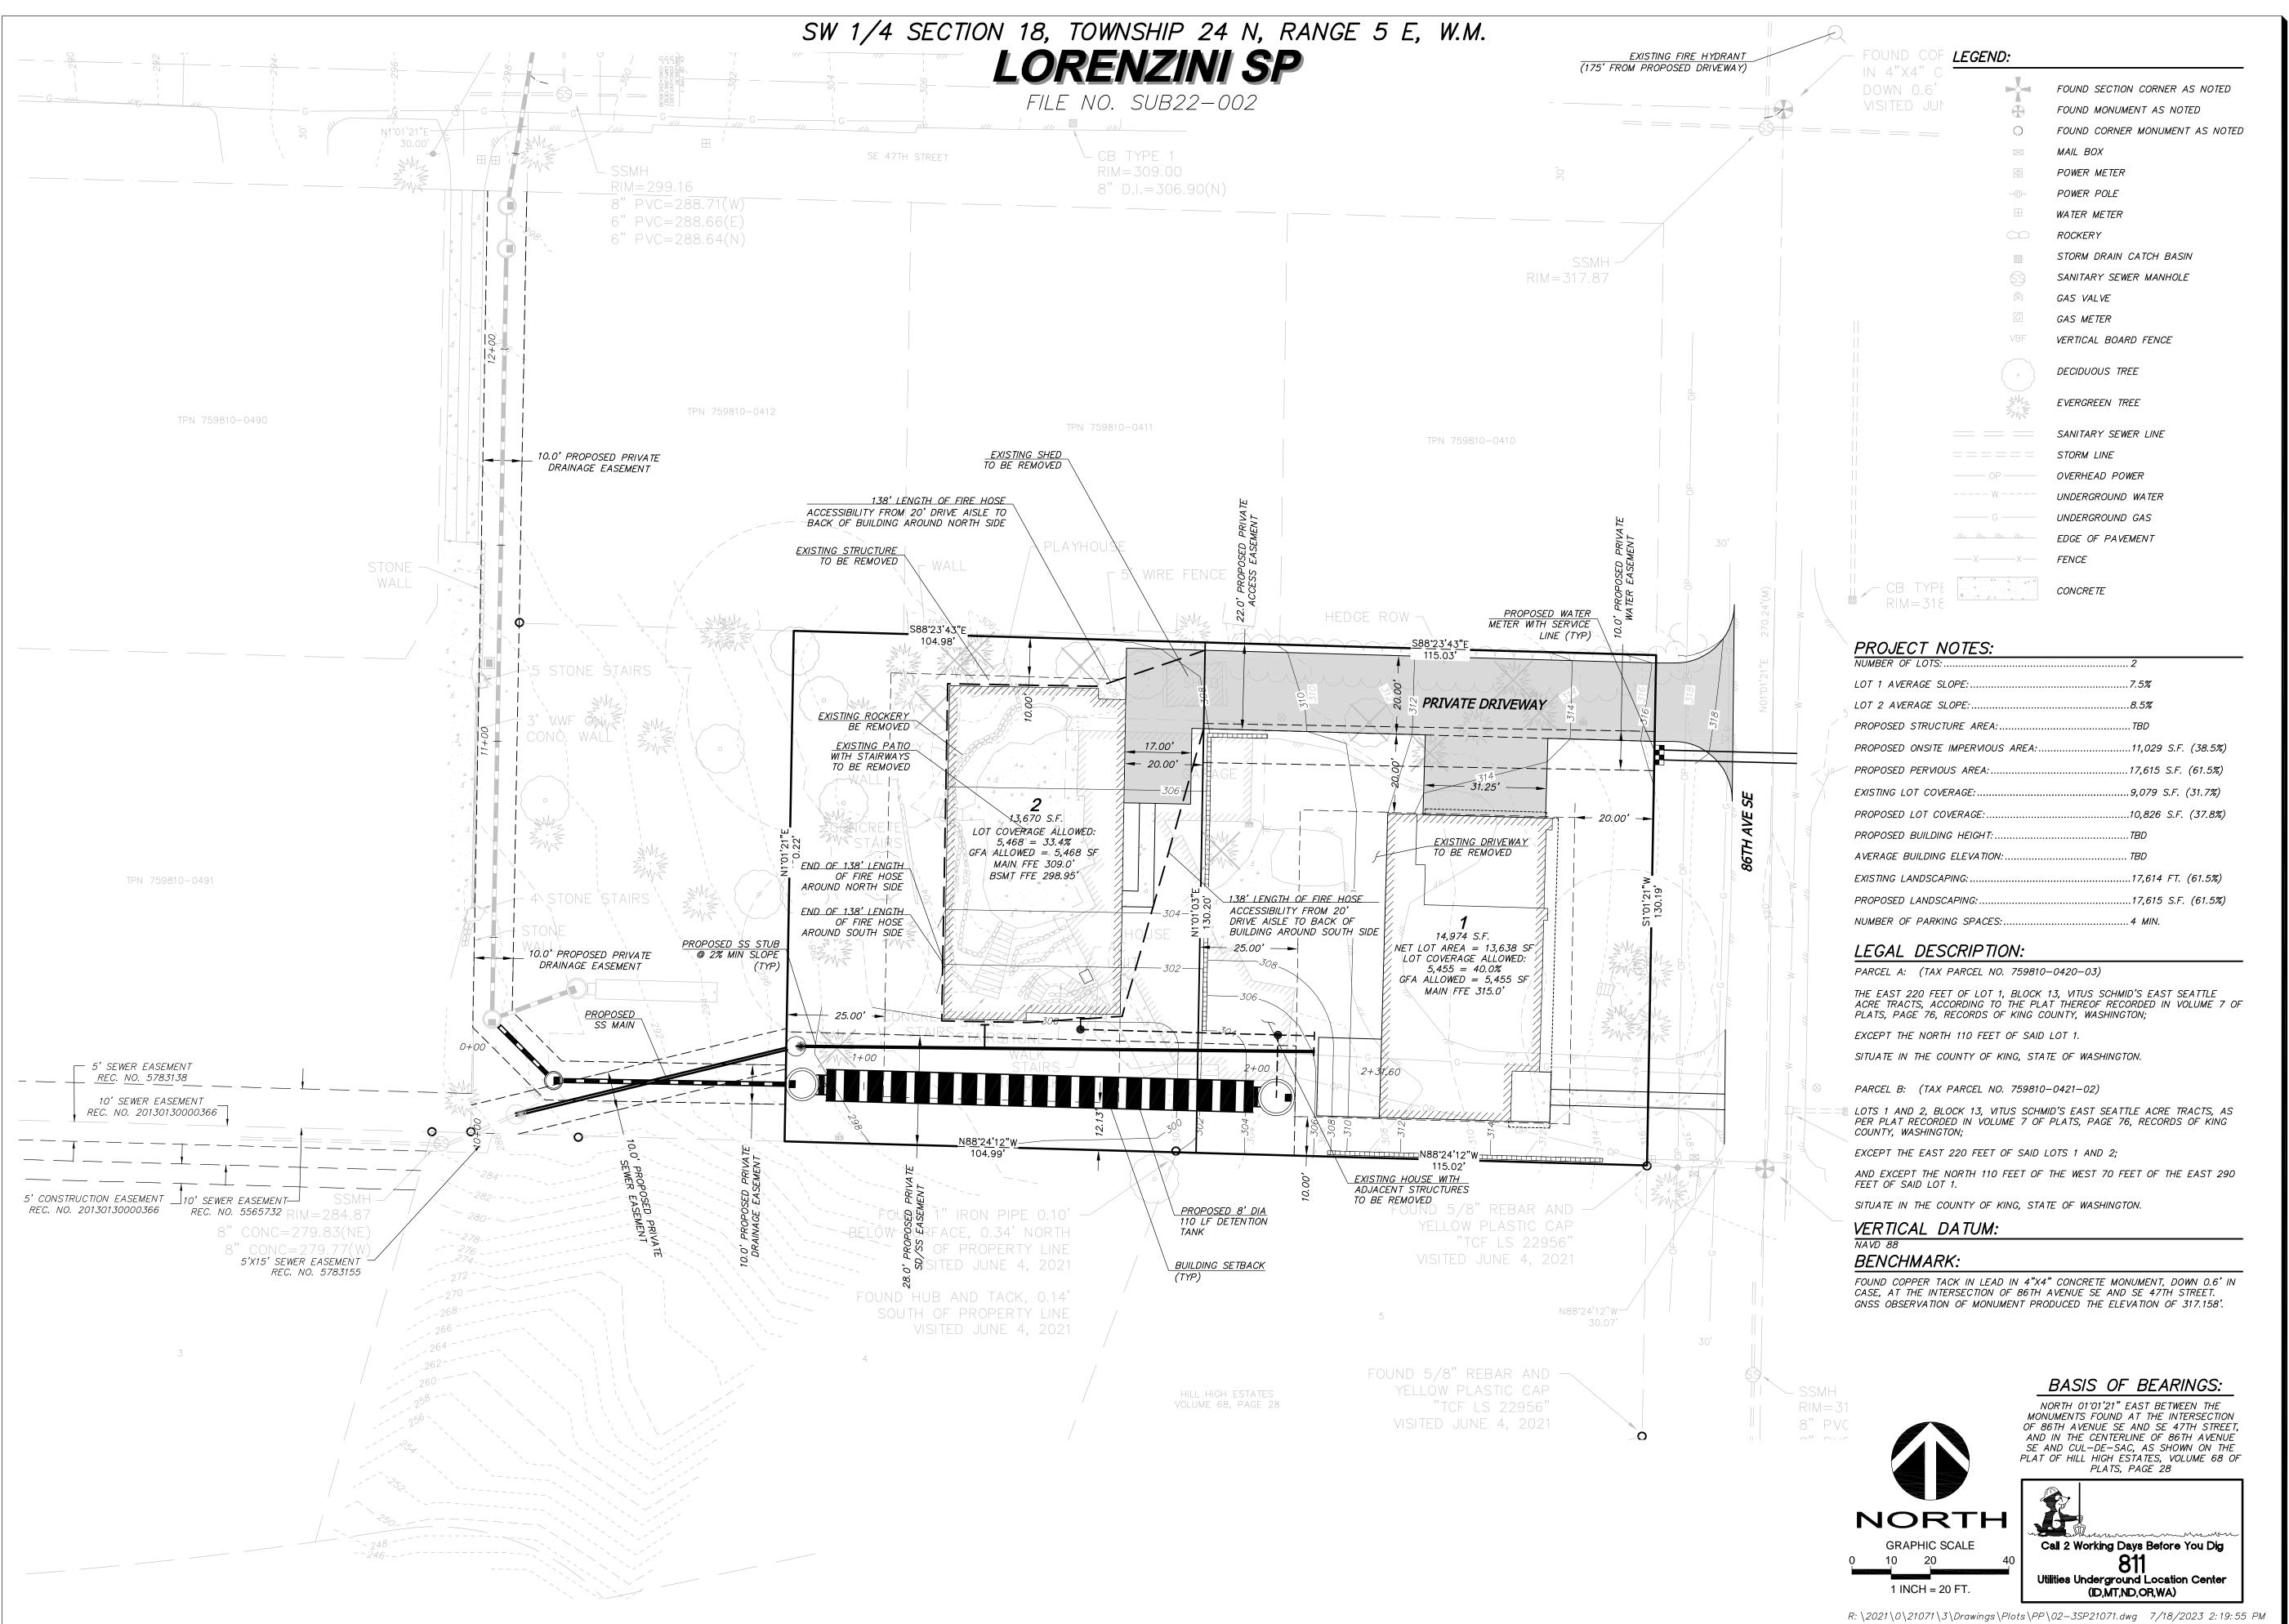
SHEET: 2 OF 4

NUMBER OF LOTS:	. 2
	LOT 1 AVERAGE SLOPE:	.7.5%
5	LOT 2 AVERAGE SLOPE:	8.5%
	PROPOSED STRUCTURE AREA:	TBD
	PROPOSED ONSITE IMPERVIOUS AREA:	11,029 S.F. (38.5%)
/	PROPOSED PERVIOUS AREA:	.17,615 S.F. (61.5%)
	EXISTING LOT COVERAGE:	.9,079 S.F. (31.7%)
	PROPOSED LOT COVERAGE:	10,826 S.F. (37.8%)
	PROPOSED BUILDING HEIGHT:	.TBD
	AVERAGE BUILDING ELEVATION:	. TBD
	EXISTING LANDSCAPING:	17,614 FT. (61.5%)
	PROPOSED LANDSCAPING:	17,615 S.F. (61.5%)
	NUMBER OF PARKING SPACES:	.4 MIN.

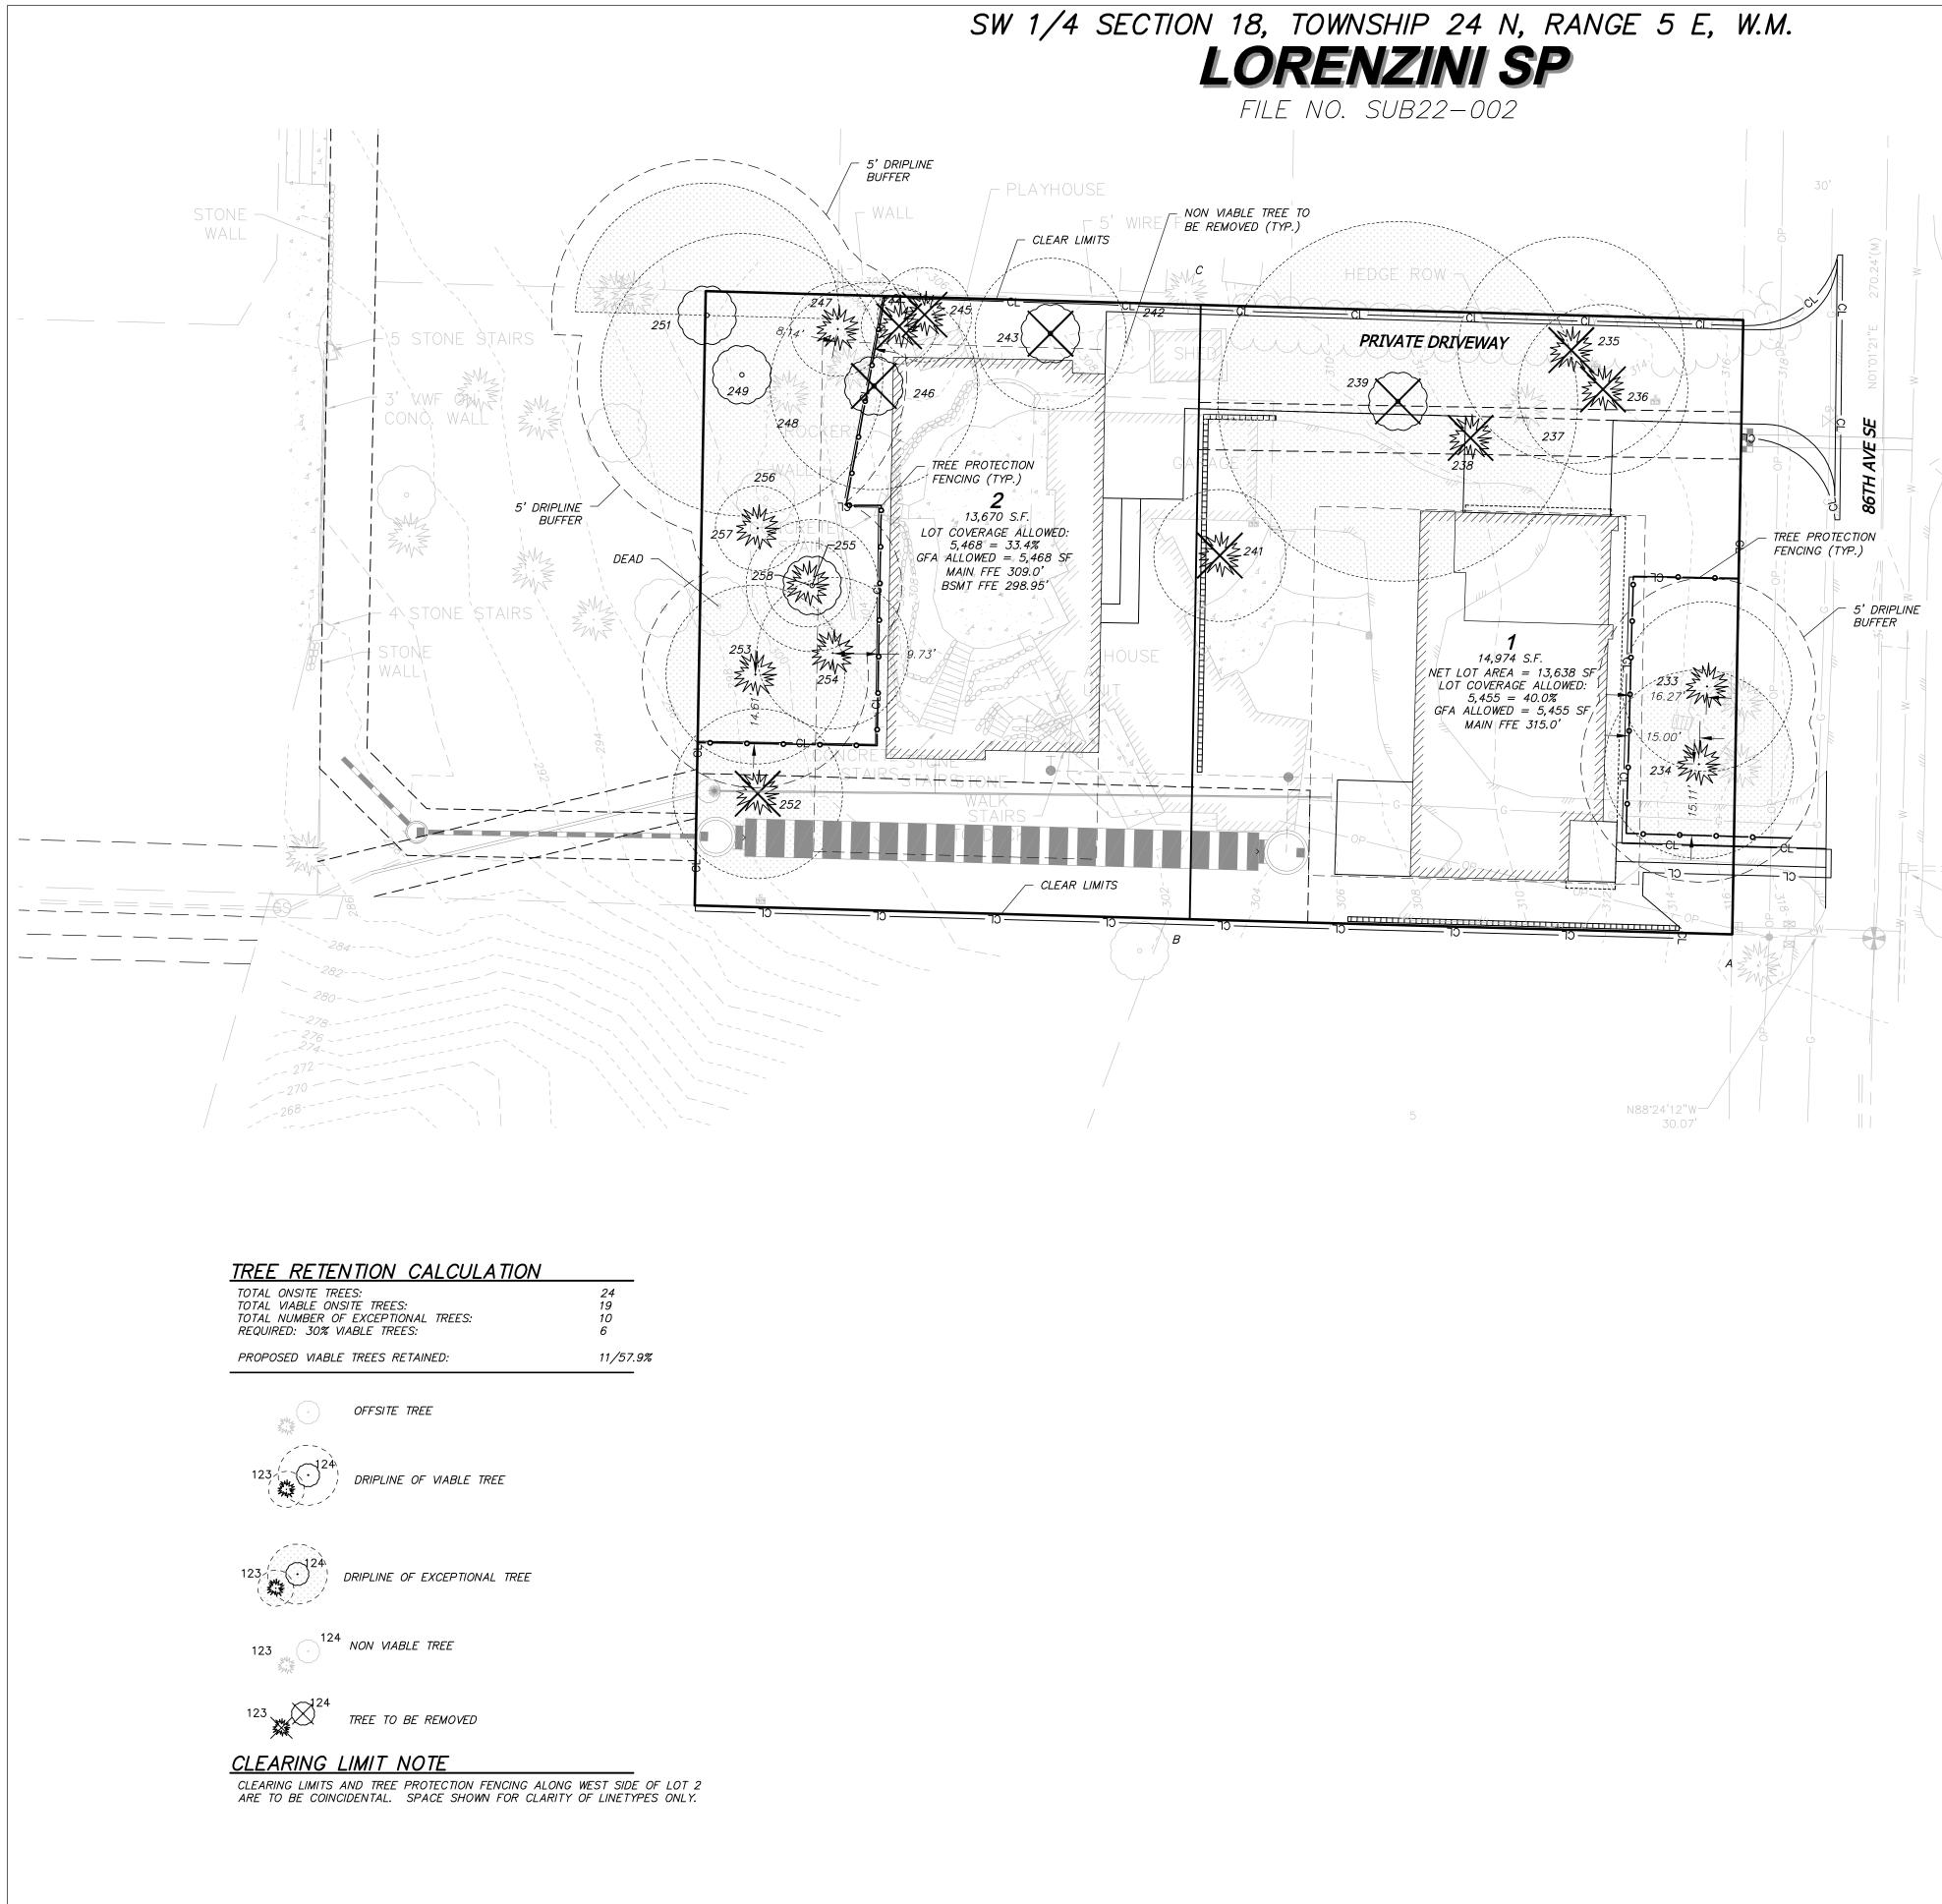
ropose Action						tree ''		ses	ses	
#	Tree Tag #	Species ID	DBH (in)	Adj. DBH (in)	Drip- line radius (ft)		OK in Grove	Health	Defects/Comments	Ret. Viable	Non-viable	Construct a	N	adius W	in fe	et S	Exceptional tree DBH > 24"	Value	Healthy Trees	Retained trees	
1	233	Douglas fir	21	21	18			ок	Typical of species	1			18	16	18	18		1	1	1	
2	234	Douglas fir	28	28	20			ок	Self-corrected lean towards west, dead wood, broken branches, dead twigs, typical of species	1			20	15	20	15	L	1	1	1	
3	235	Douglas fir	22	22	24			ок	Debris over crown, previous top loss, coning, dead wood, broken branches, typical of species			1	24	7	24	24		1	1		
1	236	Douglas fir	19	19	18			ок	Previous ivy @ root crown up to 50', typical of species, asymmetric canopy towards north			1	18	18	18	18		1	1		
5	237	Douglas fir	19	19	16			Fair	Self-corrected lean towards north, serpentine trunk, co- dominant leaders with included bark x2 @ 30' towards north, strong leader, reaction wood, horizontal crack @ 25', column of decay @ root crown up to 12' towards west, 3 calloused wounds towards west, free flowing sap		1		16	16	16	16		1

6	238	Douglas fir	24	24	18		Y	Fair	Exposed roots, moss and lichen, previous top loss, dead wood, broken branches, elongated branches			1	18	18	18	18	L	1	1		
7	239	Bigleaf maple	38	38	38			Fair	Calloused wound @ 6' towards south, exposed roots, decay in roots towards north, dead wood, broken branches, grade lowered 3' towards east		1		38	38	38	38	Е	1			
в	241	Scots pine	13	13	14			ок	Typical of species	1			14	14	14	14		1	1	1	Γ
¢	242	Bigleaf maple	16	16	14			Fair	Vertical crack @ 3' up to 10' towards south, co-dominant leaders with included bark x3 @ 10'		1		14	14	14	14		1			
0	243	Bigleaf maple	10, 8, 14, 15	24	16			ОК	Co-dominant leaders with included bark x4 @ root crown, moss and lichen, typical of species			1	16	16	16	16	L	1	1		
1	244	White pine	15	15	8			ок	Serpentine trunk, dead wood, broken branches, typical of species			1	8	8	8	8		1	1		
2	245	White pine	19	19	10			ок	Dead wood, broken branches, a towards east, typical of species <b>Co-dominant leaders</b>			1	10	10	10	10		1	1

3	246	Bigleaf maple	17, 18	25	22			ок	with included bark x2 @ 2', asymmetric canopy towards south, typical of species			1	22	22	22	22	L	1	1		
4	247	White pine	11	11	10			ок	Suppressed canopy, dead wood, broken branches, typical of species	1			10	10	6	6		1	1	1	
.5	248	Douglas fir	19	19	18			Fair	Epicormic branch formation @ 25' towards south, previous top loss, elongated branches, serpentine trunk, asymmetric canopy towards south		1		18	18	18	18		1			
16	249	Bigleaf maple	16, 44	47	30		Y	Fair	Co-dominant leaders with included bark x2 @ 4', exposed roots, calloused wound, dead wood, broken branches, asymmetric canopy towards north	1			30	30	21	30	E	1	1	1	
17	251	Bigleaf maple	26	26	28 north only			ок	Asymmetric canopy towards north, typical of species, dead wood, moss and lichen	1			28	28	28	28	L	1	1	1	
18	252	Douglas fir	28	28	18		Y	Fair	Self-corrected lean towards south, fill over crown, abnormal bark, popping bark, previous top loss, elongated branches, typical of species, dead wood, broken branches Dead wood, broken			1	18	18	18	18	L	1	1

.9	253	Douglas fir	36	36	19			ок	branches, previous top loss, carpenter ants bark only	1			19	19	7	19	E	1	1	1	
0	254	Douglas fir	36, 28	45.5	16			ОК	Co-dominant leaders with included bark x2 @ 1', previous top loss @ 50', strong laterals, dead wood, broken branches, abnormal bark, popping bark, woodpecker activity	1			16	16	16	16	E	1	1	1	
1	255	Douglas fir	16	16	14		Y	Fair	Abnormal bark, shedding bark, popping bark, topped @ 50', strong lateral, low live crown ratio <10%	1			14	14	14	14		1	1	1	Ţ
2	256	Bigleaf maple	36, 24	43.5	26			Poor	Co-dominant leaders with included bark x2 @ 1', dead scaffolds, dead wood, cavity @ 3' towards north		1		26	26	26	26	E	1			
3	257	Incense cedar	8, 9	12	9			ок	Co-dominant leaders with included bark x2 @ 3',	1			9	9	9	9		1	1	1	ſ
	258	Incense	18	18	9			ок	typical of species Typical of species	1			9	9	9	9		1	1	1	+

ANY CONSTRUCTION WITHIN THE DRIPLINE OF A TREE TO BE RETAINED WILL REQUIRE AN AIR EXCAVATION ANALYSIS TO DETERMINE THAT THE TREE WILL NOT BE DAMAGED DURING CONSTRUCTION.

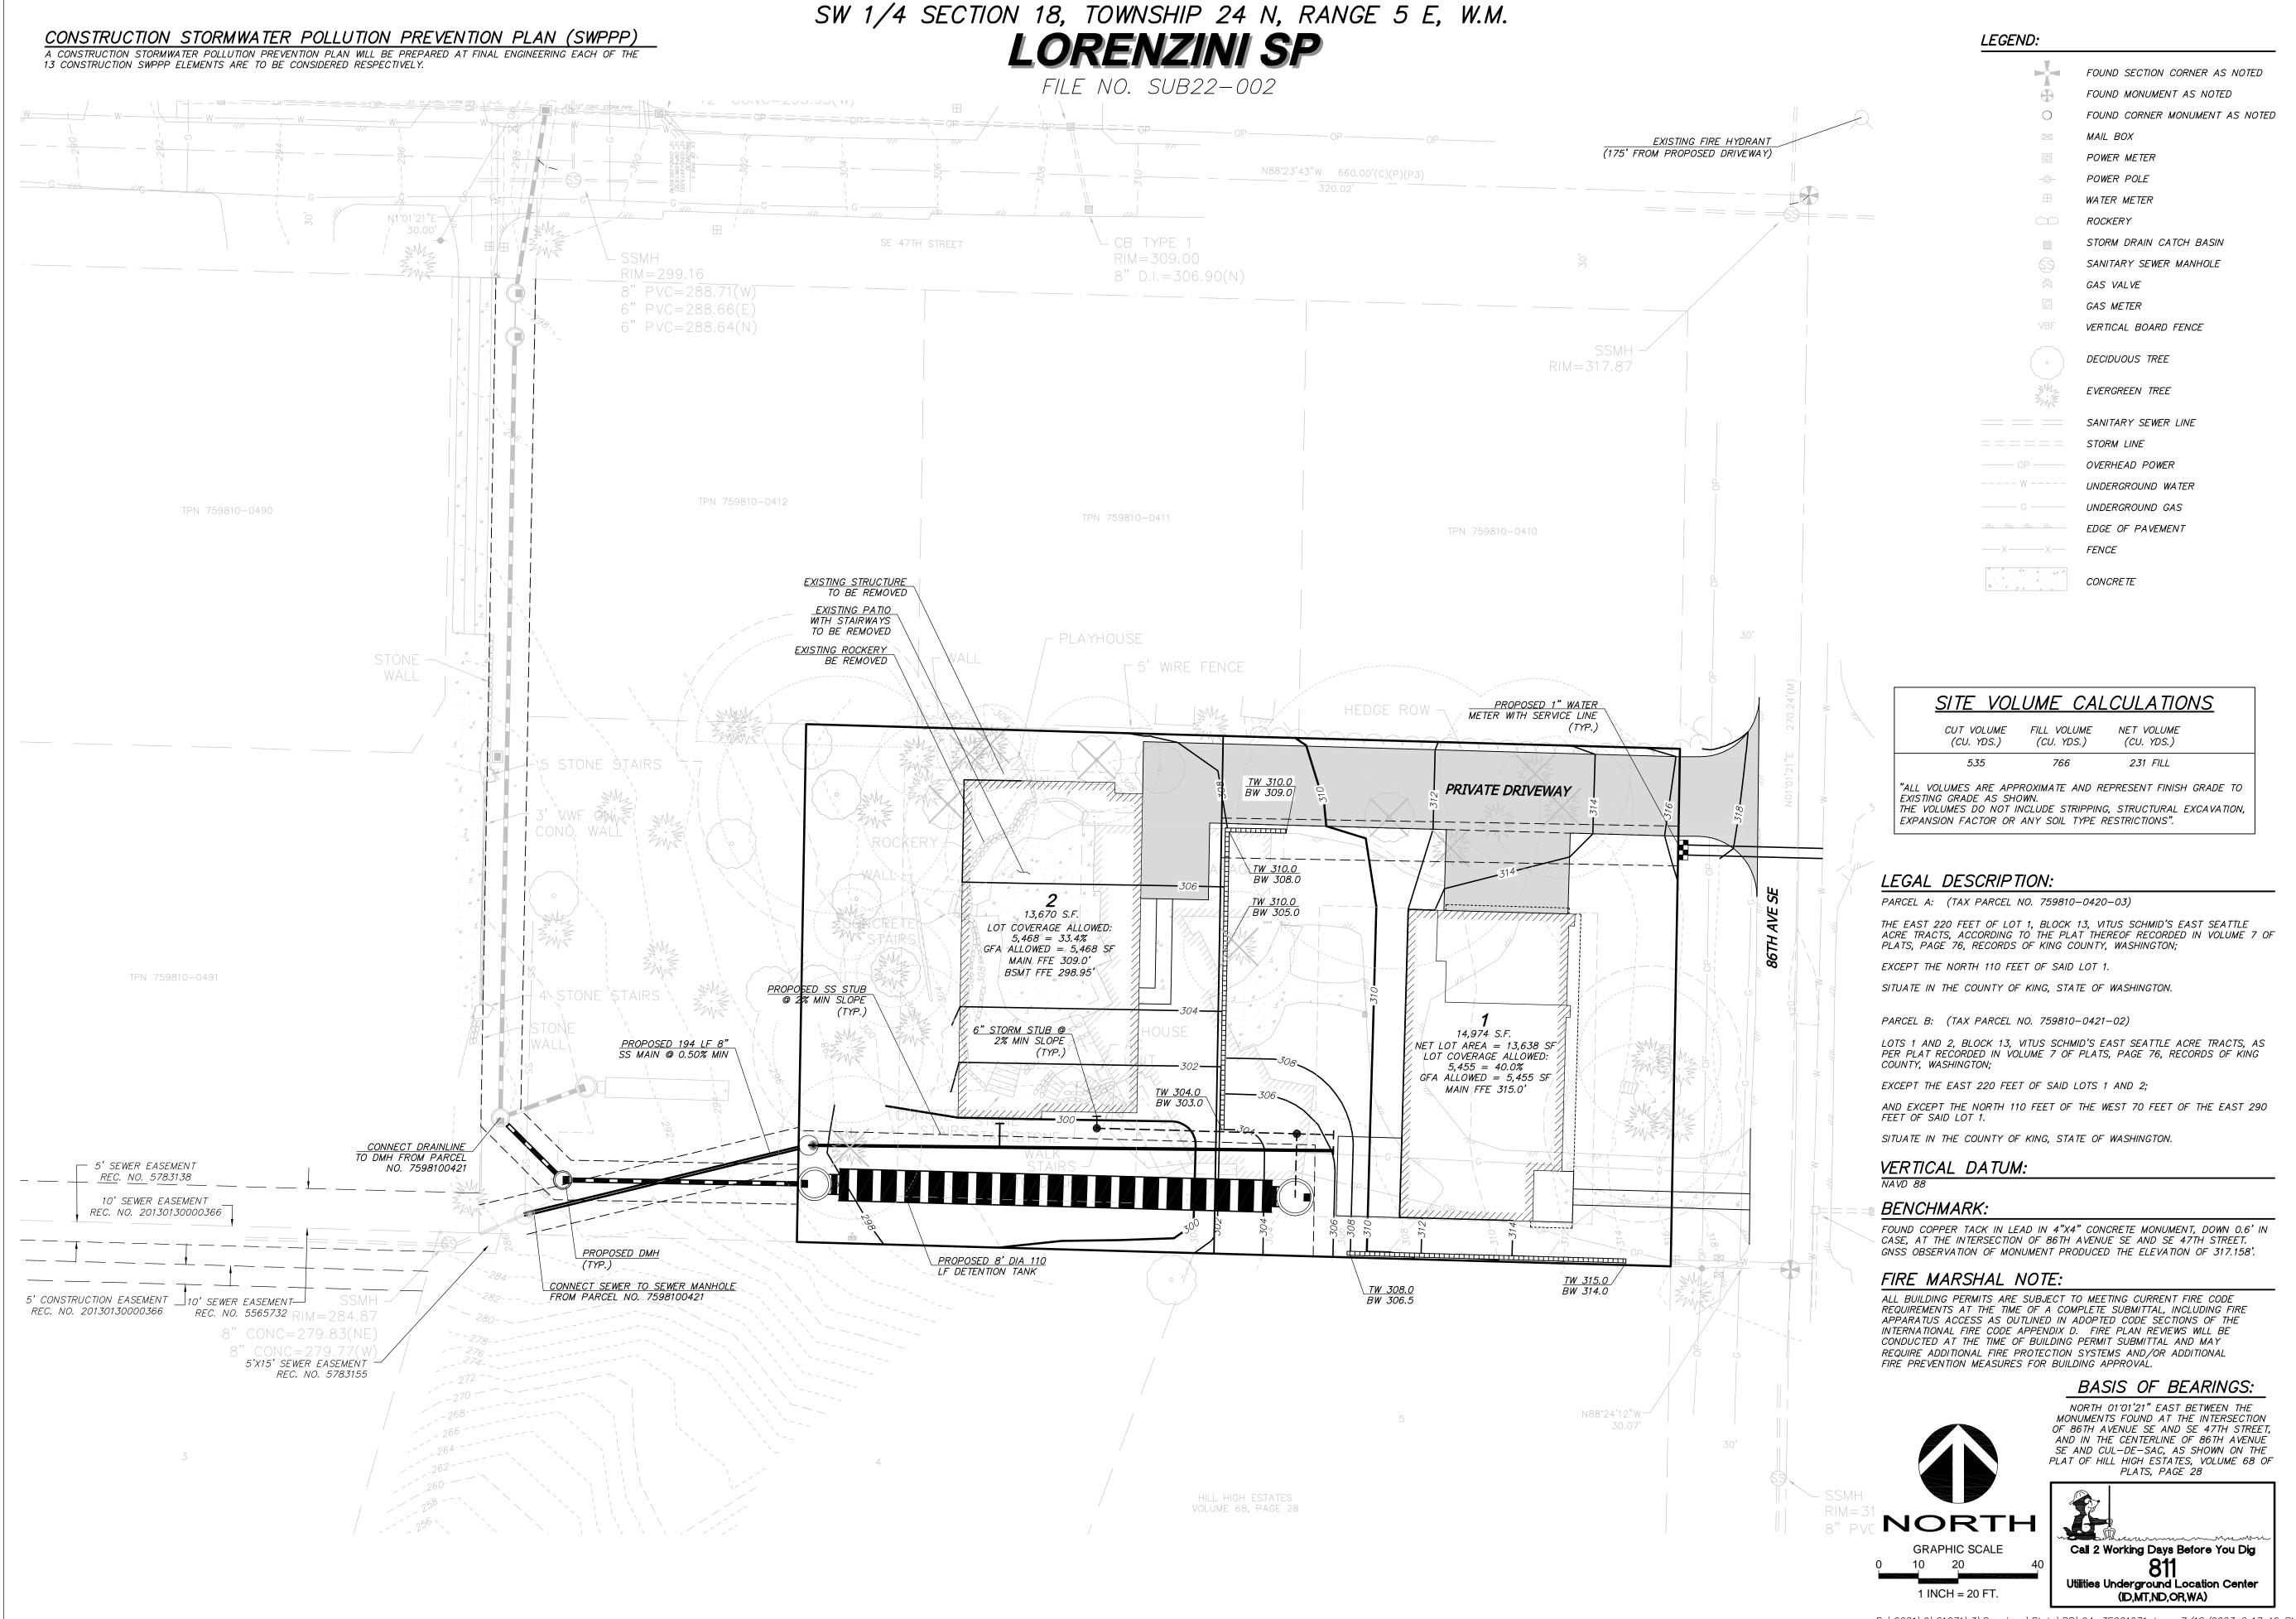
SHEET: **4** OF **4**

<u>SITE VOL</u>	UME CAL	<u>CULA TIONS</u>	
CUT VOLUME (CU. YDS.)	FILL VOLUME (CU. YDS.)	NET VOLUME (CU. YDS.)	
535	766	231 FILL	
EXISTING GRADE AS SHO	WN.	PRESENT FINISH GRADE TO S STRUCTURAL EXCAVATION	-
