CONSUL ENGINEERS 620 - 7th AV	DRS DR. STRONG CONSULTING ENGINEERS ENGINEERS PLANNERS SURVEYORS 620 - 7th AVENUE KIRKLAND, WA 98033 0 425.827.3063 F 425.827.2423						
LORENZINI SP	SITE PLAN	4719 86TH AVENUE SE MERCER ISLAND, WASHINGTON PARCEL NO. 7598100420					
TODD SHERMAN DESIGN BUILT HOMES		11400 SE 8TH STREET, SUITE 415 BELLEVUE, WASHINGTON 98004 206-909-8187					
	A. A. A. A. A. A. A. A. A. A.	08-11-23					
DATE REVISION APR 12.09.22 REVS. PER AGENCY COMMENTS MAJ							
DRAFTED DESIGNED PROJECT DATE: 1 PROJECT DRAWING:	BY: JS ENGINEE 1 2.20.21 NO.: 2	e R: Maj

CONSUL ENGINEERS 620 - 7th AV	R. STRONG TING ENGINEERS F PLANNERS SURVEYORS TENUE KIRKLAND, WA 98033 27.3063 F 425.827.2423
LORENZINI SP	TREE PLAN 4719 86TH AVENUE SE MERCER ISLAND, WASHINGTON PARCEL NO. 7598100420
TODD SHERMAN DESIGN BUILT HOMES	11400 SE 8TH STREET, SUITE 415 BELLEVUE, WASHINGTON 98004 206-909-8187
	A STATE BELLE AND A STATE AND
DATE REVISION APR 12.09.22 REVS. PER AGENCY COMMENTS MAJ	
DESIGNED PROJECT DATE: 1	NO.: 21071 C3

DRS DR. STRONG CONSULTING ENGINEERS ENGINEERS PLANNERS SURVEYORS 620 - 7th AVENUE KIRKLAND, WA 98033 0 425.827.3063 F 425.827.2423						
TORENZINI SP	CONCEPTUAL GRADING & UTILITY P

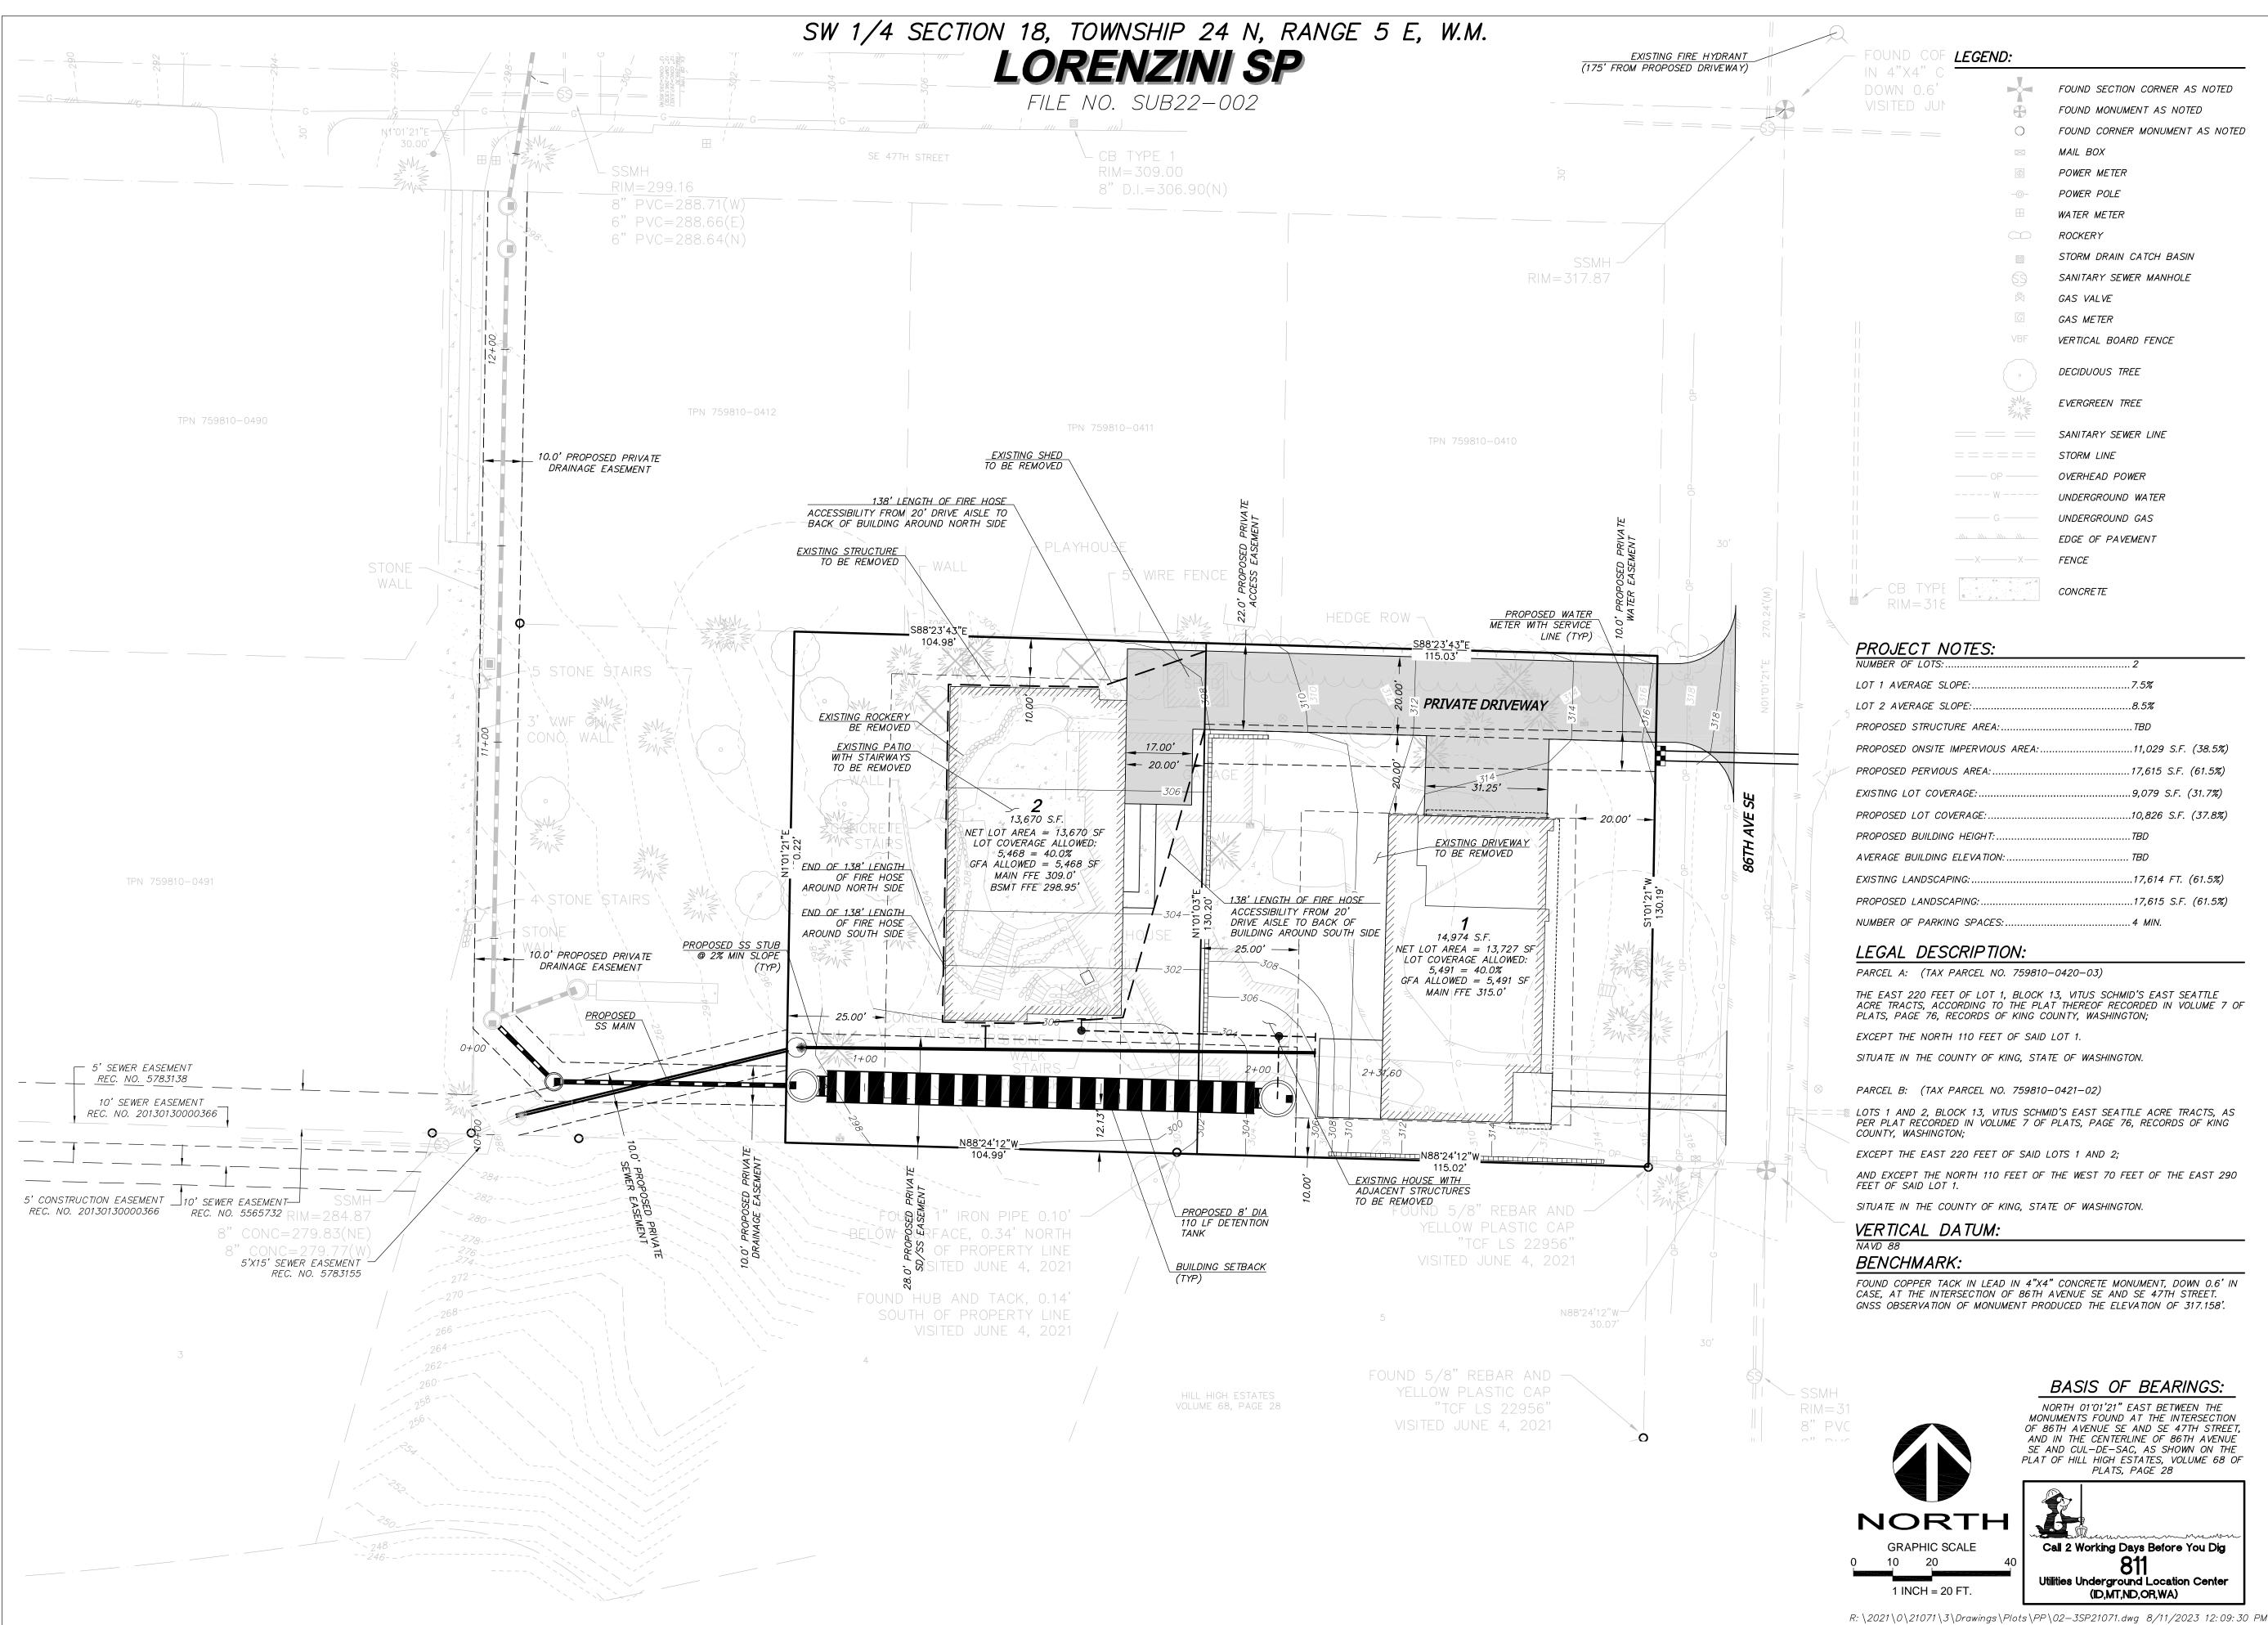
SHEET: **2** OF **4**

NUMBER OF LOTS:	2
	LOT 1 AVERAGE SLOPE:	7.5%
5	LOT 2 AVERAGE SLOPE:	8.5%
	PROPOSED STRUCTURE AREA:	<i>TBD</i>
	PROPOSED ONSITE IMPERVIOUS AREA:	11,029 S.F. (38.5%)
_	PROPOSED PERVIOUS AREA:	17,615 S.F. (61.5%)
	EXISTING LOT COVERAGE:	9,079 S.F. (31.7%)
	PROPOSED LOT COVERAGE:	10,826 S.F. (37.8%)
	PROPOSED BUILDING HEIGHT:	TBD
	AVERAGE BUILDING ELEVATION:	. TBD
	EXISTING LANDSCAPING:	17,614 FT. (61.5%)
	PROPOSED LANDSCAPING:	17,615 S.F. (61.5%)
	NUMBER OF PARKING SPACES:	4 MIN.

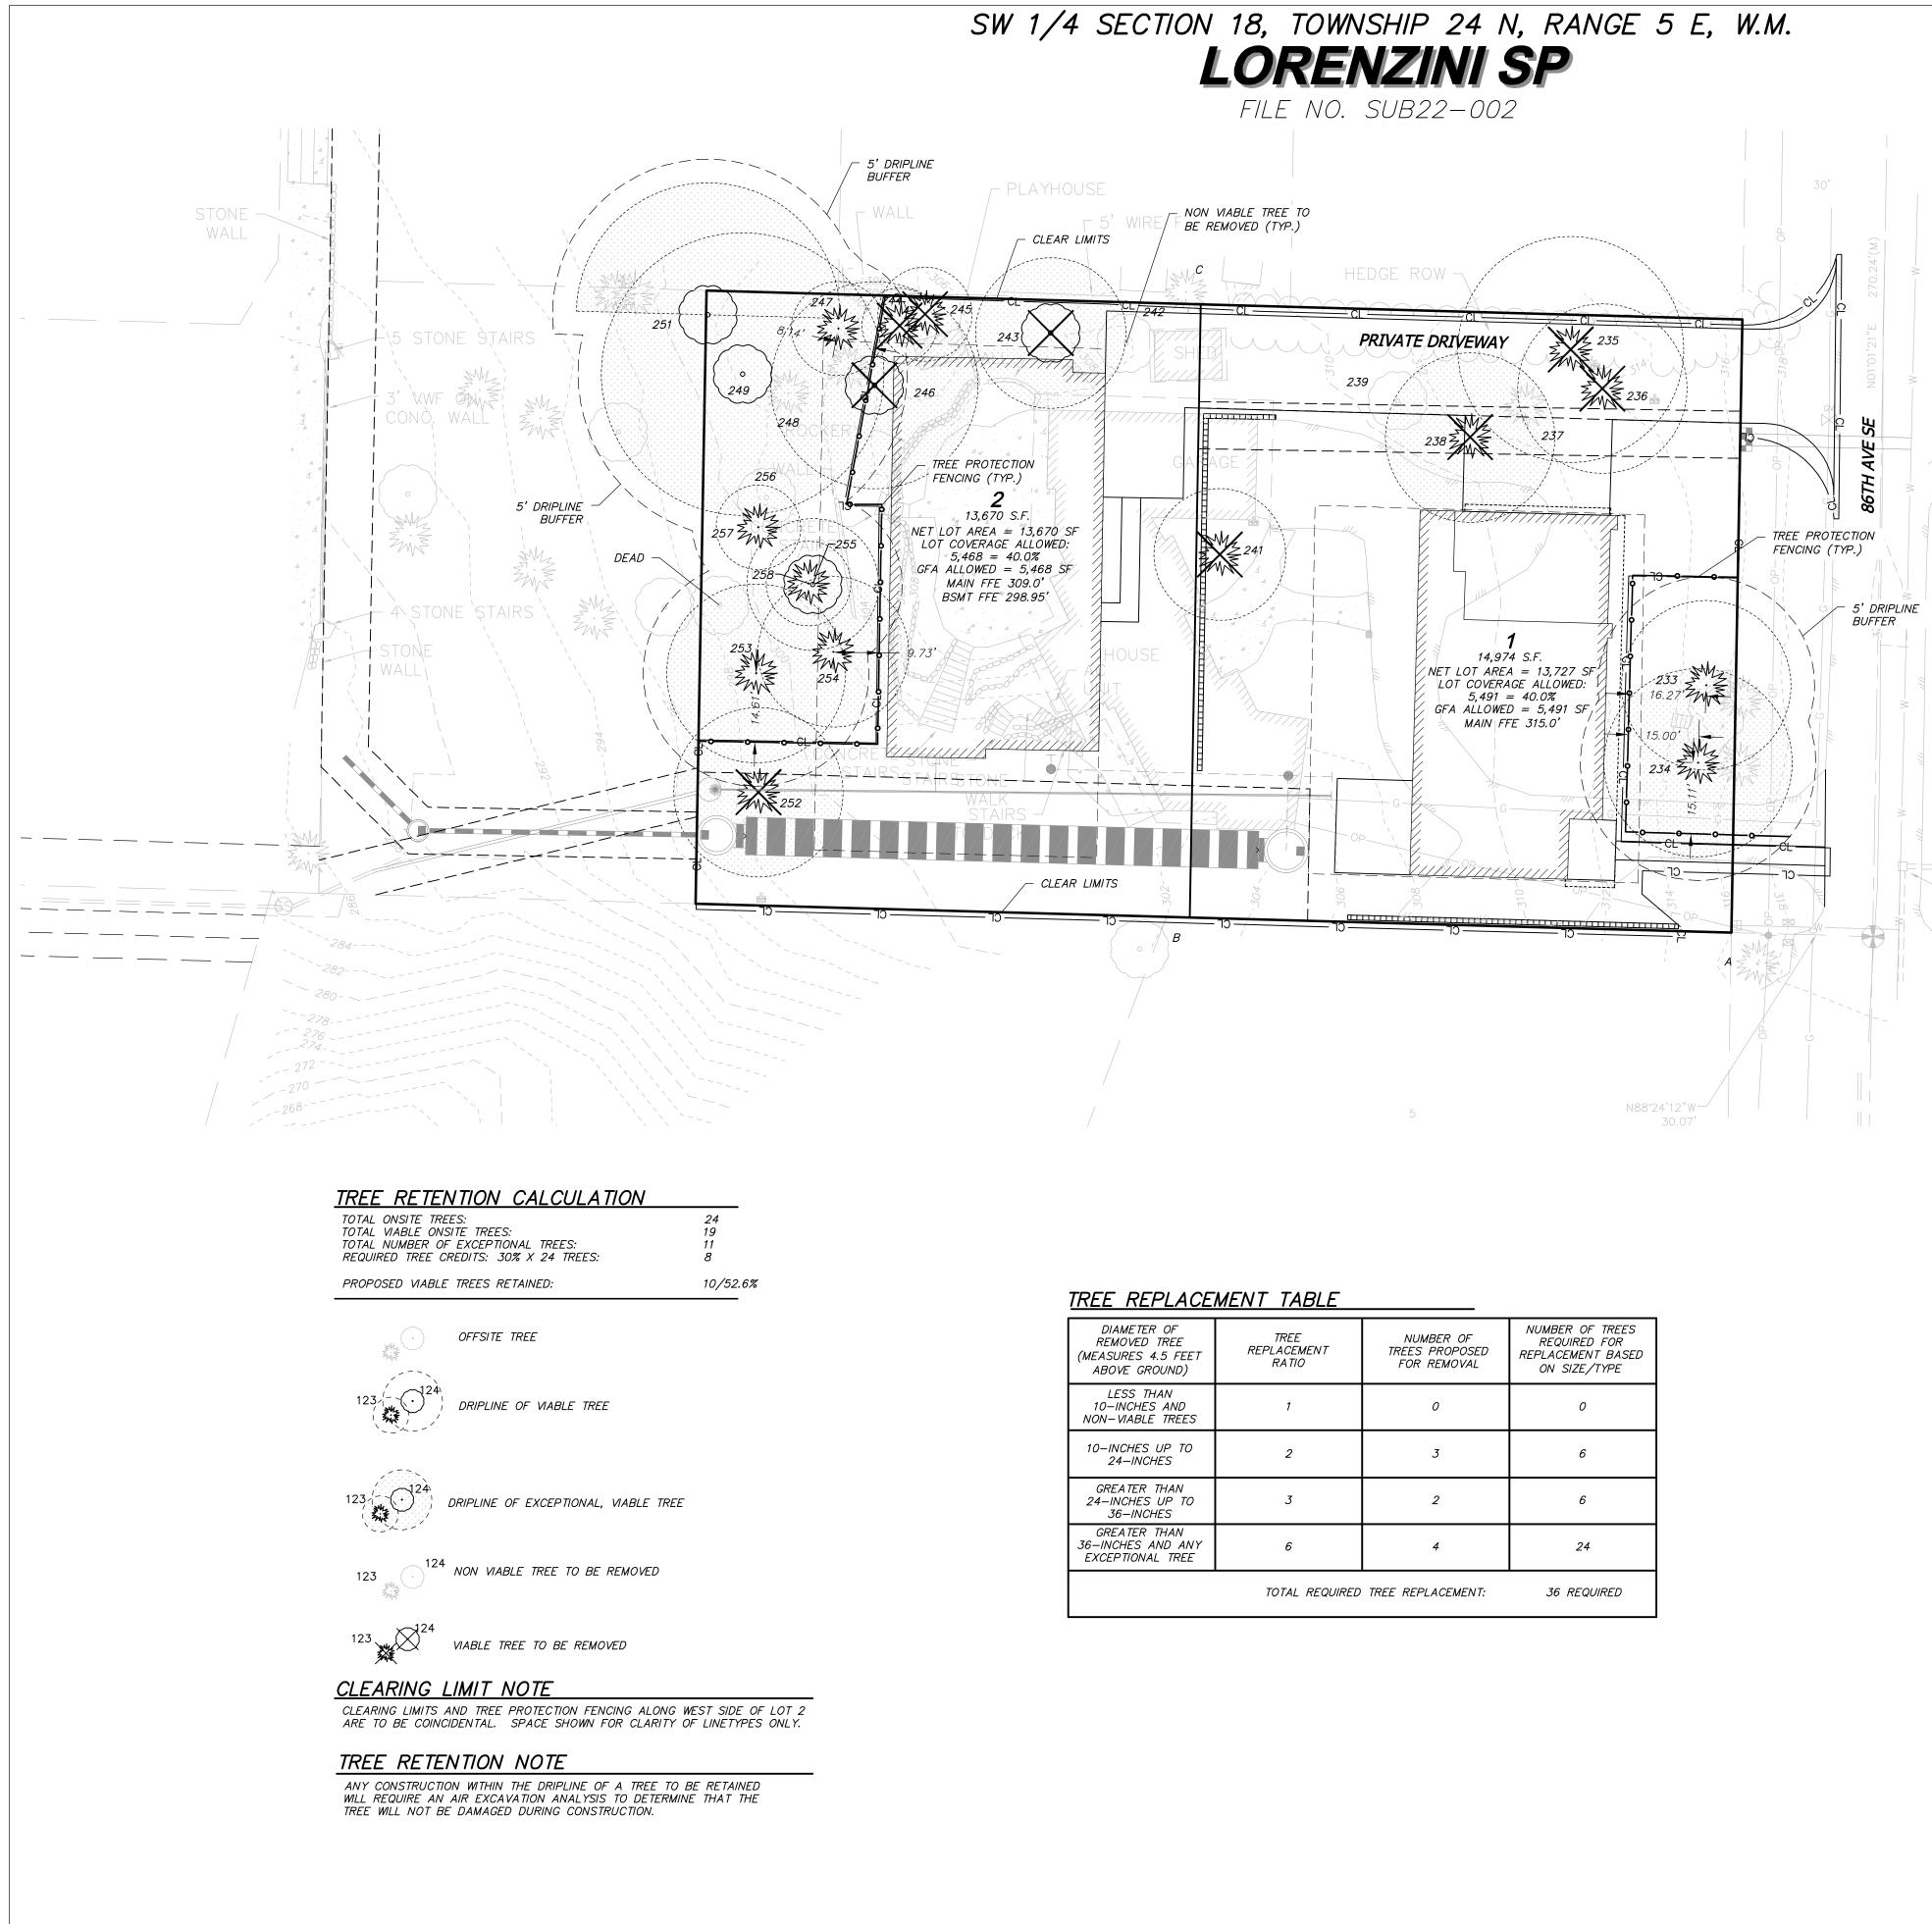
DIAMETER OF REMOVED TREE (MEASURES 4.5 FEET ABOVE GROUND)	TREE REPLACEMENT RATIO	NUMBER OF TREES PROPOSED FOR REMOVAL	NUMBER OF TREES REQUIRED FOR REPLACEMENT BASED ON SIZE/TYPE			
LESS THAN 10–INCHES AND NON–VIABLE TREES	1	0	0			
10–INCHES UP TO 24–INCHES	2	3	6			
GREATER THAN 24–INCHES UP TO 36–INCHES	3	2	6			
GREATER THAN 36–INCHES AND ANY EXCEPTIONAL TREE	6	4	24			
TOTAL REQUIRED TREE REPLACEMENT: 36 REQUIRED

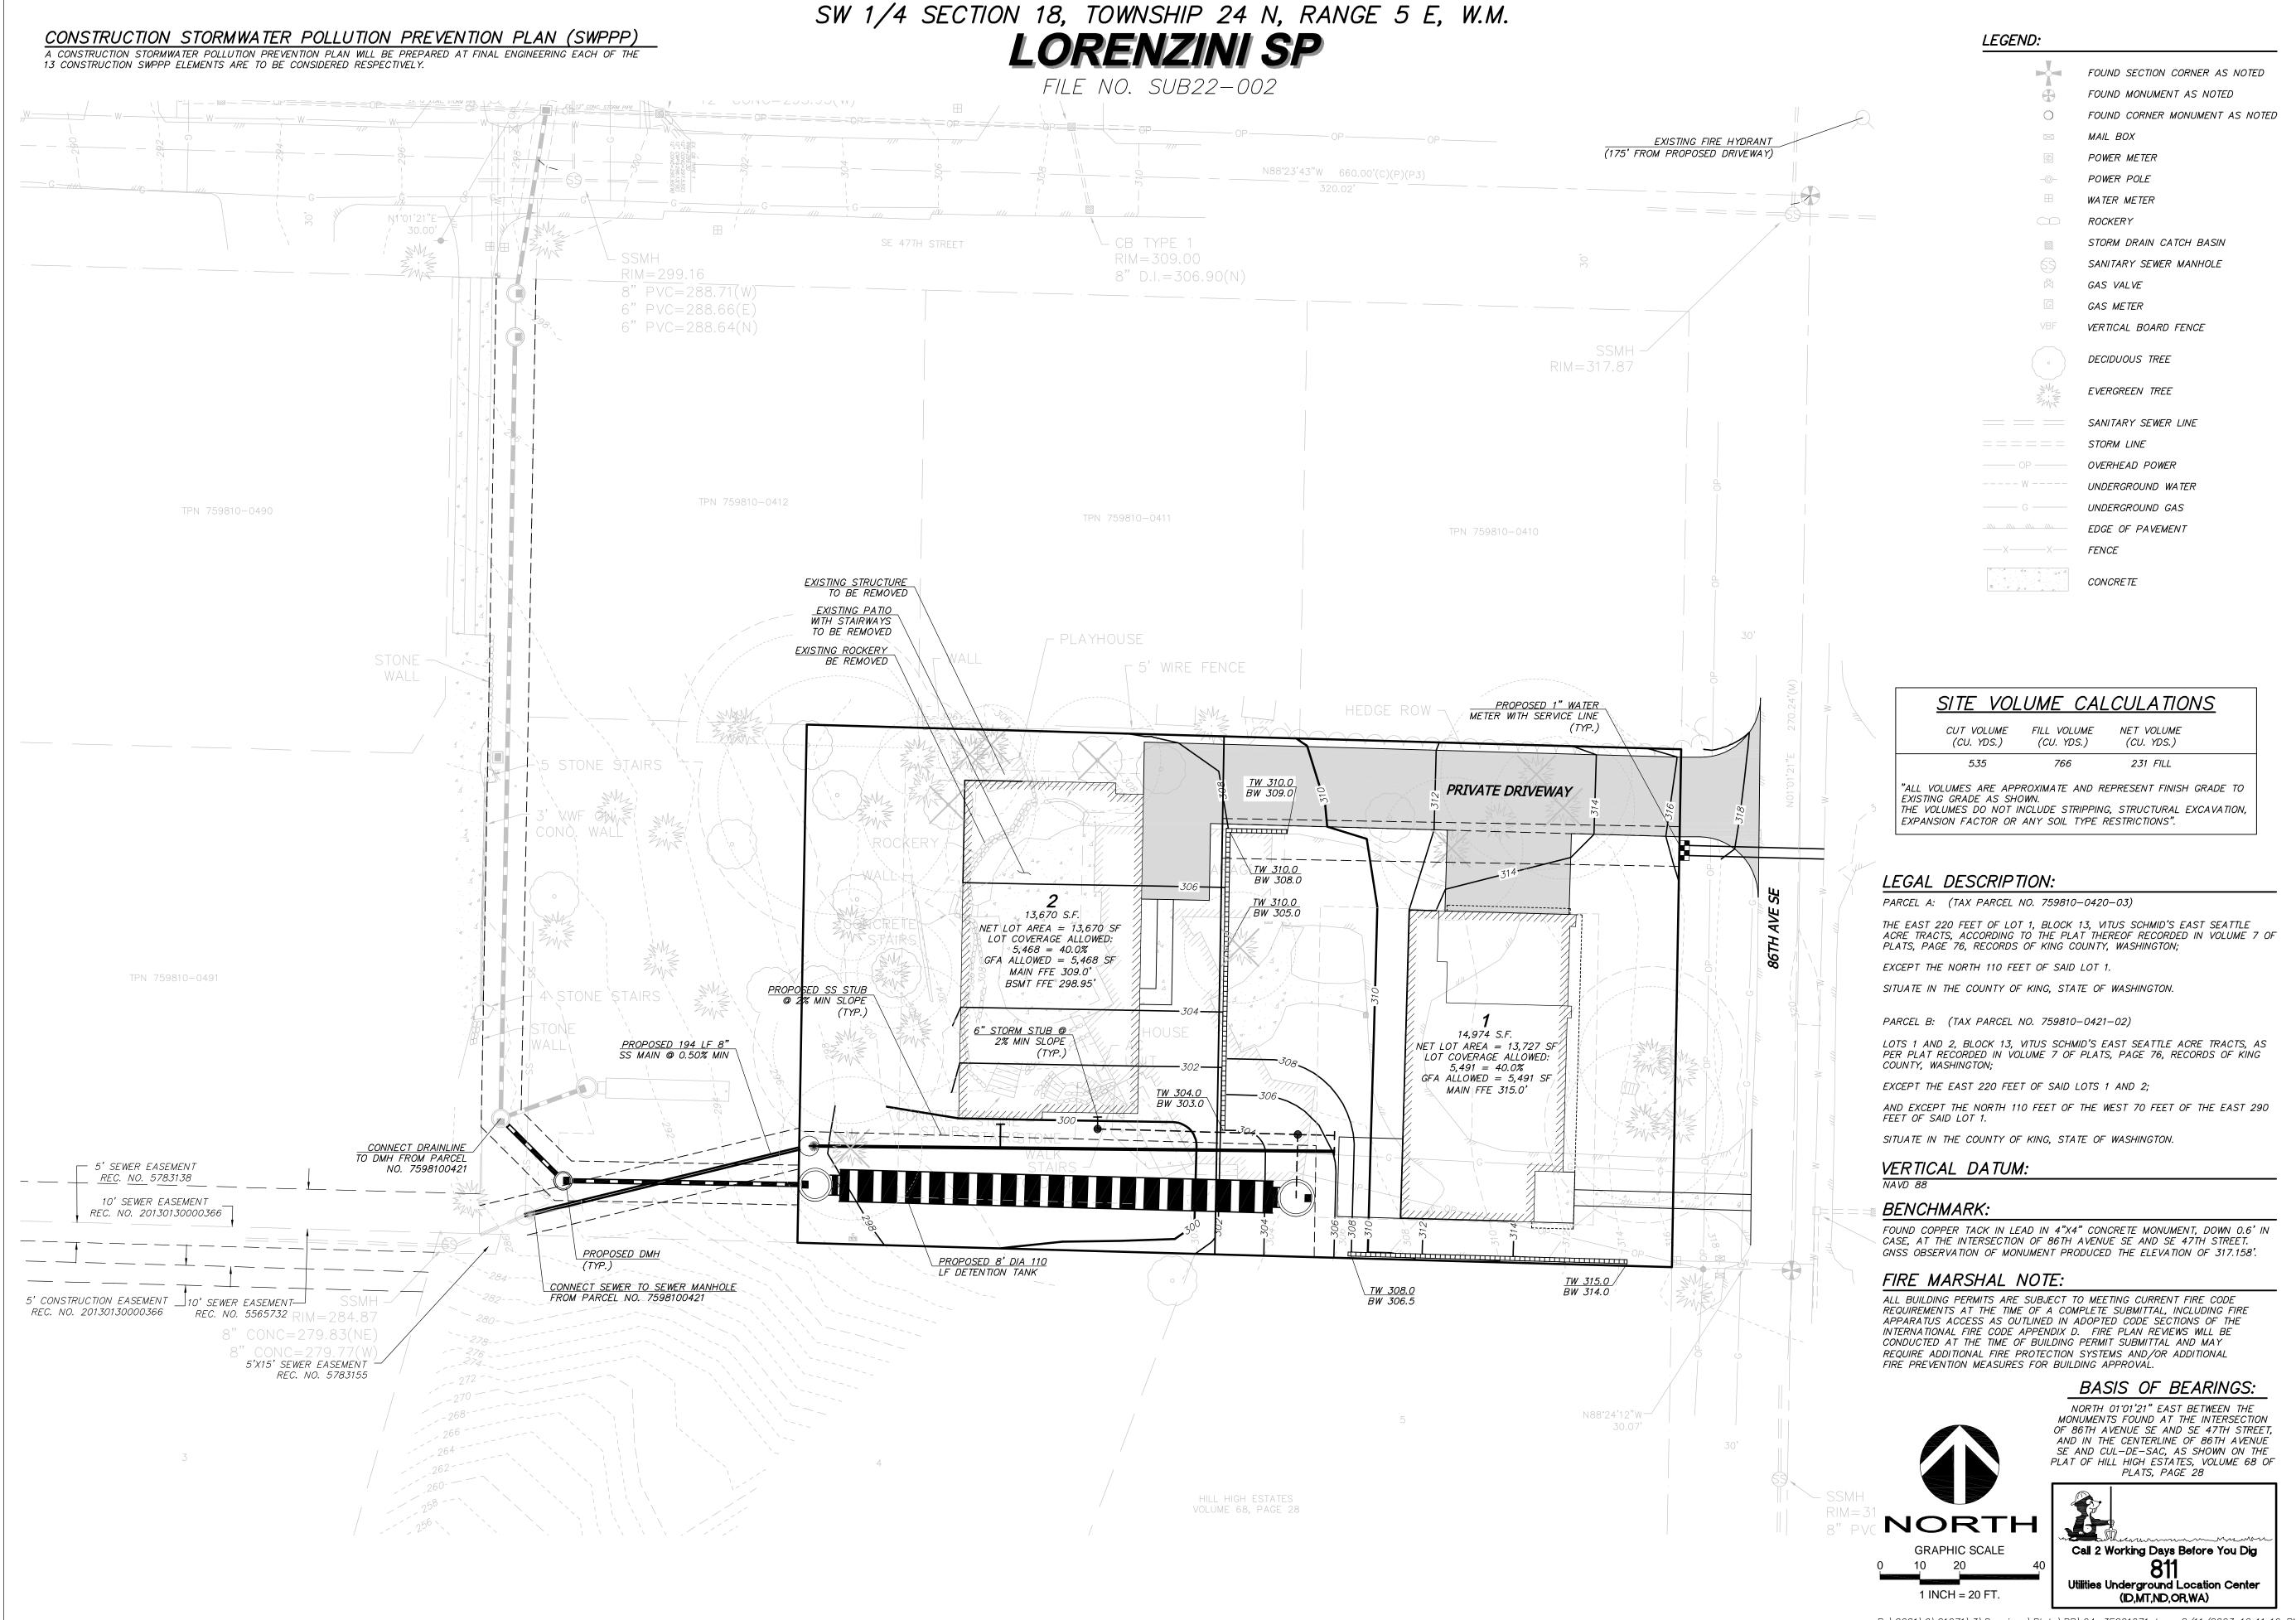
SHEET: 4 OF 4

<u>SITE VOL</u>	UME CAL	<u>CULA TIONS</u>				
CUT VOLUME (CU. YDS.)	FILL VOLUME (CU. YDS.)	NET VOLUME (CU. YDS.)				
535	766	231 FILL				
"ALL VOLUMES ARE APPROXIMATE AND REPRESENT FINISH GRADE TO EXISTING GRADE AS SHOWN. THE VOLUMES DO NOT INCLUDE STRIPPING, STRUCTURAL EXCAVATION, EXPANSION FACTOR OR ANY SOIL TYPE RESTRICTIONS"
