# LITCHFIELD ENGINEERING

## STORM DRAINAGE REPORT for the LBH RESIDENCE

Prepared By:  
Keith A. Litchfield, P.E.

Date Issued:      March 14, 2019

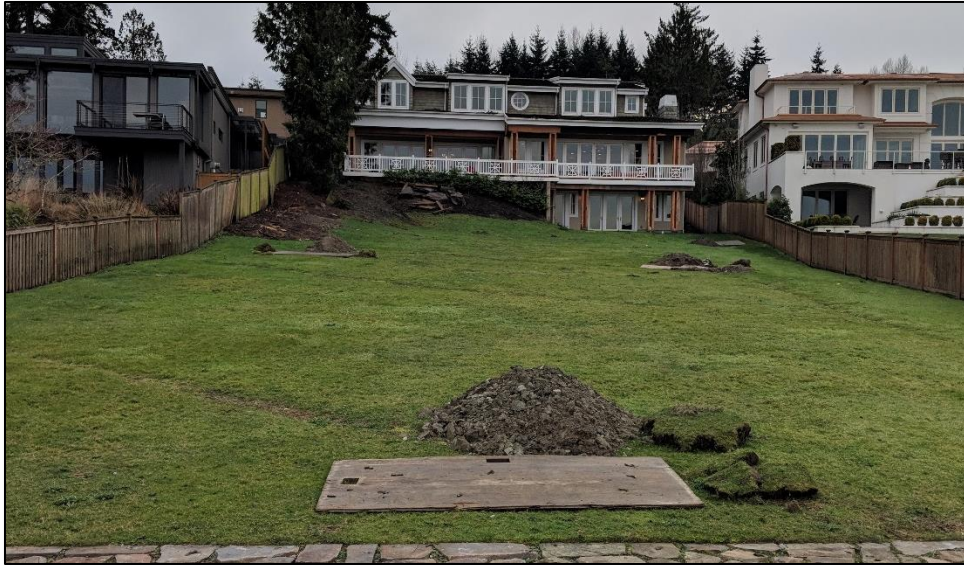
Runoff from the site sheet flows overland to the north for approximately 100 feet before discharging to Lake Washington. There is also a 4" PVC tightline that collects the existing roof runoff and discharges to Lake Washington.
