Job: 1761-KIN

Subject: 7805 SE 70th St,
Mercer Island, Washington 98040
Foundation Settlement Geotechnical Report
Parcel #056550-0150

This report presents the results of our geotechnical investigation and contains geotechnical recommendations for the installation of helical pier foundation elements at the address 7805 SE 70th St, Mercer Island, Washington. The analyses, conclusions, and recommendations in this report are based on the information available. These informational resources include: one hand augured boring completed specifically for the subject project, published geologic information for the site, and our experience with similar soil conditions. This exploratory boring is assumed to be representative of the subsurface conditions where the work will occur. If during construction, subsurface conditions differ from those described in the exploration, we should be advised immediately so we may reevaluate our recommendations.

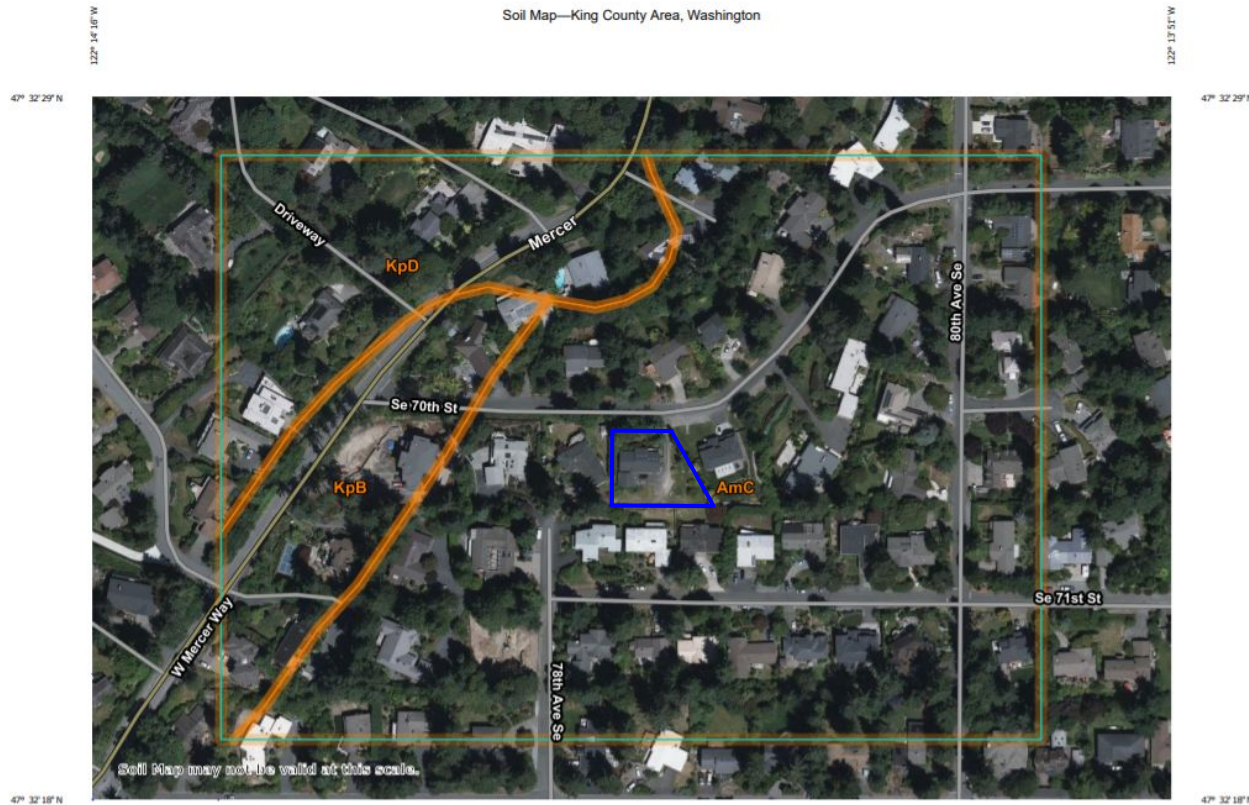
Figure 3: USDA Soil Map
7805 SE 70th St,
Mercer Island WA 98040
Geotechnical Report

Soil Map may not be valid at this scale.

In addition to the site geology, site-specific soil data made available by the United States Department of Agriculture was consulted. The USDA Soil Map is attached to this report as Figure 3. This figure suggests that the parcel is underlain by *Arents, Alderwood material, 6 to 15 percent slopes*. The USDA describes the Alderwood series as a moderately deep and moderately well-drained soil forming in the parent material of glacial drift and outwash deposits. The conditions observed on-site are generally consistent with the mapped soils for the region. It should be noted that the slope percentages displayed on the map are estimates and do not necessarily reflect true surface topography.
