### CAO23-011 CRITICAL AREA REVIEW 2

<b>Project No.:</b>	CAO23-011
<b>Description:</b>	A request for a Critical Area Review 2 for the demolition of an existing single-family residence and construction of a new approx. 4,000 square foot single-family residence on a property located within mapped geologically hazardous areas.
<b>Applicant / Owner:</b>	Jeffrey Almeter / Dorothy Strand
<b>Site Address:</b>	6950 SE Maker St, Mercer Island, WA 98040; Identified by King County Assessor tax parcel number 935090-0620.
<b>Zoning District:</b>	Single Family Residential (R-8.4)
<b>Staff Contact:</b>	Molly McGuire, Planner <a href="mailto:molly.mcguire@mercerisland.gov">molly.mcguire@mercerisland.gov</a> / (206) 275-7712
<b>Exhibits:</b>	<ol style="list-style-type: none"><li>1. Development Application, received by the City of Mercer Island on July 3, 2023</li><li>2. Revised Development Plan Set, August 29, 2023</li><li>3. Project Narrative, received July 4, 2023</li><li>4. Hazard Report, generated August 9, 2023</li><li>5. Geotechnical Engineering Study and Critical Areas Study prepared by Geotech Consultants, Inc., dated March 21, 2022 and received July 3, 2023</li><li>6. Review of Revised Pl

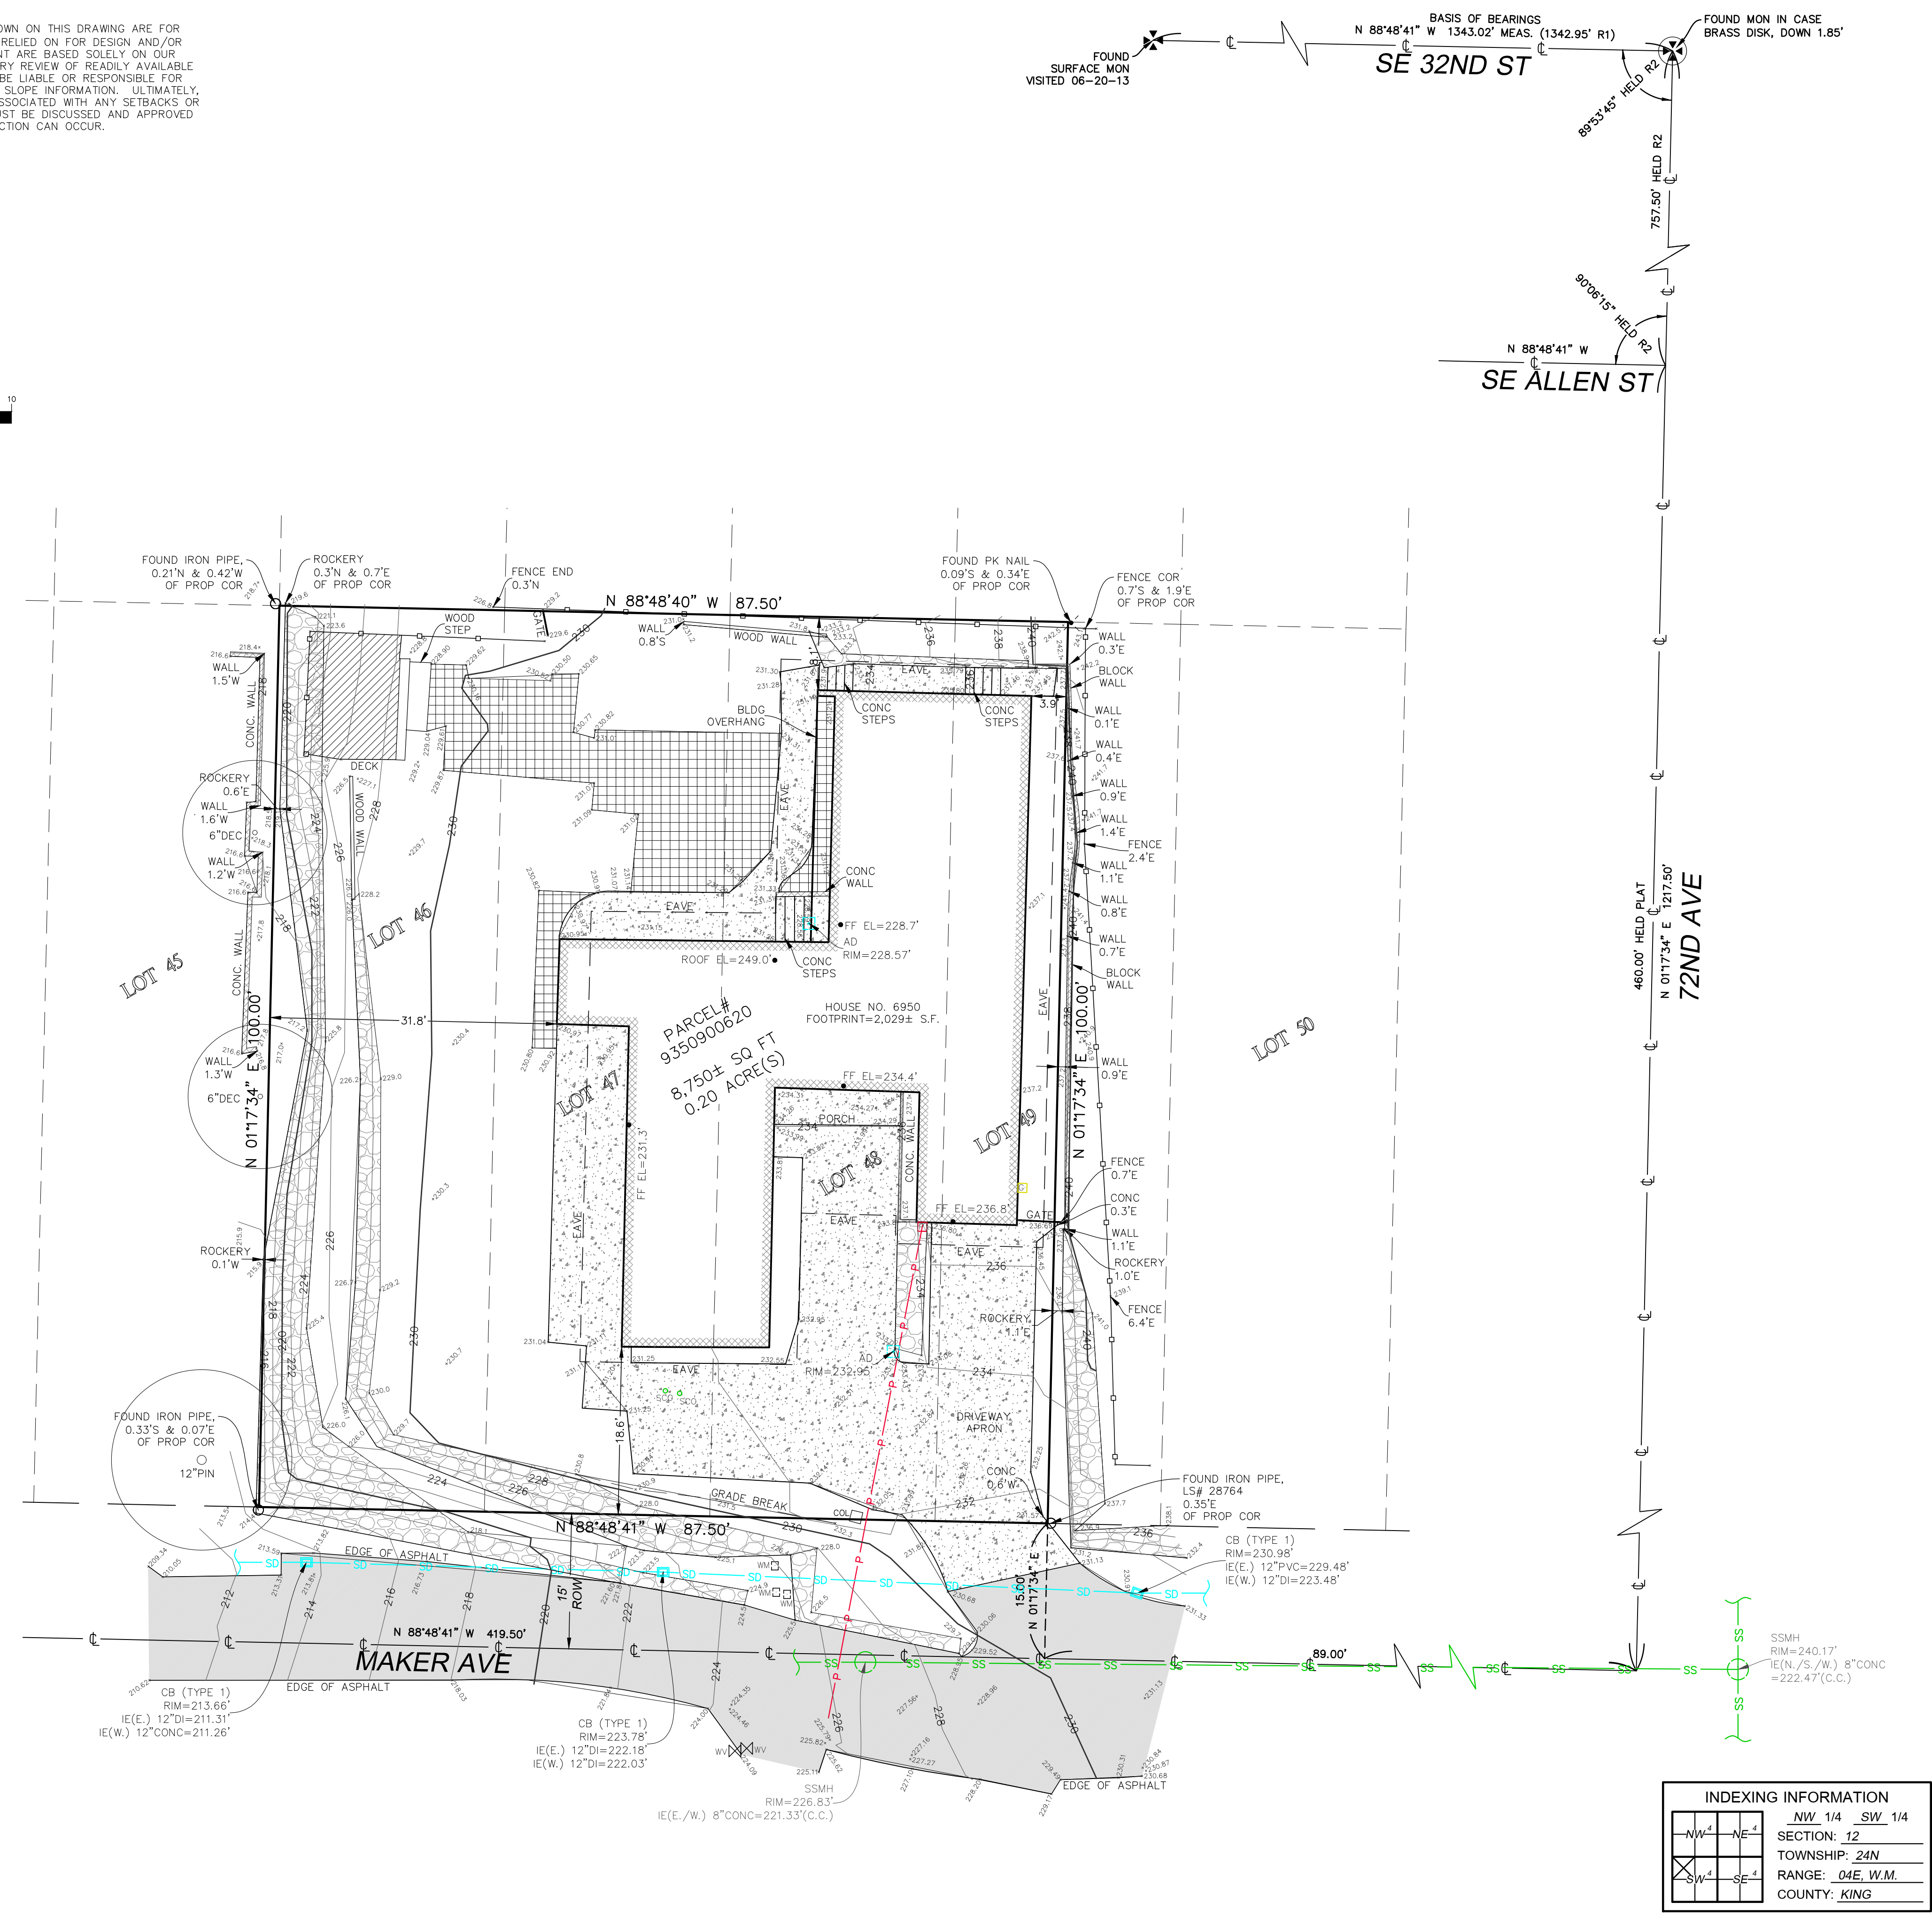
**TOPOGRAPHIC & BOUNDARY SURVEY**

THE LOCATION AND EXTENT OF STEEP SLOPES SHOWN ON THIS DRAWING ARE FOR INFORMATIONAL PURPOSES ONLY AND CANNOT BE RELIED ON FOR DESIGN AND/OR CONSTRUCTION. THE PITCH, LOCATION, AND EXTENT ARE BASED SOLELY ON OUR GENERAL OBSERVATIONS ON SITE AND OUR CURSORY REVIEW OF READILY AVAILABLE PUBLIC DOCUMENTS; AS SUCH, TERRANE CANNOT BE LIABLE OR RESPONSIBLE FOR THE ACCURACY OR COMPLETENESS OF ANY STEEP SLOPE INFORMATION. ULTIMATELY, THE LIMITS AND EXTENT OF ANY STEEP SLOPES ASSOCIATED WITH ANY SETBACKS OR OTHER DESIGN OR CONSTRUCTION PARAMETERS MUST BE DISCUSSED AND APPROVED BY THE REVIEWING AGENCY BEFORE ANY CONSTRUCTION CAN OCCUR.

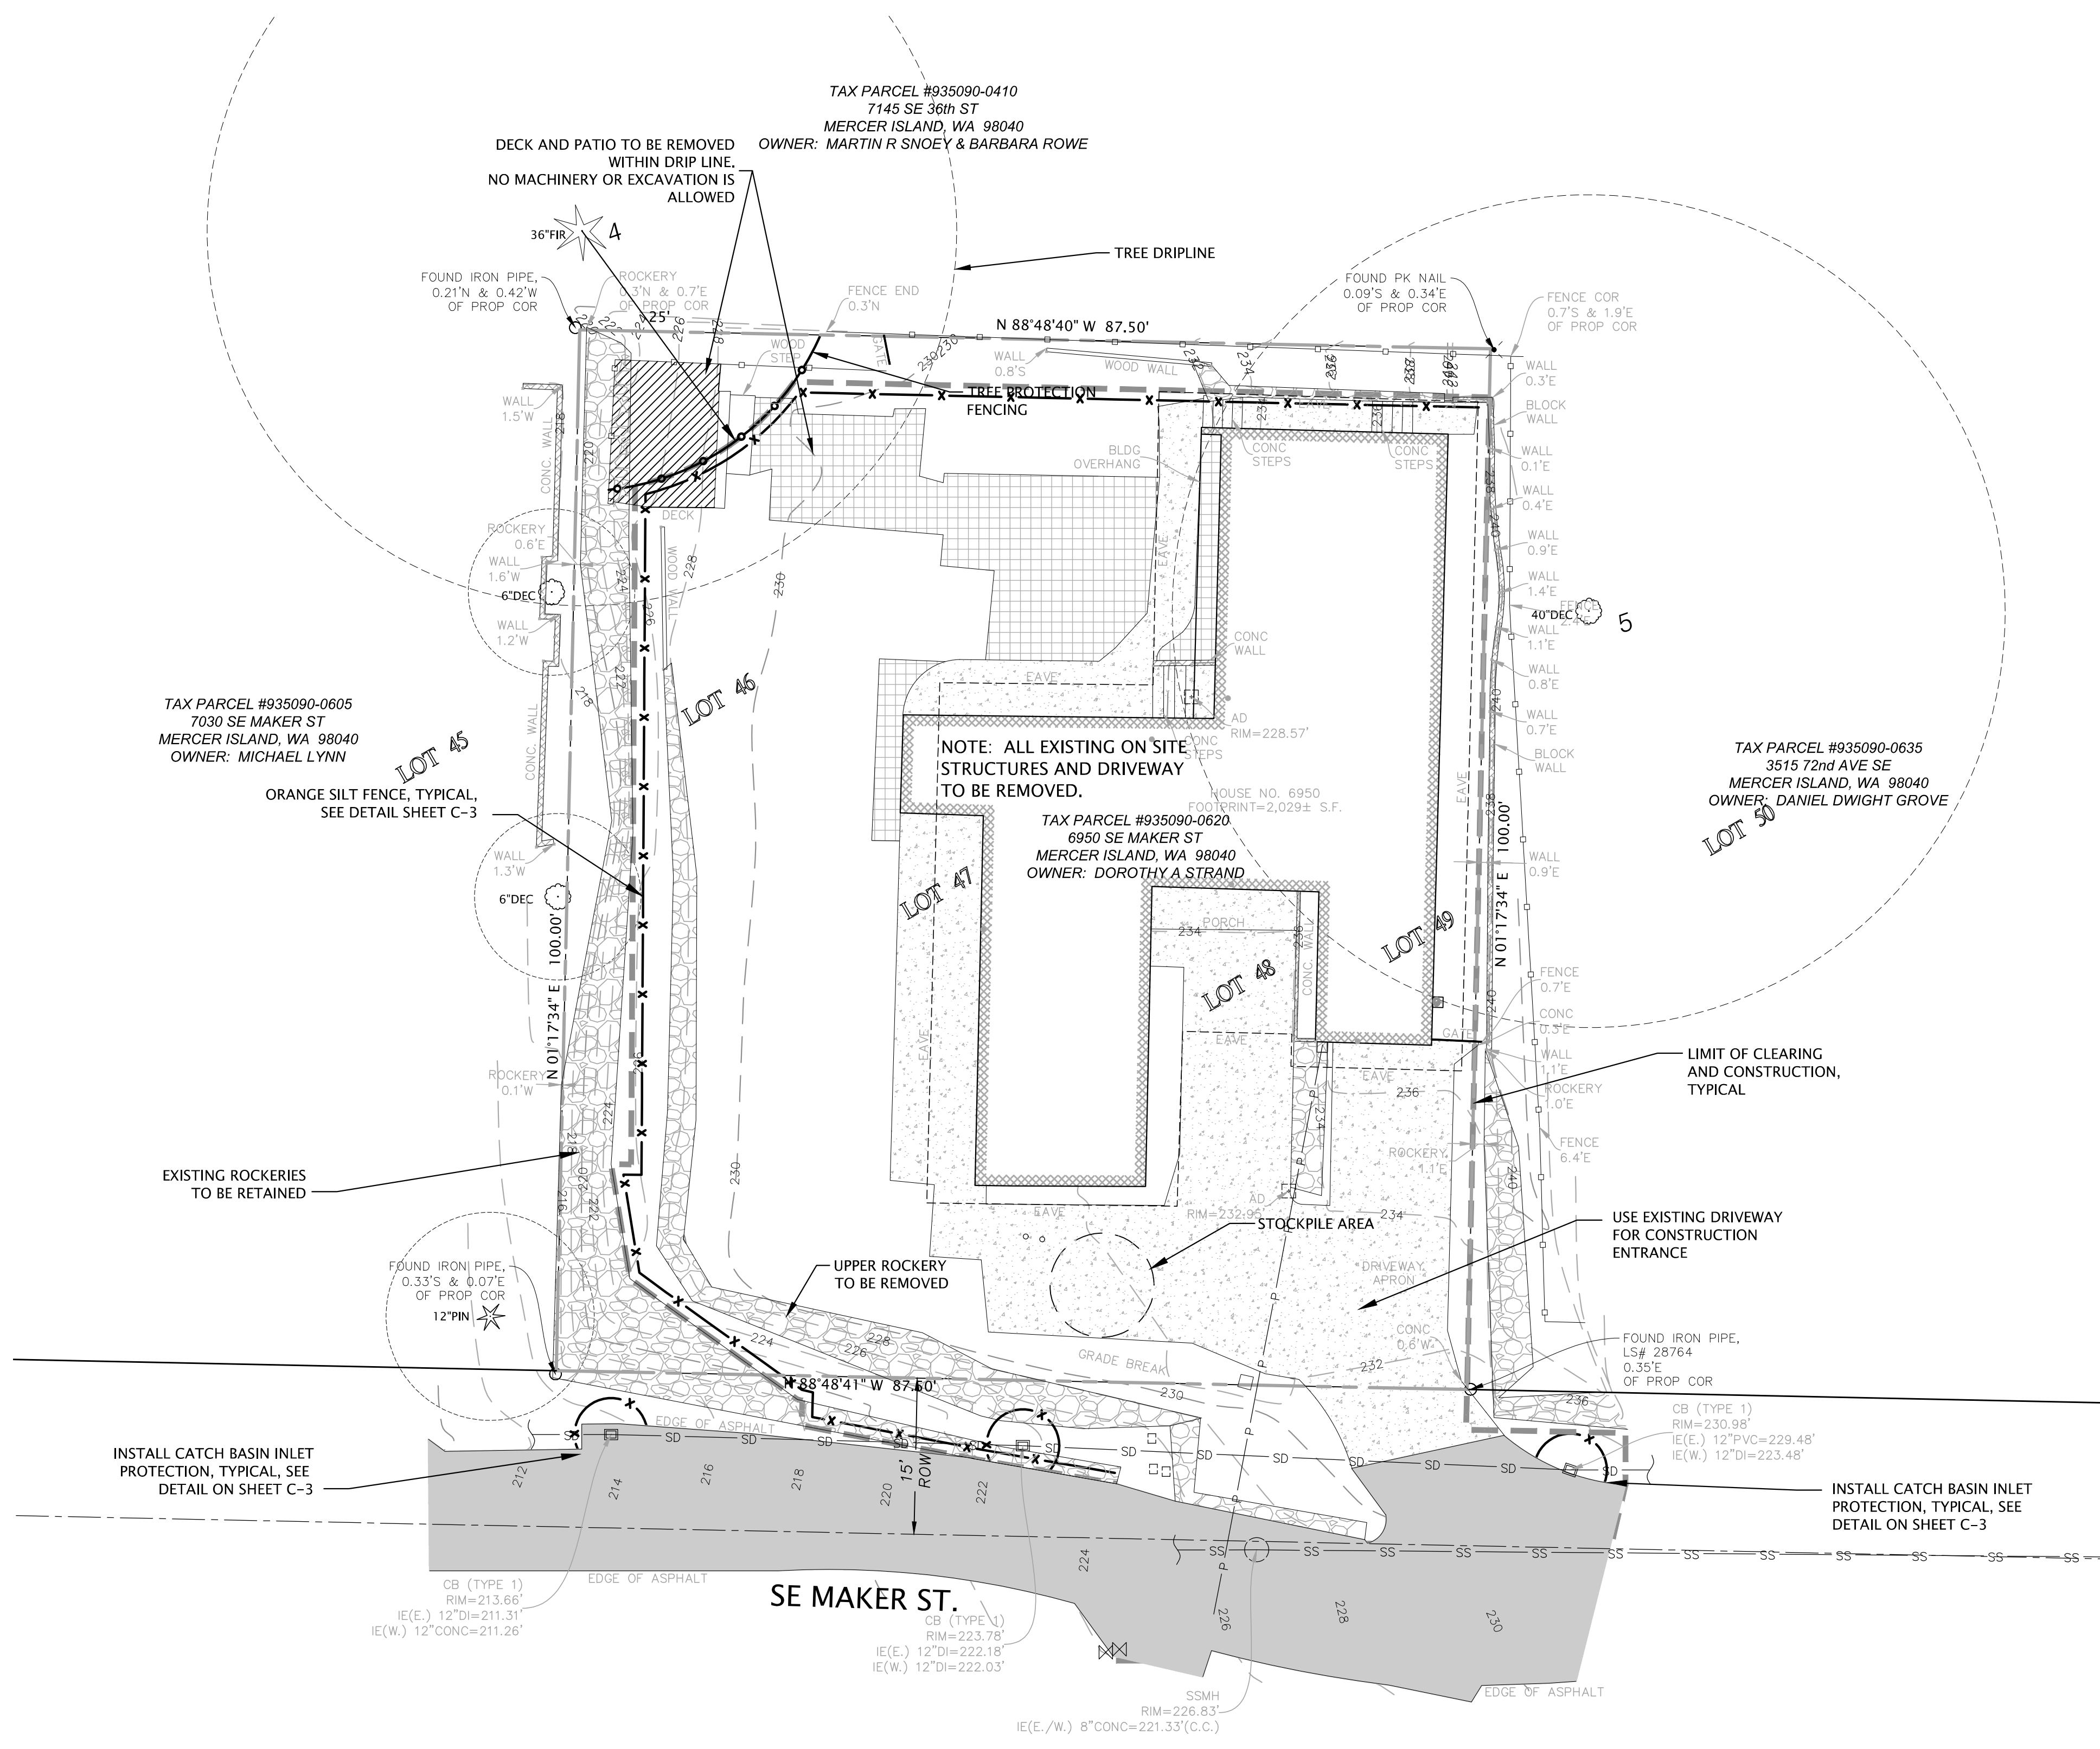
DOROTHY STRAND  
TESC PLAN FOR STRAND PROPERTY  
6950 SE MAKER ST., CITY OF MERCER ISLAND KING COUNTY, WASHINGTON

- DEMOLISH EXISTING HOUSE, PATIO, DECK, WALKWAY, WALL AND DRIVEWAY PRIOR TO PROPOSED CONSTRUCTION.
- SITE AREA: 8,750 SF (0.20 AC)
- IMPERVIOUS CALCULATIONS:  
ON-SITE  
HOUSE = 1,888 SF  
CONCRETE DRIVEWAY = 804 SF  
DECK = 61 SF  
STAIRS = 13 SF  
RETAINING WALLS = 49 SF  
NEW AND REPLACED SUBTOTAL = 2,815 SF  
EX. ROCKERY / WALL = 736 SF  
TOTAL IMPERVIOUS = 3,537 SF (40% OF LOT AREA)  
OFF-SITE  
ASPHALT DRIVEWAY = 485 SF  
TOTAL PROJECT IMPERVIOUS = 4,022 SF

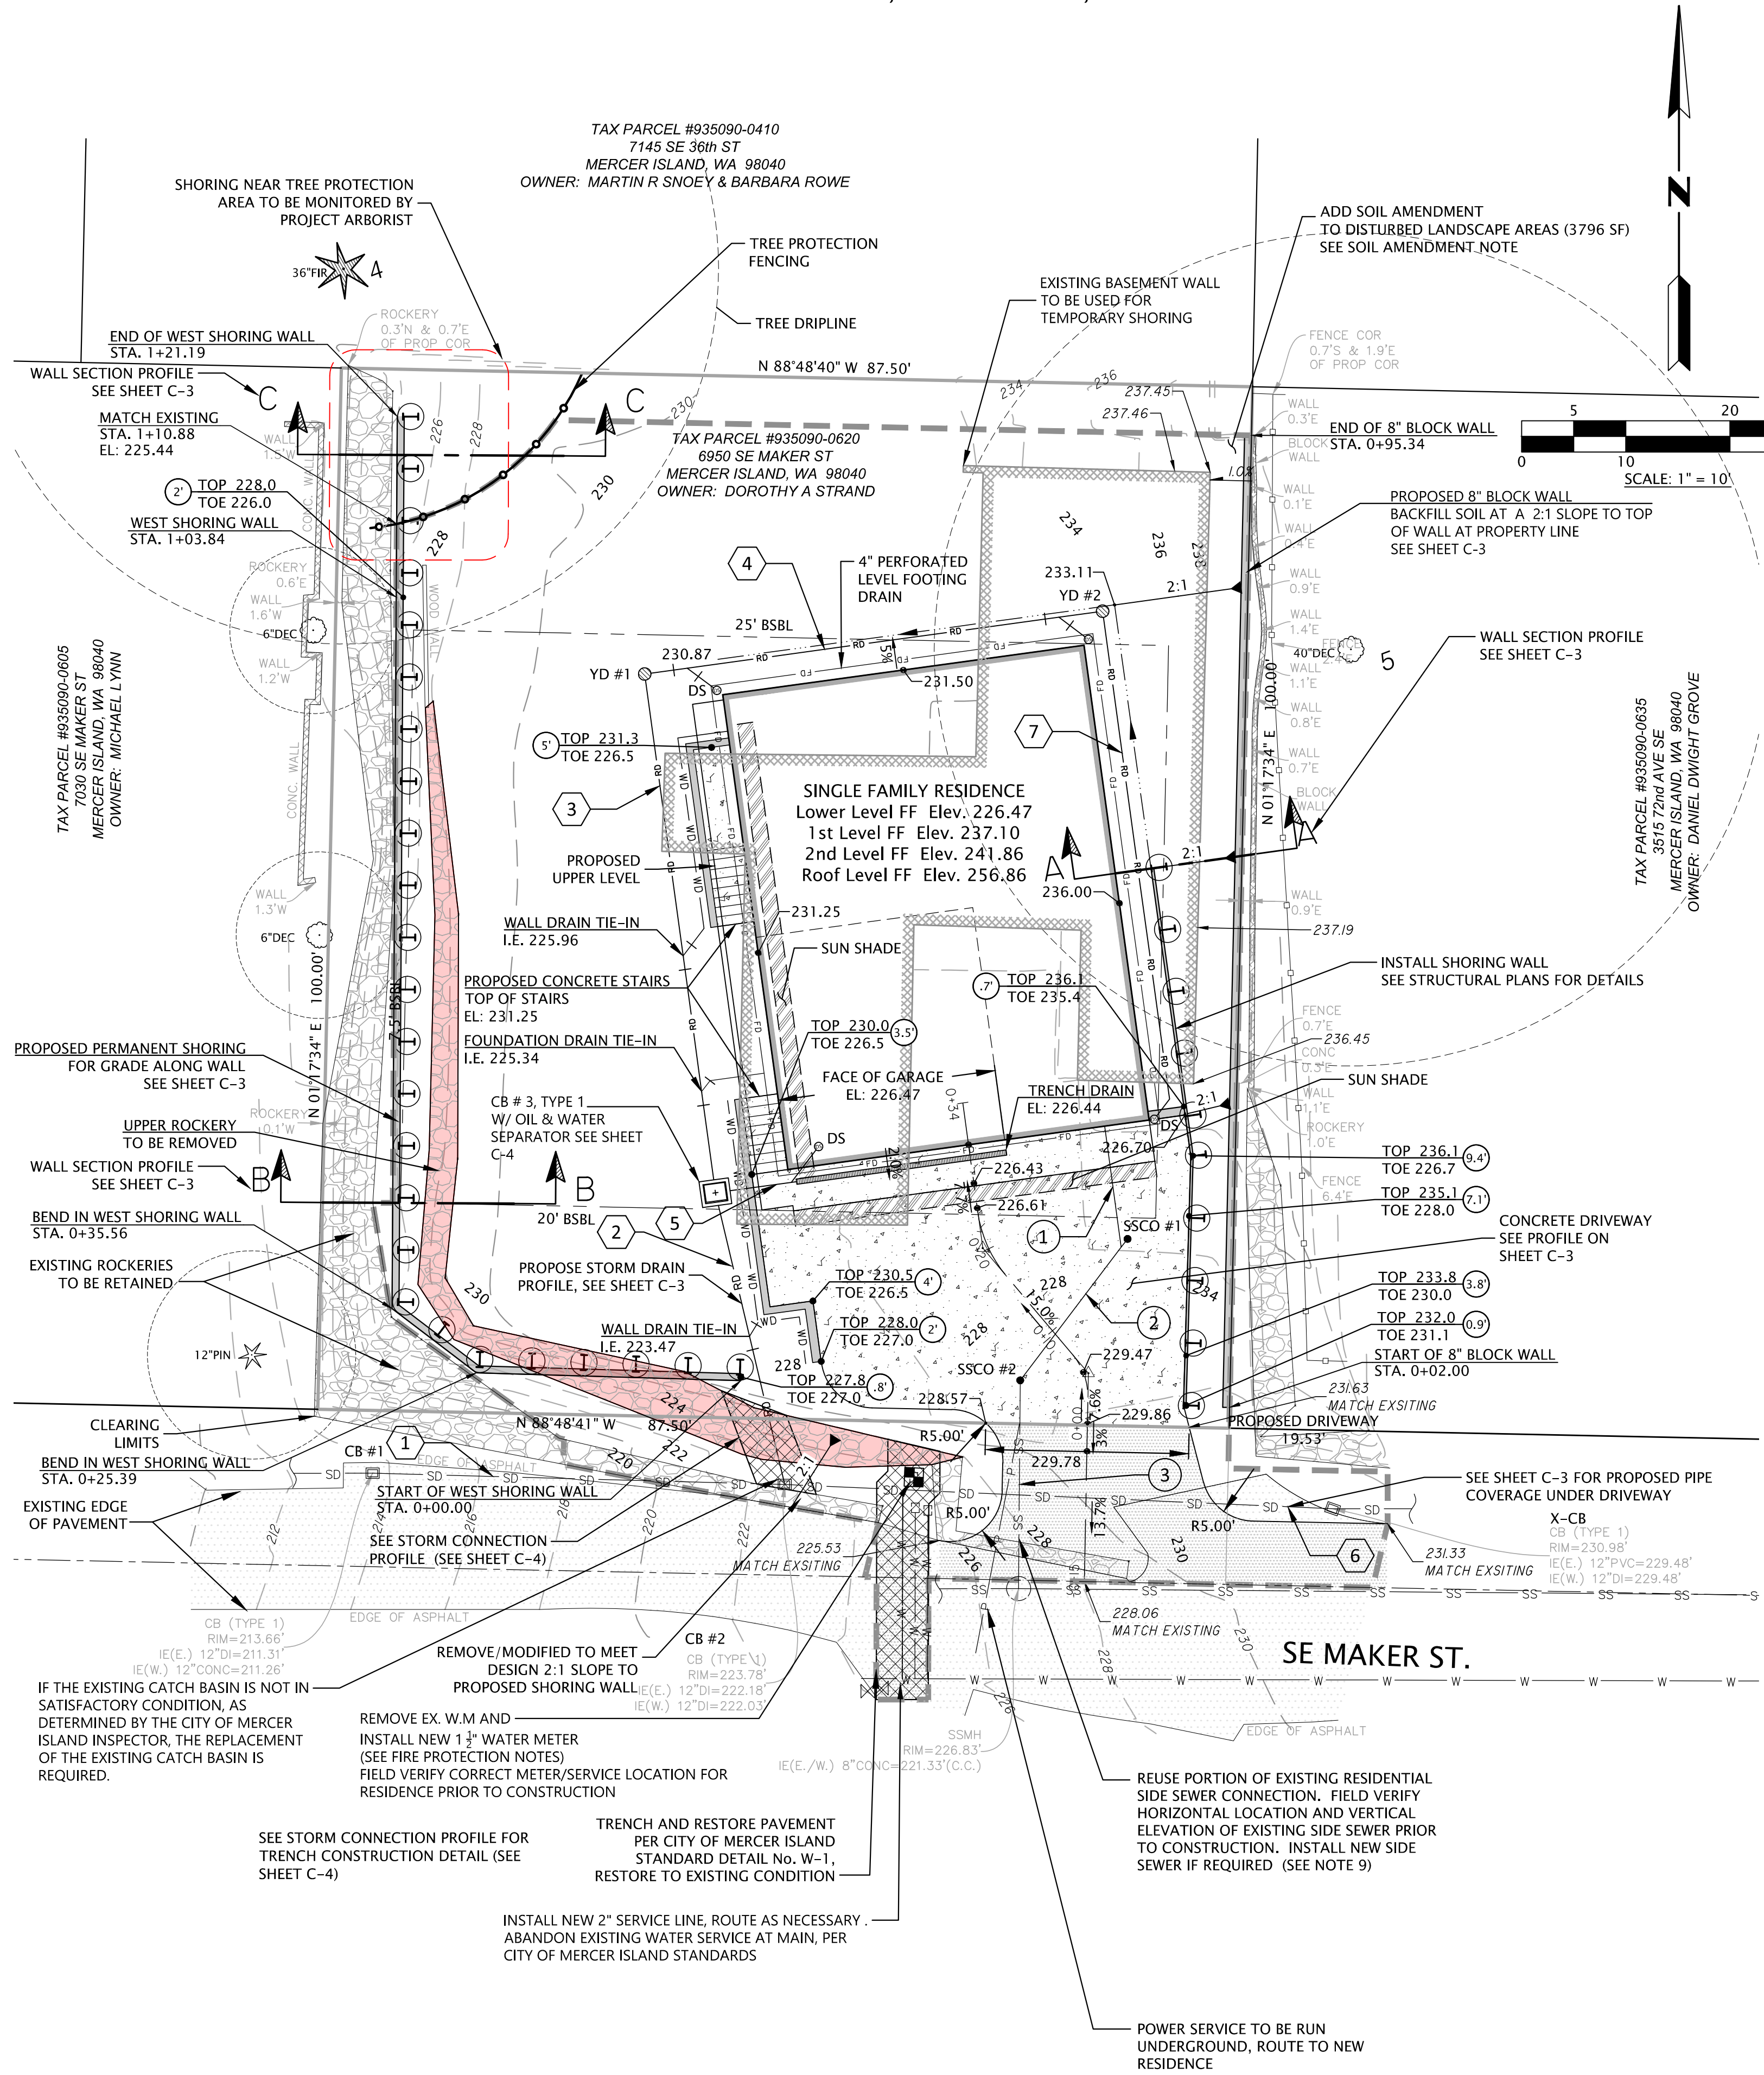
08/25/2023  
DOROTHY STRAND  
GRADING, DRAINAGE AND UTILITY PLAN  
FOR  
STRAND PROPERTY  
6950 SE MAKER ST., CITY OF MERCER ISLAND  
KING COUNTY, WASHINGTON

- CONTRACTOR TO COORDINATE EXACT LOCATION OF THE NEW METER WITH THE CITY'S WATER DEPARTMENT DURING CONSTRUCTION.
- THE TV INSPECTION OF THE EXISTING SIDE SEWER TO THE CITY SEWER MAIN ON SE MAKER ST IS REQUIRED PRIOR TO ANY WORK RELATED TO THE SIDE SEWER. IF THE RESULT OF THE TV INSPECTION IS NOT IN SATISFACTORY CONDITION, AS DETERMINED BY THE CITY OF MERCER ISLAND INSPECTOR, THE REPLACEMENT OF THE EXISTING SIDE SEWER IS REQUIRED.

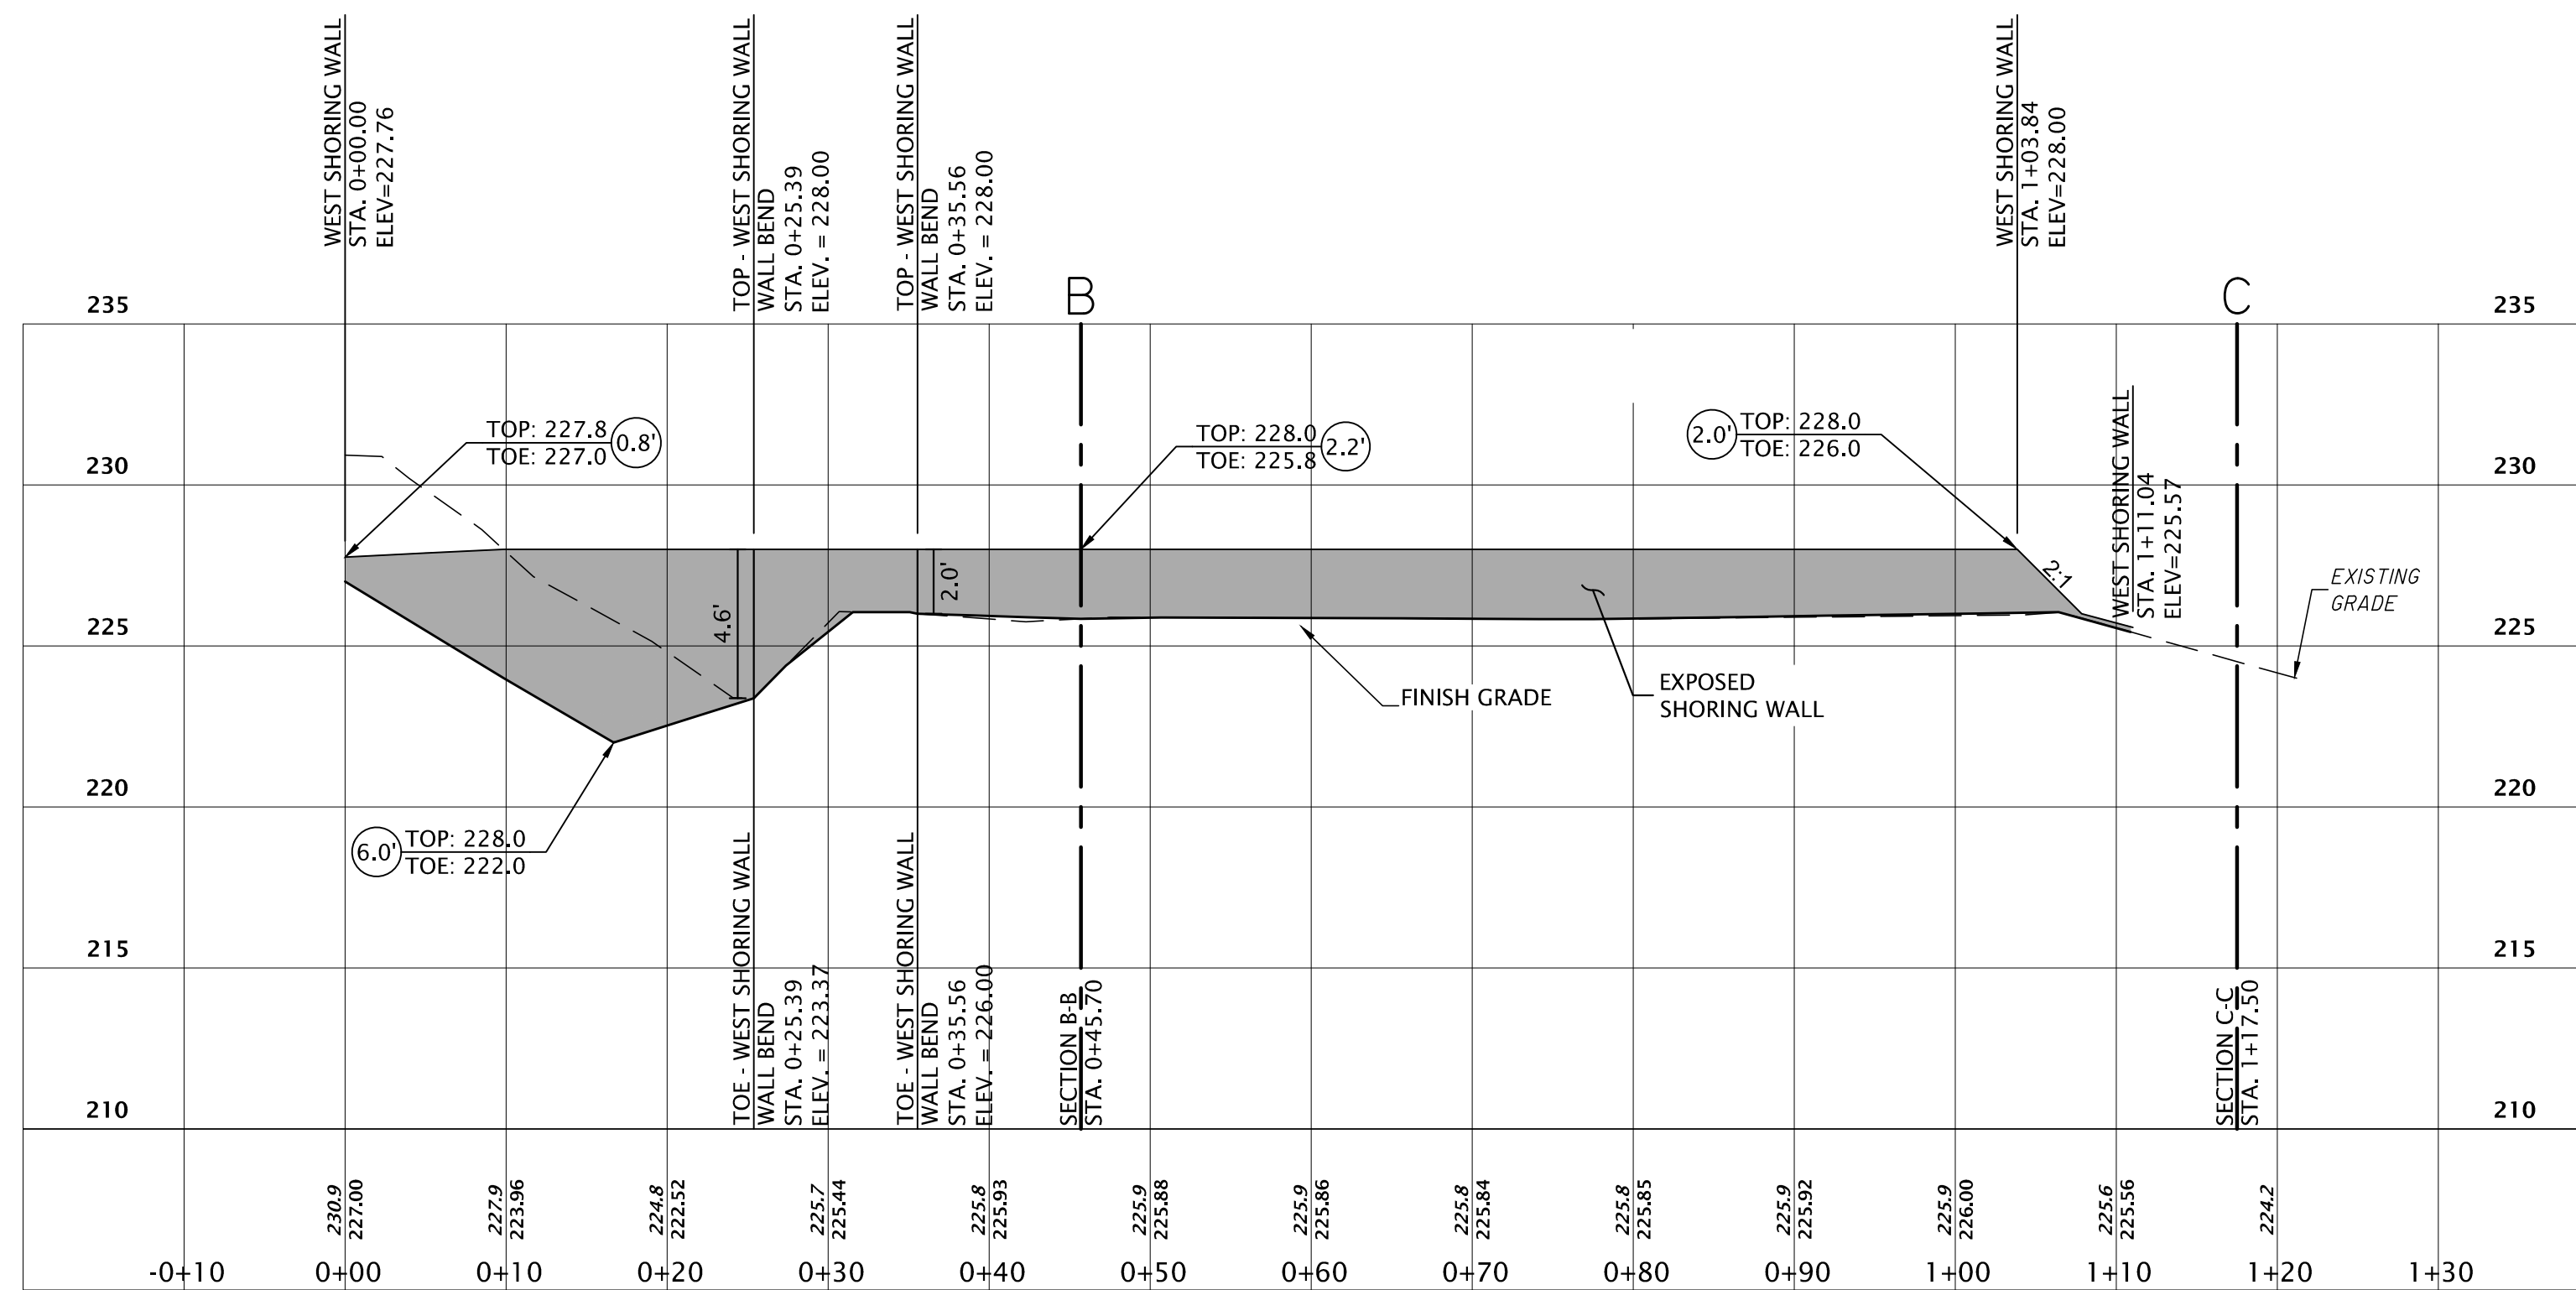
**WEST SHORING WALL PROFILE**  
STA. -0+10.00 TO STA. 1+30.00  
1" = 10.00' HORIZ.  
1" = 5.00' VERT.

**PERMANENT SHORING WALL NOTES:**  
\*MINIMUM EMBED WALL DEPTH = 10 FEET  
REFERENCE PERMANENT SHORING PLANS

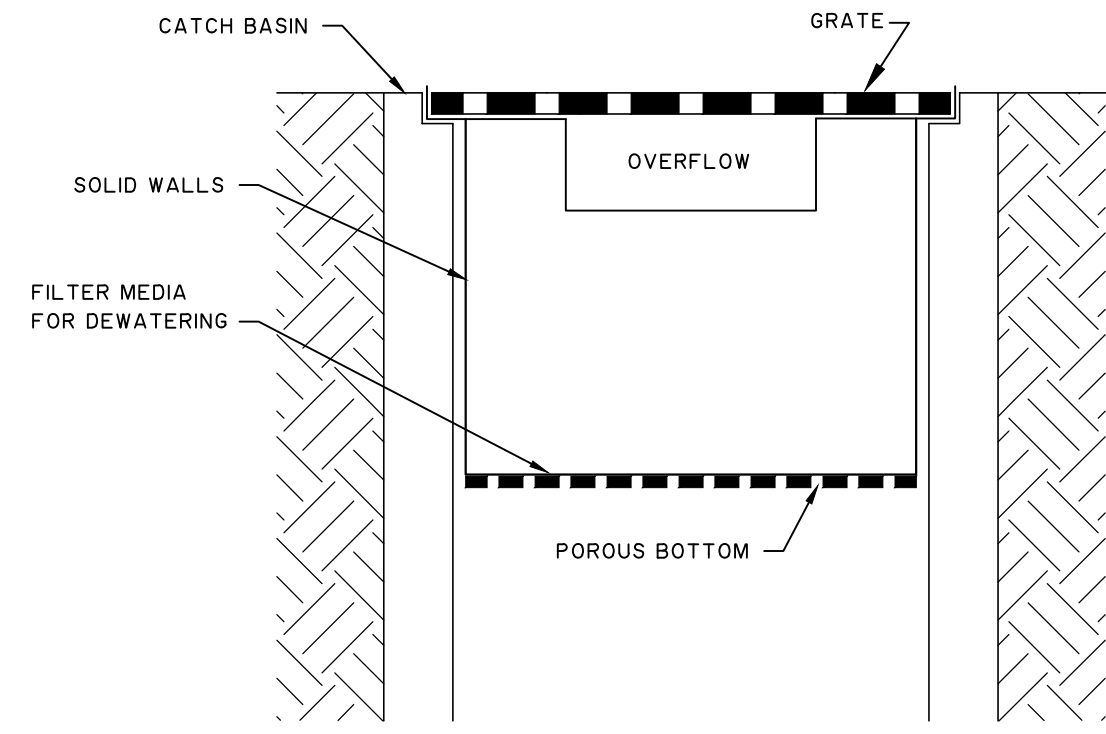
**CATCH BASIN INSERT DETAIL**

NOTE: THIS DETAIL IS ONLY SCHEMATIC. ANY INSERT IS ALLOWED THAT HAS A MIN. 0.5 C.F. OF STORAGE, THE MEANS TO DEWATER THE STORED SEDIMENT, AN OVERFLOW, AND CAN BE EASILY MAINTAINED.

1. ANY ACCUMULATED SEDIMENT ON OR AROUND THE FILTER FABRIC PROTECTION SHALL BE REMOVED IMMEDIATELY. SEDIMENT SHALL NOT BE REMOVED WITH WATER, AN ALL SEDIMENT MUST BE DISPOSED OF AS FILL ON-SITE OR HAULED OFF-SITE.
2. ANY SEDIMENT IN THE CATCH BASIN INSERT SHALL BE REMOVED WHEN THE SEDIMENT HAS FILLED ONE-THIRD OF THE AVAILABLE STORAGE. THE FILTER MEDIA FOR THE INSERT SHALL BE CLEANED OR REPLACED AT LEAST MONTHLY.
3. REGULAR MAINTENANCE IS CRITICAL FOR BOTH FORMS OF CATCH BASIN PROTECTION. UNLIKE MANY FORMS OF PROTECTION THAT FAIL GRADUALLY, CATCH BASIN PROTECTION WILL FAIL SUDDENLY AND COMPLETELY IF NOT MAINTAINED PROPERLY.

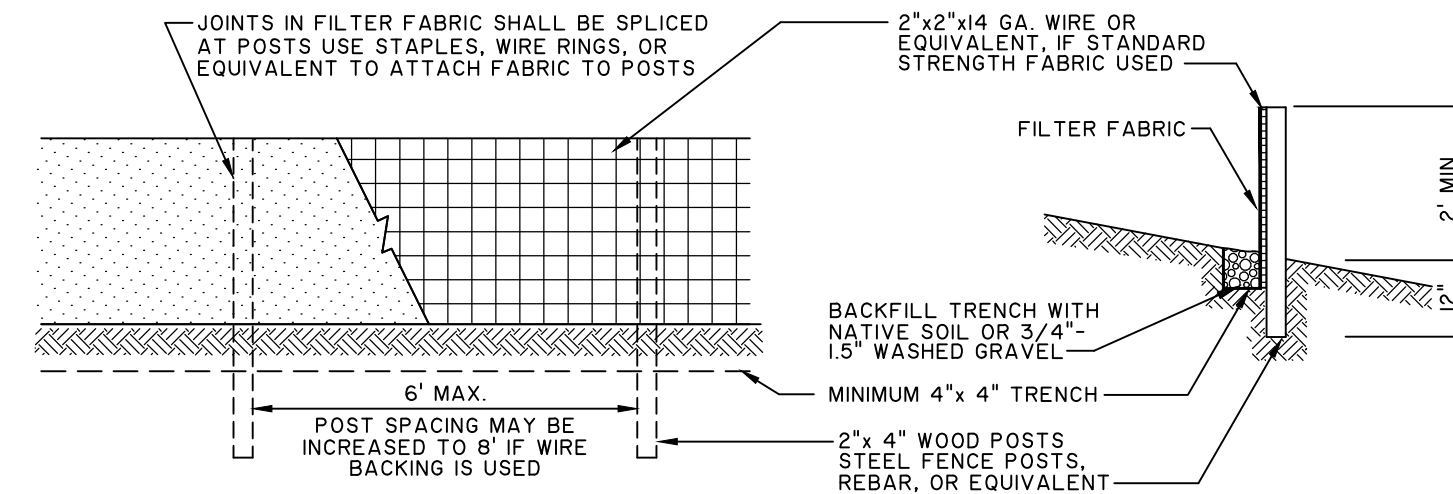
**SILT FENCE**

NOTE: FILTER FABRIC FENCES SHALL BE INSTALLED ALONG CONTOUR WHENEVER POSSIBLE.

1. ANY DAMAGE SHALL BE REPAIRED IMMEDIATELY.
2. IF CONCENTRATED FLOWS ARE EVIDENT UPHILL OF THE FENCE, THEY MUST BE INTERCEPTED AND CONVEYED TO A SEDIMENT TRAP OR POND.
3. IT IS IMPORTANT TO CHECK THE UPHILL SIDE OF THE FENCE FOR SIGNS OF THE FENCE CLOGGING AND ACTING AS A BARRIER TO FLOW AND THEN CAUSING CHANNELIZATION OF FLOWS PARALLELED TO THE FENCE. IF THIS OCCURS, REPLACE THE FENCE AND/OR REMOVE THE TRAPPED SEDIMENT.
4. SEDIMENT MUST BE REMOVED WHEN THE SEDIMENT IS 6" HIGH.
5. IF THE FILTER FABRIC HAS DETERIORATED DUE TO ULTRAVIOLET BREAKDOWN, IT SHALL BE REPLACED.

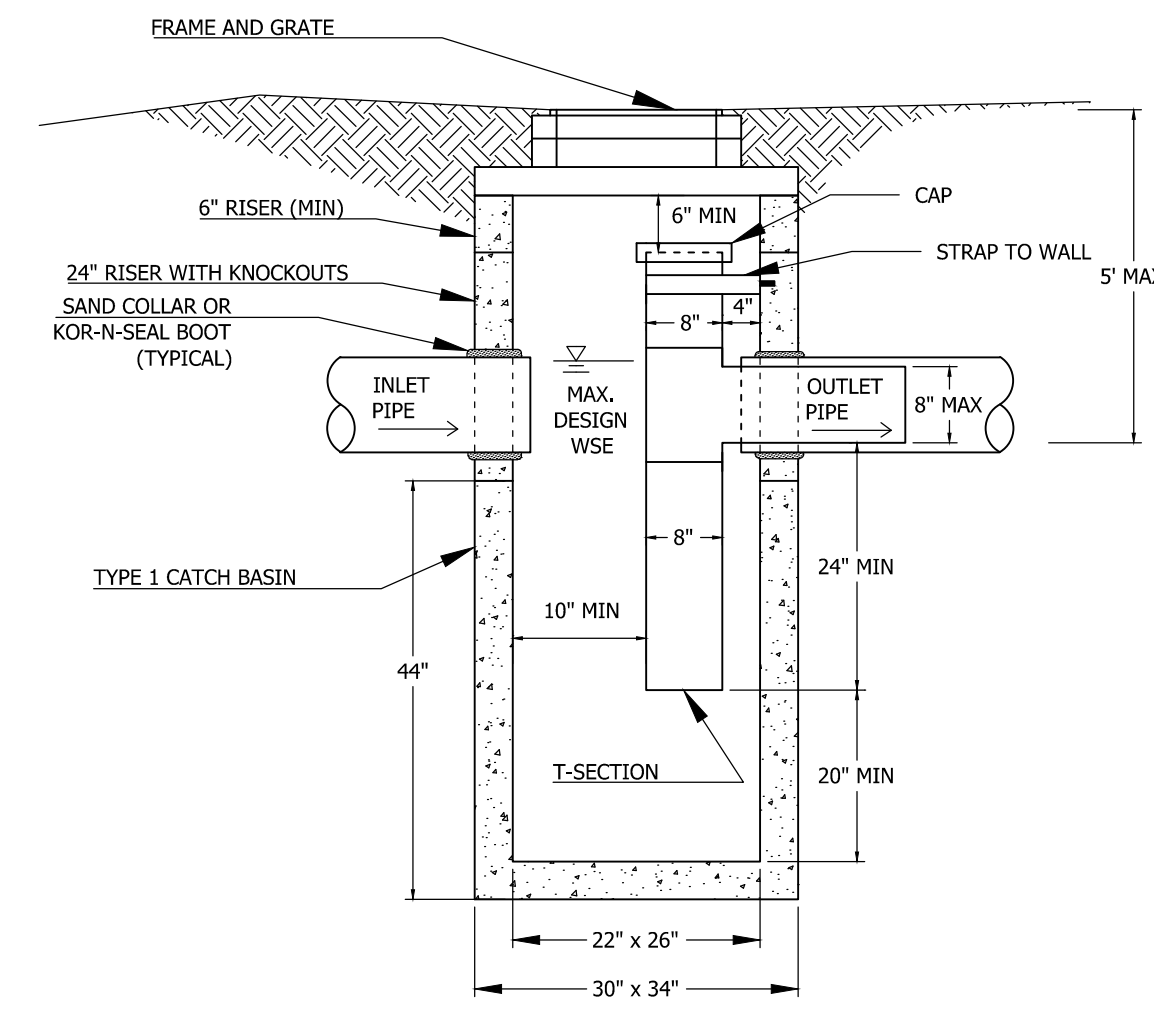
1. MAX. OUTLET PIPE DIAMETER IS 8 INCHES. VERTICAL RISER SECTION SHALL BE ALIGNED PLUMB VERTICALLY. HORIZONTAL RISER SECTION SHALL MATCH OUTLET PIPE SLOPE.
2. ALL METAL PARTS AND SURFACES MUST BE CORROSION RESISTANT. STEEL HARDWARE SHALL BE GALVANIZED. PIPES SHALL BE PVC. COMPLETE CORROSION PROTECTION MUST BE ASSURED.
3. APPLY NON-SHRINK GROUT TO INSIDE AND OUTSIDE OF ALL JOINTS, RINGS, RISERS AND FRAMES.
4. SLIP SMOOTH-BORE HORIZONTAL LEG OF FLOW CONTROL TEE INSIDE CARRIER PIPE.
5. NO FLOW CONTROL JOINT OUTSIDE OF STRUCTURE.

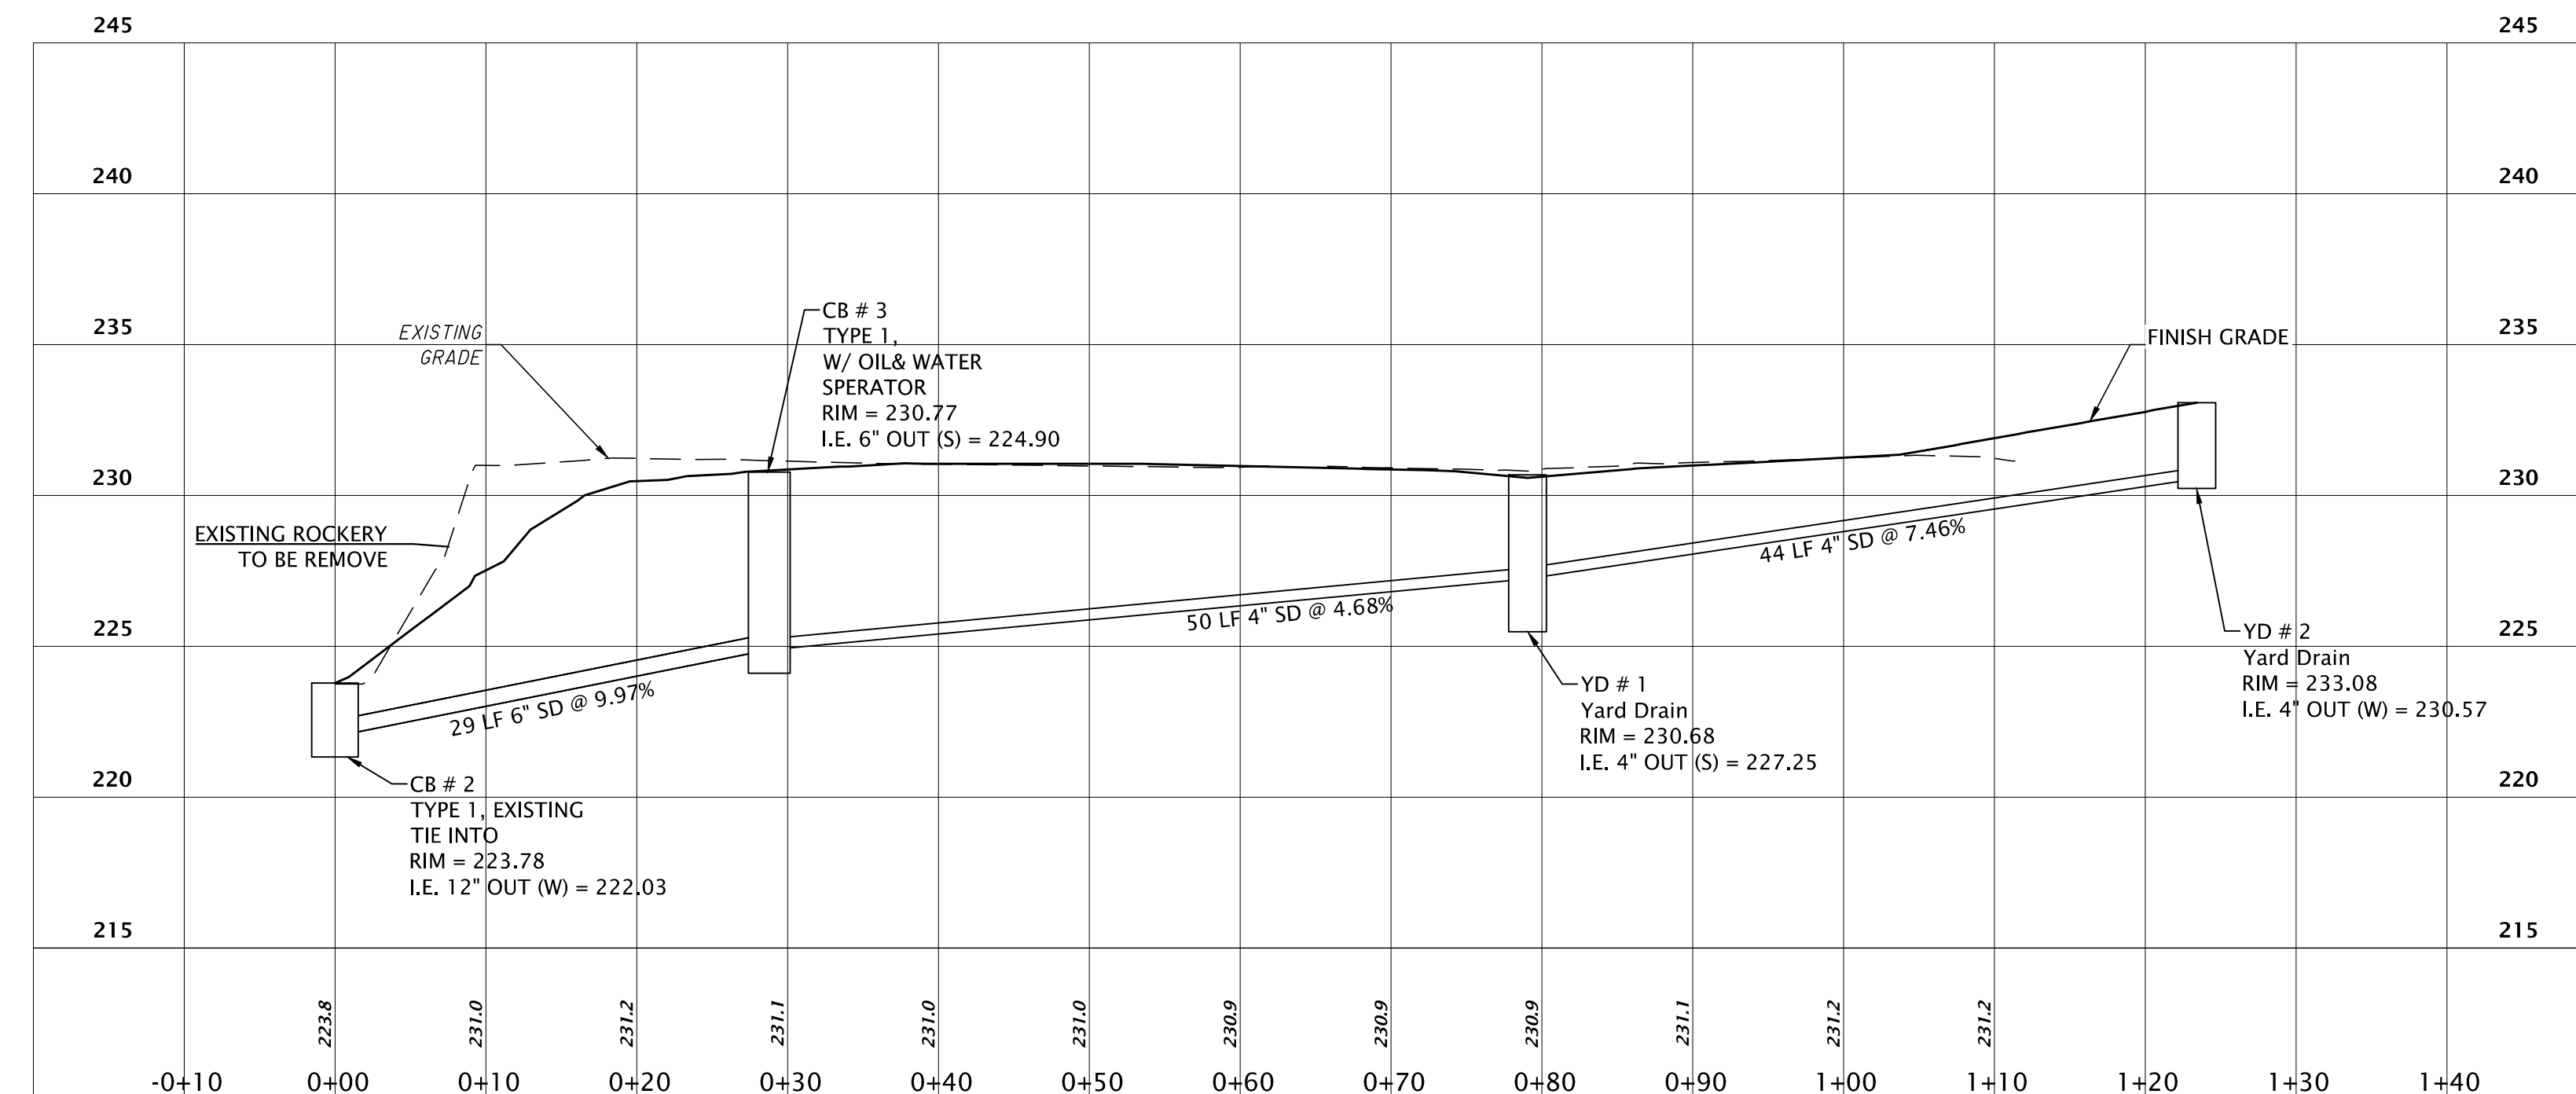
**PROPOSE RESIDENTIAL STORM DRAIN CONNECTION PROFILE**

STA. -0+10.00 TO STA. 1+40.00  
1" = 10.00' HORIZ.  
1" = 5.00' VERT.
