### CAO23-011 CRITICAL AREA REVIEW 2

<b>Project No.:</b>	CAO23-011
<b>Description:</b>	A request for a Critical Area Review 2 for the demolition of an existing single-family residence and construction of a new approx. 4,000 square foot single-family residence on a property located within mapped geologically hazardous areas.
<b>Applicant / Owner:</b>	Jeffrey Almeter / Dorothy Strand
<b>Site Address:</b>	6950 SE Maker St, Mercer Island, WA 98040; Identified by King County Assessor tax parcel number 935090-0620.
<b>Zoning District:</b>	Single Family Residential (R-8.4)
<b>Staff Contact:</b>	Molly McGuire, Planner <a href="mailto:molly.mcguire@mercerisland.gov">molly.mcguire@mercerisland.gov</a> / (206) 275-7712
<b>Exhibits:</b>	<ol style="list-style-type: none"><li>1. Development Application, received by the City of Mercer Island on July 3, 2023</li><li>2. Revised Development Plan Set, August 29, 2023</li><li>3. Project Narrative, received July 4, 2023</li><li>4. Hazard Report, generated August 9, 2023</li><li>5. Geotechnical Engineering Study and Critical Areas Study prepared by Geotech Consultants, Inc., dated March 21, 2022 and received July 3, 2023</li><li>6. Review of Revised Pl

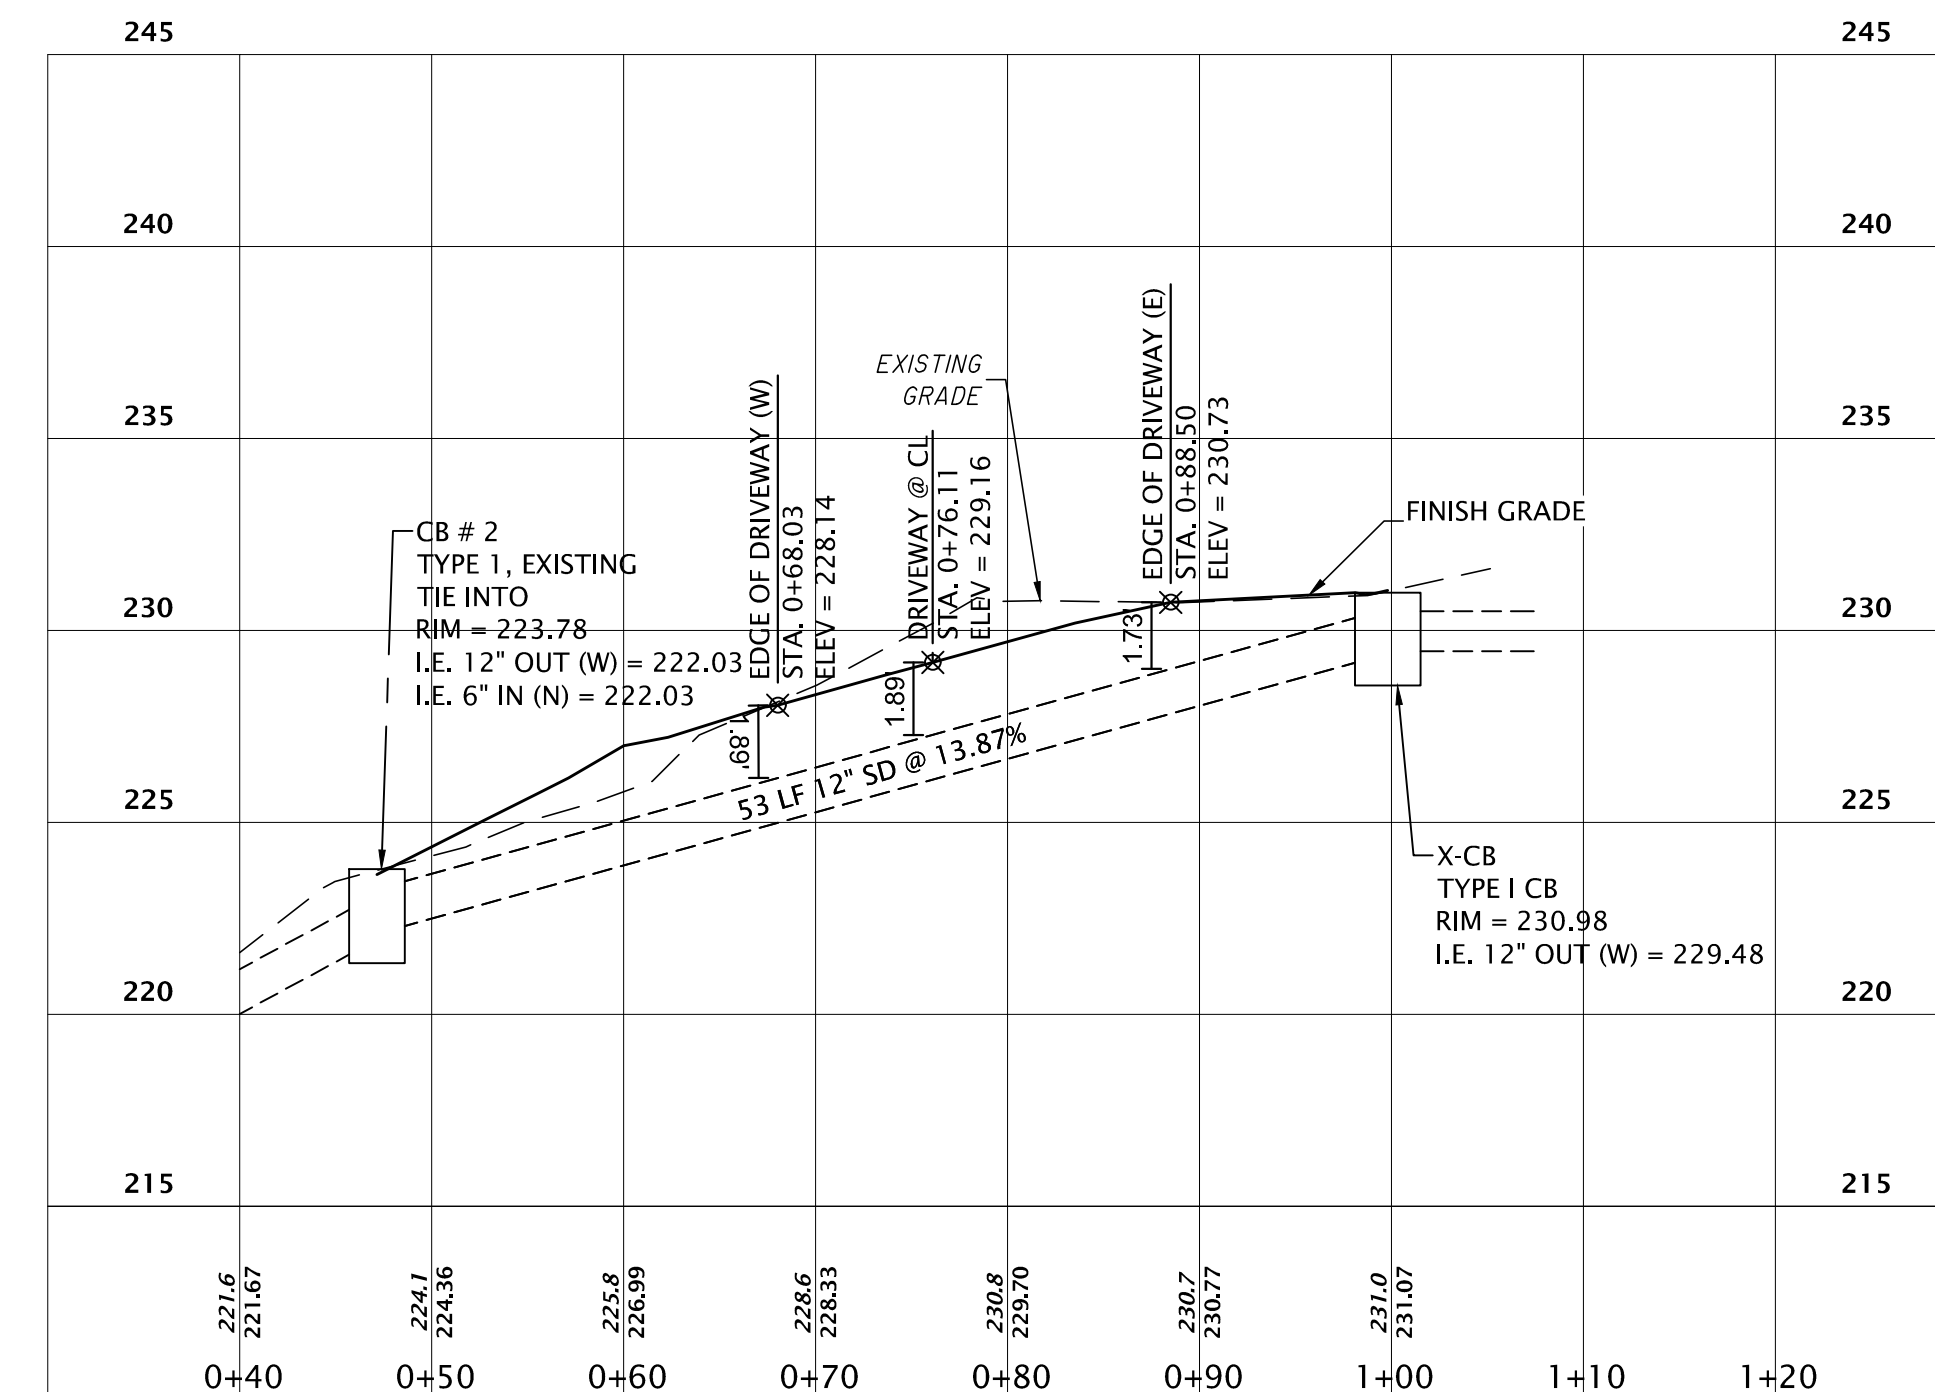
**EXISTING SE MARKER ST. STORM PROFILE**

STA. 0+40.00 TO STA. 1+20.00  
1" = 10.00' HORIZ.  
1" = 5.00' VERT.

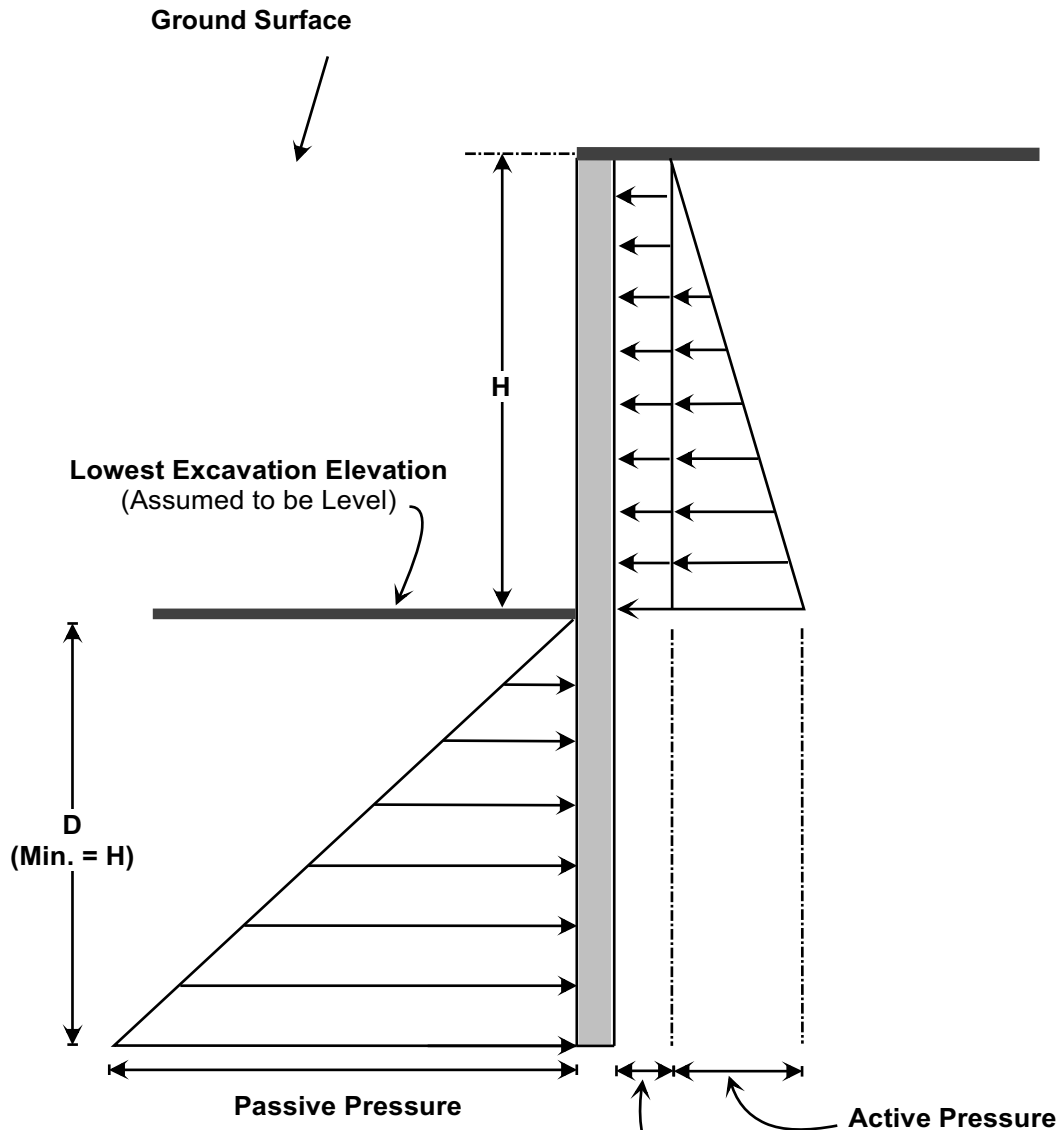
**CANTILEVERED SOLDIER PILE SHORING**  
6950 Southeast Maker Street  
Mercer Island, Washington

- (1) The report should be referenced for specifics regarding design and installation.
- (2) Active pressures act over the pile spacing.
- (3) Passive pressures act over twice the grouted soldier pile diameter or the pile spacing, whichever is smaller.
- (4) It is assumed that no hydrostatic pressures act on the back of the shoring walls.
- (5) Cut slopes or adjacent structures positioned above or behind shoring will exert additional pressures on the shoring wall.

**Surcharge Pressure From Adjacent Slope, Retaining Walls/Rockeries, and/or traffic as applicable.**

Lateral movement of the soldier piles below the excavation level will be resisted by an ultimate passive soil pressure equal to that pressure exerted by a fluid with a density of 450 pcf. A reduction factor is included in this passive pressure to account for strain compatibility in regards to pile deflection. For permanent walls, we recommend a minimum factor of safety of 1.5 be applied to overturning and sliding calculations when using this ultimate value (temporary installations may use a factor of safety of 1.2). This soil pressure is valid only for a level excavation in front of the soldier pile; it acts on two times the grouted pile diameter. Cut slopes made in front of shoring walls significantly decrease the passive resistance. This includes temporary cuts necessary to install internal braces or rakers. The minimum embedment below the floor of the excavation for cantilever soldier piles should be equal to the height of the "stick-up." A typical cantilevered soldier pile shoring detail was attached to this report as Plate 7.

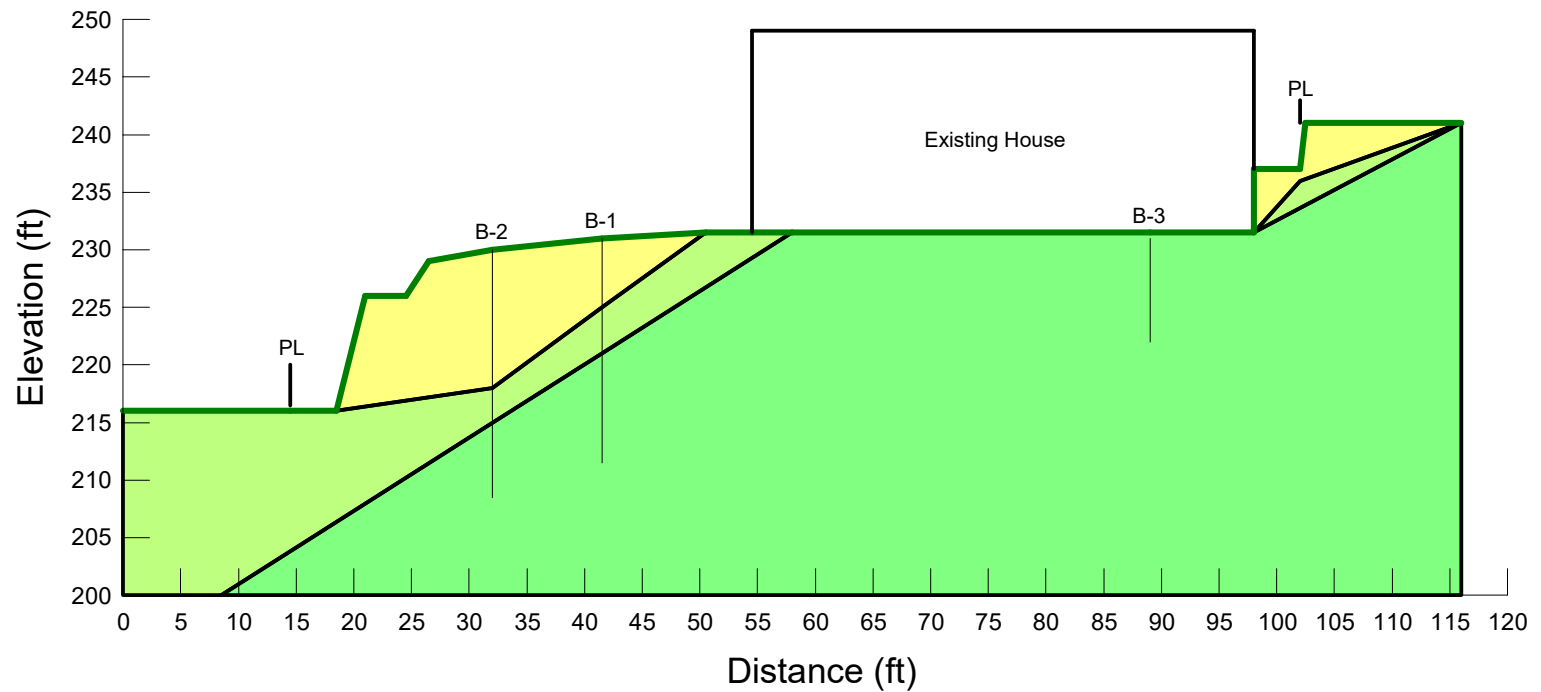
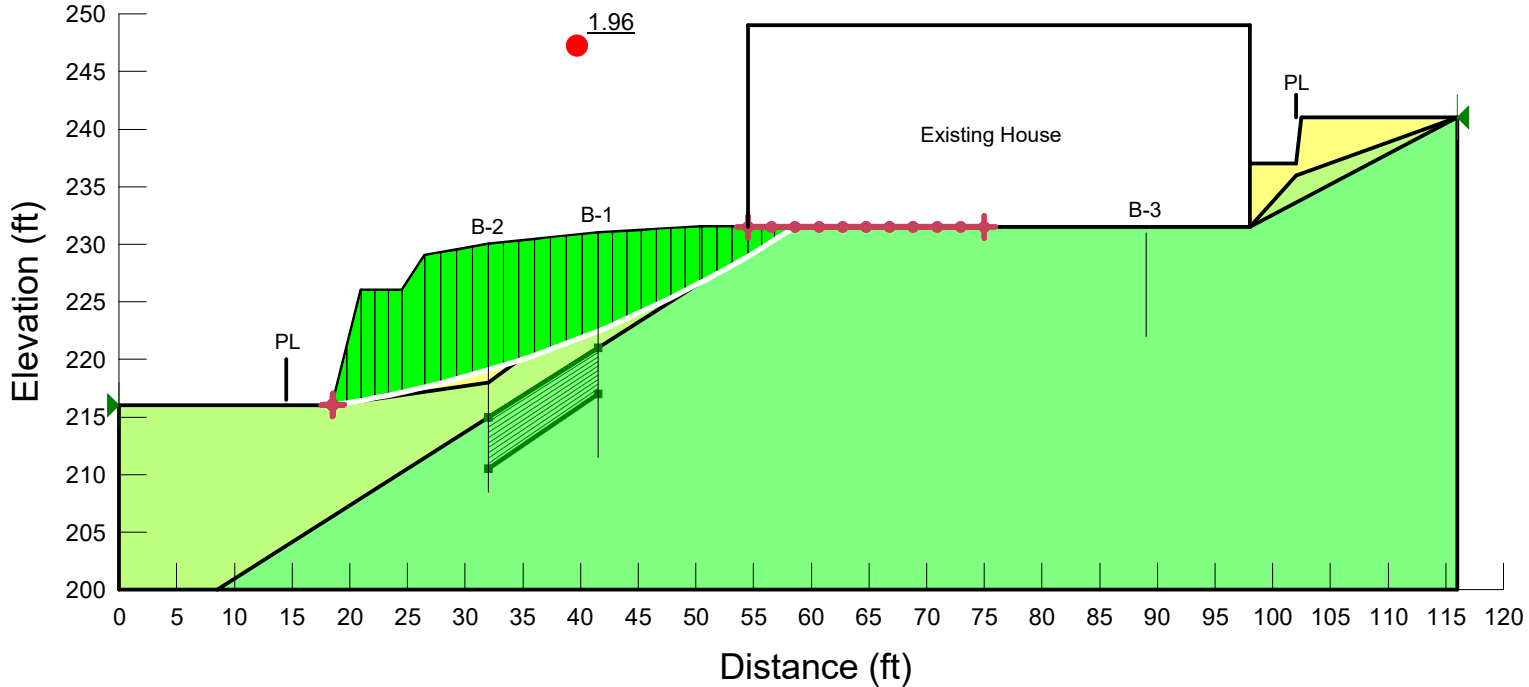
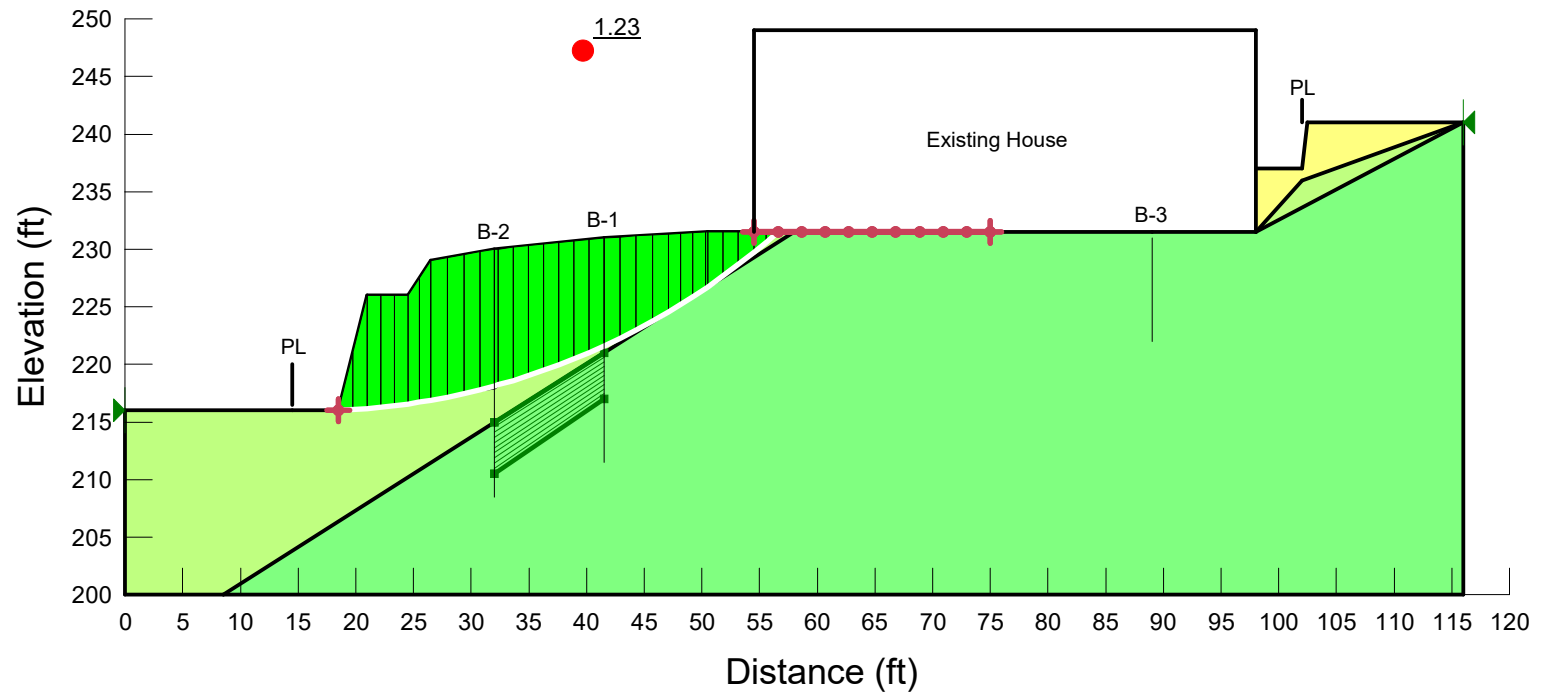
Name: Medium-Dense Silty SAND  
Unit Weight: 125 pcf  
Cohesion: 0 psf  
Phi: 34 °

Name: Dense GLACIAL TILL  
Unit Weight: 140 pcf  
Cohesion: 100 psf  
Phi: 40 °

## Static

# Seismic

We conducted a slope stability analysis of the western steep slope using the modeling program Slope/W developed by GeoStudio. Based on this analysis (attached to the end of this report for reference), a potential deep-seated slope failure that reaches the western edge of the proposed residence has static and seismic safety factors greater than 1.5 and 1.2, respectively. The modelled failures occur in the loose upper soils above the competent glacial till.

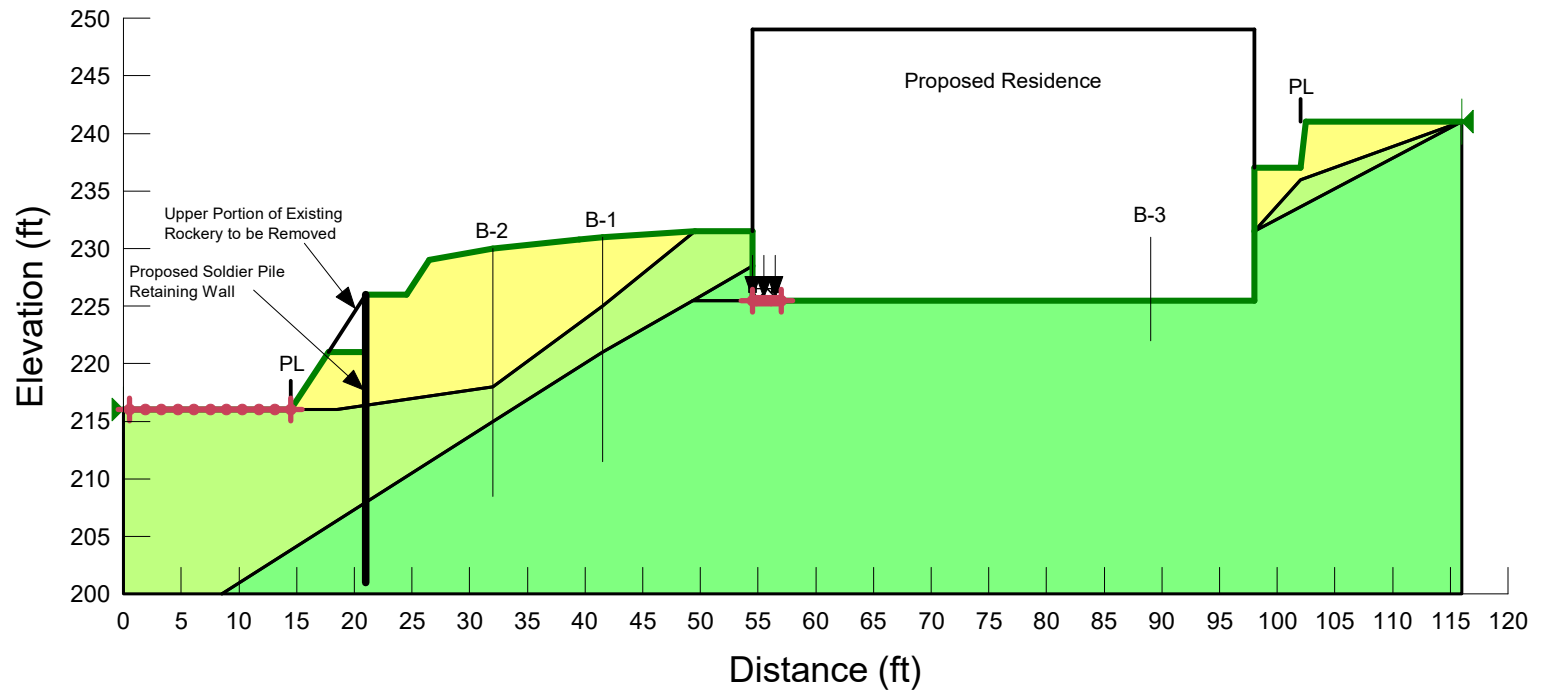
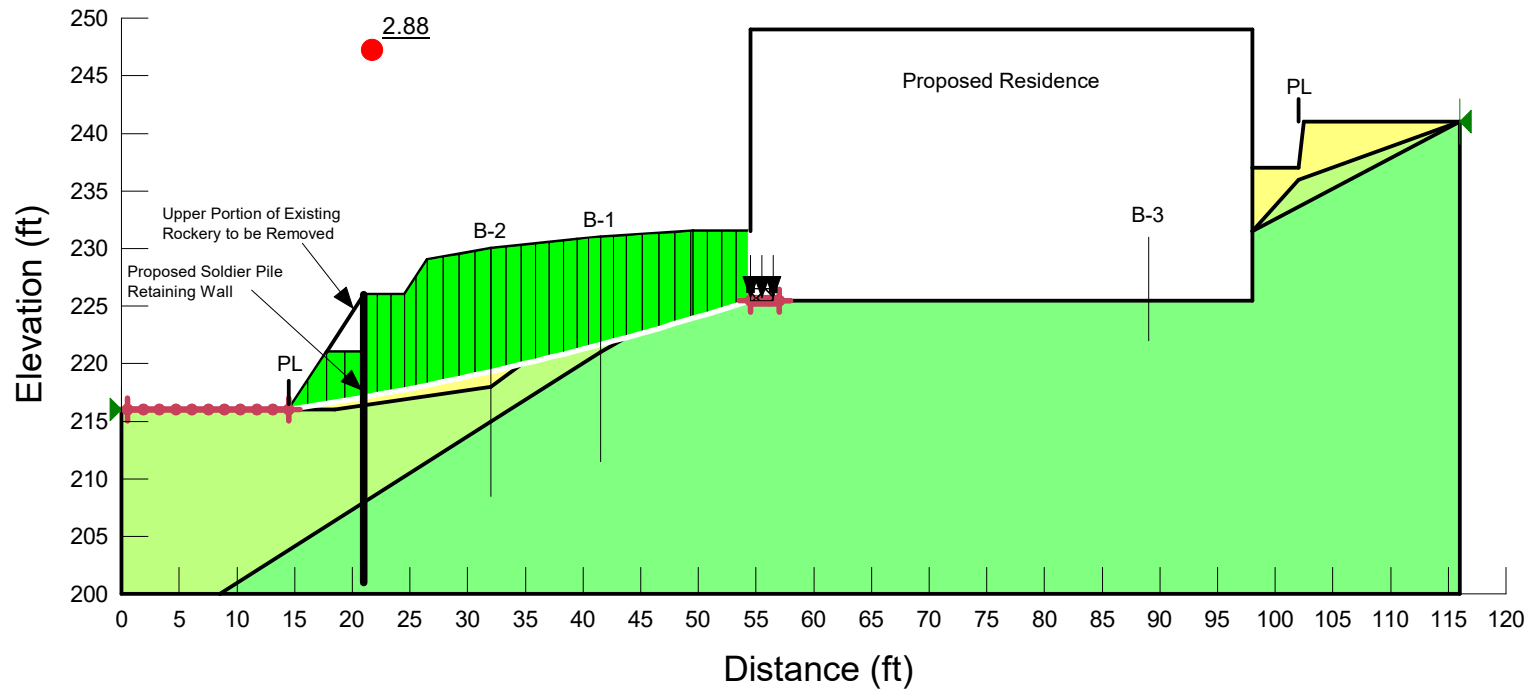
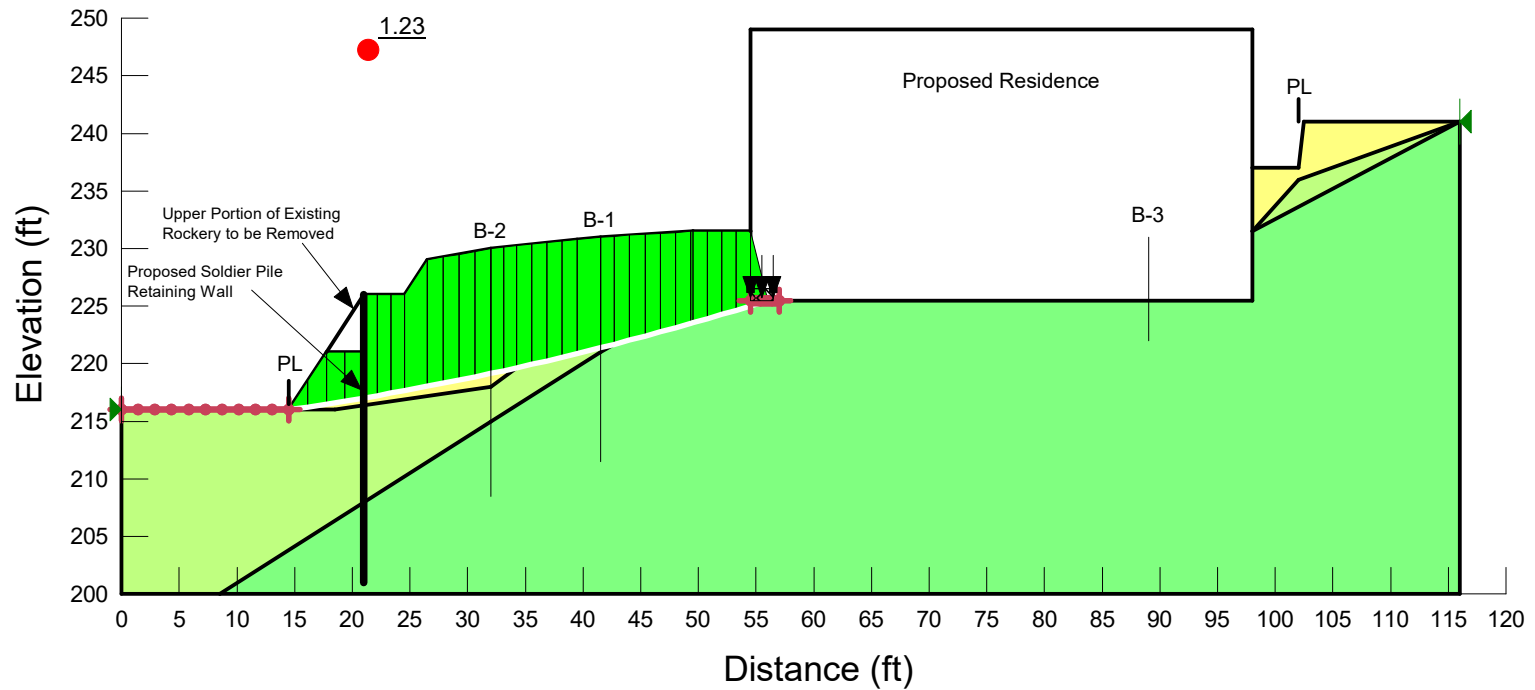
Name: Medium-Dense Silty SAND  
 Unit Weight: 125 pcf  
 Cohesion: 0 psf  
 Phi: 34 °

Name: Dense GLACIAL TILL  
 Unit Weight: 140 pcf  
 Cohesion: 100 psf  
 Phi: 40 °

## Static

# Seismic

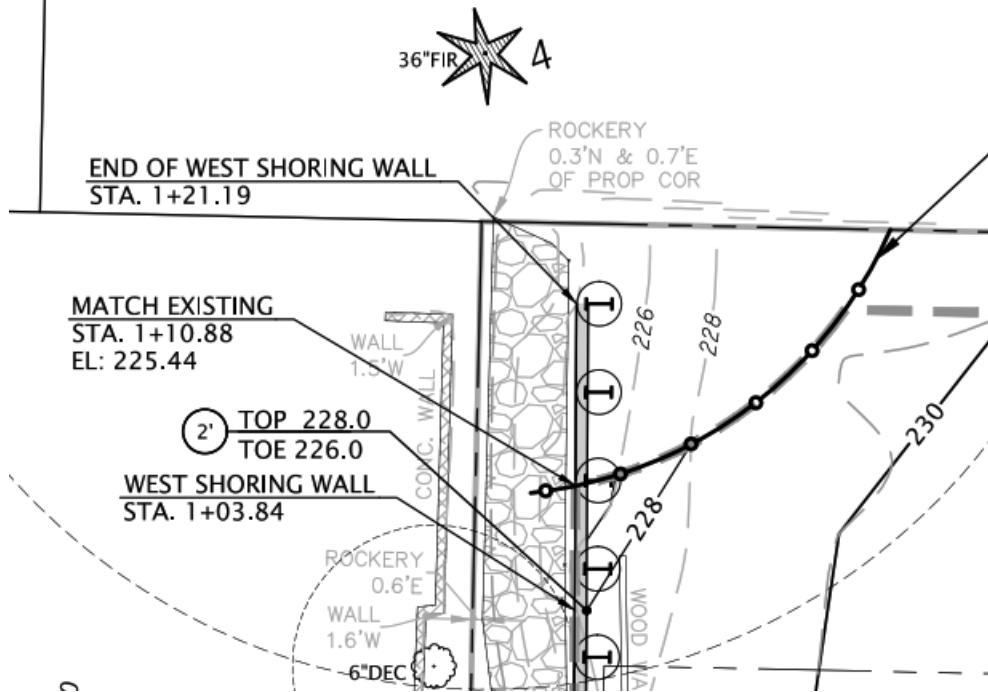
Figure 1. Excerpt from page C-2 of the submitted plan set. The base of the fir is roughly at the 214 grade level. Fir tree rarely if ever have roots deeper than 3' below grade. It is highly unlikely that this tree has any significant root density in the area east (right) of the existing rock wall.

Based on the plan set drawing shown in Figure 1 the north end of the new wall will terminate 15' out from the base of the tree. This means there is no chance that the work will damage the Structural Root Plate of the tree.

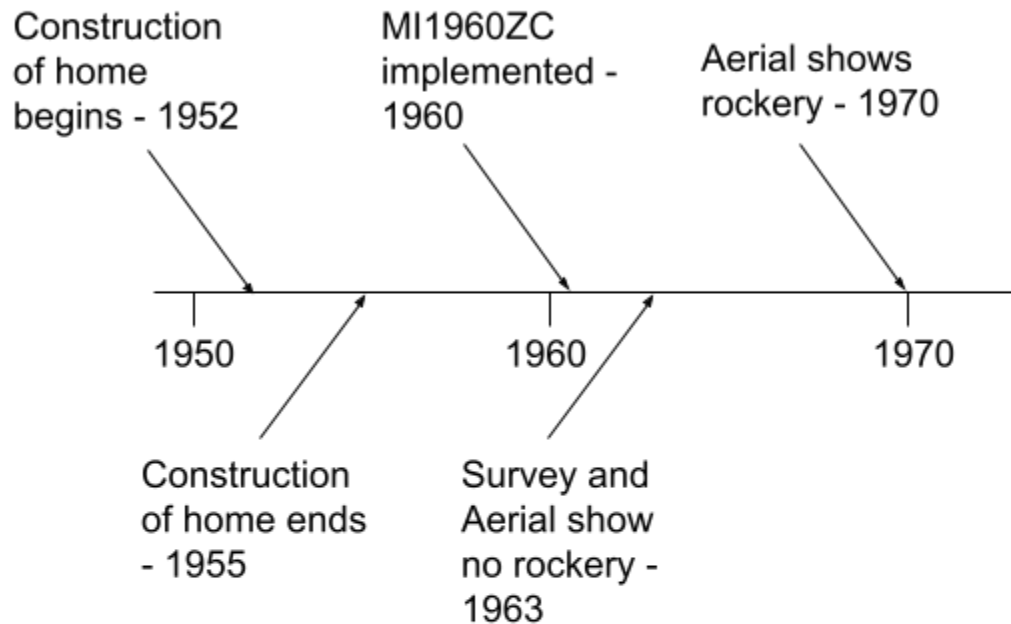
Here is a timeline of the Site's history:

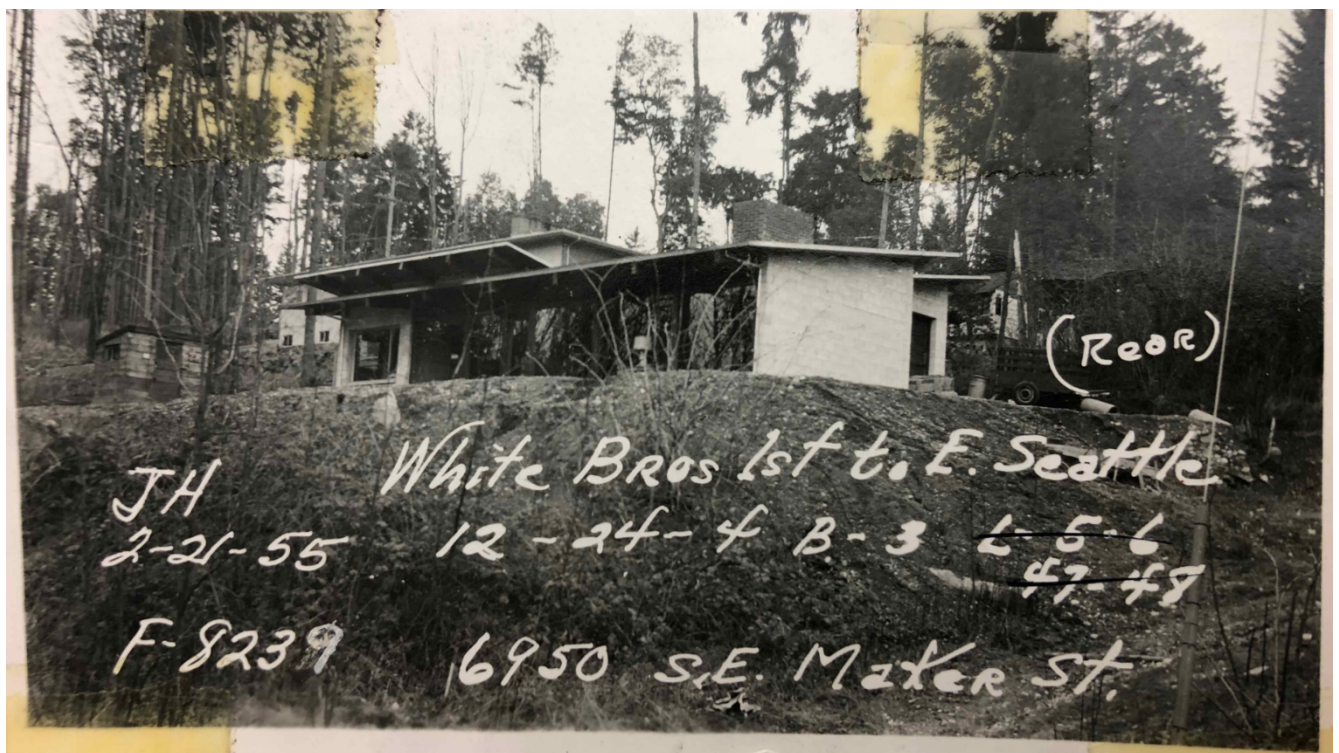
Figure 1. 1955 King County Assessor photo showing same hillside as 1963 Aerial Image in Figure 2b

Figure 1 shows the Site in 1955, before the current rockery was installed.

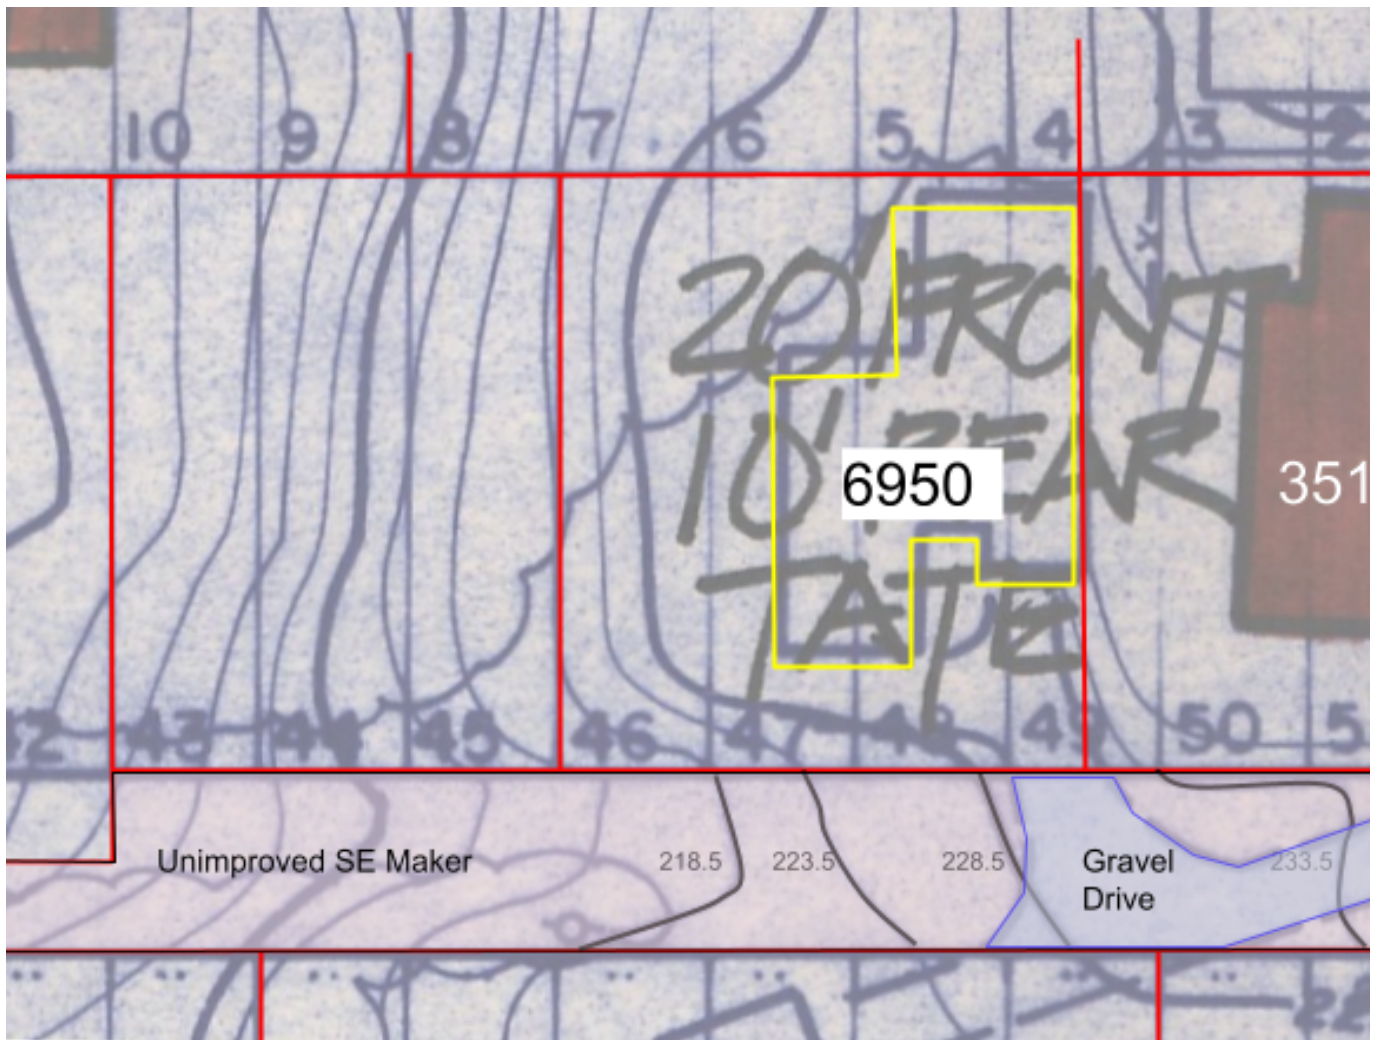
Figure 2. Survey showing original grade of SE Maker Street, 1963. The grade shown for 6950 is already Altered from the Existing Grade.  
("1963 Survey")

Figure 2 is taken from a [Mercer Island 1963 survey](#) (dated 1/19/1963) that shows the contours of the Lot and the SE Maker right-of-way after the 6950 house was completed in 1955, but before the rockery was put in place around 6950.

It is important to note that there is no rockery in the SE Maker right-of-way south of 6950, and no rockery on the western boundary of 6950. This is confirmed by the 1963 (dated “Winter 1963” in the Mercer Island GIS) aerial image in Figure 2a.

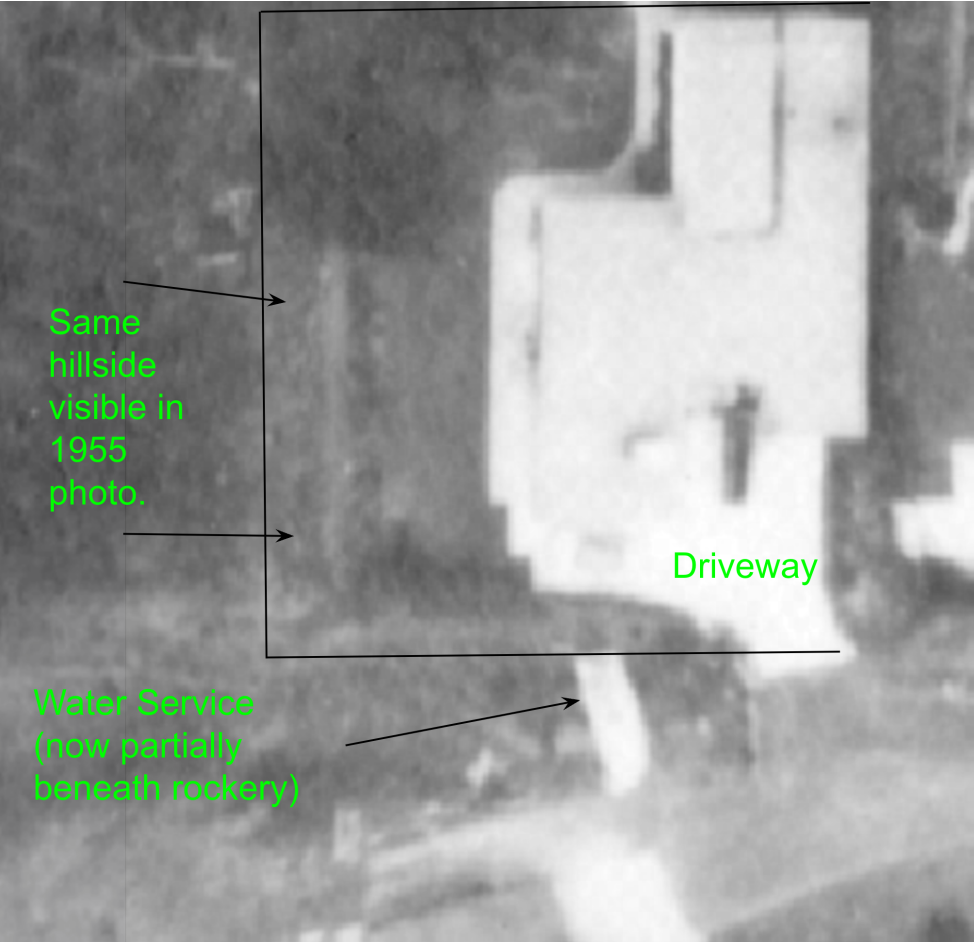
Figure 2a. 1963 Aerial Image showing no rockery to the west and no rockery in SE Maker ROW

The 1963 survey and 1963 aerial photograph clearly demonstrate that there was no rockery in place on either the west or south boundaries of the Site. By 1992 (shown in Figure 2b), the rockeries had become clearly visible.

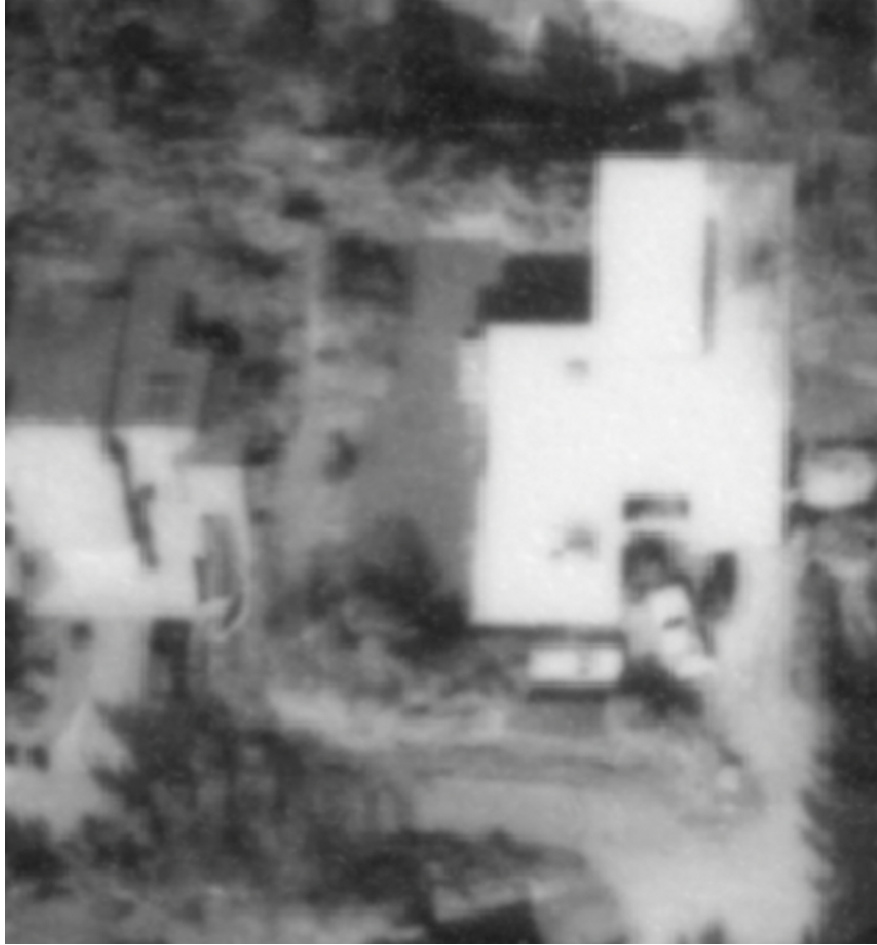
Figure 2b. For comparison, 1992 Aerial Image showing rockery to the west and rockery in SE Maker ROW

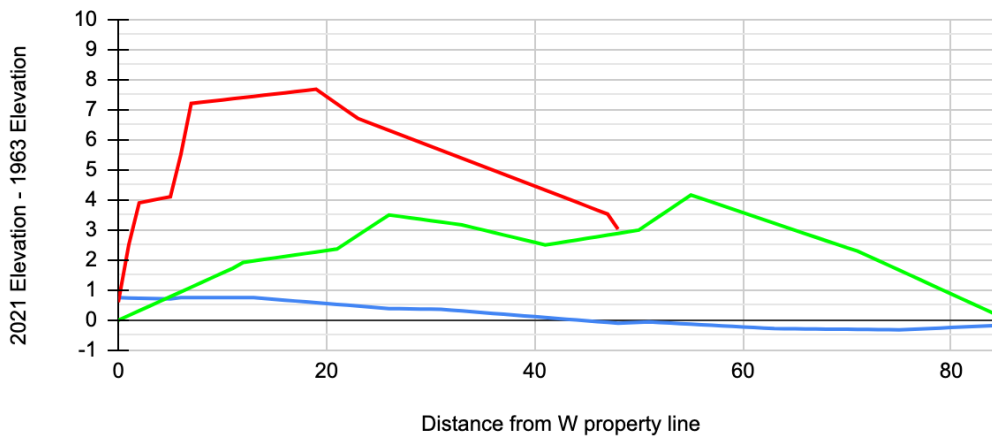
### Difference in Elevations between 1963 and 2021 on 3 Cross Sections

- 2021-1963 diff @ Maker midline
- 2021-1963 diff @ property line
- 2021-1963 diff @ 10' north of property line

Figure 4. Comparison of cross sections of 1963 and 2021 Survey elevations

A comparison of cross sections (shown in Figure 4) of the 1963 Survey in figure with the 2021 Survey clearly confirms that the rockery was installed between the dates of the two surveys. In these two surveys, 60 years apart:

- The elevation of the Maker Street midline (shown in Blue) differs from 1963 to 2021 by only a few inches (despite the street being paved several times between the two surveys).
- At the south boundary of 6950 (in Green), the rockery that was added is clearly visible - there are up to 4 feet of difference between 1963 and 2021.
- The cross section 10' north of the boundary (in Red) shows that the rockery increased the elevation of the yard by 7.5 feet when comparing 2021 and 1963 elevations.

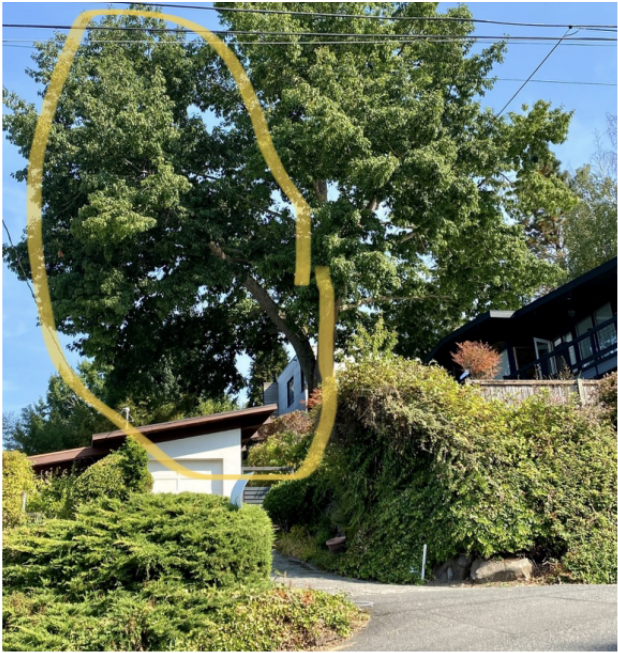
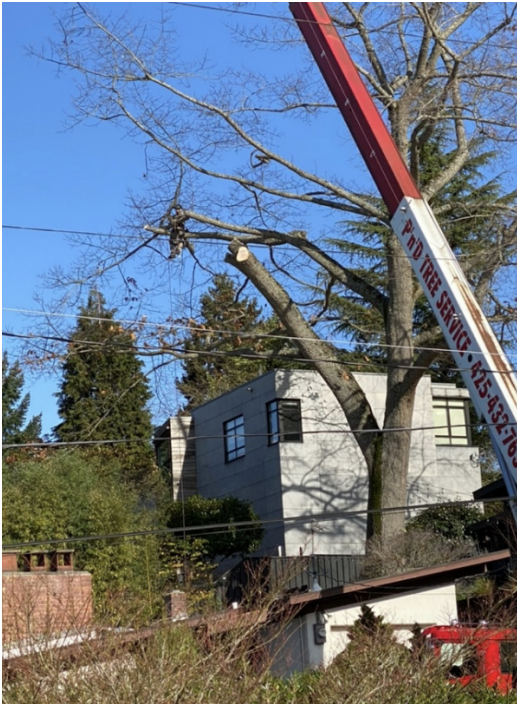
This City guidance provides further evidence that the Owner's alteration of Tree #5 should be considered not Pruning, but Cutting. The above pictures in the City's guidance display imbalances caused by practices that do not constitute Pruning. Compare the below pictures of the Tree #5, before and after the Owner's actions on November 10, 2021. These pictures mirror the City's examples of practices that fail to qualify as pruning and the harmful imbalances that result. The graphic below illustrates the way the Owner's Tree Removal left the tree unbalanced and damaged.

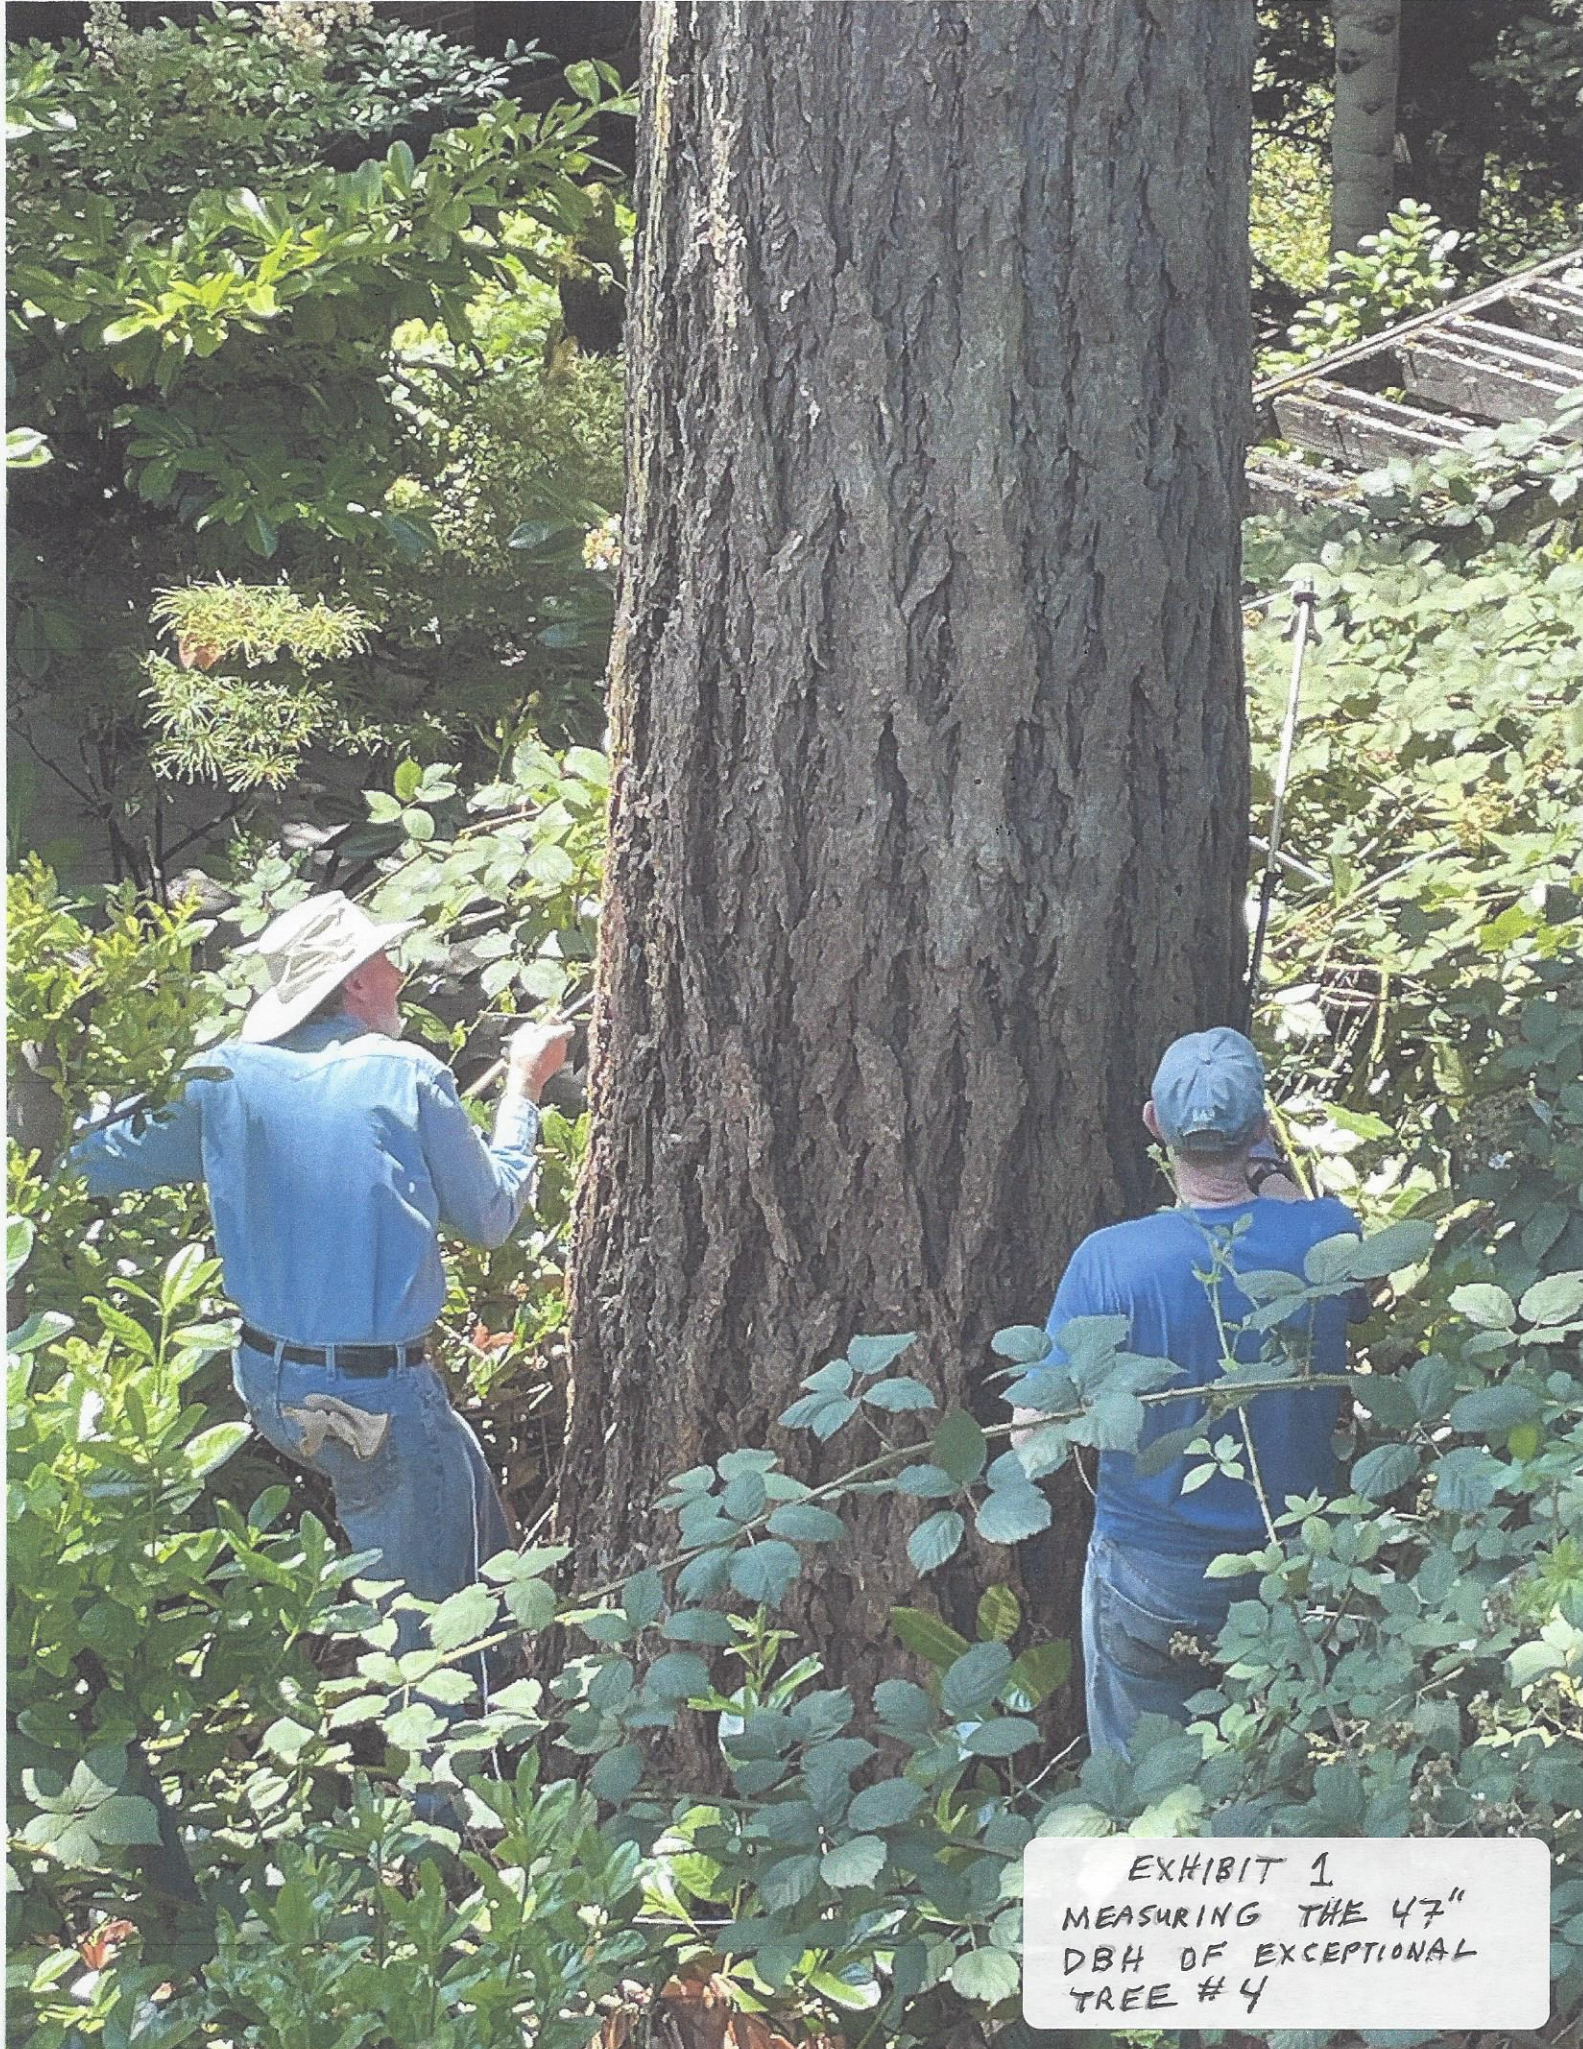
EXHIBIT 1  
MEASURING THE 47"  
DBH OF EXCEPTIONAL  
TREE # 4

ANY CERTIFIED ARBORIST  
 WOULD NOT ALLOW THE  
 SHORING WALL INSIDE  
 THE 47' "TRUNK DIAMETER"  
 CRITICAL ROOT ZONE (CRZ)  
 FOR TREE # 4

Martin Snoey recently measured the diameter of Tree #4 and found that Superior NW Enterprises (SNWE) arborist's report was incorrect in its assessment of the DBH at 36 inches. The actual DBH of 47 inches is 31% larger than reported. (The DBH may in fact be even larger if measurements are taken on the downslope side of the tree and then averaged per ISA.)
