### CAO23-011 CRITICAL AREA REVIEW 2

<b>Project No.:</b>	CAO23-011
<b>Description:</b>	A request for a Critical Area Review 2 for the demolition of an existing single-family residence and construction of a new approx. 4,000 square foot single-family residence on a property located within mapped geologically hazardous areas.
<b>Applicant / Owner:</b>	Jeffrey Almeter / Dorothy Strand
<b>Site Address:</b>	6950 SE Maker St, Mercer Island, WA 98040; Identified by King County Assessor tax parcel number 935090-0620.
<b>Zoning District:</b>	Single Family Residential (R-8.4)
<b>Staff Contact:</b>	Molly McGuire, Planner <a href="mailto:molly.mcguire@mercerisland.gov">molly.mcguire@mercerisland.gov</a> / (206) 275-7712
<b>Exhibits:</b>	<ol style="list-style-type: none"><li>1. Development Application, received by the City of Mercer Island on July 3, 2023</li><li>2. Revised Development Plan Set, August 29, 2023</li><li>3. Project Narrative, received July 4, 2023</li><li>4. Hazard Report, generated August 9, 2023</li><li>5. Geotechnical Engineering Study and Critical Areas Study prepared by Geotech Consultants, Inc., dated March 21, 2022 and received July 3, 2023</li><li>6. Review of Revised Pl

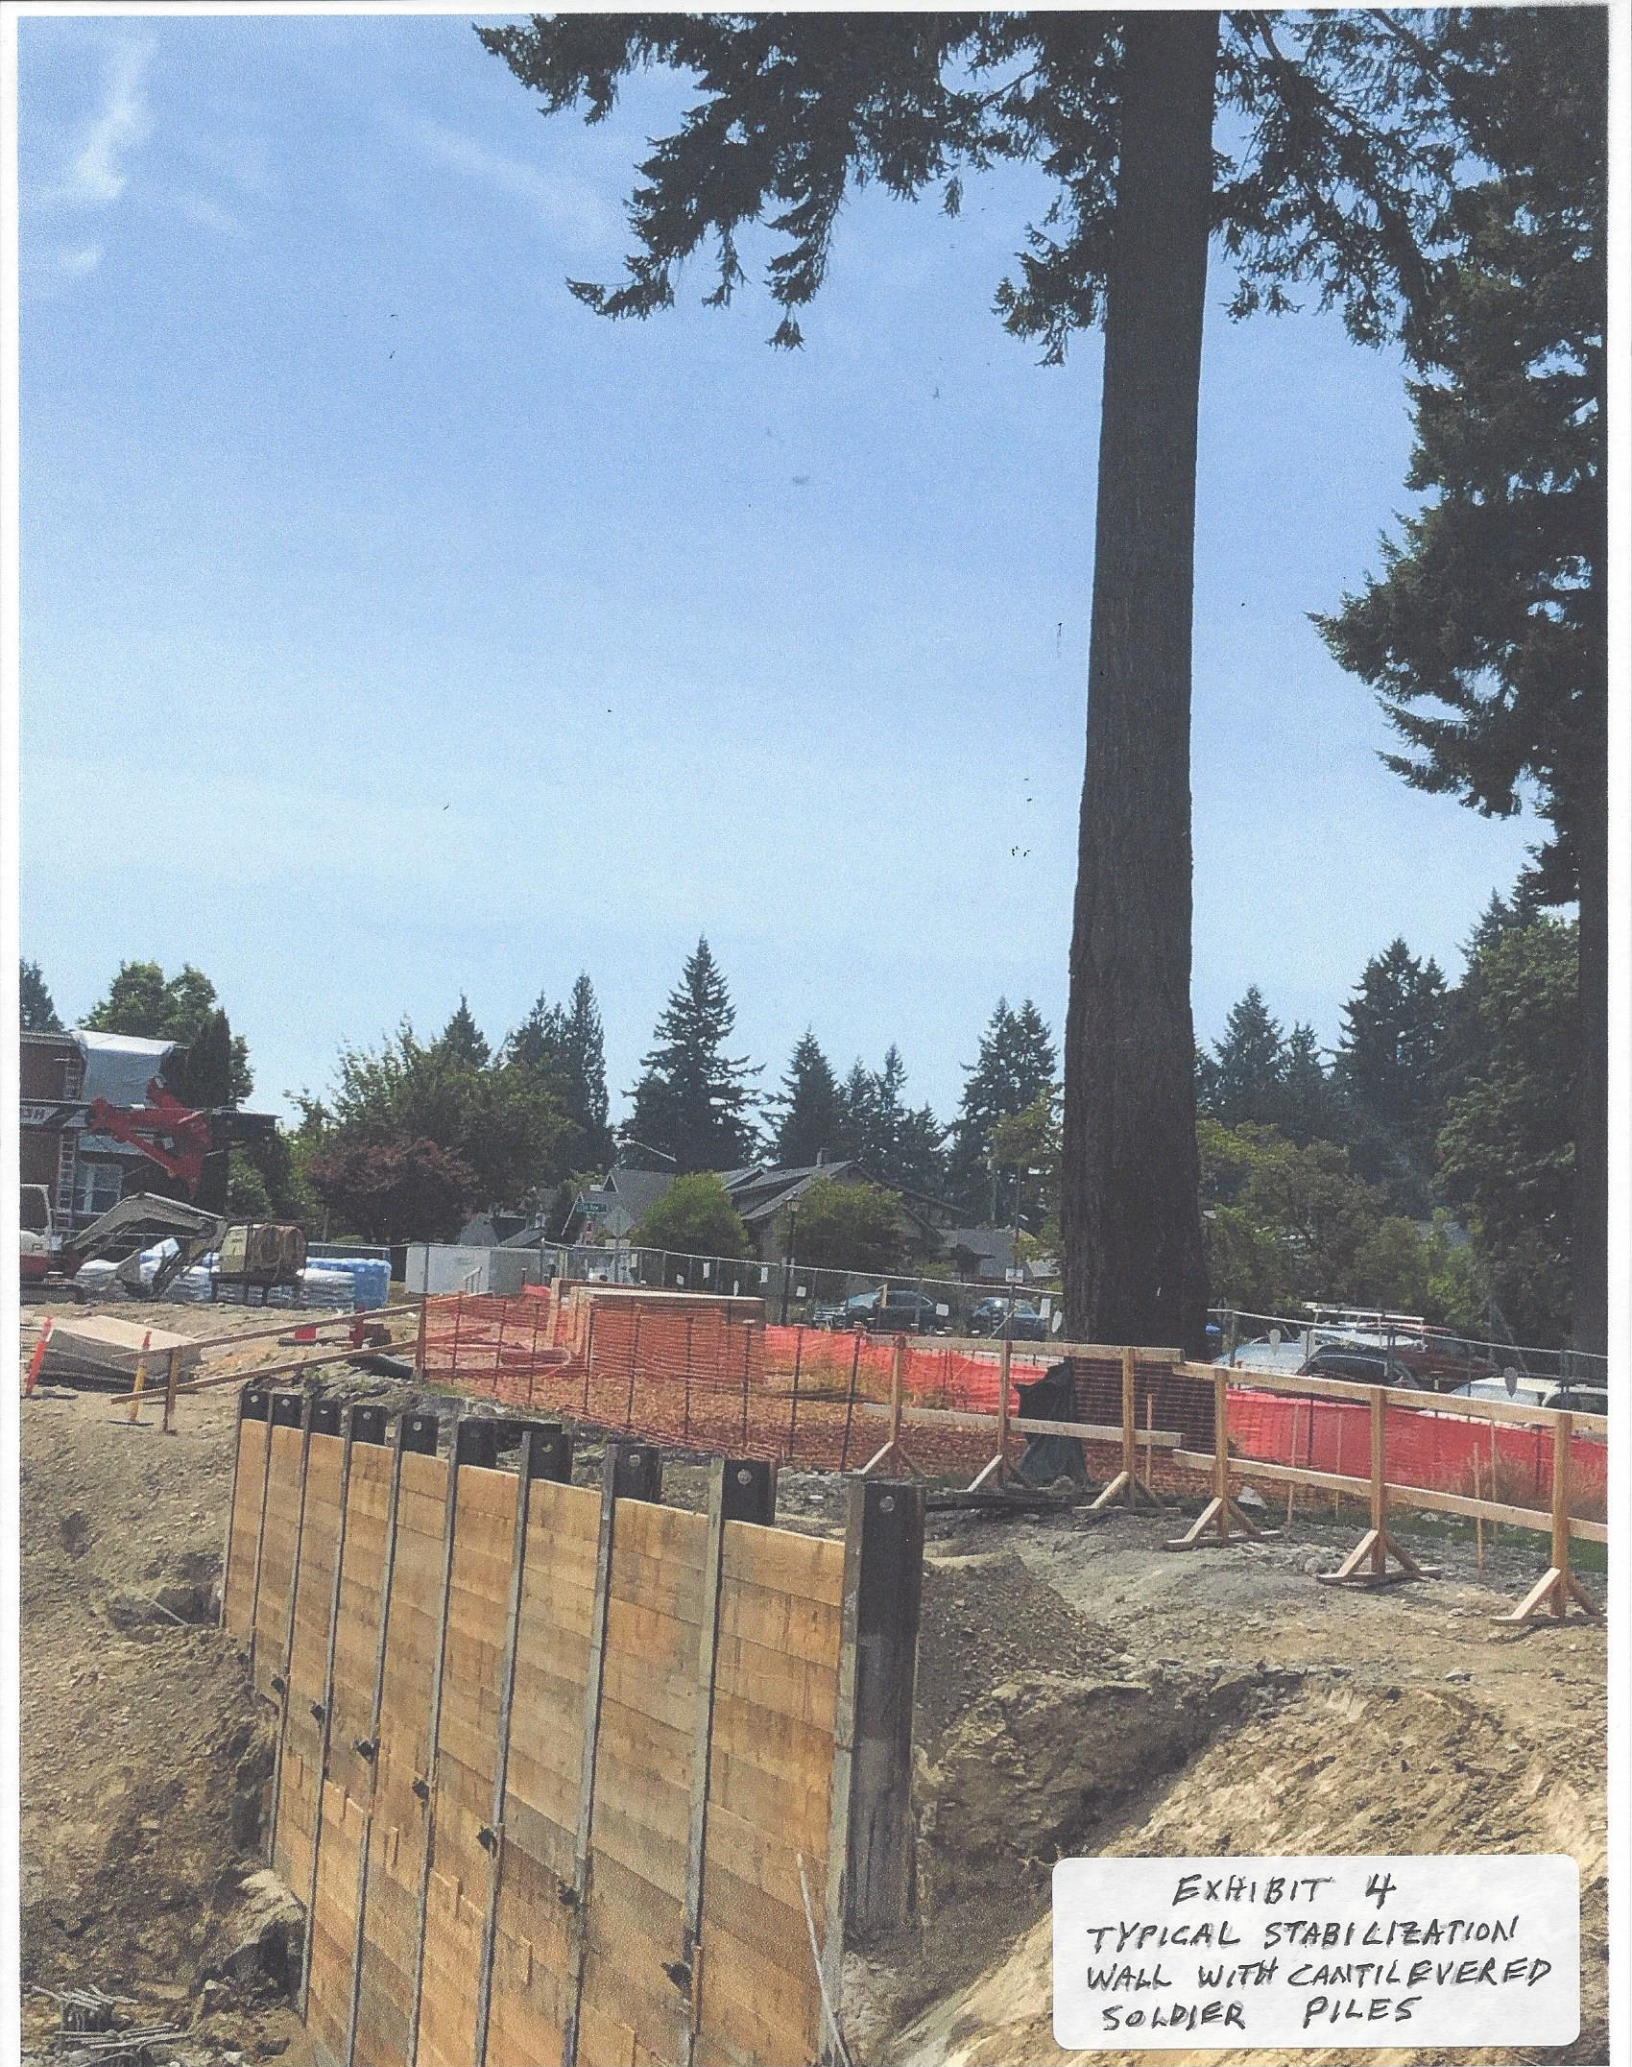
EXHIBIT 4  
TYPICAL STABILIZATION  
WALL WITH CANTILEVERED  
SOLDIER PILES

DRAWING C-2 P. 7

- 19.02.050(E)(1)(a)(i) - The proposed combined rockery + retaining wall for the fill slope in the western Required Side Yard and Required Rear Yard exceed the maximum allowed height of 72 inches. The proposed retaining wall in these yards is ~120" (Piles 23 through 37 in the table from SUB3, sheet SH3 below).
- 19.020.050(E)(1)(a)(ii) - The proposed combined rockery + retaining wall for the fill slope in the Required Front Yard exceeds its maximum allowed height of 42 inches. The proposed retaining wall in these yards is ~120" (Piles 13 through 22 in the table from SUB3, sheet SH3 below).

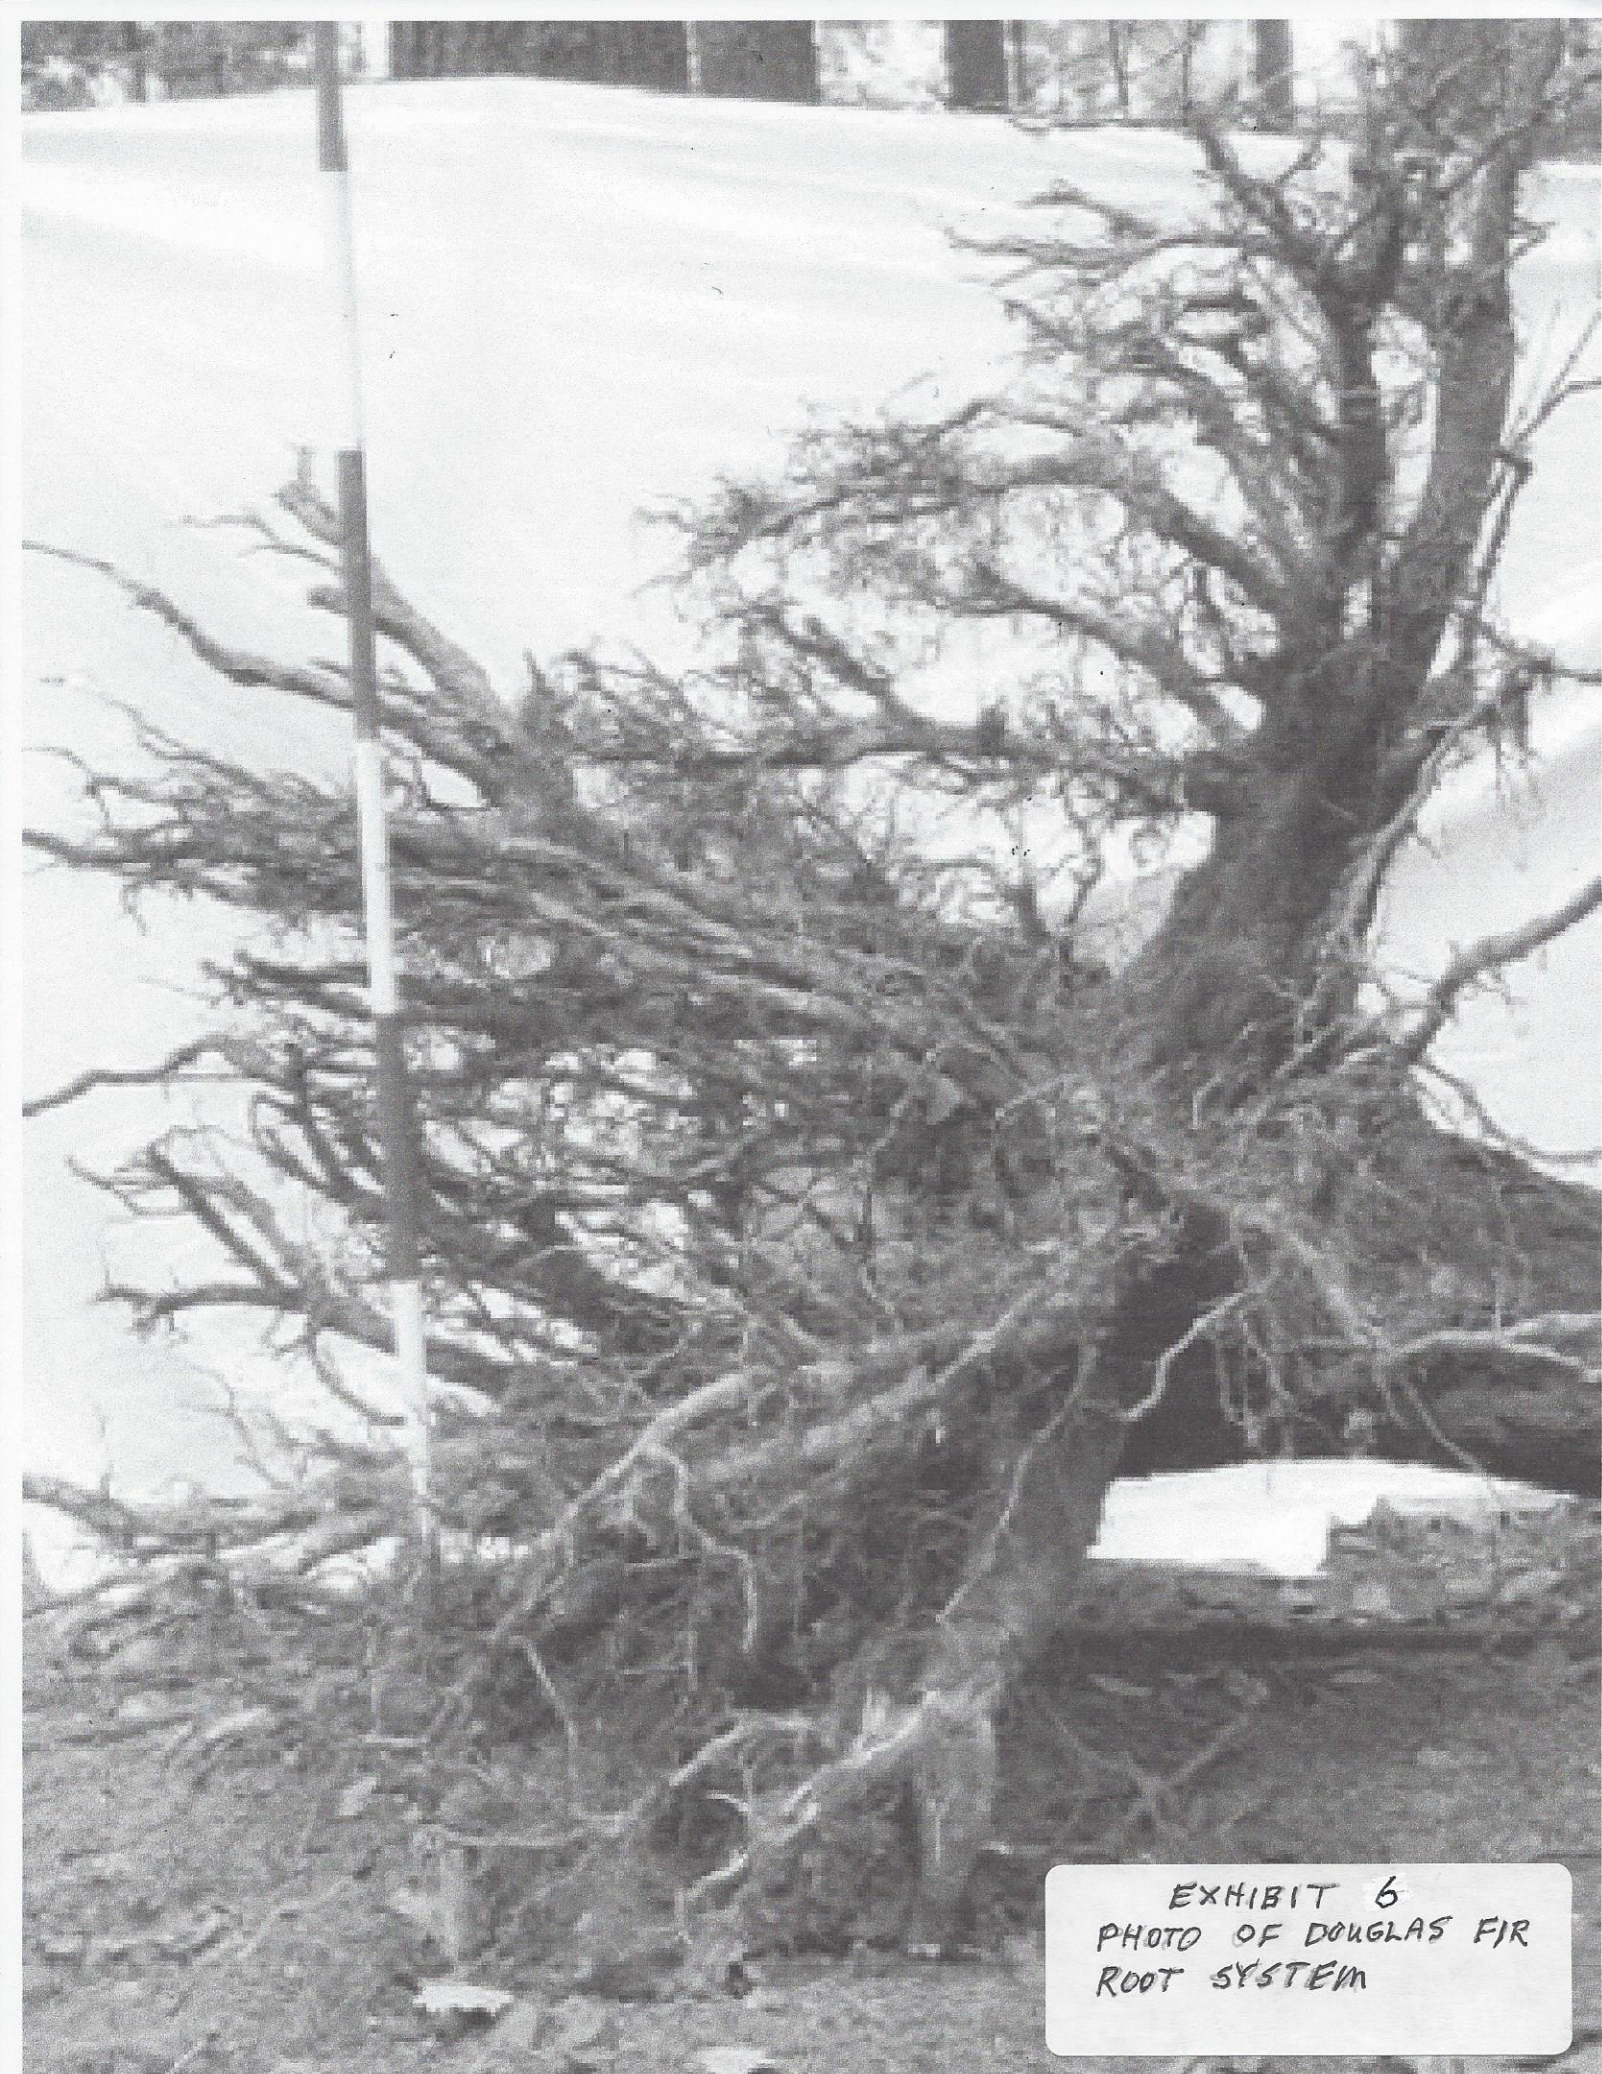
EXHIBIT 6  
PHOTO OF DOUGLAS FIR  
ROOT SYSTEM

- WHY CRZ IS SO IMPORTANT -
- ROOTS MUST EXTEND FAR FROM TREE (LARGE MOMENT ARM)
  - ROOTS MUST REMAIN UNDAMAGED (LARGE FORCE)

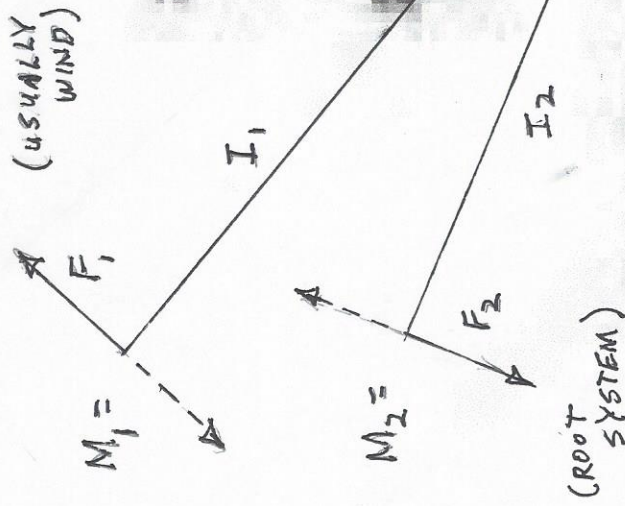
EXHIBIT 7  
 SHAPE AND SIZE OF  
 ROOT SYSTEM AND  
 HOW IT CAN FAIL

M = MOMENT (OR TORQUE)  
 F = FORCE  
 I = MOMENT ARM

- TREE REMAINS STANDING WHEN  $M_1 \leq M_2$
- TREE FALLS OVER WHEN  $M_1 > M_2$

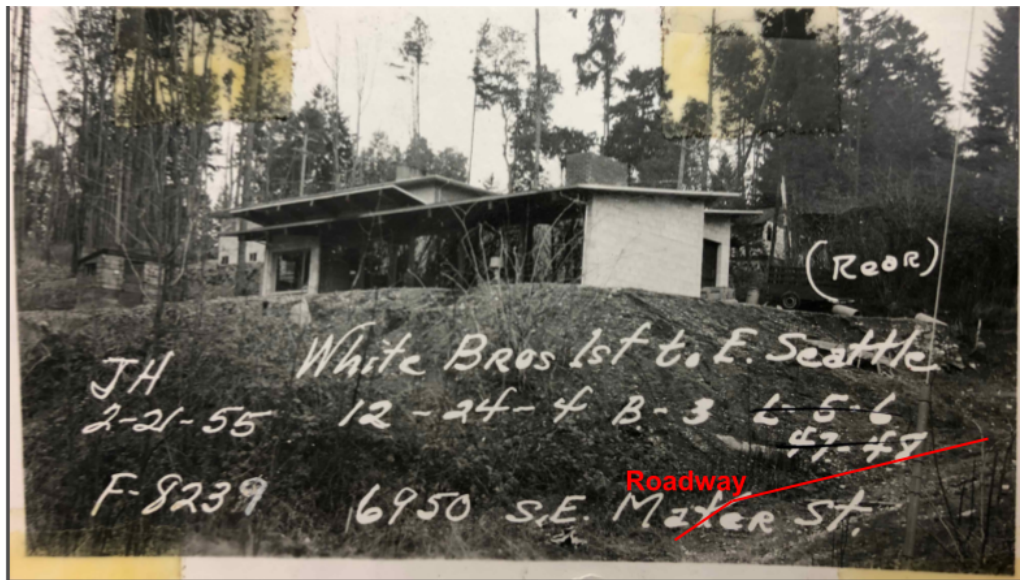
The 1955 image below of the 6950 house shows the same unimproved road, and shows that the rockery was not in place in 1955.
