RE: Appeal of Land Use Approval for CAO23-011 October 23, 2023

Part 1. CAO23-011 violates MICC 19.07 and MICC 19.10

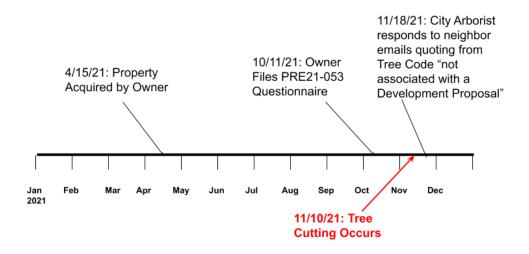
The timeline below shows that the Tree Removal occurred in direct connection with this Development Proposal, underscoring the need for proper permitting (which did not occur). This timeline further affirms that the Tree Removal was caused by the Owner, contrary to representations made in the TPP submitted by the Applicant.

The purchase of the Development Site by the Owner closed on April 15, 2021.

On **October 11, 2021** the Applicant filed a Site Development Questionnaire with the City as part of PRE21-053 for a 1471 square foot second floor addition. In this filing, the Applicant stated that "no large trees would be removed as a result of this development activity".

On **November 10, 2021**, the Owner's agents Cut the Exceptional Tree. Per Master Arborist Selby's report (page 2), "approximately 30 percent of the total biomass of the crown" was removed.

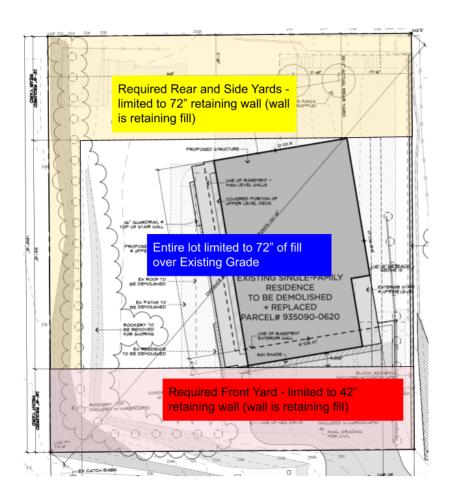
Below is an illustration showing the MICC requirements that are violated by CAO23-011:

- 1. The heights of retaining walls containing fill in Required Yards must be reduced to 42" in the Required Front Yard, and 72" in the Required Side and Rear Yards. Note that MICC restricts the **combined** height of retaining walls + rockeries in each required yard. Therefore the remaining portions of the existing rockery and the new retaining/shoring walls must have their heights combined for comparison with MICC 19.02.050(E)(1)(a)'s requirements.
- 2. Fill that raised the Finished Grade to more than 72" above the Existing Grade must be removed.

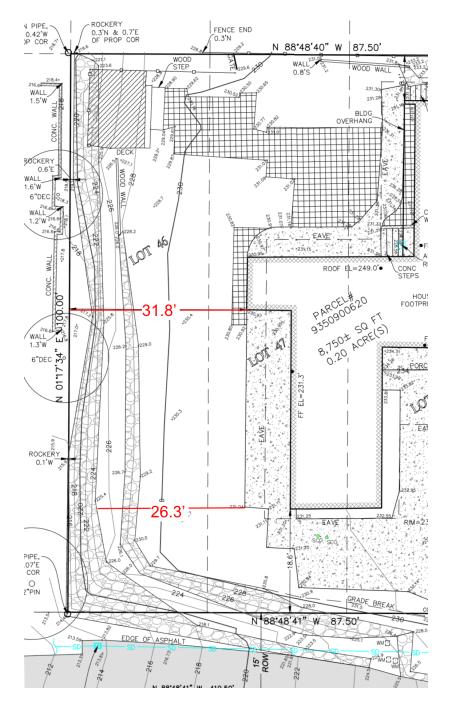
Figure 1. Applicant's 2021 Survey of 6950 SE Maker showing distance from retaining wall to walkway

The 2021 survey of the Development Site shows the distance from the walkway on the western side of the existing house to the top and bottom of the retaining wall west of the house.

Figures 1 & 4: CAO23-011 Survey performed in 2021, page 2

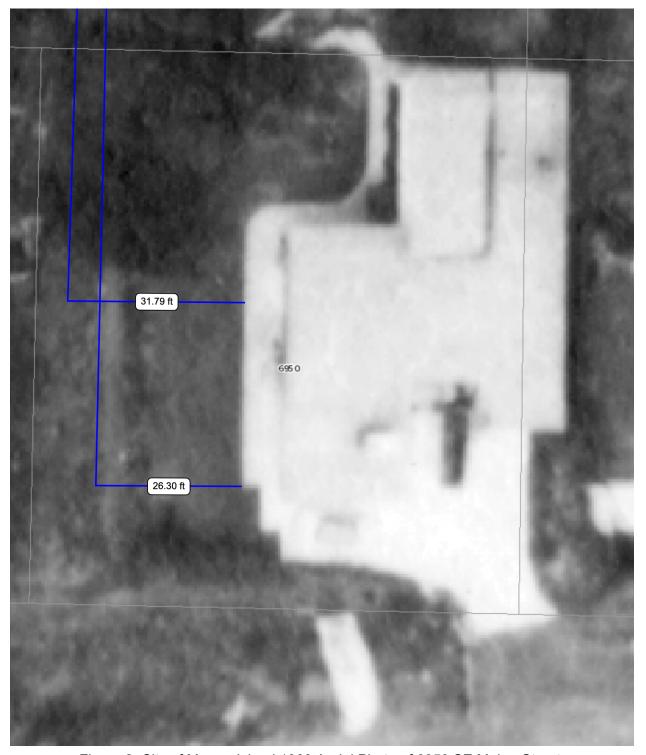
Figure 2. City of Mercer Island 1963 Aerial Photo of 6950 SE Maker Street

By using those same measurements on the 1963 aerial photo of the property (from the City of Mercer Island GIS), it's clear that there was no retaining wall in 1963.

Figure 2: 1963 Aerial photo from Mercer Island GIS

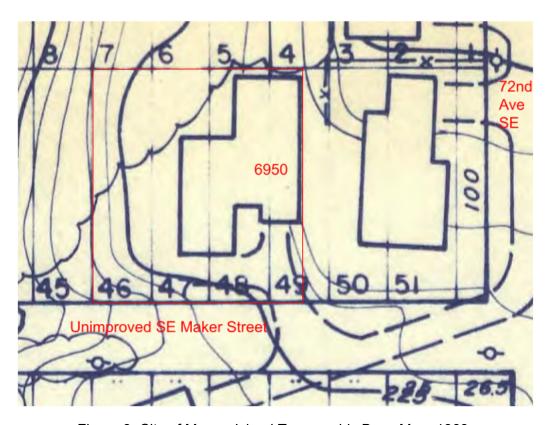
Figure 3. City of Mercer Island Topographic Base Map, 1963

The <u>City of Mercer Island Topographic Base Map of 1963</u> ("1963 Map") was created based on the same 1963 aerial photos in the Mercer Island GIS.

Figure 3 is a detail from <u>1963 Map page C-2</u> that shows 6950 SE Maker Street (I have added the property boundaries of 6950 in red).

Figure 3: 1963 City of Mercer Island Topographic Base Map

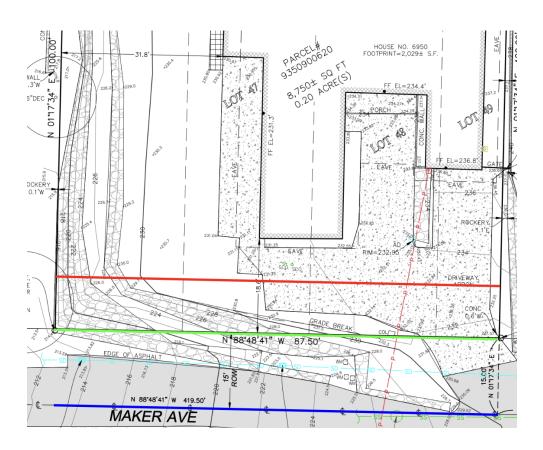
Figure 4. Locations of 3 cross sections of surveys

Figures 4 and 5 show comparisons between 3 east-west cross sections (shown below in Figure 4) of the 1963 Survey and the 2021 Survey. These clearly confirm that the retaining wall was installed between the dates of the two surveys. In these two surveys, 60 years apart:

- The elevation of the Maker Street midline (shown in Blue in Figure 4) differs from 1963 to 2021 by only a few inches (despite the street being paved several times between the two surveys).
- At the south boundary of 6950 (in Green in Figure 4), the retaining wall that was added is clearly visible there are up to 4 feet of difference between 1963 and 2021.
- The cross section 10' north of the boundary (in Red in Figure 4) shows that the retaining wall increased the elevation of the yard by 7.5 feet when comparing 2021 and 1963 elevations.

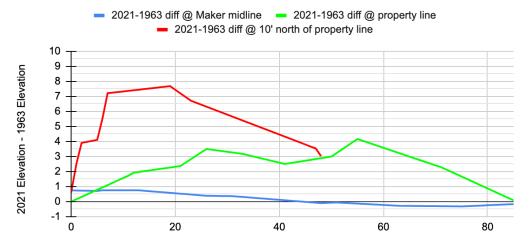
Figure 5. Comparison of cross sections of 1963 and 2021 Survey elevations²³

Difference in Elevations between 1963 and 2021 on 3 Cross Sections

It is clear from these cross sections that the retaining wall's installation occurred after the 1963 aerial photos were taken for the City.
