Re: Permit No. 2207-019 SUB2 - Strand Residence - 6950 SE Maker St. - Additional Input and Feedback

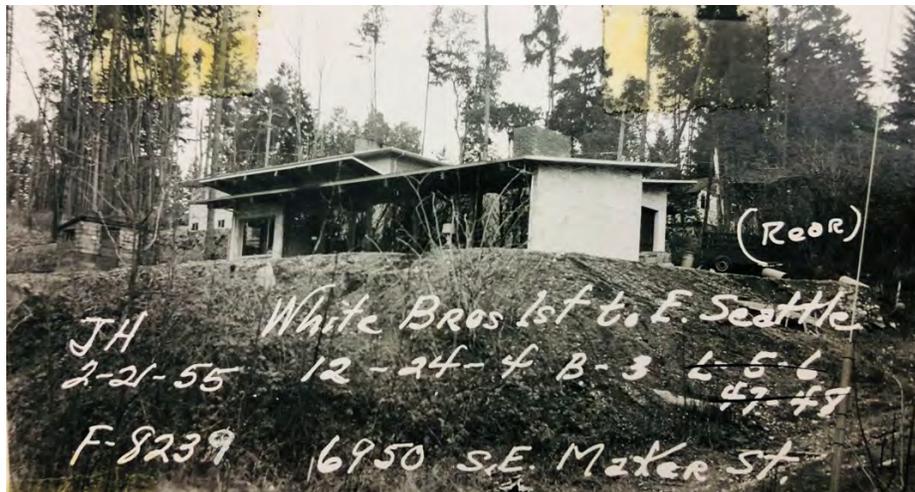
Ca. 1955 view of south (front) and west (rear yard) elevations of 6950 SE Maker Street depicting extensive fill material sloping to foreground prior to rockery placement. Note the lack of native vegetation. Present day Maker Street is in lower right of photo.

This site was significantly "altered" prior to development of the existing home with extensive placement of fill materials which were retained with tall rockeries. This is well documented in the October 2022 public comments and the geotechnical engineer's initial report.

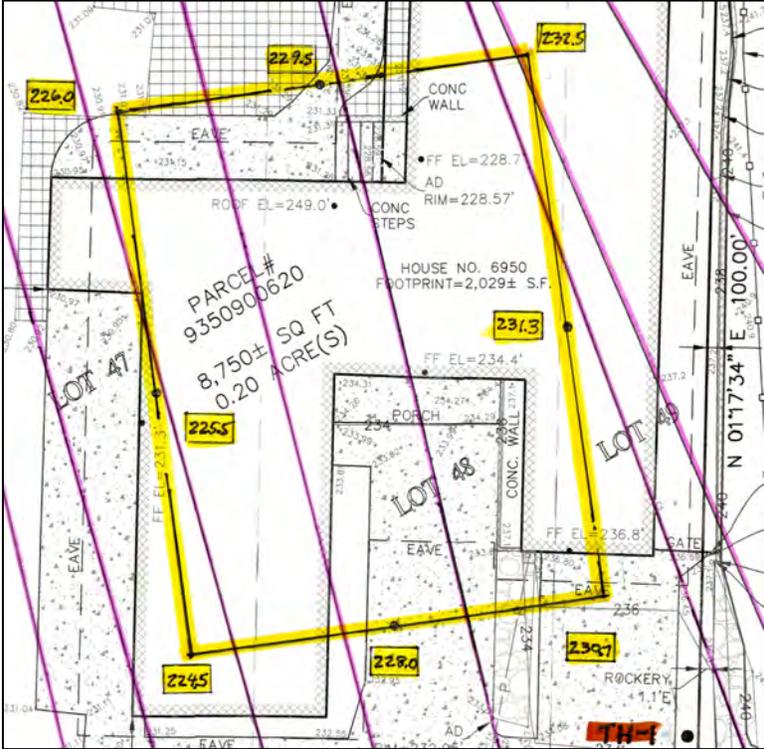
This figure was taken from the modified survey drawing (Terrane 5/27/21) submitted to the City on October 27, 2022, and prepared by Dan Grove and Jim Mattison. (See attached DG.JM survey).

This modified survey of the 6950 project site aggregates and locates contours from both the DR Strong May 1989 and MW Marshall May 2004 surveys and adjusts them to conform to NAV88 vertical datum.

Given this information, we and our neighbor, Dan Grove, utilized these surveys along with test bore and hole logs from the two geotechnical reports to compile a thoughtful and well researched contour interpolation that factually best represents the native topography of the 6950 site prior to alteration.
