**Re: Comment Letter for Proposed Redevelopment of 6950 SE Maker Street  
Permit No. 2207-019**

<p>Topographic Survey</p>	<p>CLIENT Myrvang Architects</p>	<p>PROJECT Pederson Residence</p>	<p>             DRAWN JMR DATE May 1989 DRAWING NO. 89-848            CHECKED GES SCALE 1" = 10' SHEET         </p>
---------------------------	--------------------------------------	---------------------------------------	---

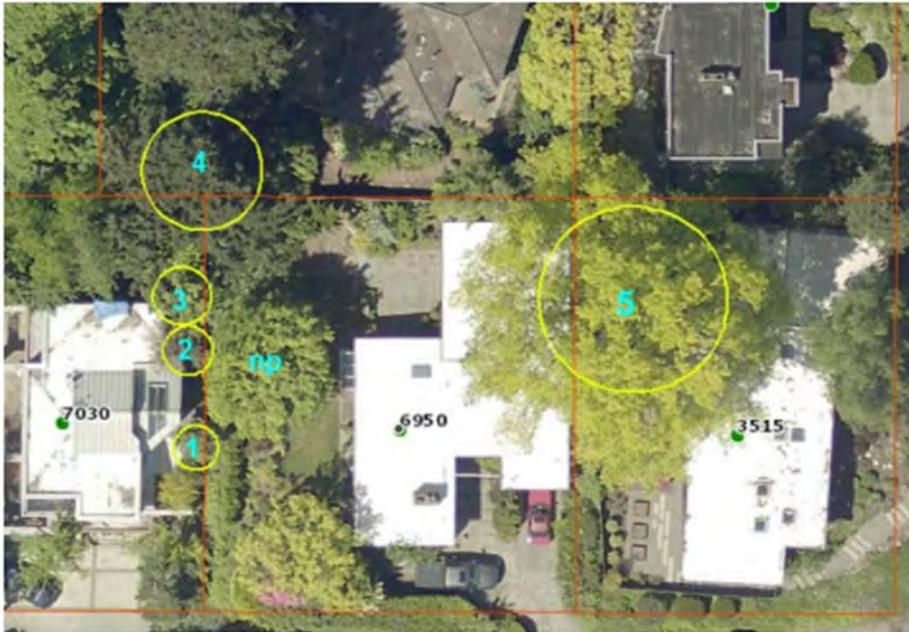
The following excerpt from the Assessment shows the Red Oak Tree on Mr. Grove’s property as Tree #5:

The Assessment states: “[The] Red oak (*Quercus rubra*) easily 40” DSH, 50’ tall in the highest reaches, spreads as much as 45’ north and south, around 35’ east, but was cut back quite hard on the west and extends no more than 18’ to that side (Figure 6). The base of the tree is 25’ south of the northeast corner and 10’ on center east of the east line. It sits on top of a large stone retaining wall that is near 5’ tall and fully on the neighbor’s lot (Figure 7).”<sup>19</sup> The Assessment further states that “[i]f grade changes due to landscaping are proposed later in the project they should be analyzed for potential impact prior to implementation.”<sup>20</sup>

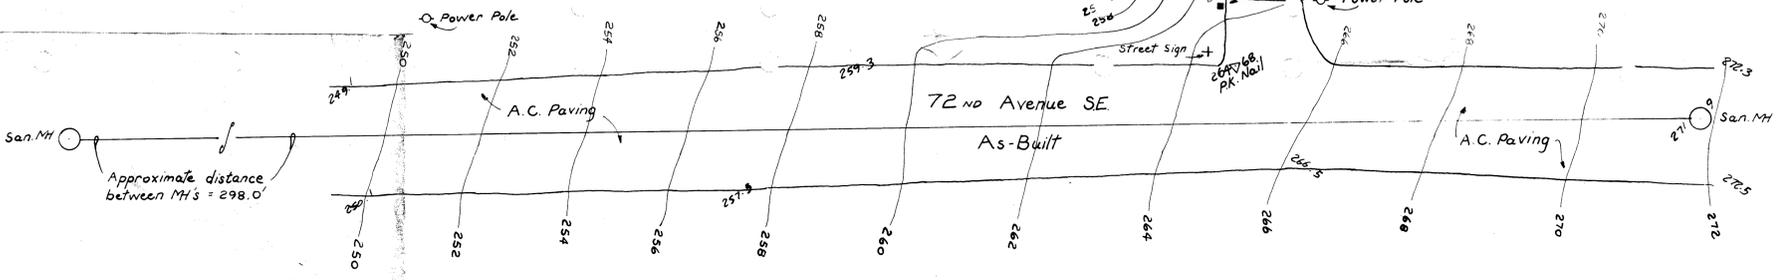
Basis of Elevations:  
 A spike in a power pole at the intersection  
 of 71st Ave. SE. and SE. 32nd Street,  
 being called B.M. 443, and having an  
 elevation of 288.96 as per the Public  
 Works Department of the City of Mercer Island.

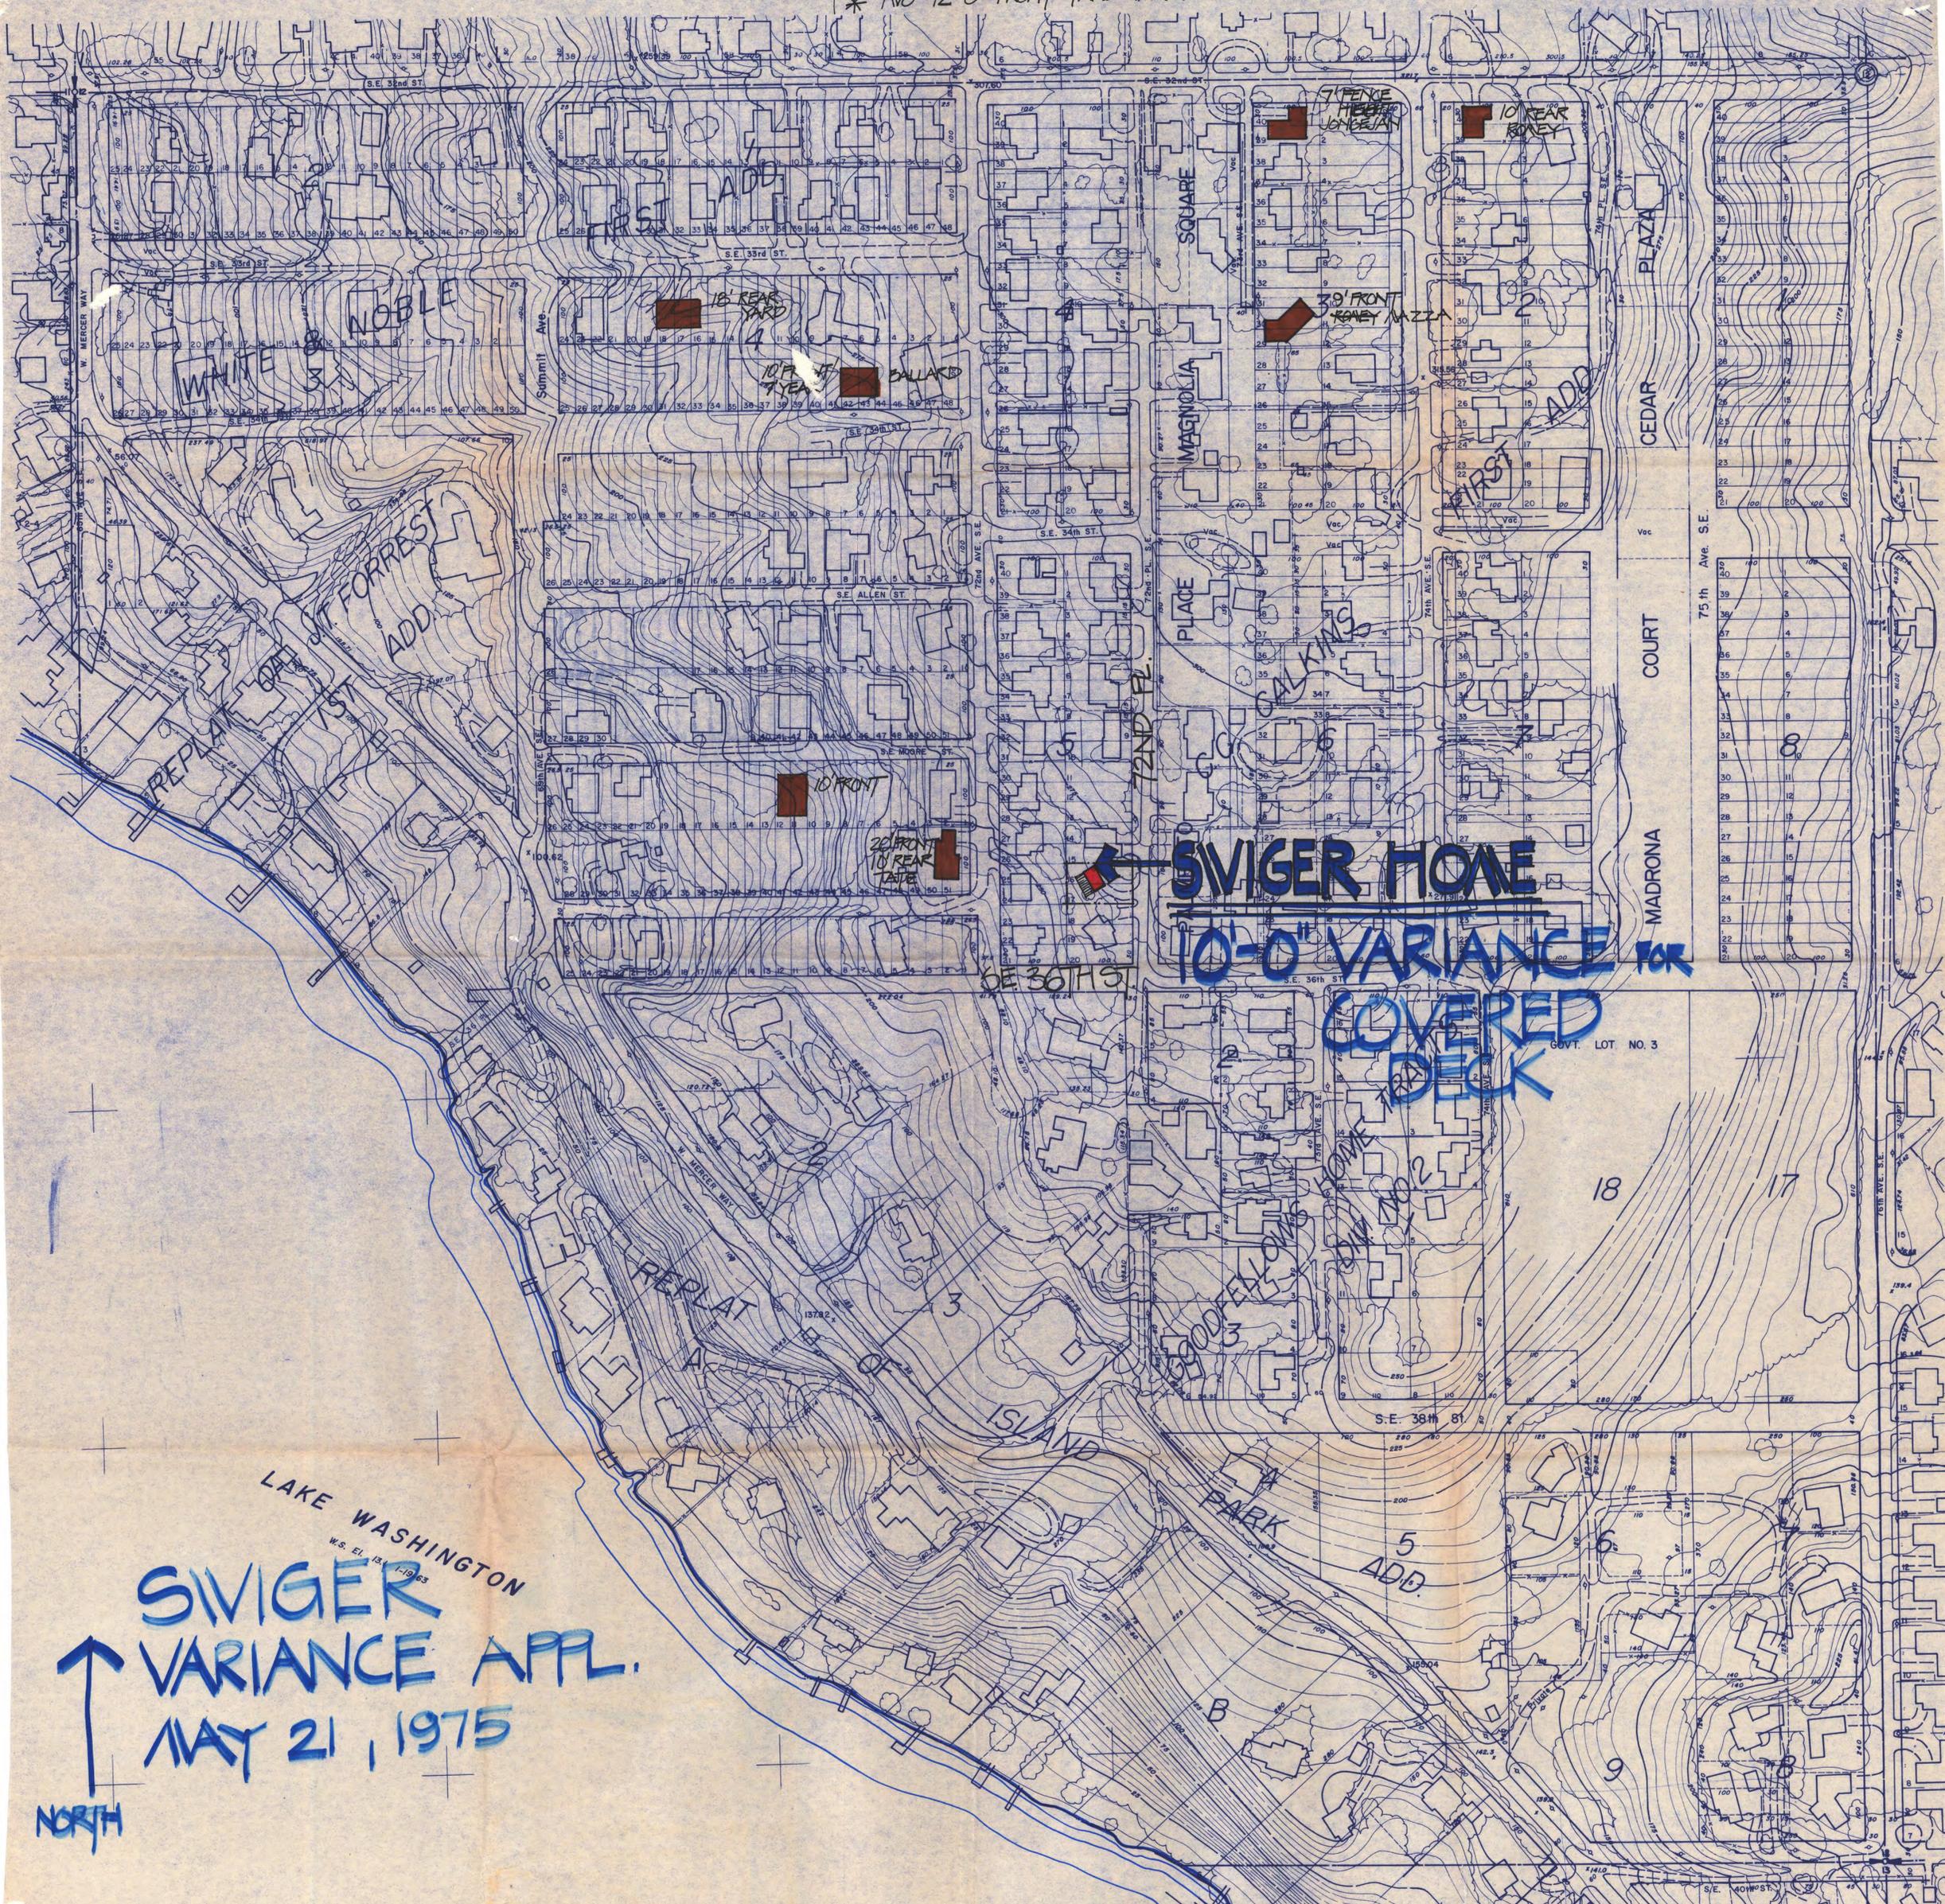
\* TWO 12'-0" FRONT YARD VARIANCES

**SWIGER HOME**  
**10'-0" VARIANCE FOR**  
**COVERED DECK**

LAKE WASHINGTON  
W.S. EL. 151 1-1963  
**SWIGER**  
**VARIANCE APPL.**  
**MAY 21, 1975**
