Re: Public Comment Overview - File No. 2207-019 / 6950 SE Maker Street / Parcel
No. 9350900620

We are commenting on this proposed project because we believe the GFA calculation and the existing grades designated by the applicant do not comply with the Mercer Island City Code (MICC). We also have several concerns and questions for the City that pertain to the geotechnical and storm drainage report of which we request be answered. Additionally, due to the complexity of the proposed project, site considerations by the geotechnical consultant, and tight confines of Maker Street, we are requesting the City require a Construction Management Plan be filed. And lastly, based upon our understanding, the MICC tree code may have been violated, and we've provided information pertaining to that issue.

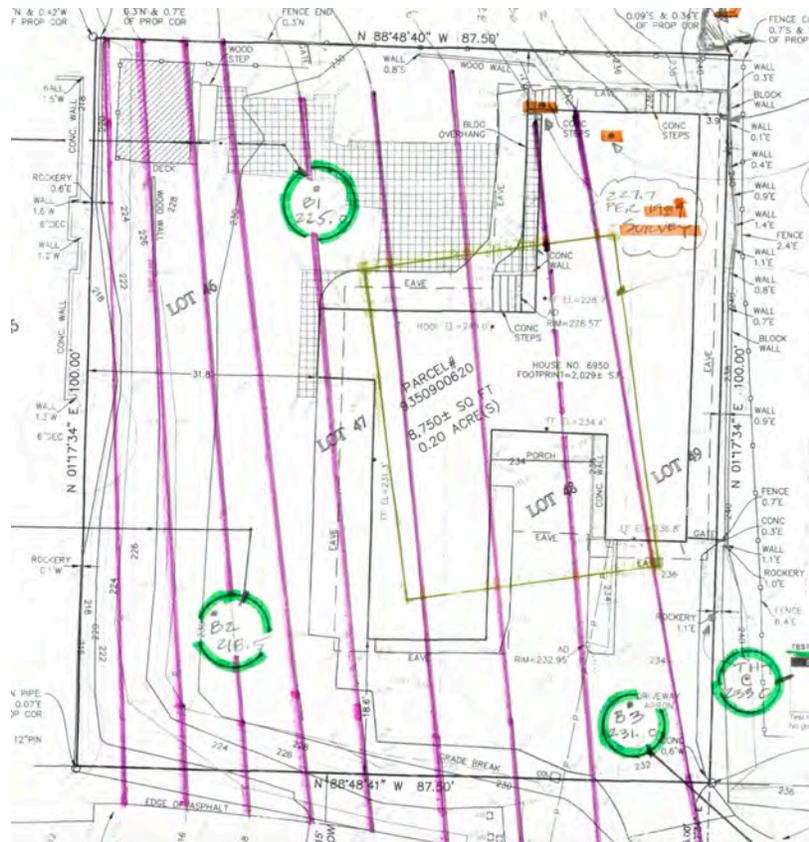
From this simple interpolation, the original topography of the 6950 site really takes shape, and again, is what you might expect both on paper and if you were out on site. Yes, the linear contours (highlighted in pink) lack the natural meander one would get had several shots been taken for each contour. But by the same token, all three parcels are laterally aligned with respect to the steep slope orientation and the contours line up in way that is expected. The adjusted existing grade for the borings and test holes are markedly in the ballpark on the 6950 site. And the basement floor spot elevation is within a foot of the floor elevation taken in the 2021 survey.

Furthermore, our neighbor, Dan Grove who is commenting about the proposed project as well, has made additional contour and elevation interpolations including an instructive graphical interpolation that illuminates why the designated existing elevations need to be reset to the original topography of the steep slope. His detailed analyses can more accurately define where the original contours lie and therefore, what specific existing grades should be used for the proposed project.

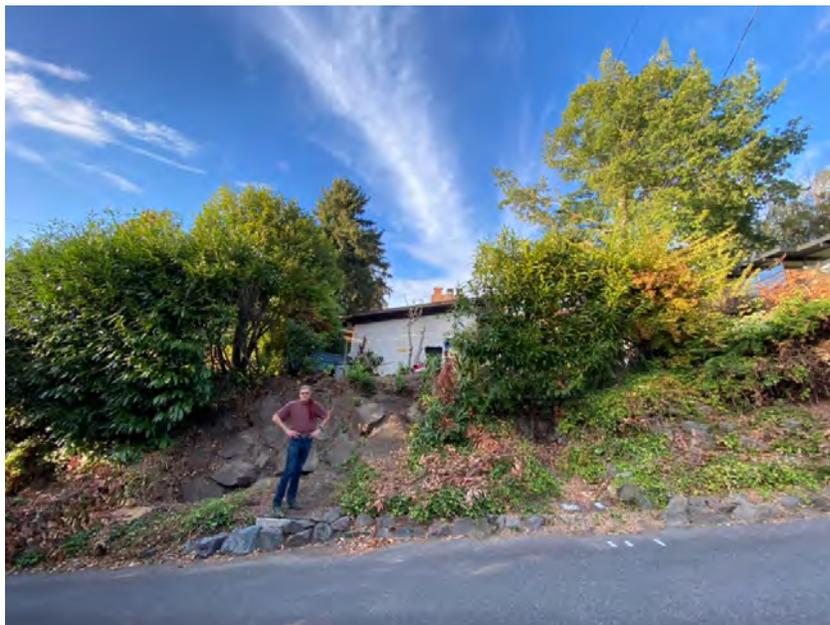
This rockery is identified on the map by atypical square-shaped map contours surrounding the property which clearly outline the man-made rockery supporting the fill. Even the south side of the rockery adjacent to SE Maker Street is over 6 feet tall (per photo). Note that Jim is standing on top of the catch basin as described in the Storm Drainage Report as Photo 3.

In the Critical Area Study, Geotechnical Consultants determined that this steep slope was created by fill. Per Geotech Consultants, the "flat yard area that appears to have been created by placing loose fill soils over the original ground surface during the original site development which was confirmed by test borings conducted for our study". "Borings found 5.5 to 11 feet of loose silty sand beneath the relatively flat yard" which is contained by an immense rockery on the south and west borders, at the highest point reaching 15.5 feet.

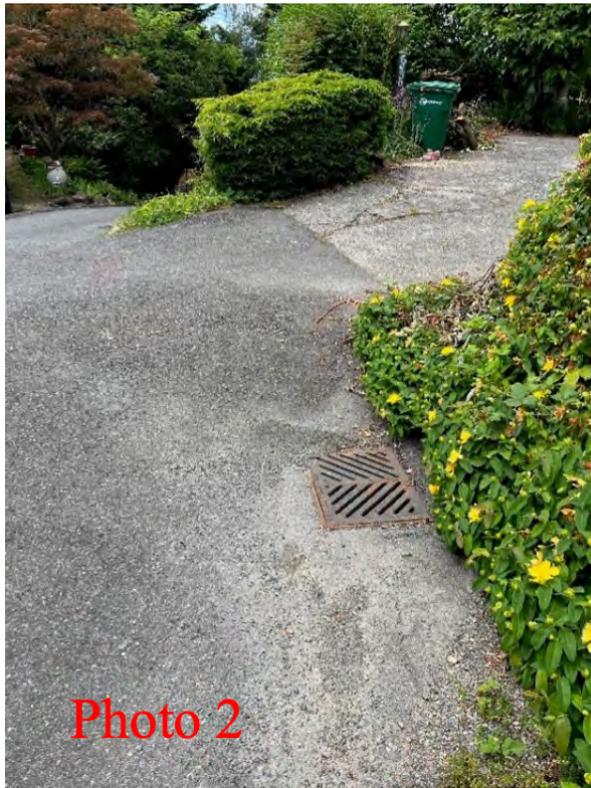
Photo 2 and Photo 3 from Stormwater Drainage report below. Note: Due to elevations and slope, No stormwater run-off is able to reach either culvert.

The challenge for the subject property, 6950 SE Maker Street, is that **neither** catch basin in Photo 2 and Photo 3, catch runoff from the subject property or the street, SE Maker. The one

catch basin just east of the driveway (Photo 2) is at a higher elevation than the subject's driveway and SE Maker Street. It was completely grown over from nonuse and recently cleared from weeds, i.e. St. John's Wort and ivy. This culvert doesn't collect rainwater coming down Maker Street due to the location and elevation.

The catch basin in Photo 3 is elevated in the rockery. The only way for this basin to collect stormwater is if water collection was directed in pipes to this culvert/catch basin. This storm drain is located midway below the subject property but is not located at road grade.

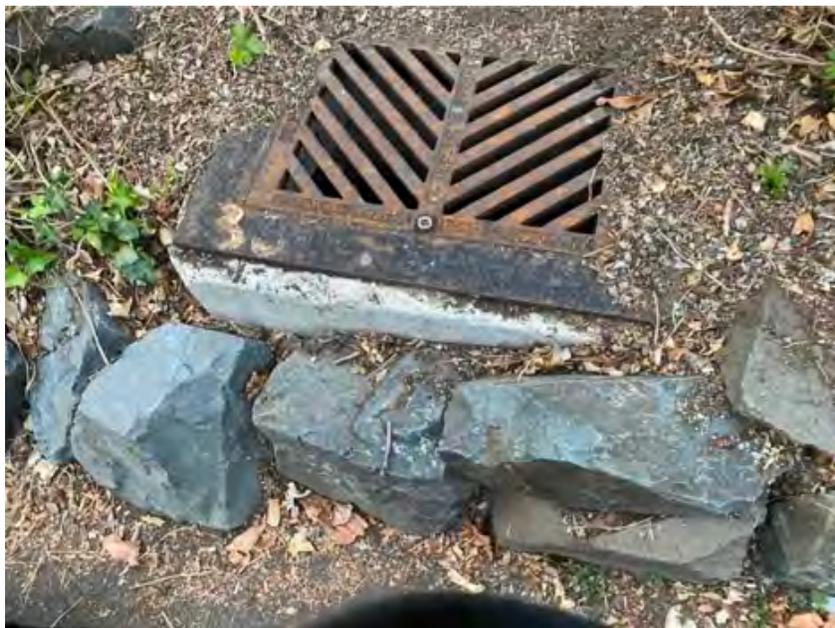
Photo of elevated catch basin on Maker Street (same culvert referred to per Photo 3 in Storm Drainage Report).

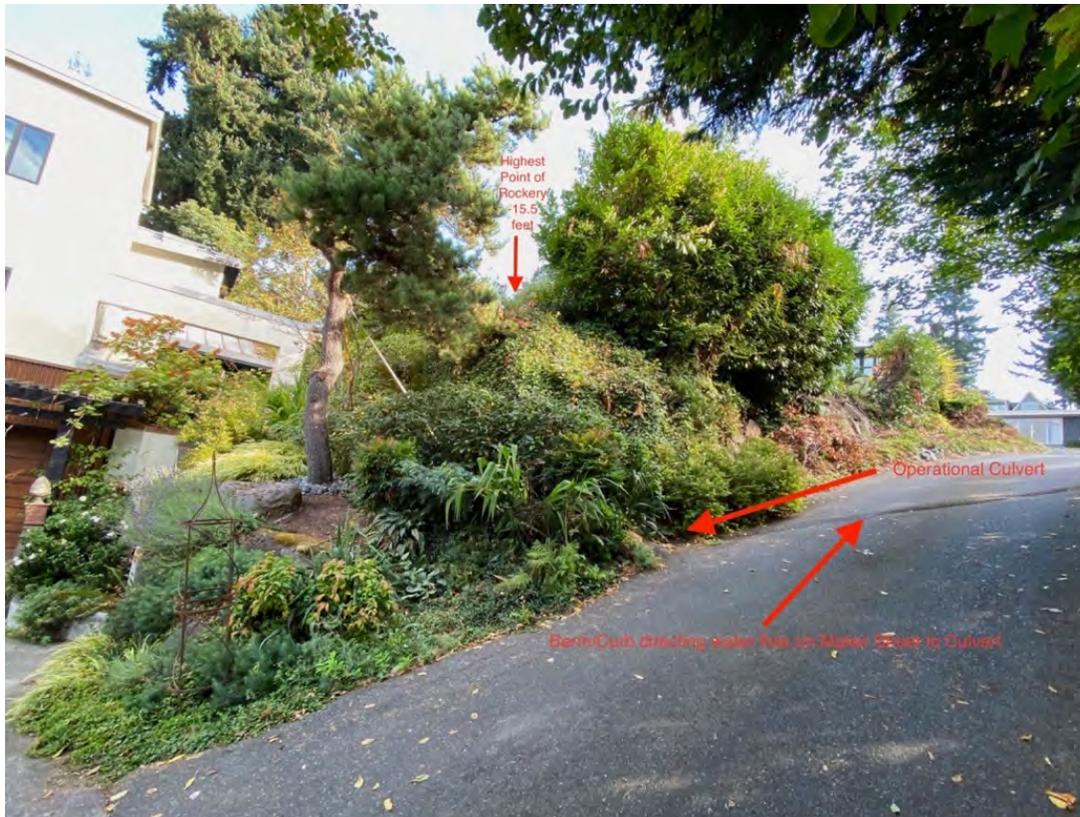
Photo of Maker Street: Looking up from house on 7030 Maker Street to adjacent uphill property, 6950 SE Maker Street. Arrows point to operational culvert and berm/curb that directs Maker Street runoff to culvert.

Therefore, we believe that the subject property should be required to tightline/pipe all stormwater during construction and construction runoff into one of the unused storm drains. In that case there is less chance that the construction project stormwater would breach the existing berms/curbs and overwhelm the two functional culverts located at 7030 SE Maker Street. See photos below and Appendix.

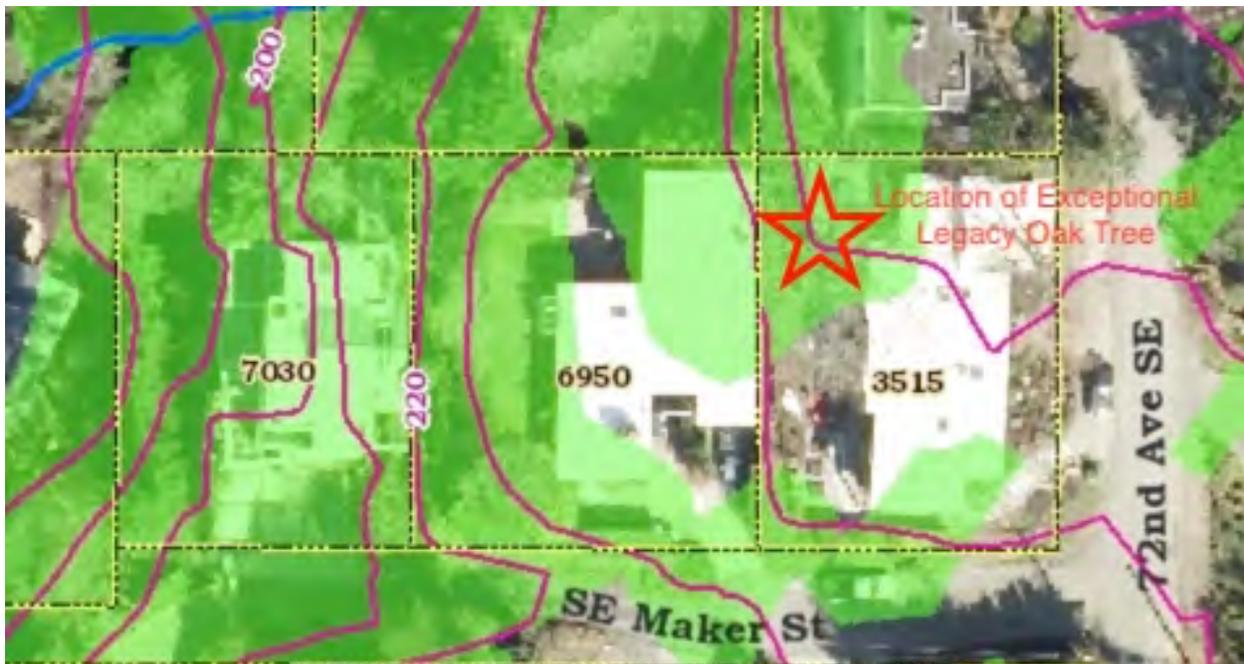
This Red Oak has a diameter of 46 Inches (measured by owner) or 3' 10" and is located on a mapped critical area (indicated in green on map) on neighbor's property (3515), adjacent to (6950) as shown on the map below:

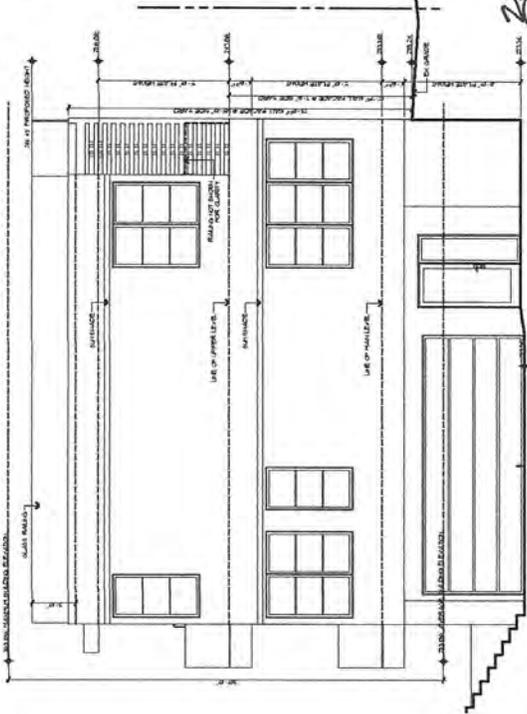
1 SOUTH ELEVATION
 SCALE 1/4" = 1'-0"

227.74 PROPOSED FINISH GRADE
 NONE OF WALL IS BELOW FF & EXIST. GRADE (COVERED)

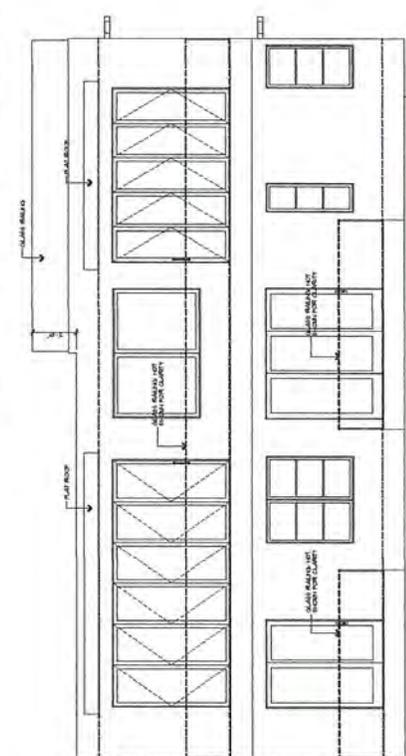
2 WEST ELEVATION
 SCALE 1/4" = 1'-0"

APPROX. 50% OF 35'-0" WALL IS COVERED

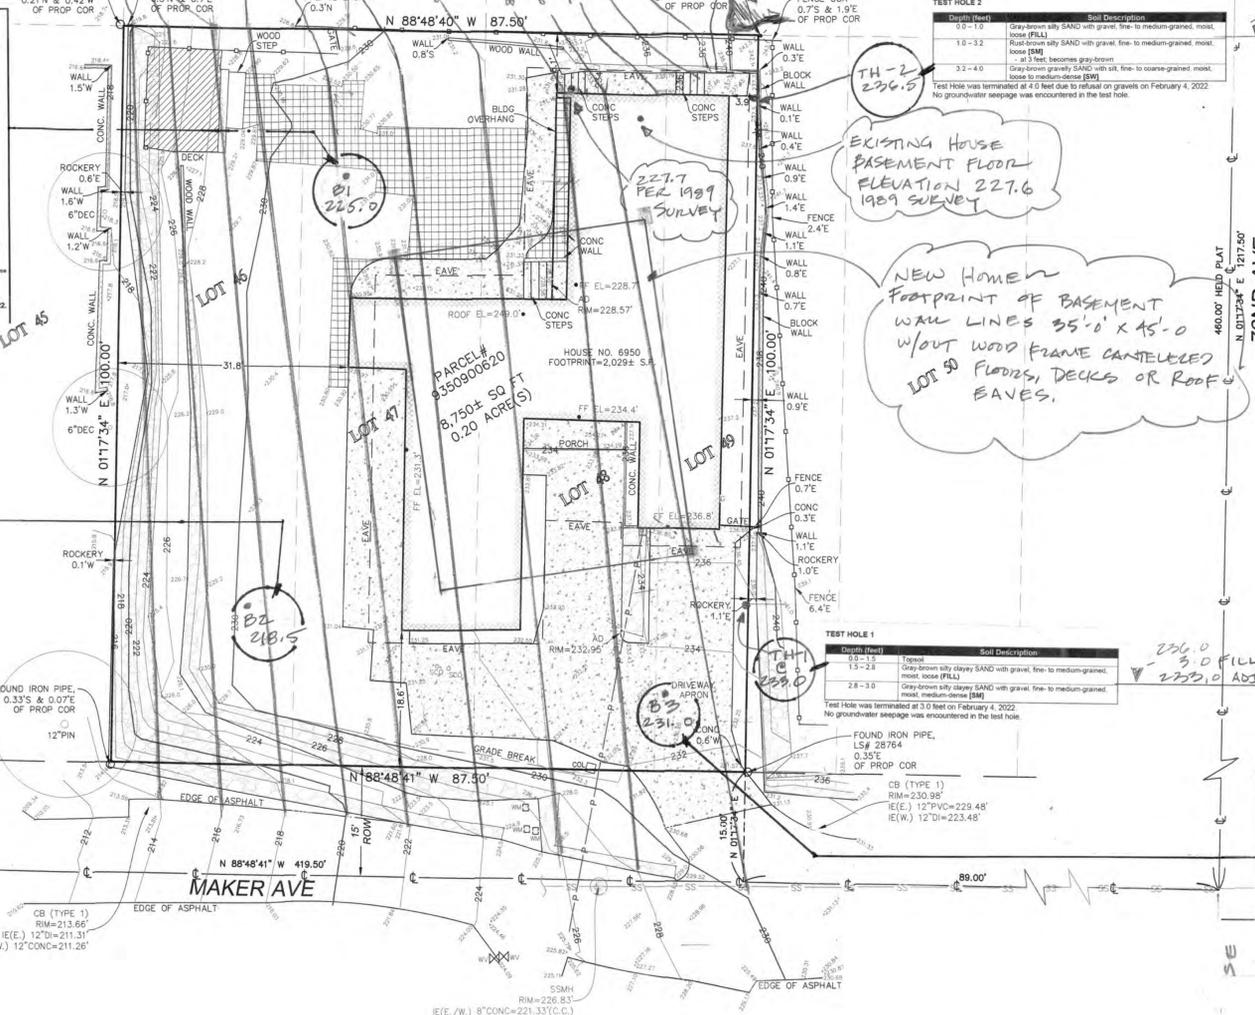
TEST BORING LOG
 6950 Southeast Maker Street
 Mercer Island, Washington

Job No. 210007 Date: Mar 2022 Prepared by: JMA
 Scale: 1"=10' Plot Date: 3/27/2021

Given the information from the boring logs and GCI’s observations about the extent of loose fills, the topography of the original sloping site begins to reveal itself. The adjusted elevations of these borings benchmark locations of a few of the original contours.

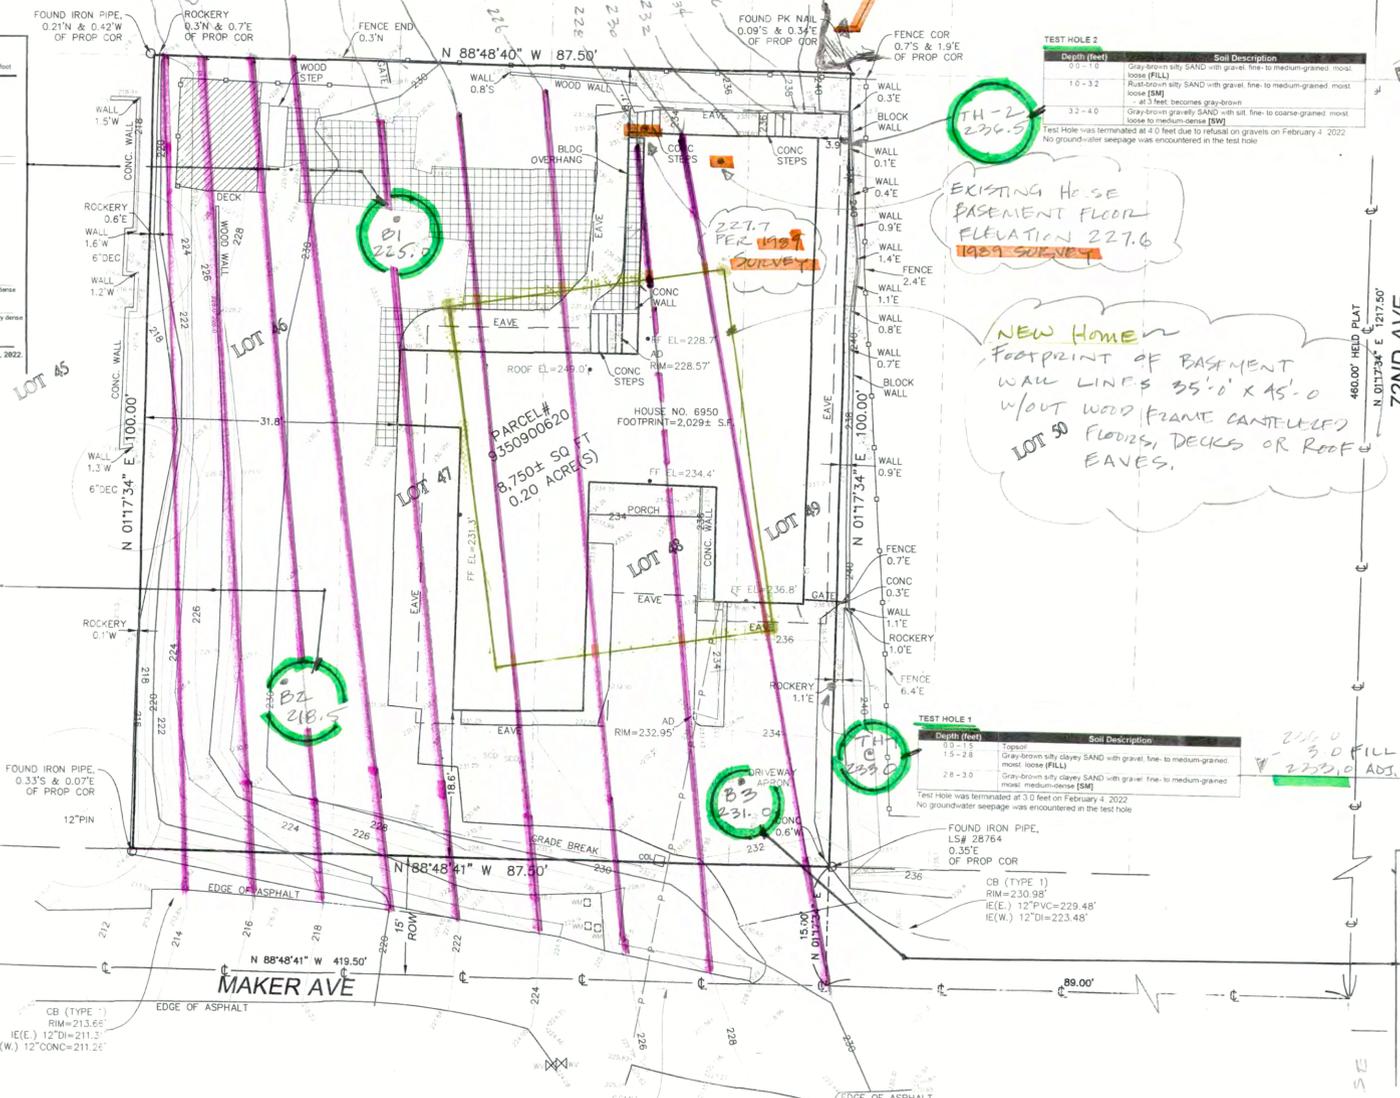
TEST BORING LOG
 6950 Southeast Maker Street
 Mercer Island, Washington

DRAWN CONTOURS TAKEN FROM:
 MAY 1989 SURVEY DR. STRONG CONSULTING
 PARCEL NO. 9350900410 ENCL'S.
 7145 SE 35TH ST.
 MERCER ISLAND, WA

EXISTING HOUSE BASEMENT FLOOR ELEVATION 227.6
 1989 SURVEY
