**TOPOGRAPHIC SURVEY**  
JAKE ZHEN LIN LI AND MOON YANGI WU  
5660 E MERCER WAY  
MERCER ISLAND, WA 98040

PROJECT NO. 17-361  
DRAWN BY: EFJ  
CHECKED BY: TNW  
DATE: 8/29/17  
SHEET 1 OF 1

**TESC PLAN**

**PRELIMINARY WALL  
 REMOVAL PLAN**

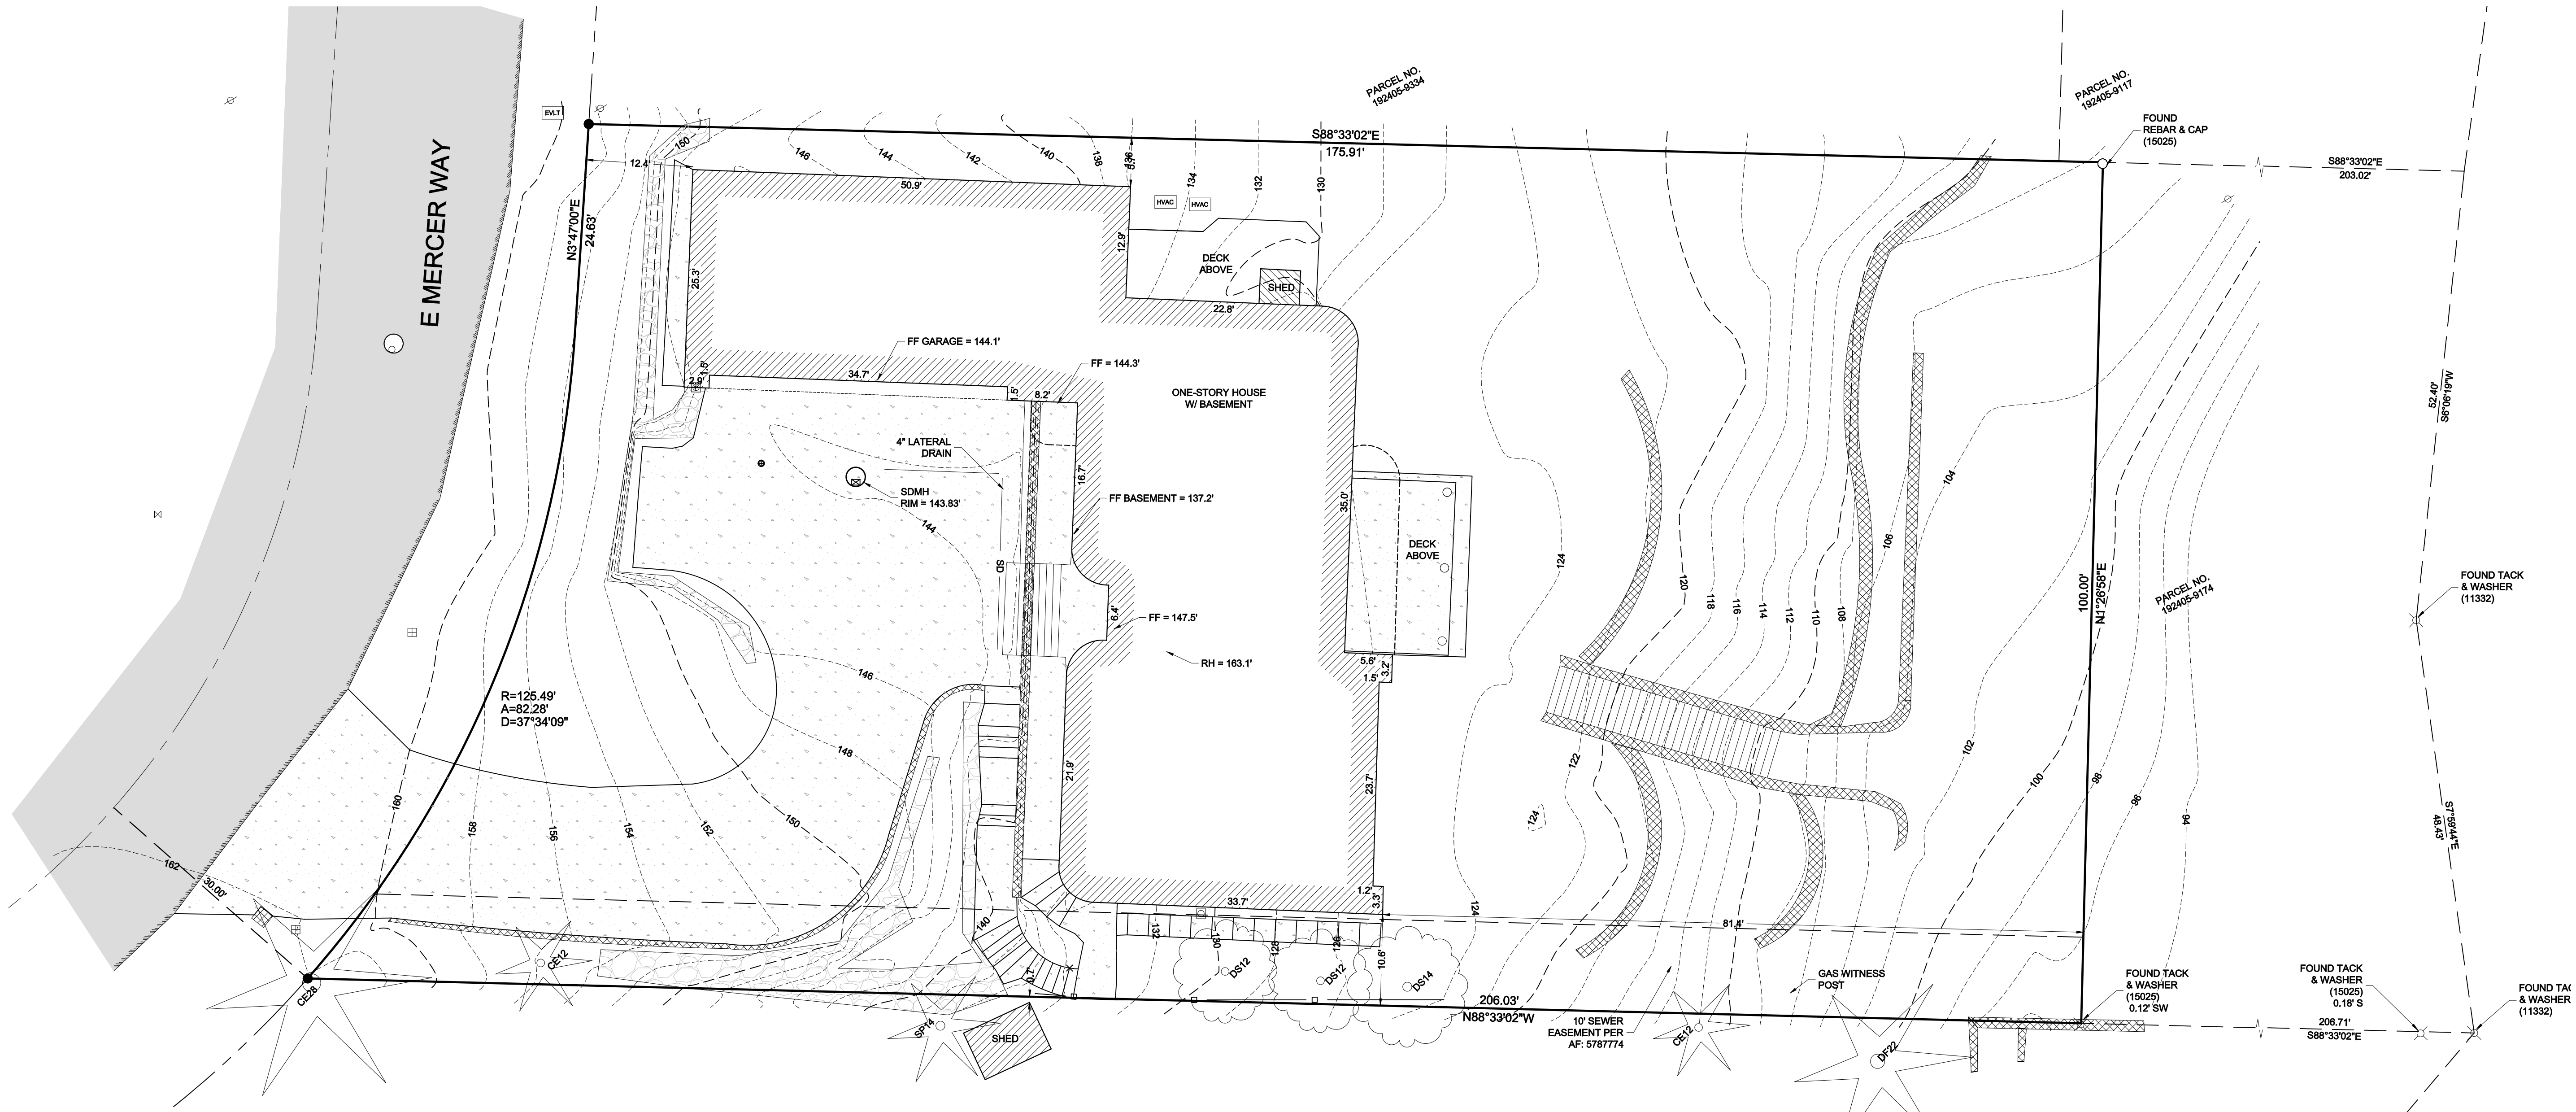
**VERTICAL DATUM & CONTOUR INTERVAL**

ELEVATIONS SHOWN ON THIS DRAWING WERE DERIVED FROM INFORMATION PROVIDED BY THE WGS SURVEY DATA WAREHOUSE.

2.0' CONTOUR INTERVAL - THE EXPECTED VERTICAL ACCURACY IS EQUAL TO 1/2 THE CONTOUR INTERVAL OR PLUS / MINUS 1.0' FOR THIS PROJECT.
