Klein Residence

King County Parcel: 362350-0226
Mercer Island, WA

Technical Information Report For Off-site Drive

October 2018

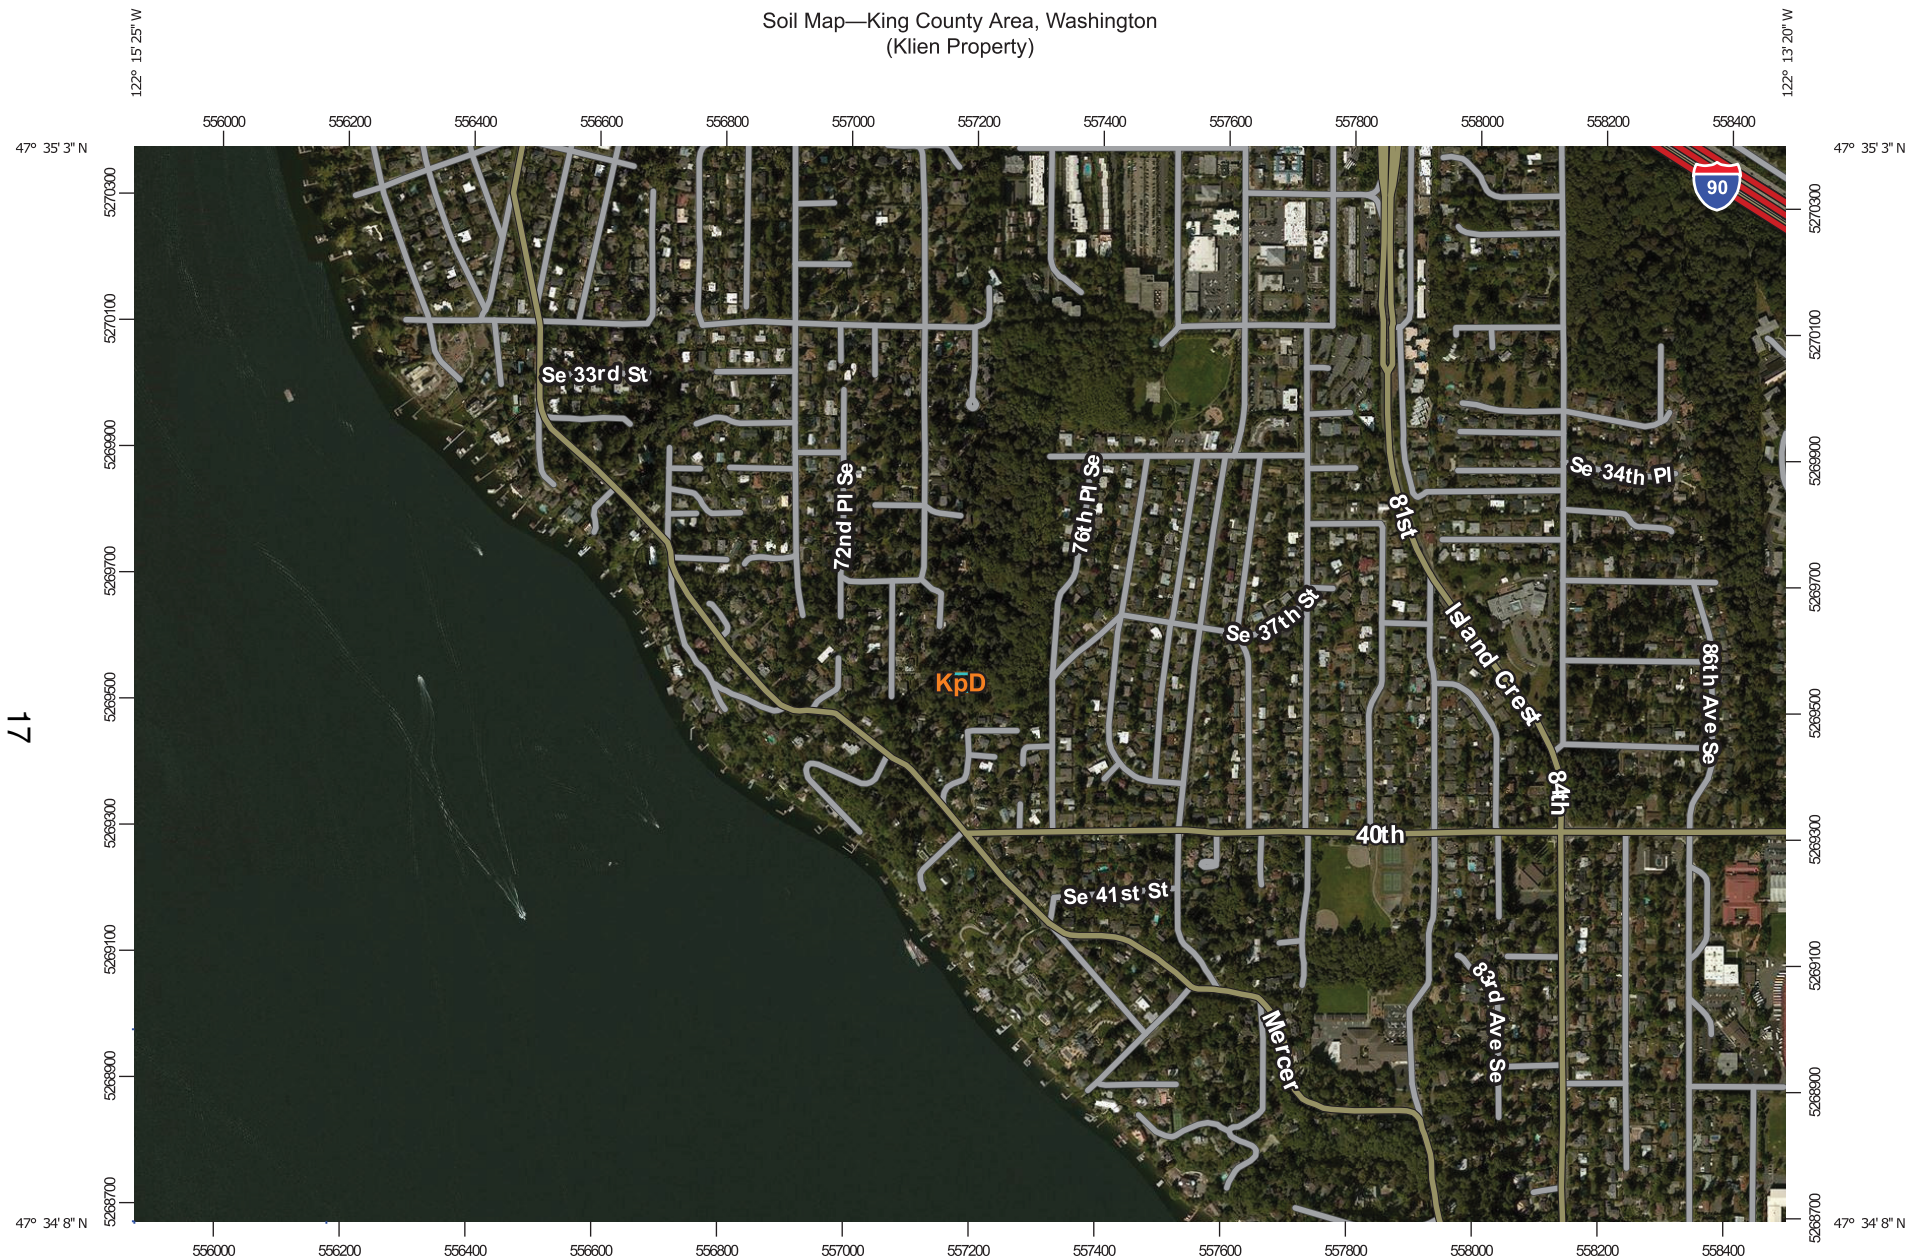
Soil Map—King County Area, Washington
(Klien Property)

Map Scale: 1:12,000 if printed on A landscape (11" x 8.5") sheet.

Research on the soils from Web Soils Survey NRCS indicates that the project parcel is underlain with KpD-Kitsap Silty Loam and Silty Clay soils up to a depth of 5. The hydrologic group is C. The infiltration rates for such soils are very limited. Please see the soils map for the site and associated engineering properties included in the appendix.
