LITCHFIELD ENGINEERING

TECHNICAL INFORMATION REPORT for the BCH 93rd AVENUE PROJECT

Prepared By:
Keith A. Litchfield, P.E.

Date Issued: March 30, 2021
Date Revised: May 25, 2021

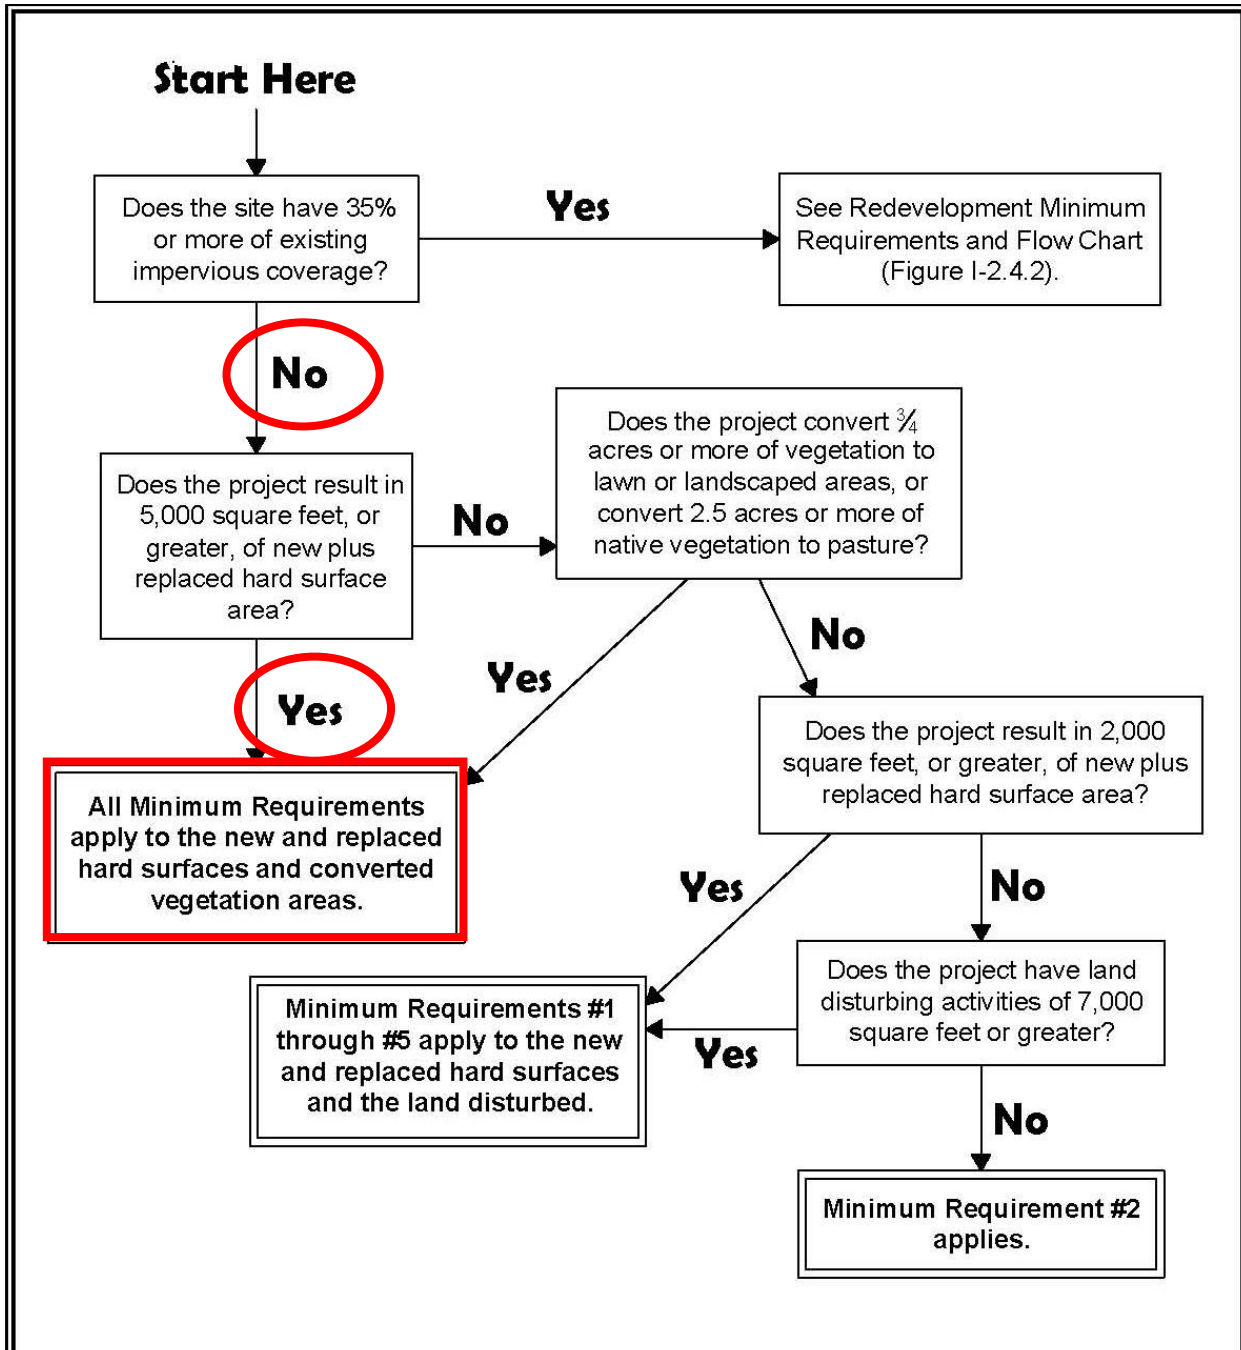
Figure I-2.4.1
Flow Chart for Determining Requirements for New Development

Flow Chart #1: Flow Chart for Determining Requirements for New Development was utilized to determine which requirements apply to the project. Per Flow Chart #1 all Minimum Requirements apply to the new and replaced hard surfaces and converted vegetation areas. Please refer to page #4 for Flow Chart #1.

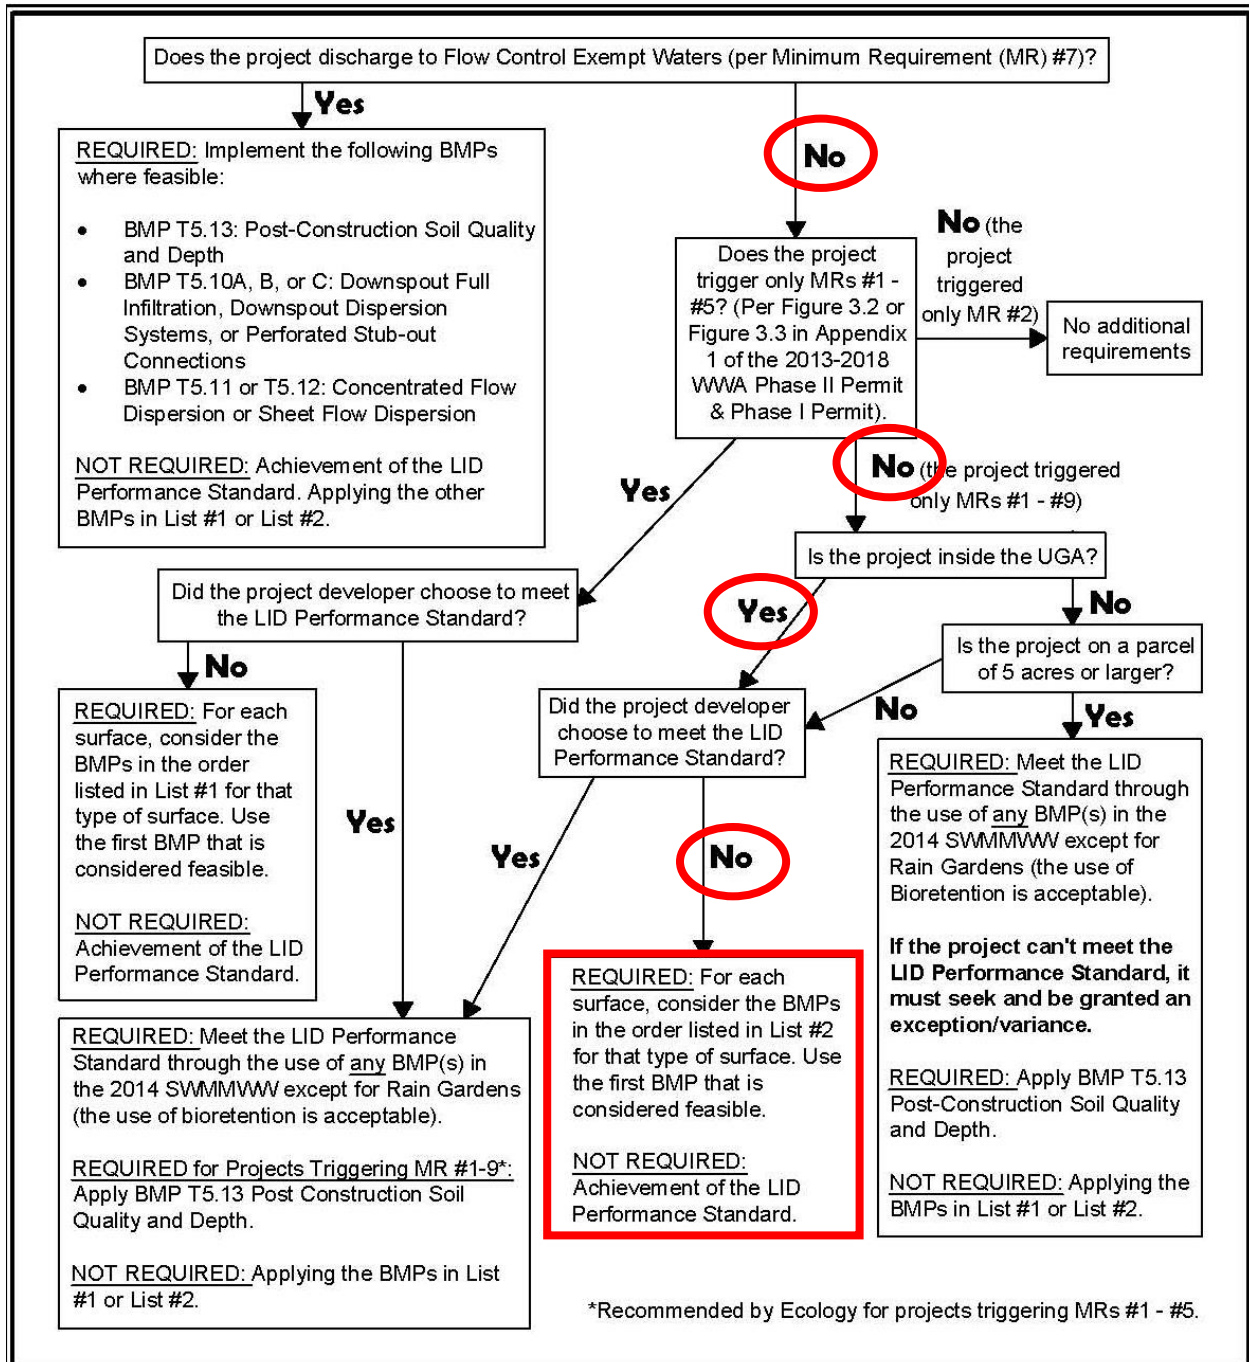
Flow Chart #2:

*Recommended by Ecology for projects triggering MRs #1 - #5.

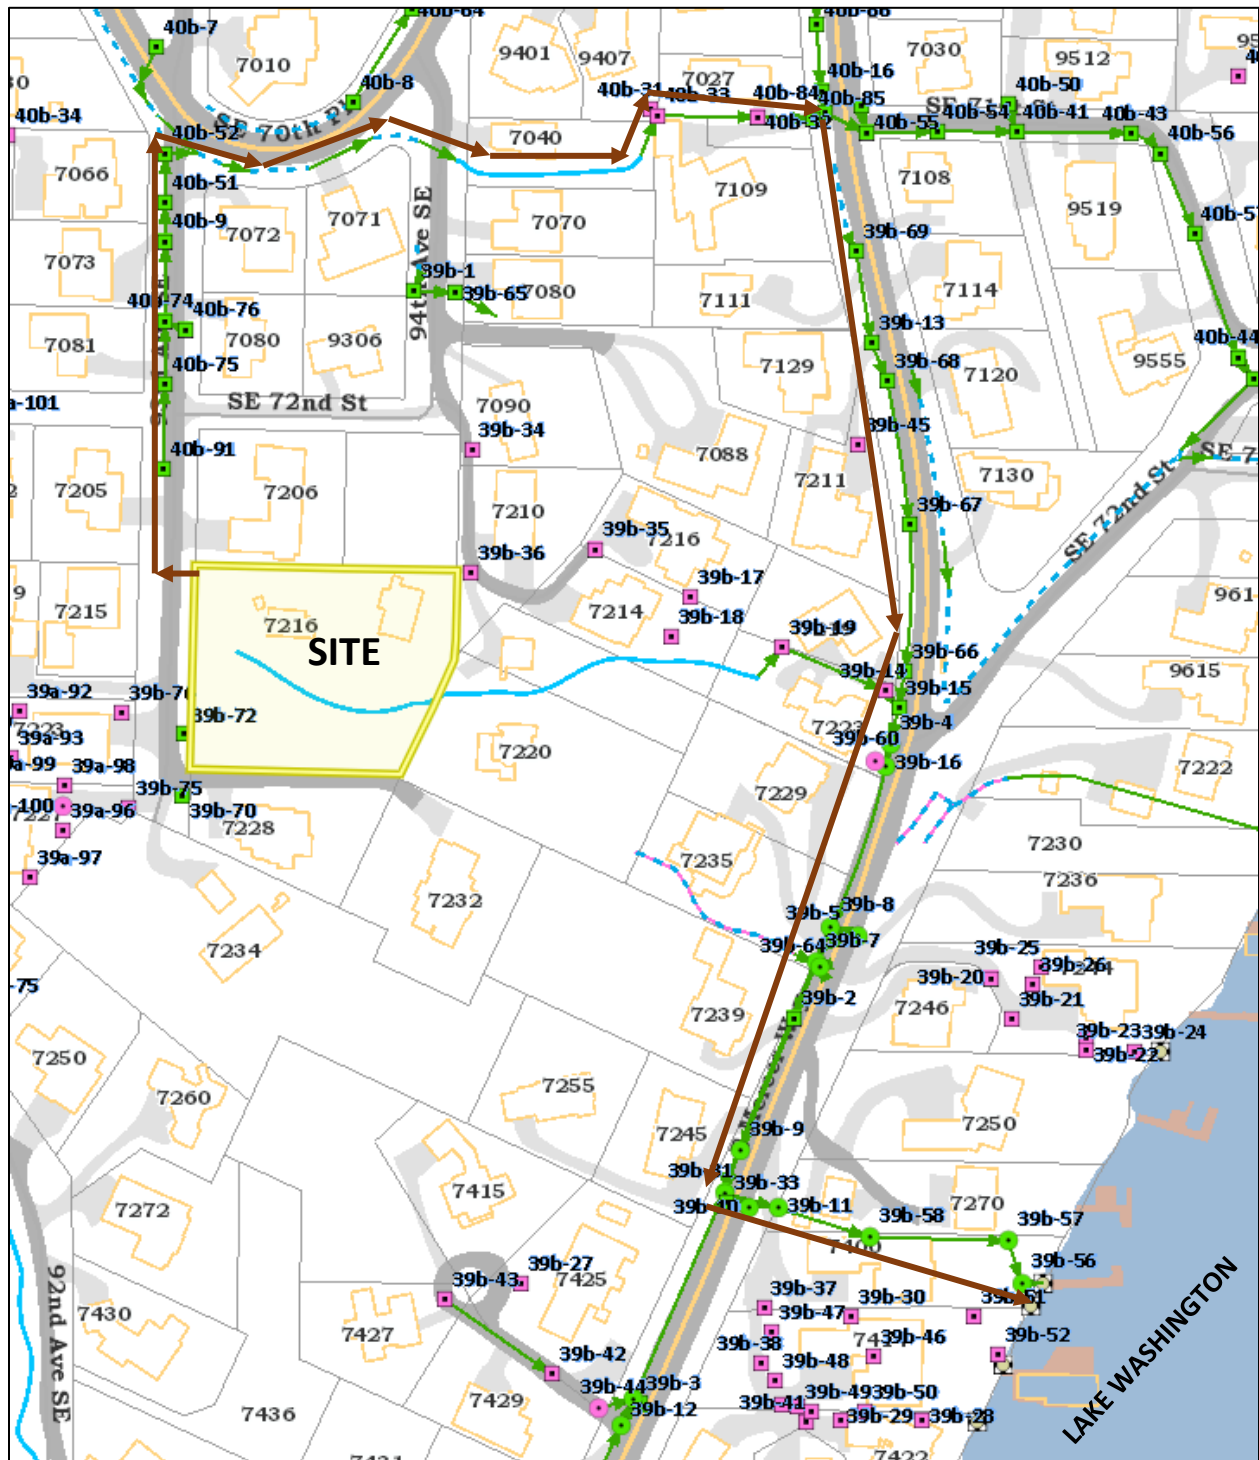
Figure 2 – Downstream Map

FIGURE 1	VICINITY MAP
FIGURE 2	DOWNSTREAM MAP

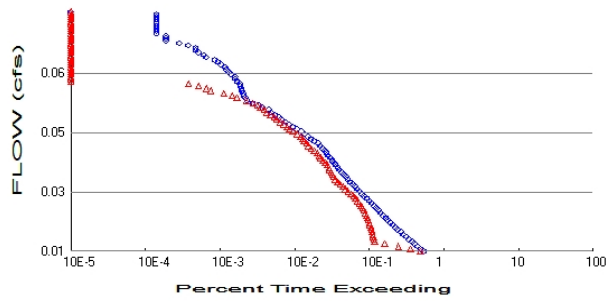
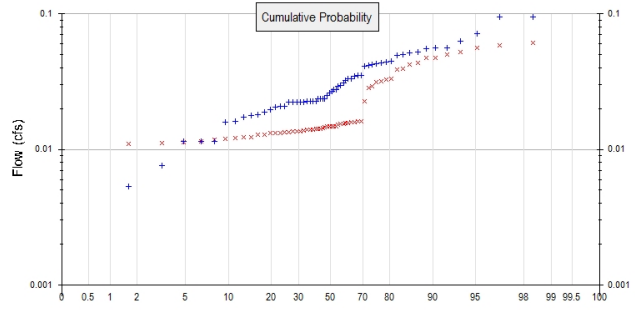
POC 1

Analysis Results

+ Predeveloped x Mitigated

Flow(cfs)	Predev	Mit	Percentage	Pass/Fail
0.0143	11424	10307	90	Pass
0.0150	10371	7602	73	Pass
0.0156	9441	5227	55	Pass
0.0163	8630	3418	39	Pass
0.0169	7948	2513	31	Pass

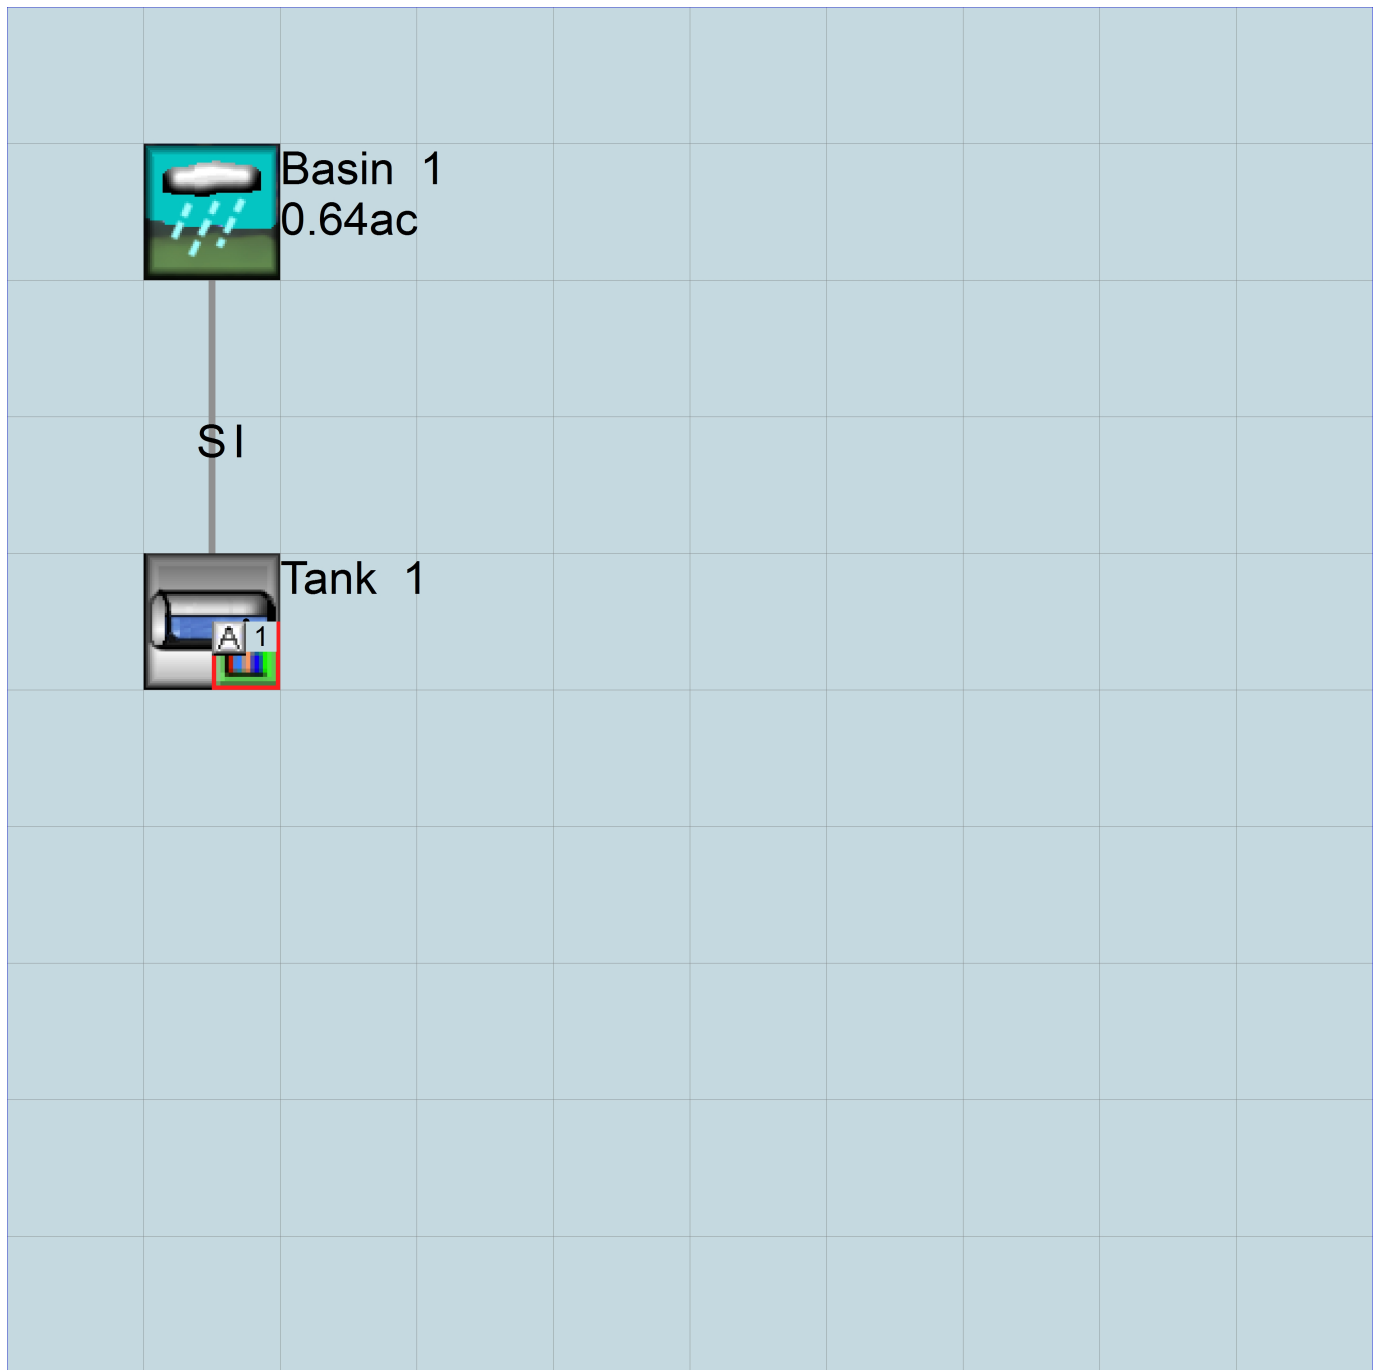
Basin 1
0.64ac

Mitigated Schematic

The detention tank system was designed for the drainage basin using WWHM. The proposed detention tank is 67 LF and 10' diameter. Please see Appendix A for the complete WWHM tank analysis. The discharge from the proposed detention tank will be pumped to an onsite catch basin located in the northwest corner of the site. The catch basin will convey runoff via gravity to the existing public conveyance system within 93rd Ave SE. In order to provide gravity flow, approximately 314 feet of the existing conveyance system will need to be replaced.

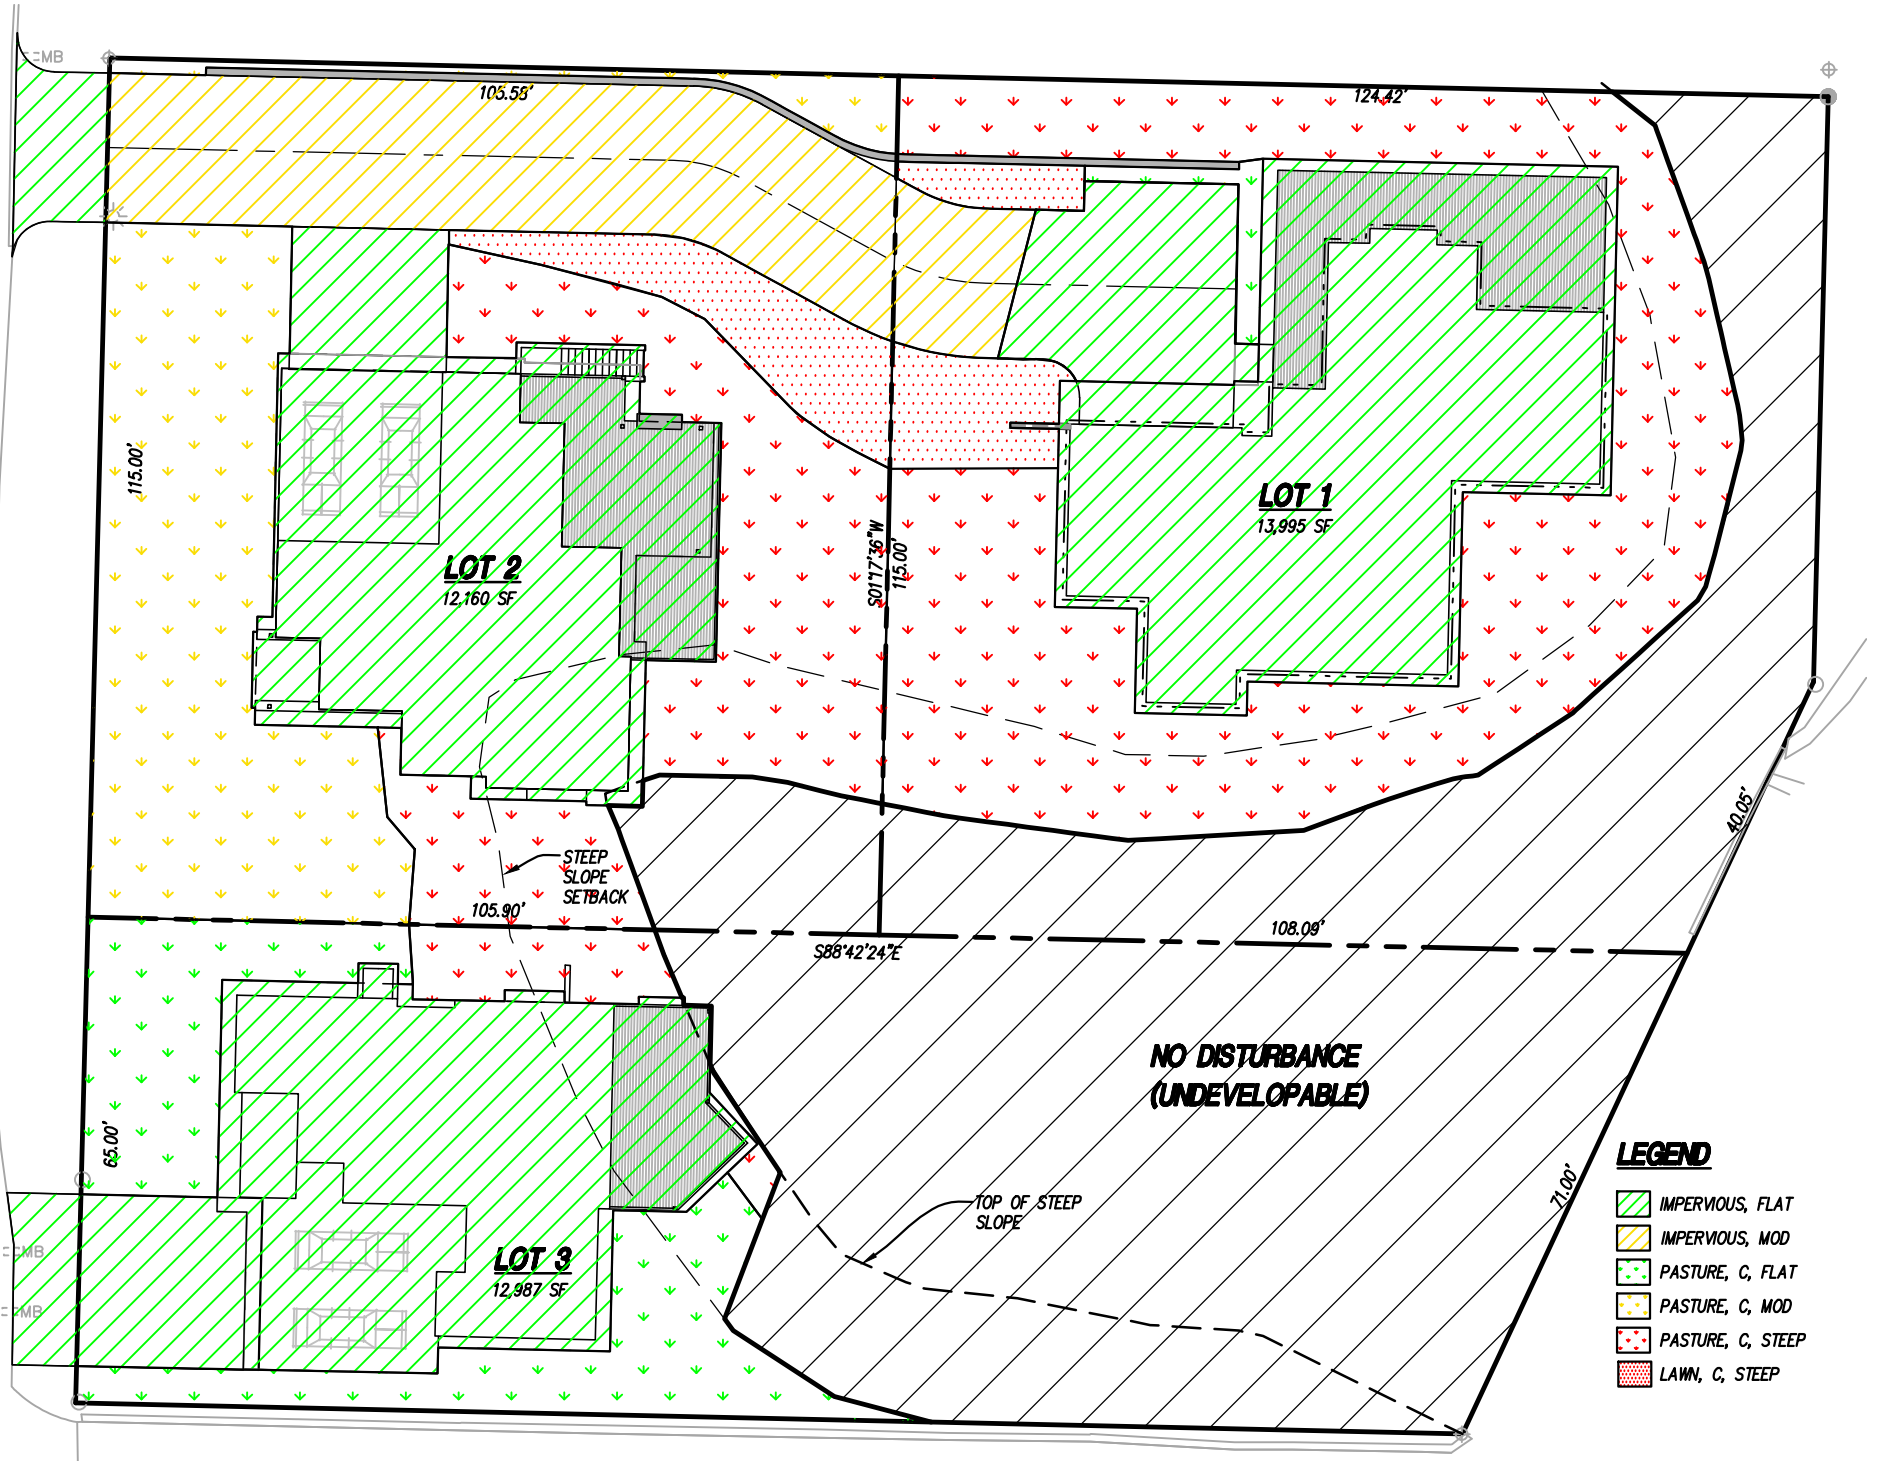
BCH 93rd SHORT PLAT MODELING AREAS EXHIBIT

Since the project is proposing greater than 10,000 square feet of effective impervious surface a formal flow control facility is required. The site was analyzed using the Western Washington Hydrology Model (WVHM) provided by the Department of Ecology (DOE). The project site is located in a Level 2 Flow Control Area, therefore forested conditions have been used for the pre-developed modeling analysis. The hydrologic analysis of the site was completed in order to determine the on-site detention necessary to account for the increase in the peak storm release rate for the developed site. Please note for the purpose of this analysis only the developable area of the site was used, as the steep slope areas and associated buffers will not be disturbed. As discussed, given the topography of the existing project site, a single drainage basin was analyzed for the project. Per Appendix III – C: Washington State Department of Ecology Low Impact Development Flow Modeling Guidance, C-9 Soil Quality and Depth, pervious areas that meet the requirements for BMP T5.13 may be modeled as pasture. Therefore, the pervious areas to be amended per BMP T5.13 have been modeled as pasture. The site basin criterion is summarized below. Refer to Appendix A for a detailed depiction of the project’s WVHM modeling areas.
