# **MOUNGER RESIDENCE**

4006 East Mercer Way

## Storm Drainage Report

Mercer Island, Washington November 16, 2021

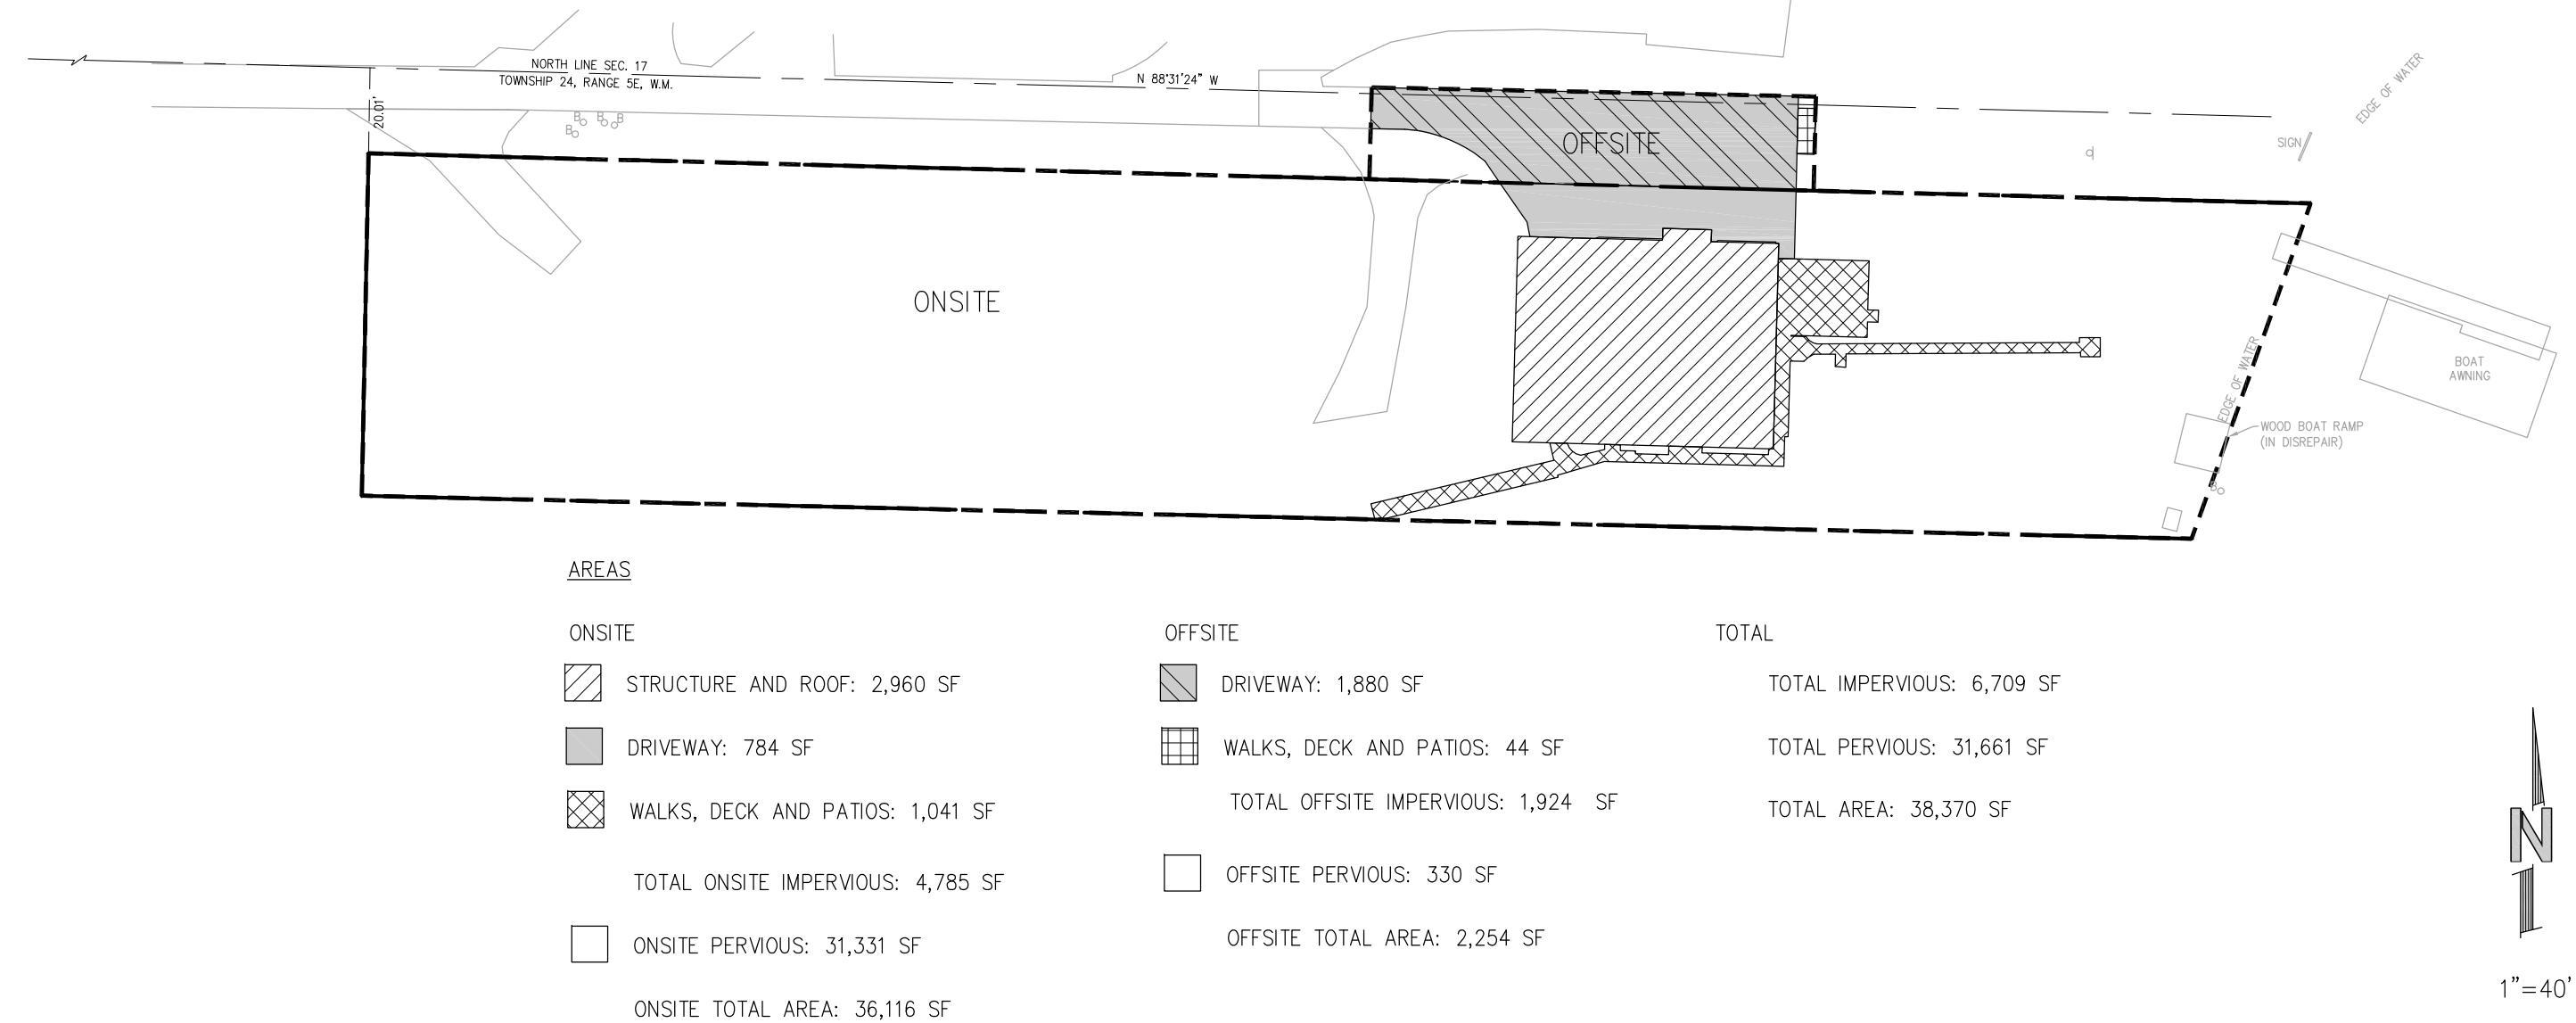
# EXISTING **IMPERVIOUS AREA**

The existing property is 13 percent impervious. Impervious areas include the building roof, concrete driveway, patios and footpaths. There is also a boat dock with awning. Existing lawn and landscaping east of the house slopes down to the water's edge. There is no bulkhead. The area west of the house is wooded.

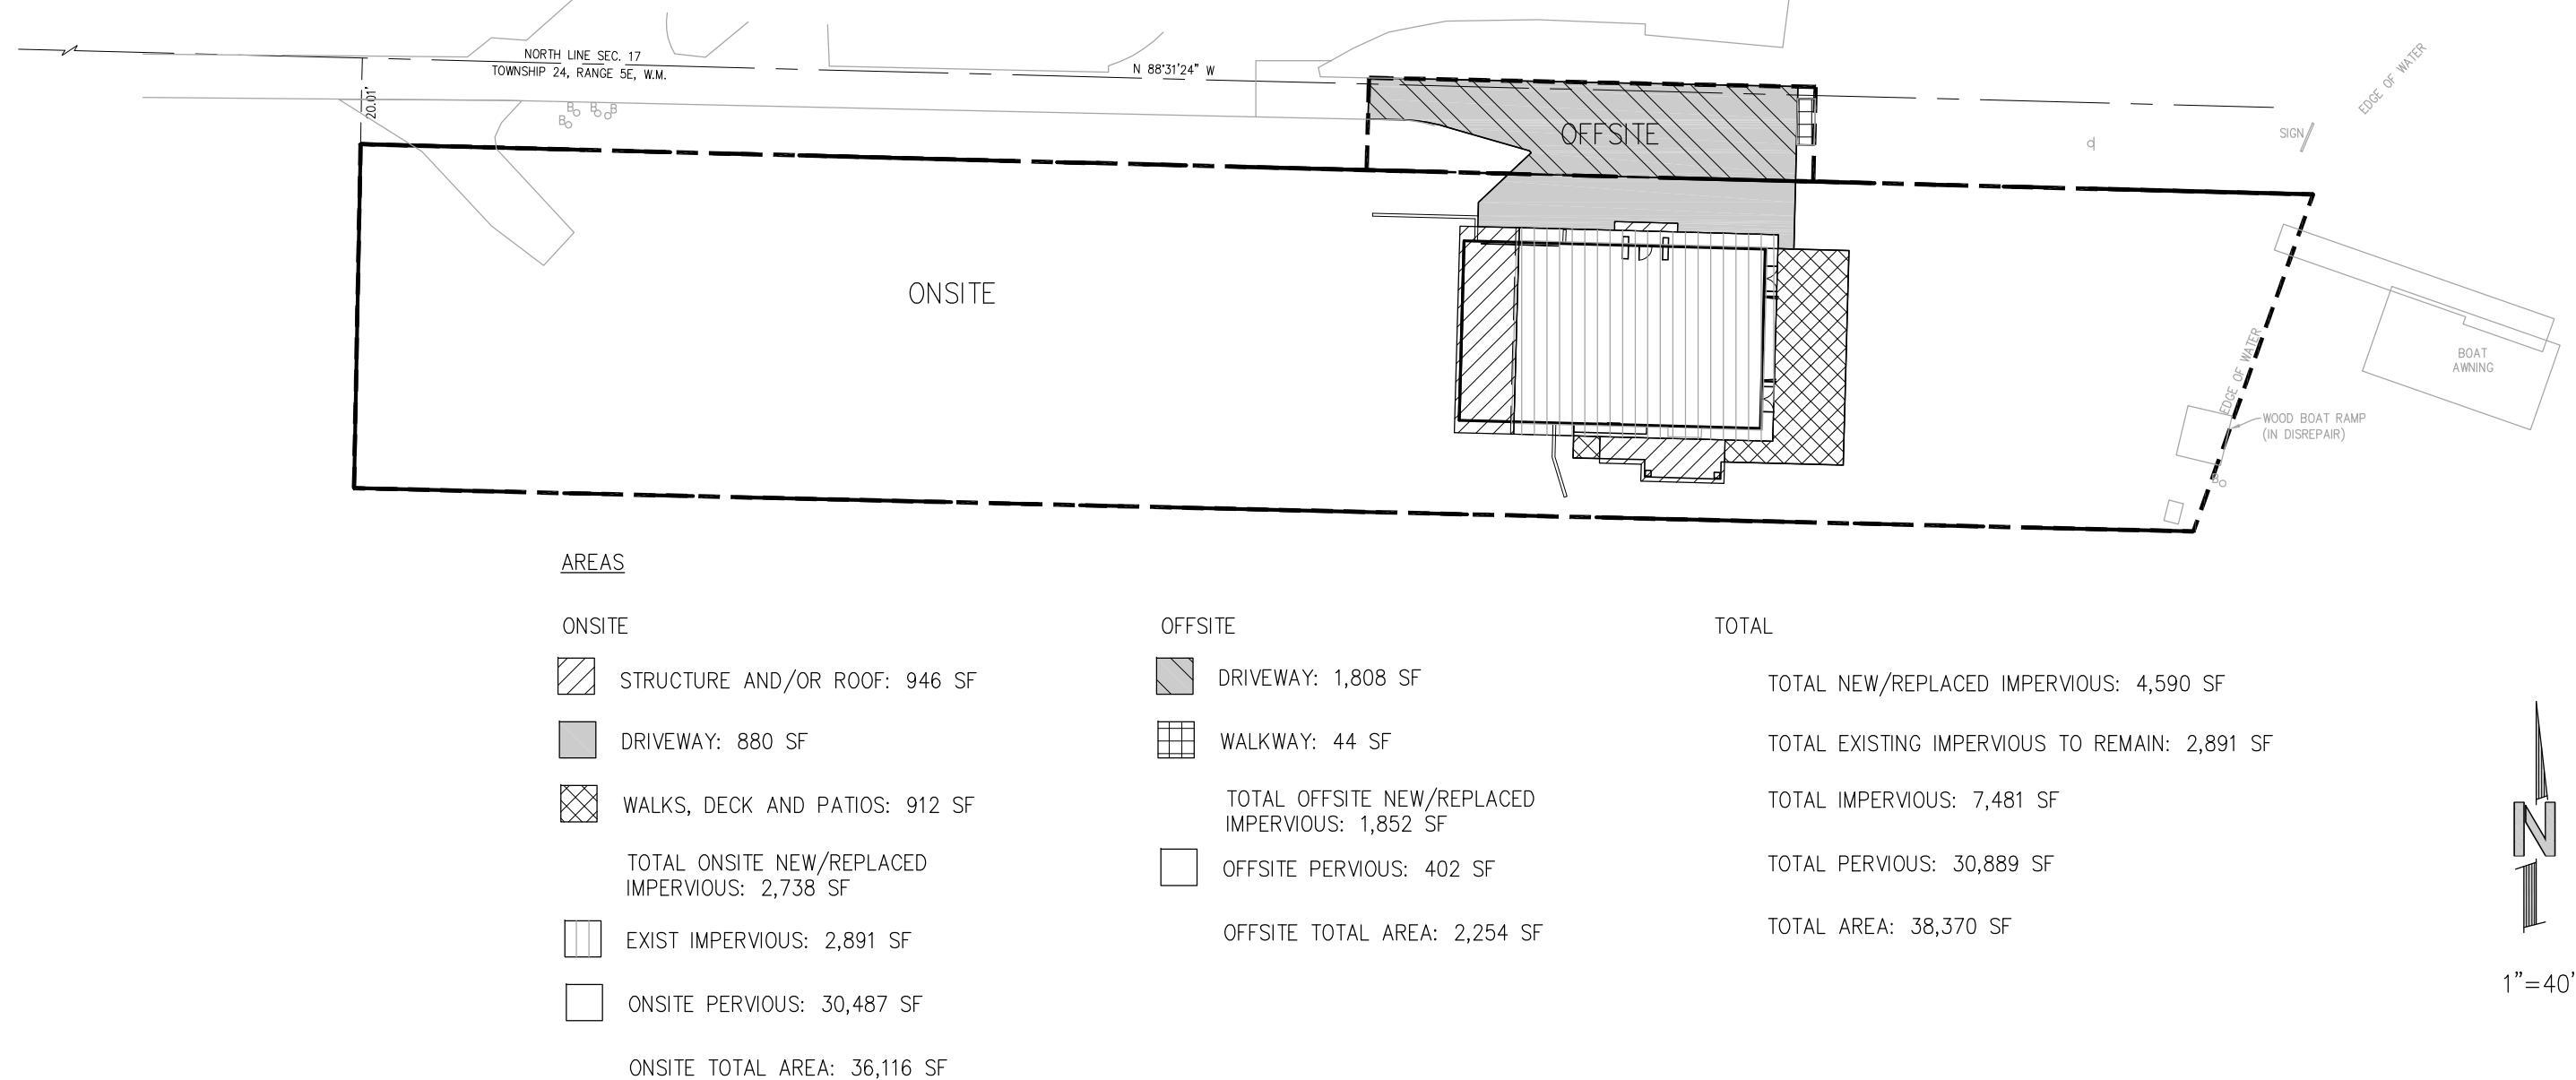
# DEVELOPED **IMPERVIOUS AREA**

Development of the site and right-of-way will create an additional 772 square feet of impervious area. The onsite impervious area will increase to 16%. Impervious area will include the existing house roof, the new addition with associated roof, new roof over patios and the entry, new driveway, and new uncovered patios.

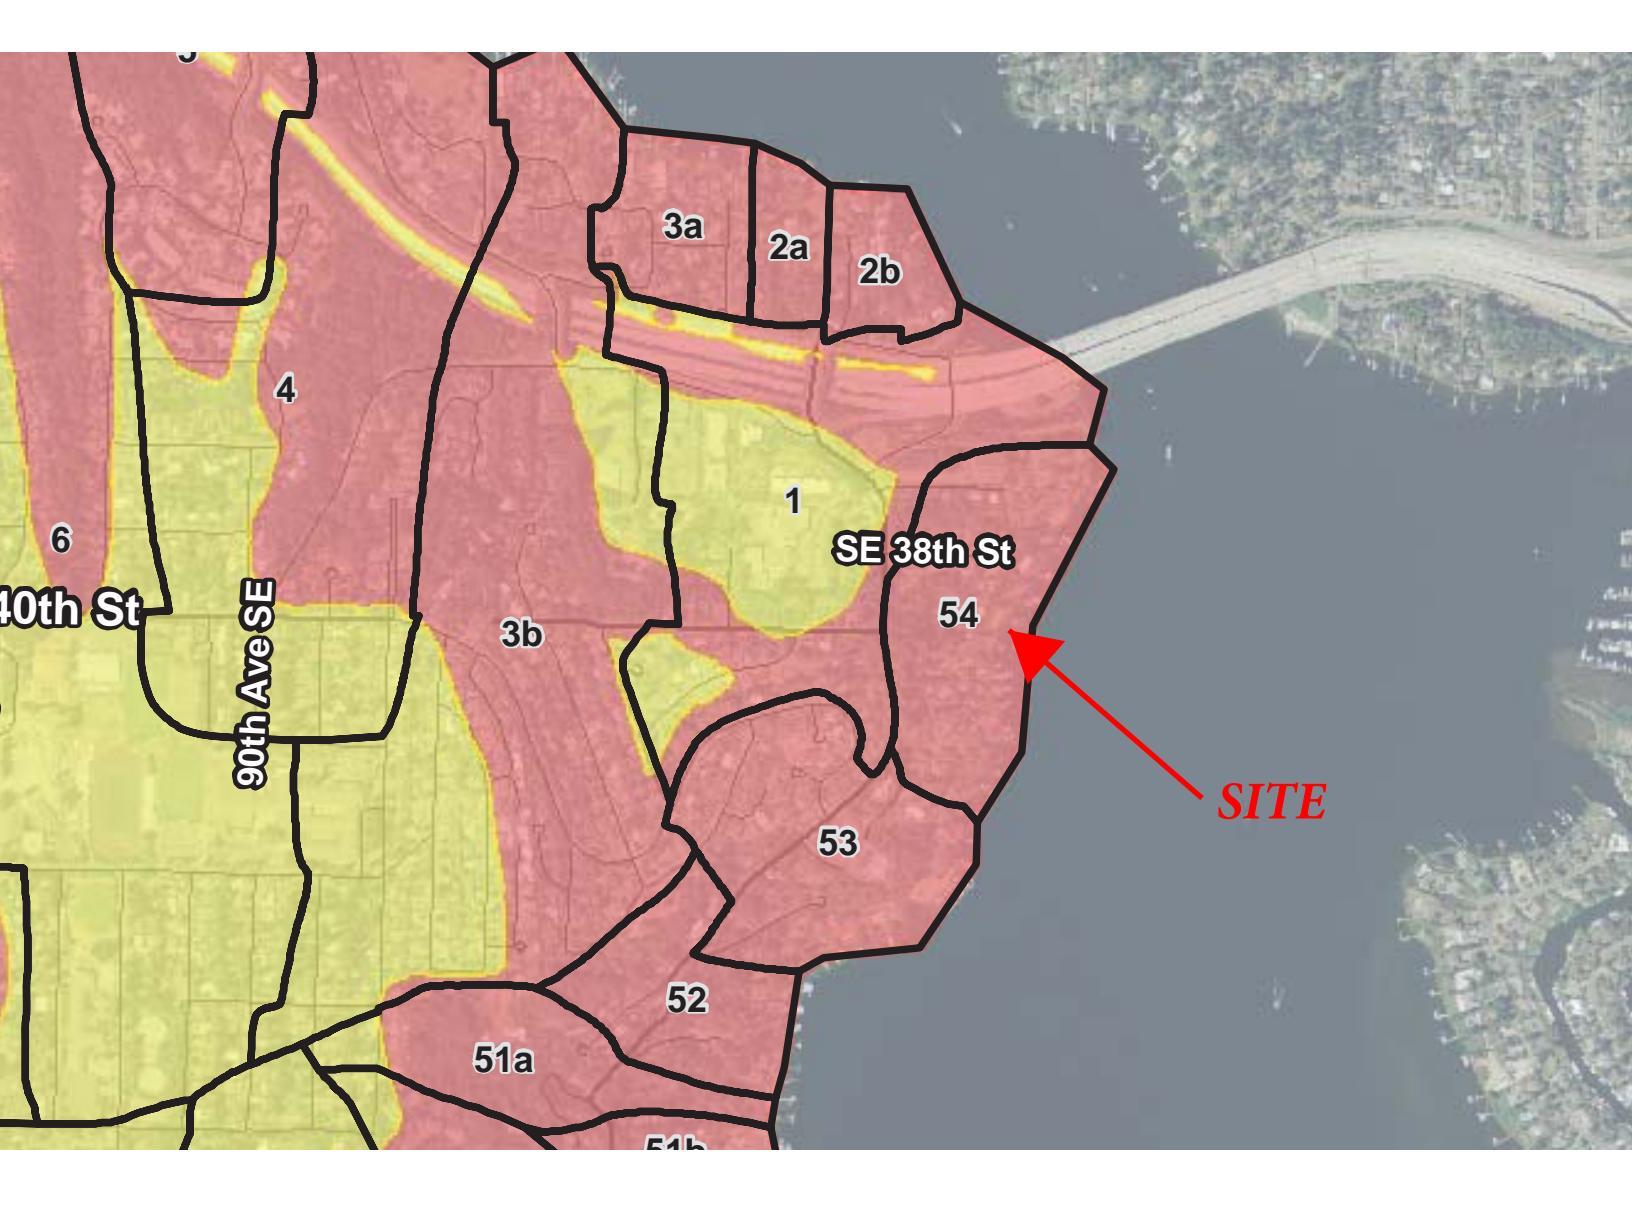
## LID Infeasibility Map

The existing terrain west of the house slopes down to the east at about 20%, steepening as it approaches the house pad. The landscaped area between the house and the lake also slopes at an average of 20%. Soil type is Kitsap Loam according the NRCS. The site is in an area mapped as Infiltrating LID Facilities Not Permitted on the City's map.

The site is in an area mapped as Infiltrating LID Facilities Not Permitted on the City's map.

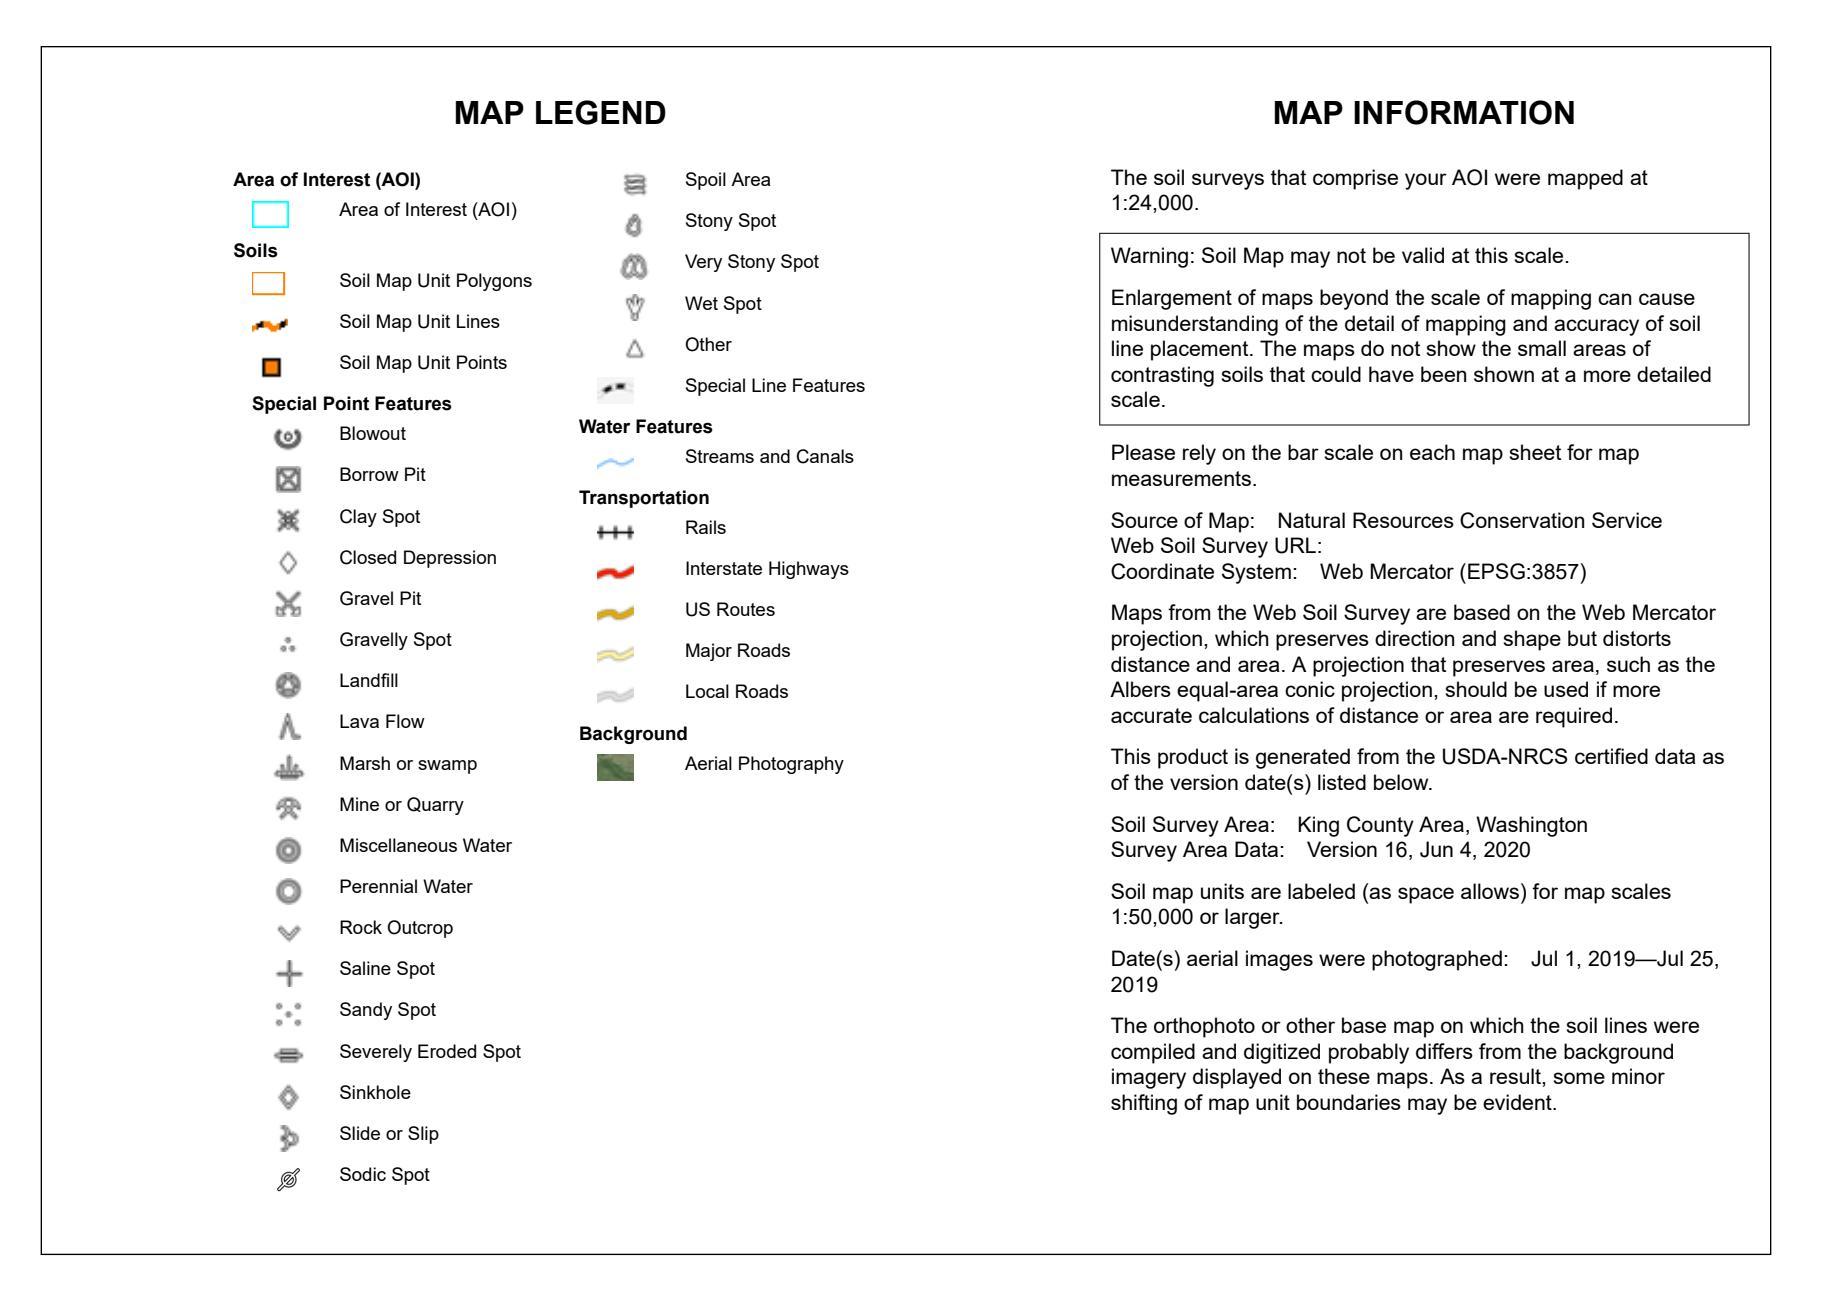
Map Unit Symbol	Map Unit Name	Acres in AOI	Percent of AOI	
AgC	Alderwood gravelly sandy loam, 8 to 15 percent slopes	4.5	10.0%	
КрВ	Kitsap silt loam, 2 to 8 percent slopes	22.1	49.0%	
КрС	Kitsap silt loam, 8 to 15 percent slopes	0.5	1.2%	
КрD	Kitsap silt loam, 15 to 30 percent slopes	9.4	20.9%	
Totals for Area of Interest		45.0	100.0%

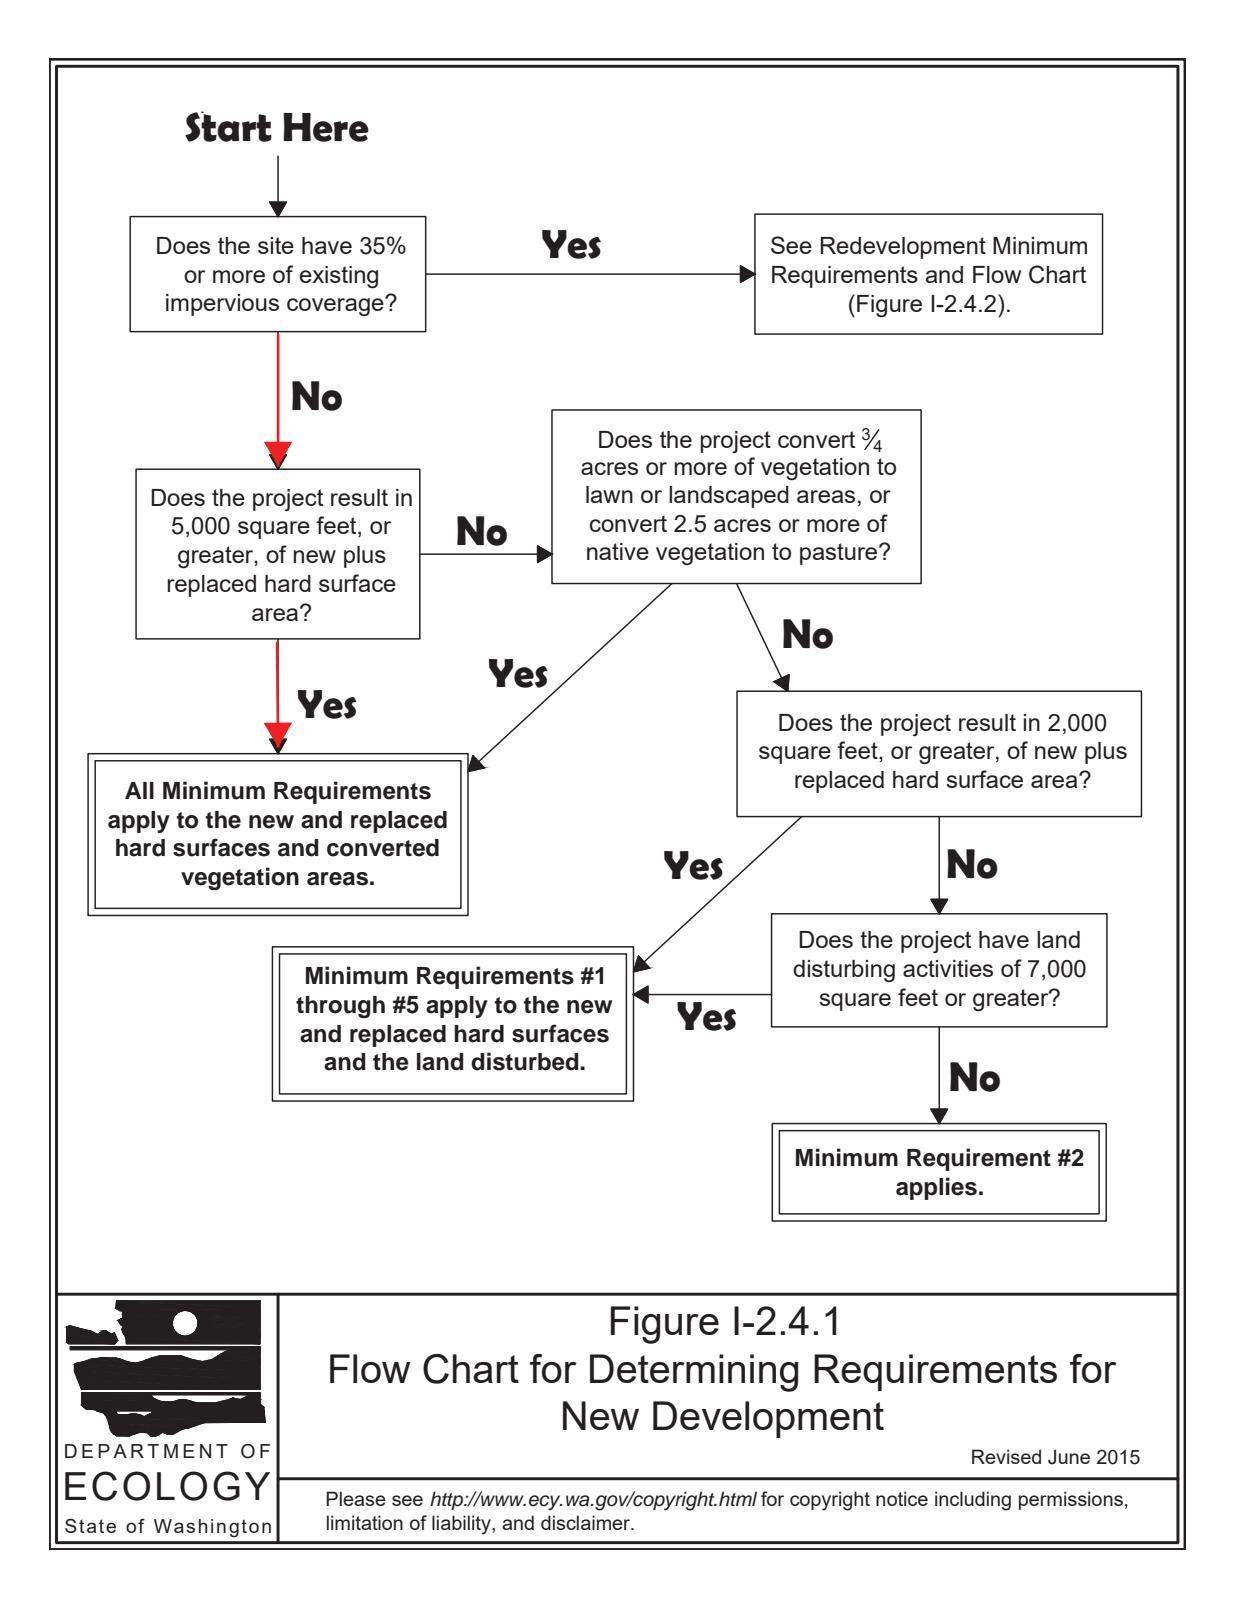
# Figure I-2.4.1 Flow Chart for Determining Requirements for New Development

Per Figure I-2.4.1 of the 2014 DOE Stormwater Management Manual for Western Washington, the project is required to meet all Minimum Requirements.

The project is classified as a New Development project (existing impervious area is 17%, inclusive of site and disturbed offsite area) with 772 square feet of new impervious area and 3,818 square feet of replaced impervious area. The quantity of new plus replaced hard surface (4,590 square feet) is less than 5,000 square feet. The project therefore is required to comply with Minimum Requirements #1 through #5 of the 2014 DOE manual.
