**3603 W Mercer Way Mercer Island, WA 98040**

## **Drainage Report**

**October 3<sup>rd</sup>, 2017**

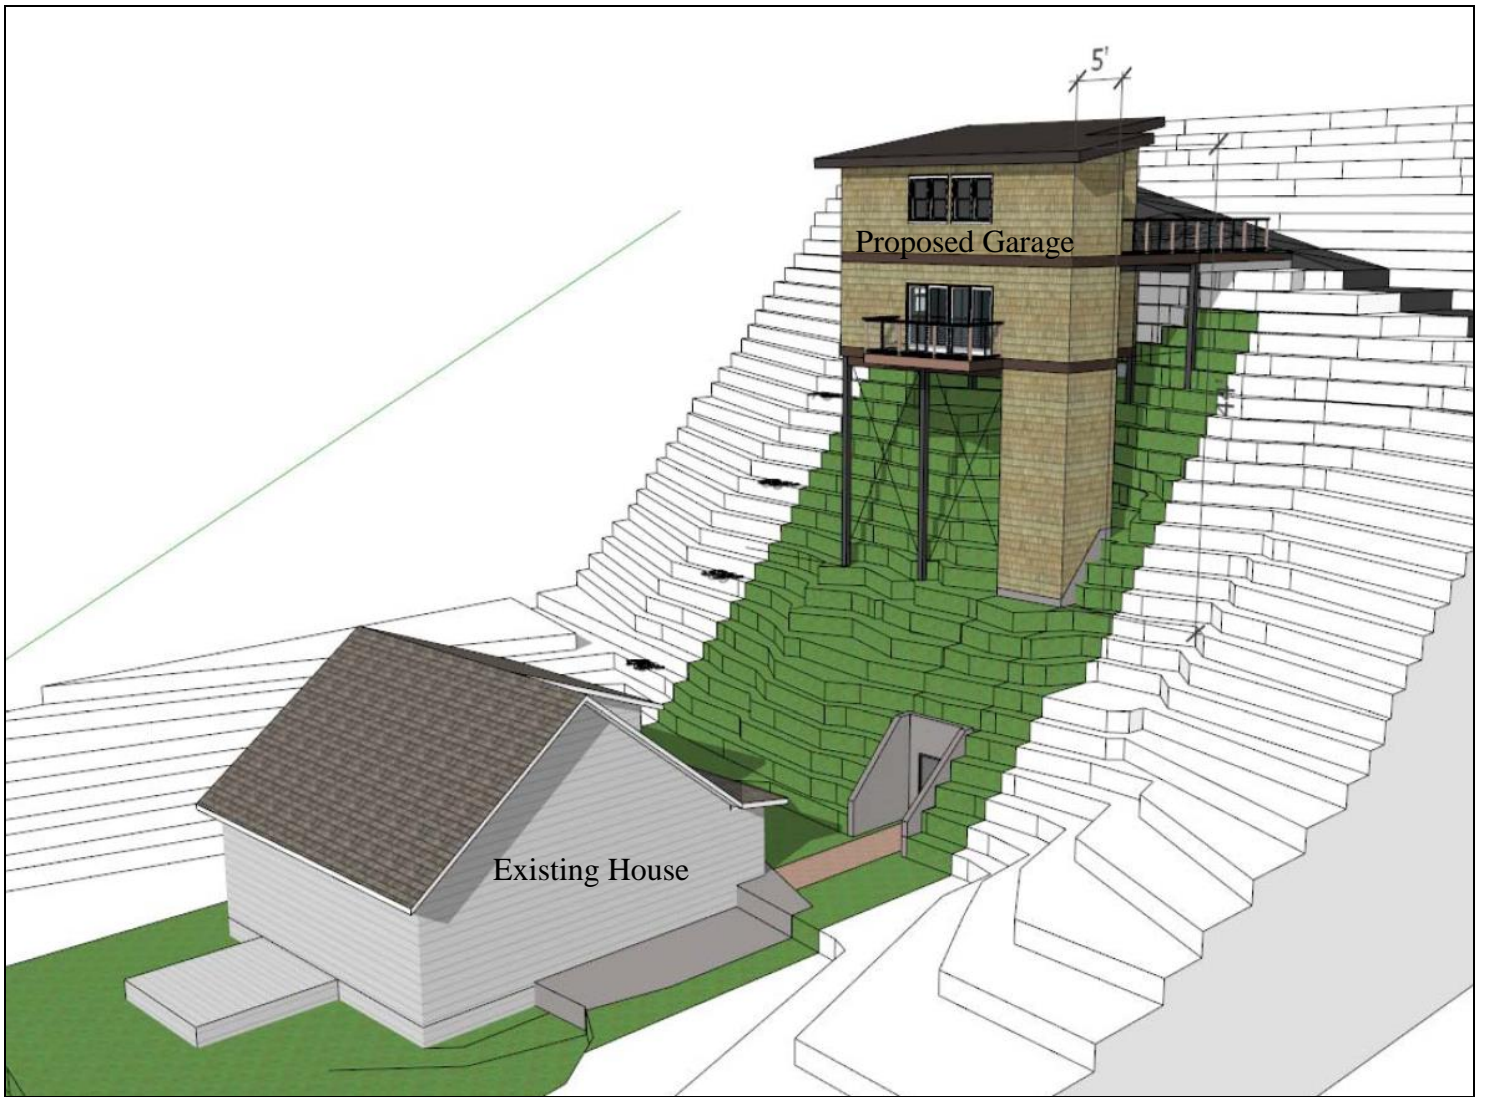
Figure 2

Our understanding of the project is based on telephone and email correspondences with you; a review of the proposed site plan and grading plan; our understanding of the City of Mercer Island Critical Areas Ordinance and Site Development codes; and our past experience on the Mercer Island. We understand that you propose to construct a new detached garage. The garage will be constructed at grade with the existing private driveway that bisects the upper, eastern portion of the site. Because of slopes on the site, the garage will be constructed on posts and pilings with a structural deck. A conceptual plan showing the proposed garage configuration is attached as Figure 2.

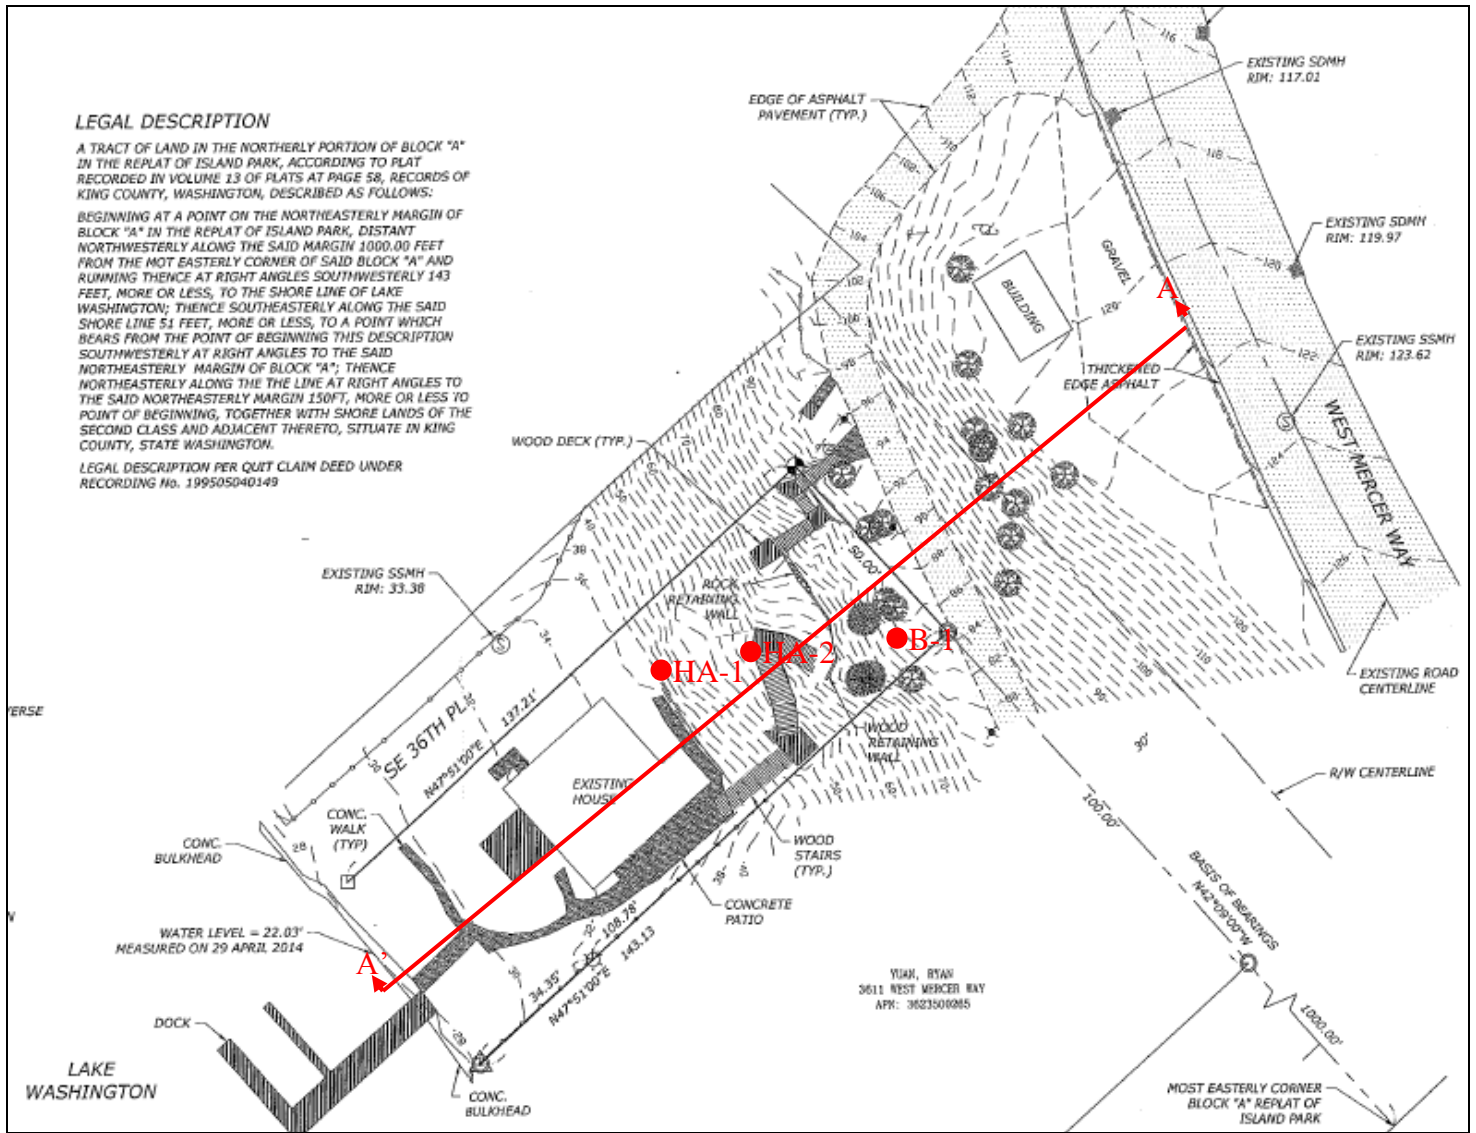
**Site and Exploration Plan**

**Approximate Site Location**  
(site plan by Beyler Consulting, 9/11/2014)

On November 3, 2015 a geologist from GeoResources, LLC was onsite and monitored the drilling of a single hollow stem auger boring logged the subsurface conditions, and obtained representative soil samples. The location of the boring was selected by GeoResources personnel in the field based on existing site conditions relative to the proposed development.

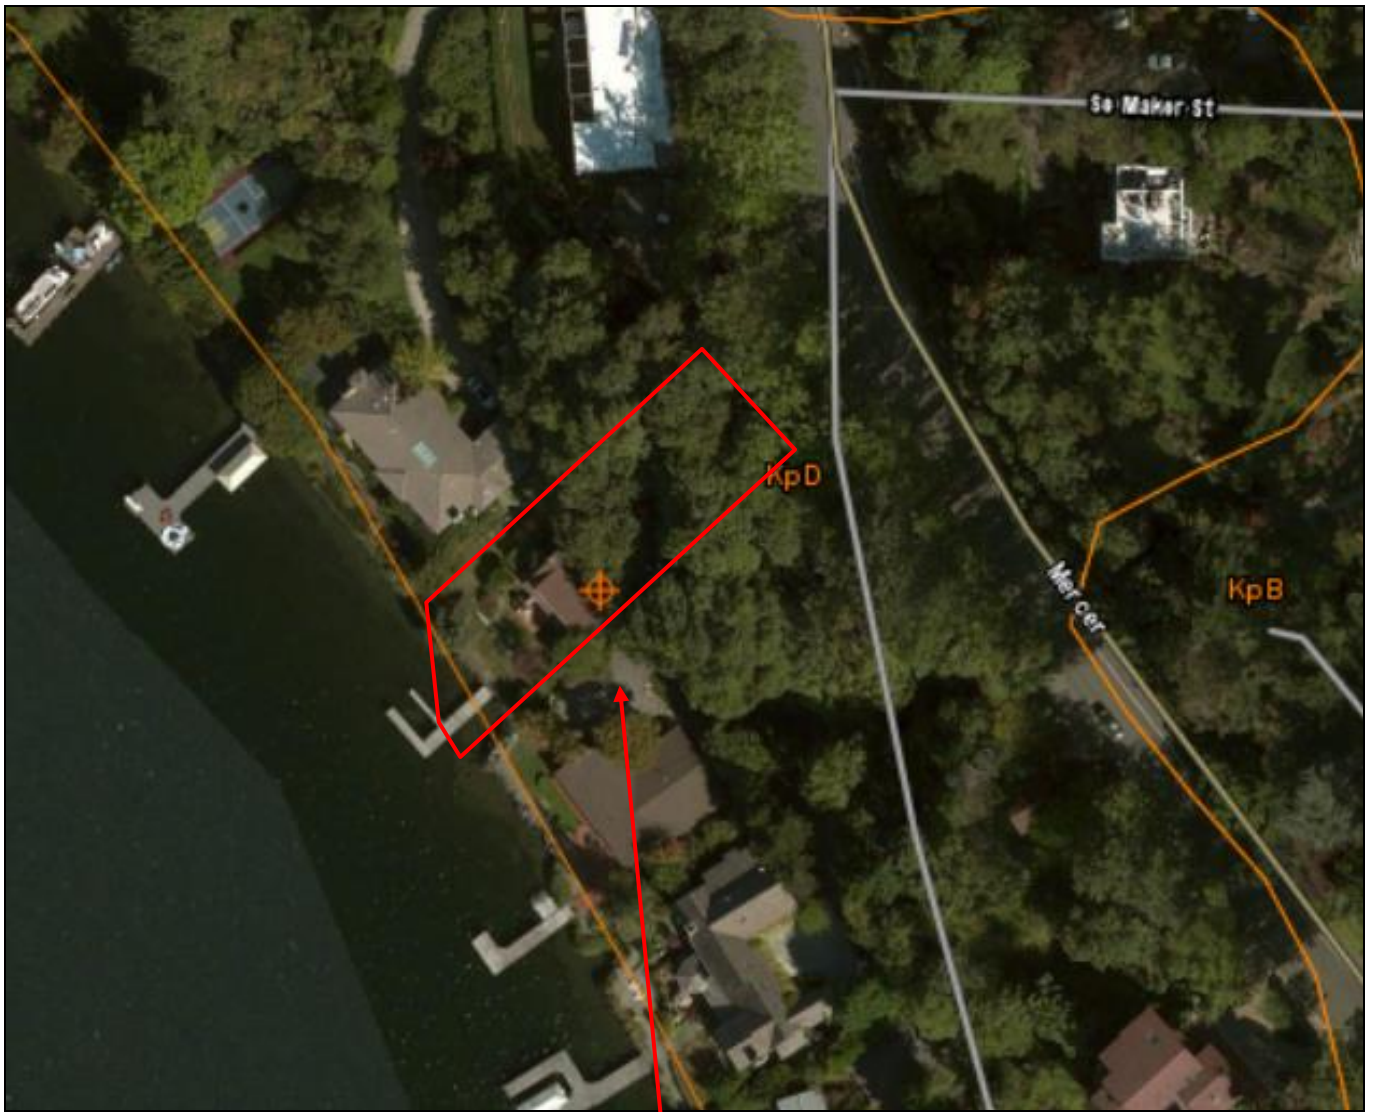
Figure 4

**Approximate Site Location**

(map created from the USDA Natural Resource Conservation Service Web Soil Survey)

The Natural Resource Conservation Services (NRCS) Web Soil Survey for King County indicates that the site soils consist of the Kitsap silt loam (KpD) soils that form on slopes of 15 to 30 percent. These soils derived from glacial lake sediments, have a moderate to severe erosion hazard, and are listed in hydrologic soil group C. A copy of the SCS soils map for the site area is attached as Figure 4.

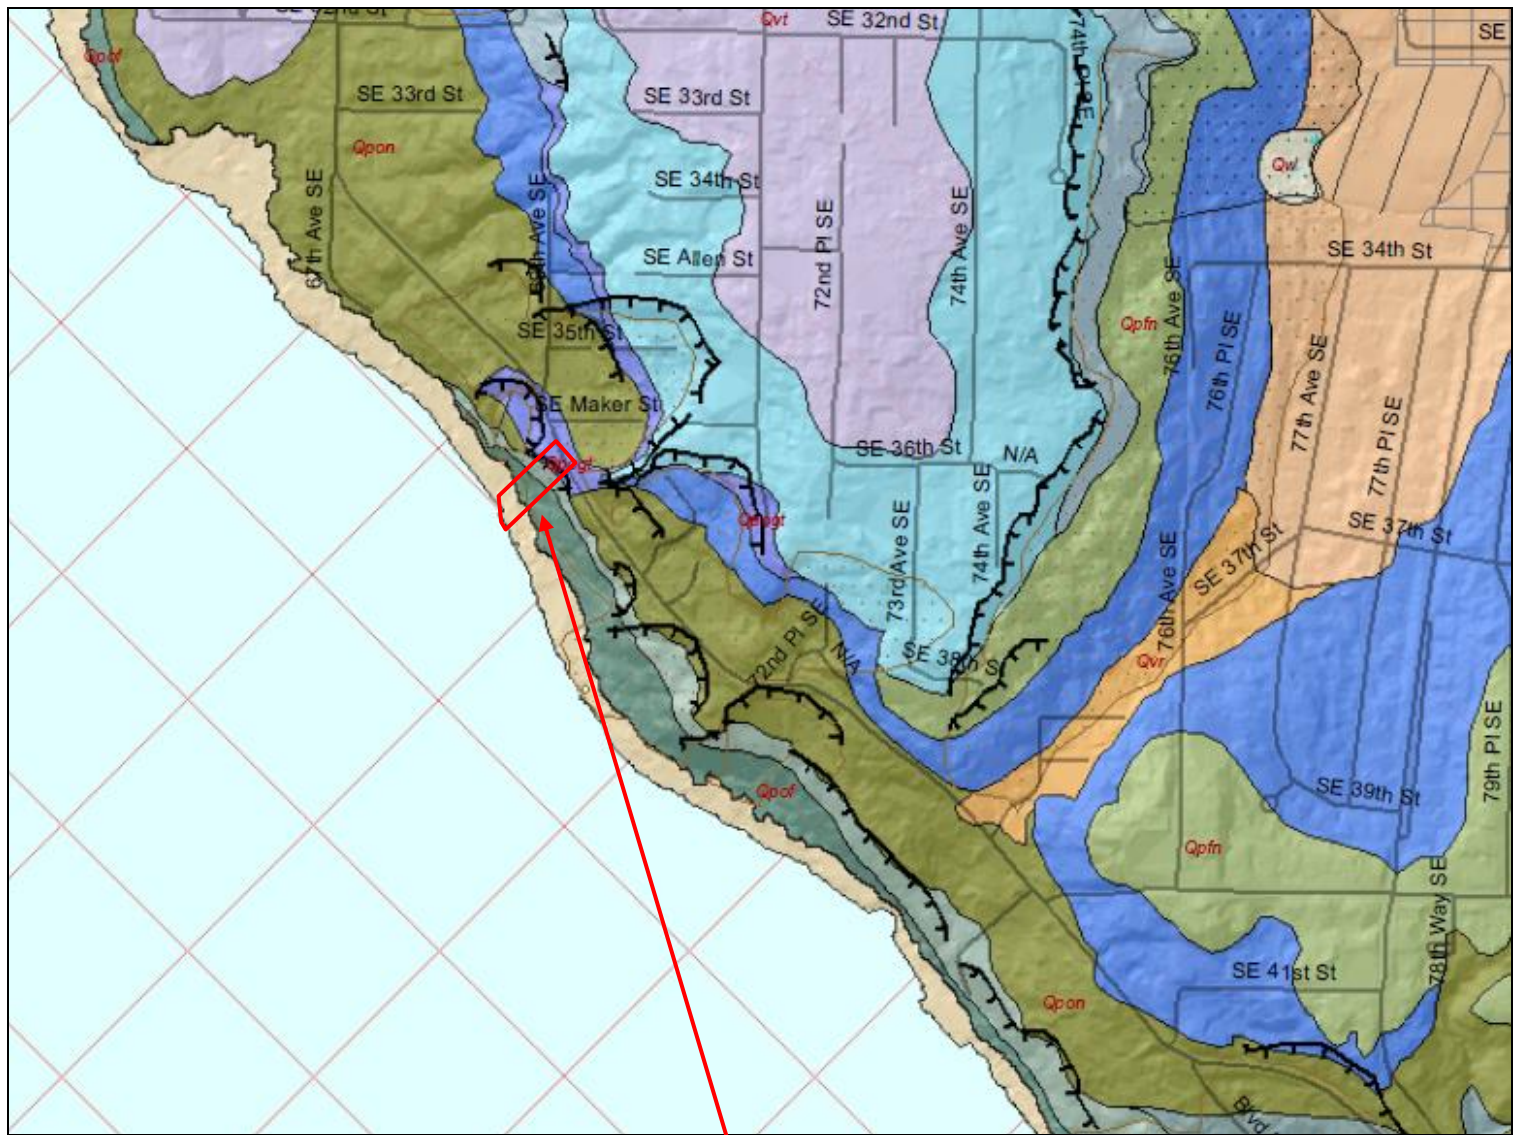
### Approximate Site Location

Excerpt from the *Geologic Map of Mercer Island, Washington* by Kathy G. Troost and Aaron P. Wisler (October 2006)

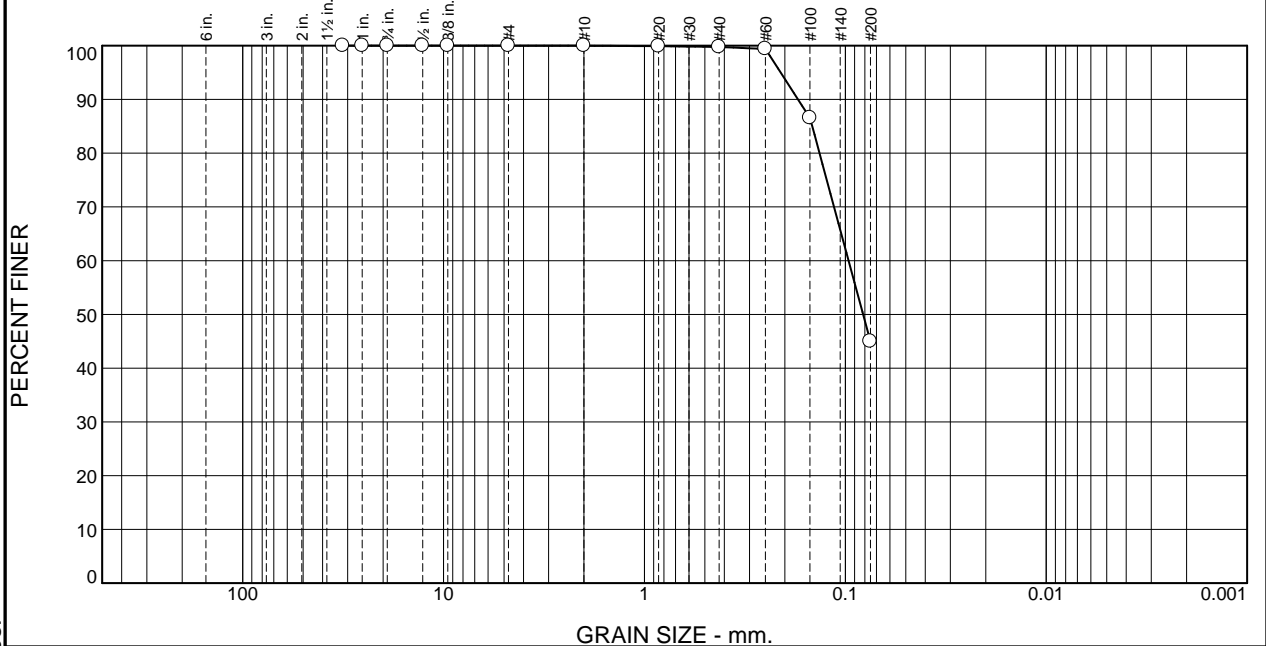
# Particle Size Distribution Report

% +3"	% Gravel		% Sand			% Fines	
	Coarse	Fine	Coarse	Medium	Fine	Silt	Clay
0.0	0.0	0.0	0.0	0.2	54.8	45.0

TEST RESULTS			
Opening Size	Percent Finer	Spec.* (Percent)	Pass? (X=Fail)
1.25	100.0		
1	100.0		
.75	100.0		
.5	100.0		
.375	100.0		
#4	100.0		
#10	100.0		
#20	99.9		
#40	99.8		
#60	99.4		
#100	86.6		
#200	45.0

Geotechnical laboratory tests were performed on selected samples to determine soil index and engineering properties encountered. Laboratory testing included visual soil classification per ASTM D: 2488, moisture content determinations per ASTM D: 2216 and grain size analyses were performed in accordance with the ASTM D: 422 standard procedures. The results of our two sieve analysis are included in Appendix B.

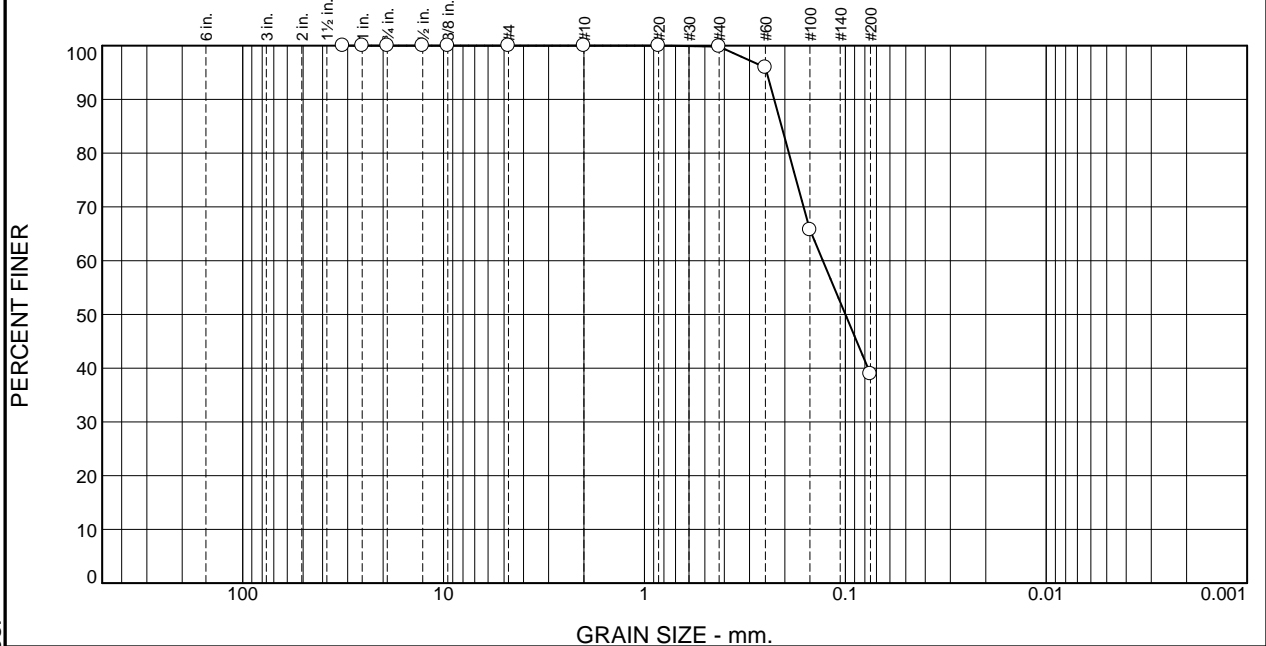
# Particle Size Distribution Report

% +3"	% Gravel		% Sand			% Fines	
	Coarse	Fine	Coarse	Medium	Fine	Silt	Clay
0.0	0.0	0.0	0.0	0.2	60.9	38.9

TEST RESULTS			
Opening Size	Percent Finer	Spec.* (Percent)	Pass? (X=Fail)
1.25	100.0		
1	100.0		
.75	100.0		
.5	100.0		
.375	100.0		
#4	100.0		
#10	100.0		
#20	100.0		
#40	99.8		
#60	95.9		
#100	65.7		
#200	38.9

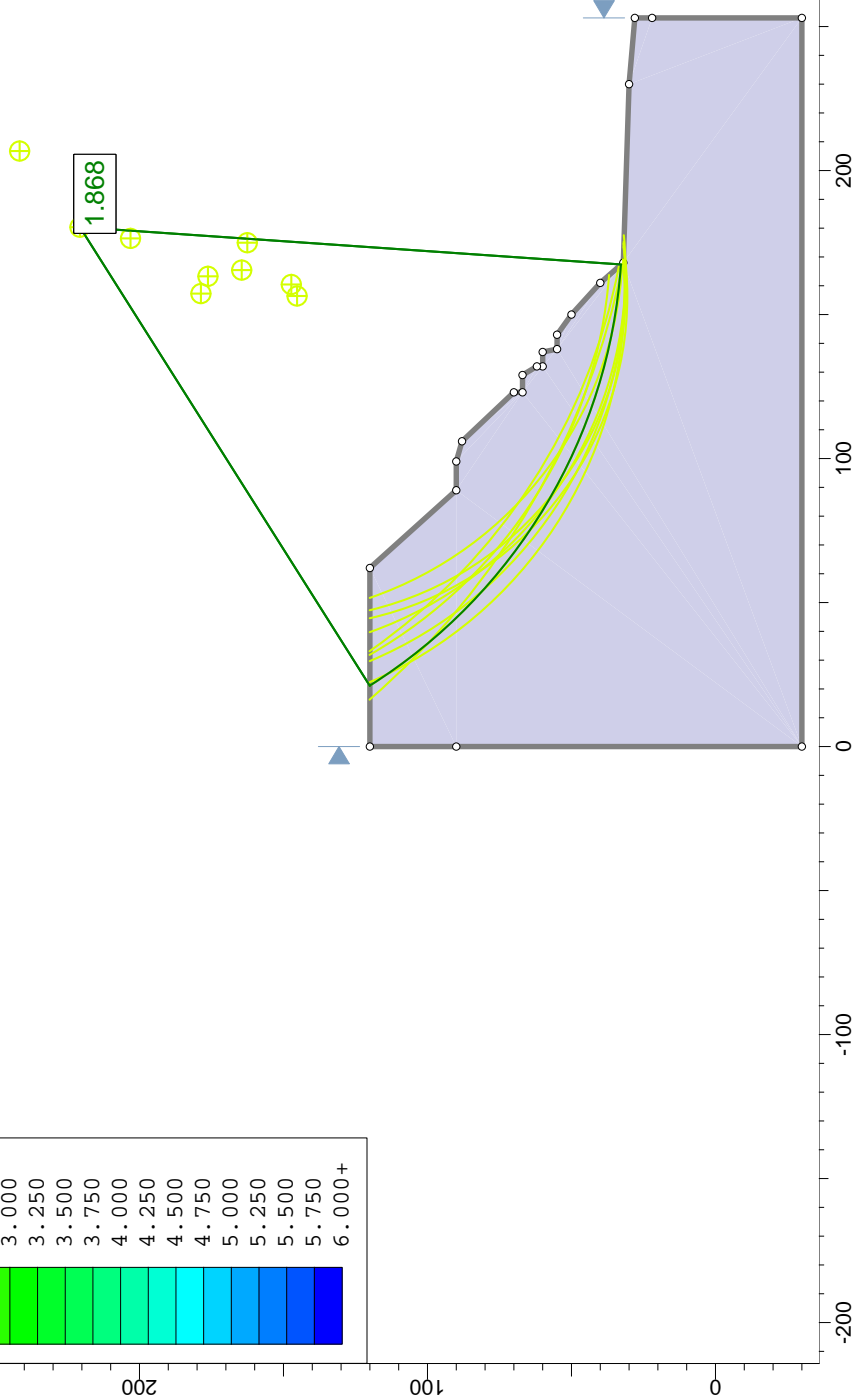
### **Slope Stability Analysis**

Material Name	Color	Unit Weight (lbs/ft <sup>3</sup> )	Strength Type	Cohesion (lb/ft <sup>2</sup> )	Phi	Water Surface	Ru
Glacial Consolidated Silty Sand		130	Mohr-Coulomb	1000	33	None	0

Project		SLIDE - An Interactive Slope Stability Program	
Analysis Description			
Drawn By	Scale	1:800	Company
Date	12/28/2015, 2:20:24 PM	File Name	
		FatBoyCon.WMercerWay.existing.static.slim

We analyzed the global and internal slope stability of the existing slope geometries using subsurface profile A-A', as shown on Figure C-1. We used the computer program SLIDE version 6.020, from RocScience, 2012, to perform the slope stability analyses. The computer program SLIDE uses a number of methods to estimate the factor of safety (FS) of the stability of a slope by analyzing the shear and normal forces acting on a series of vertical "slices" that comprise a failure surface. Each vertical slice is treated as a rigid body; therefore, the forces and/or moments acting on each slice are assumed to satisfy static equilibrium (i.e., a limit equilibrium analysis). The FS is defined as the ratio of the forces available to resist movement to the forces of the driving mass. **An FS of 1.0 means that the driving and resisting forces are equal;** an FS less than 1.0 indicates that the driving forces are greater than the resisting forces (indicating failure). We used the Generalized Limit Equilibrium method using the Morgenstern-Price analysis, which satisfies both moment and force equilibrium, to search for the location of the most critical failure surfaces and their corresponding FS. **The most critical surfaces are those with the lowest FS for a given loading condition, and are therefore the most likely to move.** Based on our analyses, **the FS for the current conditions is about 1.8 and 1.2 for static and seismic conditions, respectively.** Details of the slope stability analyses for both static and seismic conditions are included in Appendix C.

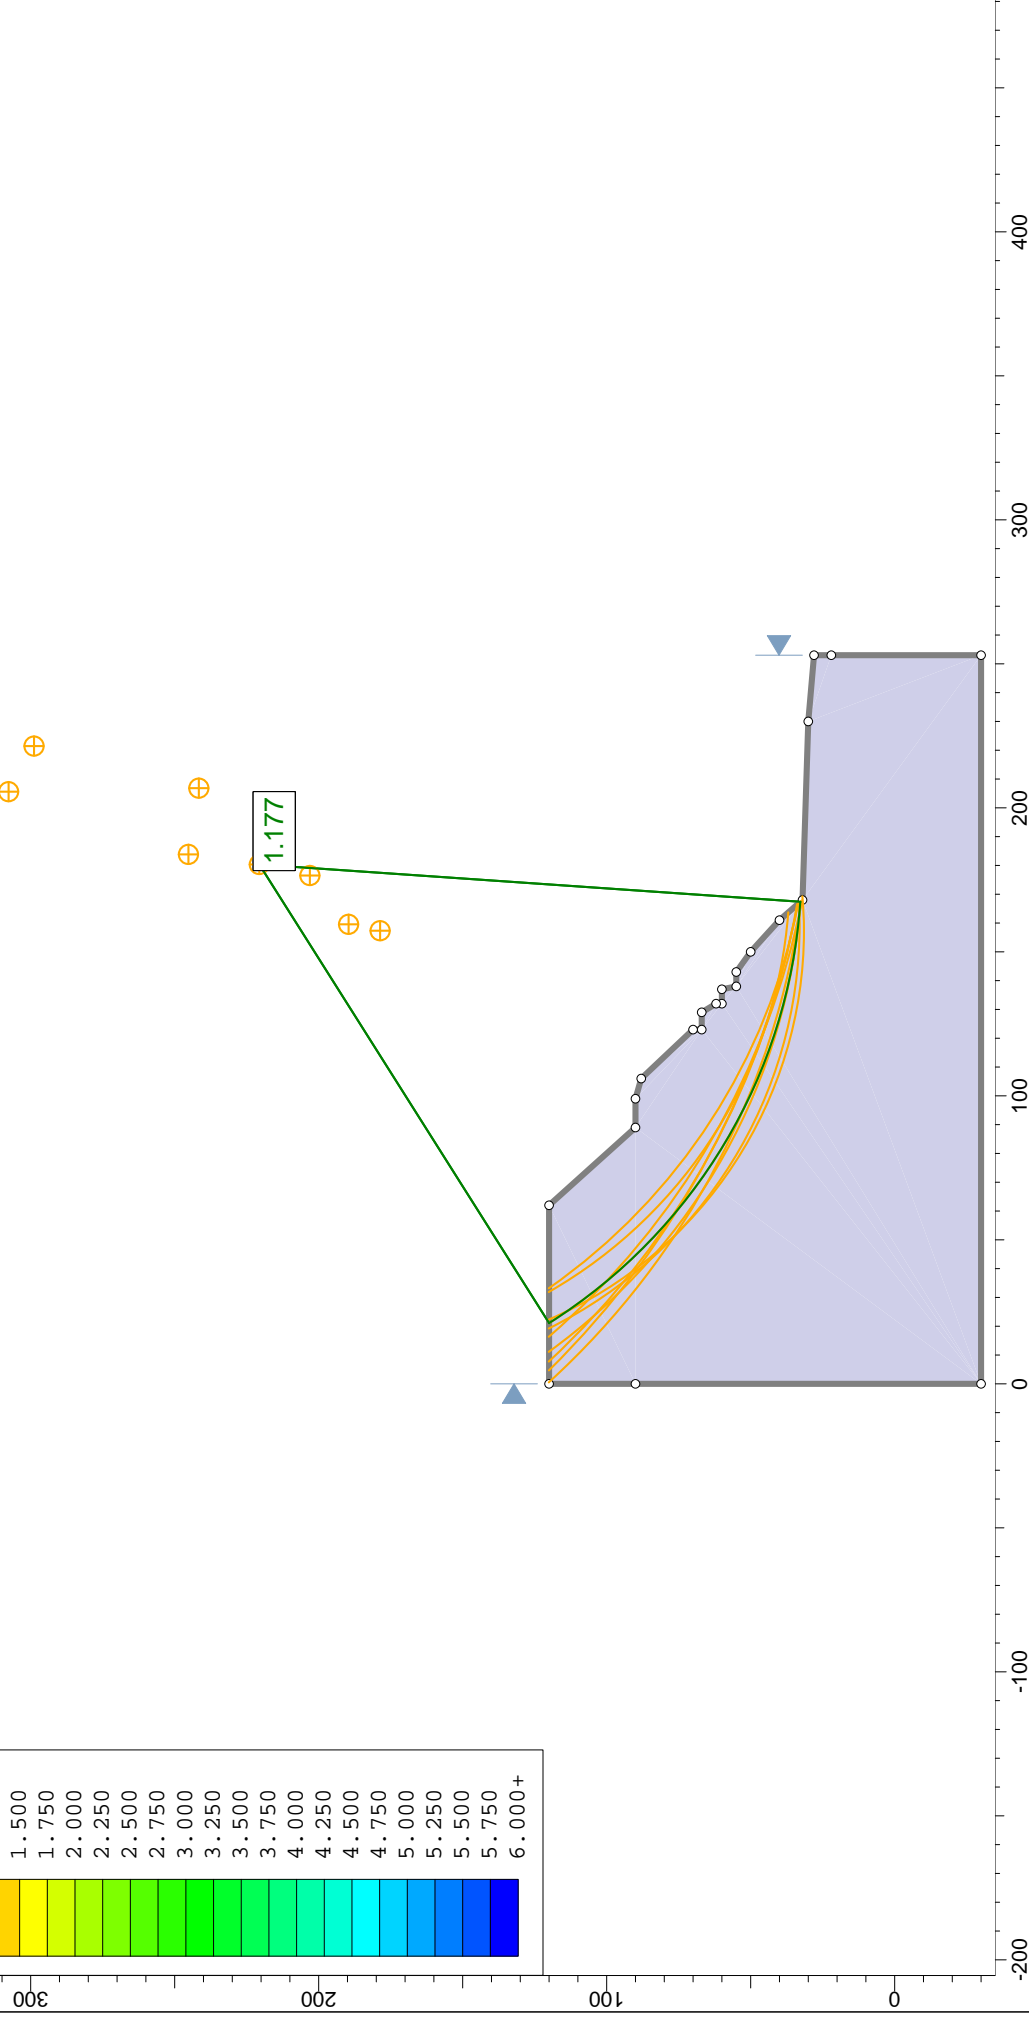
Material Name	Color	Unit Weight (lbs/ft <sup>3</sup> )	Strength Type	Cohesion (lb/ft <sup>2</sup> )	Phi	Water Surface	Ru
Glacial Consolidated Silty Sand		130	Mohr-Coulomb	1000	33	None	0

Project	
		FatBoyConst.WMercerWay	
Analysis Description			
Existing Slope Static Conditions A-A'			
Drawn By	DCB	Scale	1:800
Company		GeoResources, LLC	
Date	12/28/2015, 2:20:24 PM	File Name	FatBoyCon.WMercerWay.existing.Siesmic.slim
