### GEOTECHNICAL REPORT PROPOSED RESIDENCE 8243 West Mercer Way Mercer Island, Washington

PROJECT NO. 17-405 February 2018

**Subject:** Geotechnical Report

825X West Mercer Way, Mercer Island, Washington

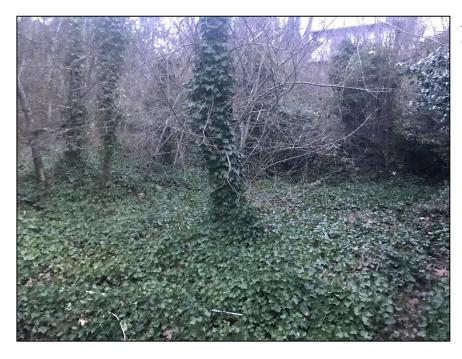
**Plate 1:** View of site from south looking north.

The site is currently vacant. Single-family homes are located on the north, south, east and west sides of the property. The site is forested with deciduous trees with an understory of ferns and ivy. Plate 1 on the following page shows the general site conditions in the proposed building area.

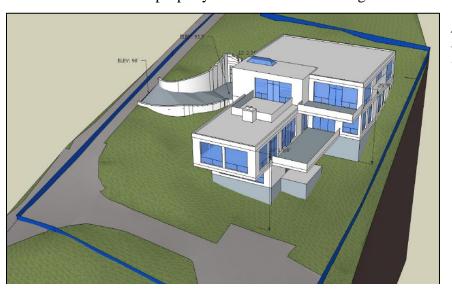
**Plate 2:** Rendering of the proposed residence.

Plate 2 below and the attached Figure 2 depicts the approximate location of the proposed house in relation to the property boundaries and existing site features.

The main level of the house will have an elevation of about 93.5 feet and there will be a partial daylight basement level below the main floor. We anticipate the excavation to achieve construction subgrade elevations will be comprised of series of level benches that range from 10 to 15 feet deep, but the excavation for the garage may be as deep as 18 to 20 feet deep. The excavation will extend to within 10 to 25 feet of the north property line, 20 feet of the west property line, 10 feet of the east property line and will daylight to the south.

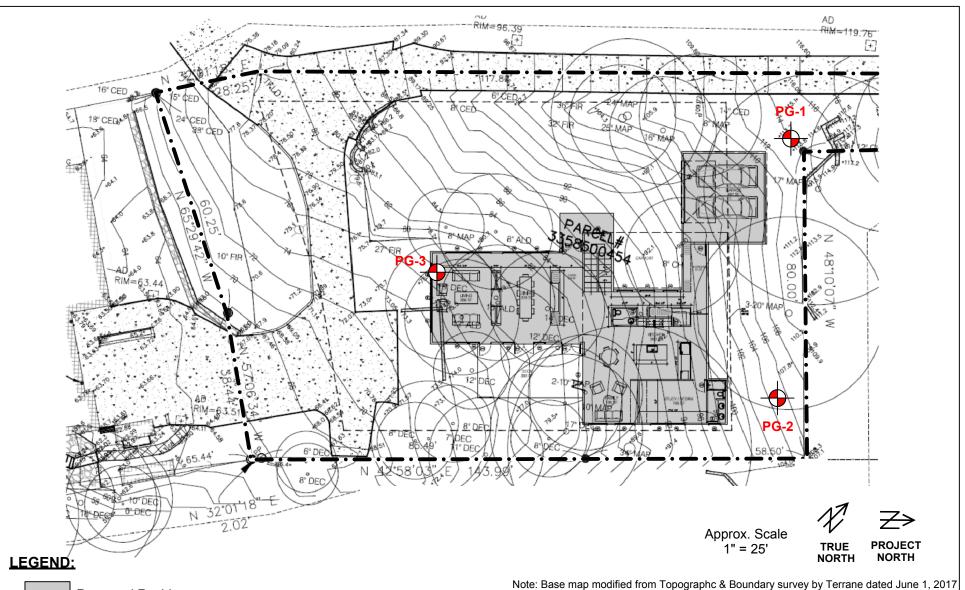
Figure No.

Figure 2 Site and Exploration Plan

Our field exploration was performed on January 15, 2018. The subsurface exploration program included drilling three test borings identified as PG-1, PG-2 and PG-3. The approximate test boring locations were measured from existing site features and are shown on the attached Site and Exploration Plan (Figure 2). The borings were drilled to depths of about 9 to 16½ feet below grade using a portable Acker Soil Mechanic drill rig owned and operated by CN Drilling, of Seattle, Washington under subcontract to PanGEO. The drill rig was equipped with a 4-inch outside diameter hollow stem auger, and soil samples were obtained from the borings at 2½ and 5-foot intervals in general accordance with Standard Penetration Test (SPT) sampling methods (ASTM test method D-1586) in which the samples are obtained using a 2-inch outside diameter split-spoon sampler. The sampler was driven into the soil a distance of 18 inches using a 140-pound hammer falling a distance of 30 inches. The number of blows required for each 6-inch increment of sampler penetration was recorded. The number of blows required to achieve the last 12 inches of sample penetration is defined as the SPT N-value. The N-value provides an empirical measure of the relative density of cohesionless soil, or the relative consistency of finegrained soils.

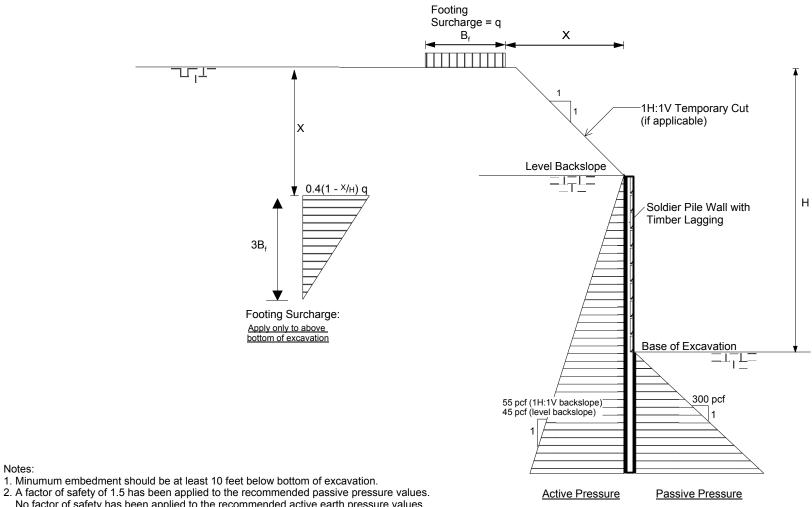
Figure 3 Design Lateral Parameters – Cantilevered Soldier Pile Wall

We recommend the earth pressures depicted on Figure 3, Design Lateral Pressures, Soldier

design parameters assume the excavation is fully dewatered and do not include hydrostatic

Permanent walls can be designed using the soil parameters shown on Figure 3. However, a surcharge pressure of 7H to account for seismic loading must be included in the design. In addition, the piles should include corrosion protection, or be over-sized to account for corrosion. Lagging for permanent walls may consist of pressure-treated timber, cast-in-
