December 11, 2017  
Project No. 17-381

**Subject: Geotechnical Engineering Evaluation  
Proposed Addition  
8110 SE 70<sup>th</sup> Street, Mercer Island, Washington**

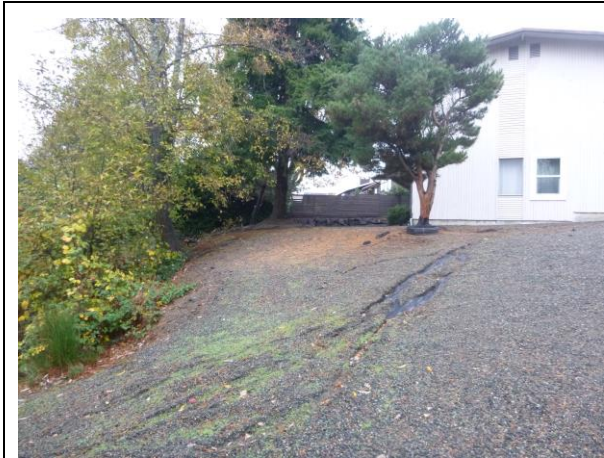
**Plate 1.** View of the southwest side of the house. Looking north.

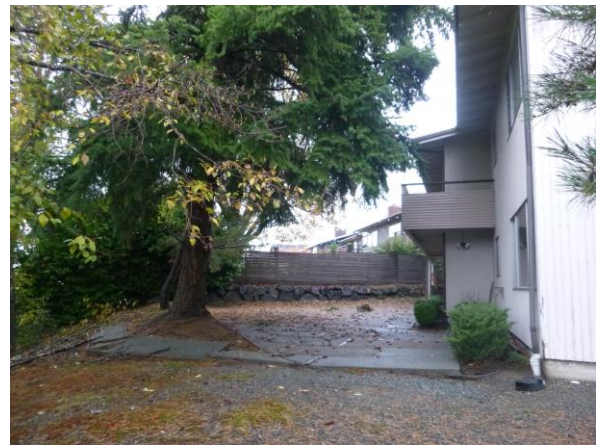
**Plate 2.** View of the north side of the site. Looking northeast.

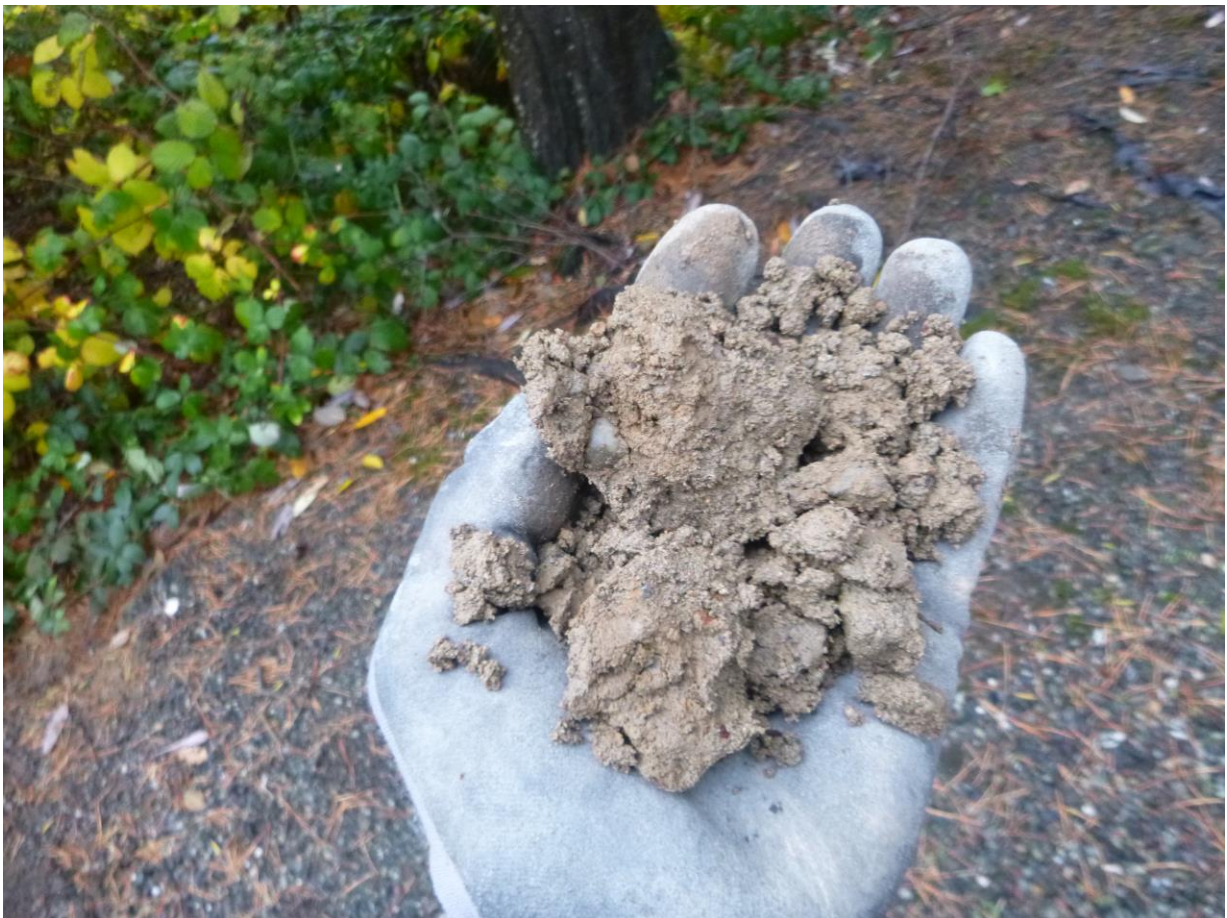
**Plate 1:** Cuttings from about 3½ feet below surface in HB-1. Moist, light brown, medium SAND with gravel and trace silt.

<u>Depth (ft)</u>	<u>Material Description</u>
0 – 1½	<b>Unit 1:</b> Loose, brown, fine to medium SAND with silt, roots; moist (Fill)
1½ – 2¾	<b>Unit 2:</b> Medium dense, brown, medium SAND with gravel and trace silt; moist (Weathered Advance Outwash)
2¾ – 5½	<b>Unit 3:</b> Medium dense to dense, brown, medium SAND with trace gravel and silt; moist, minor iron oxide staining (Alluvium) <ul style="list-style-type: none"><li>- Becomes wet at 4½ feet</li><li>- Becomes gray with moderate iron oxide staining at 5 feet</li></ul>

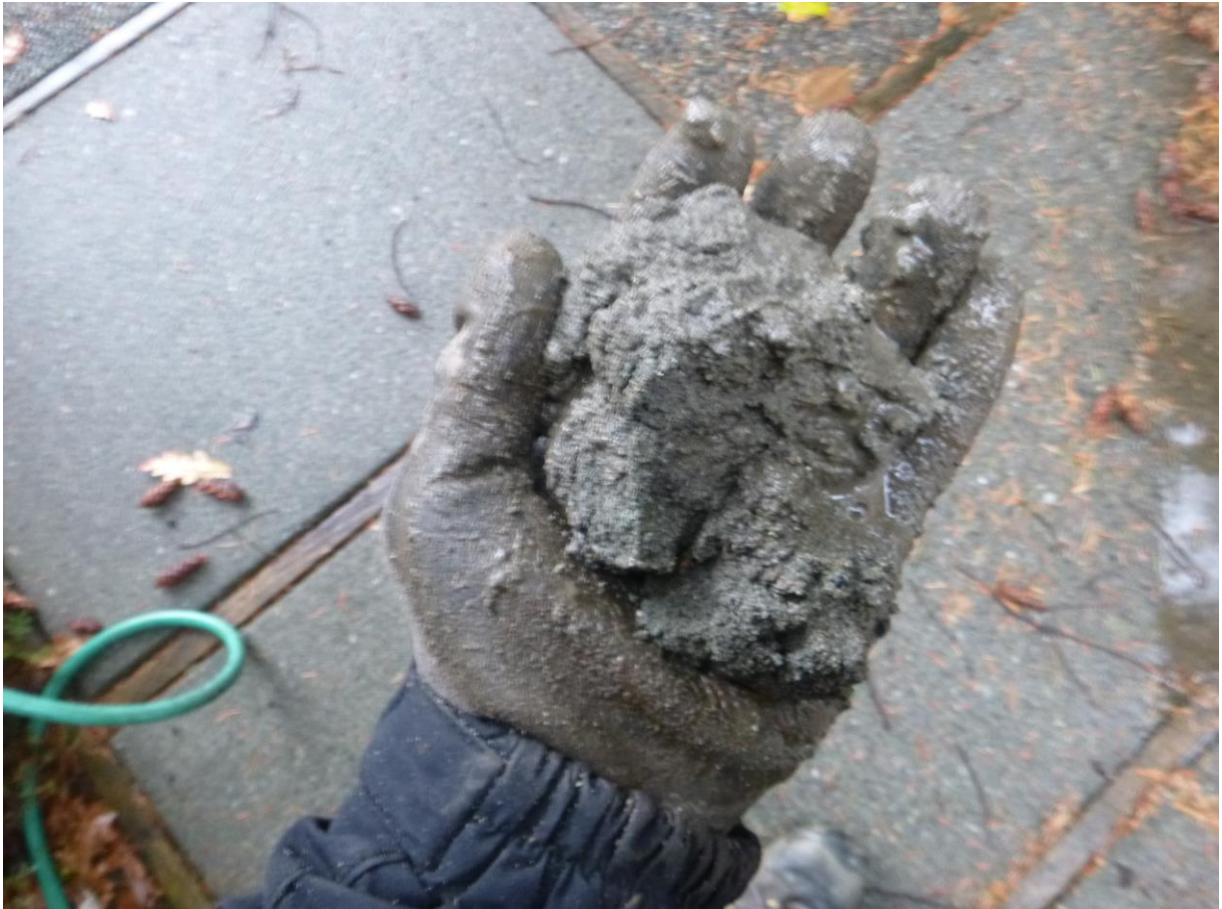
**Plate 1.** Cuttings from about 3 feet below the surface in HB-2. Wet, gray, medium SAND with trace silt.

<u>Depth (ft)</u>	<u>Material Description</u>
0 – 1½	<b>Unit 1:</b> Loose, dark brown, silty SAND with roots and organics; moist (Fill)
1½ – 5½	<b>Unit 2:</b> Medium dense, wet, gray SAND with silt; moist (Advance Outwash) - Becomes dense at 3½ feet
