Subject: Geotechnical Report
Proposed Residence:
6024 Southeast 22nd Street, Mercer Island, Washington

**GEOTECHNICAL REPORT
PROPOSED RESIDENCE
6024 SOUTHEAST 22ND STREET
MERCER ISLAND, WASHINGTON**

Geotechnical Report

Proposed Residence: 6024 Southeast 22nd Street, Mercer Island, Washington

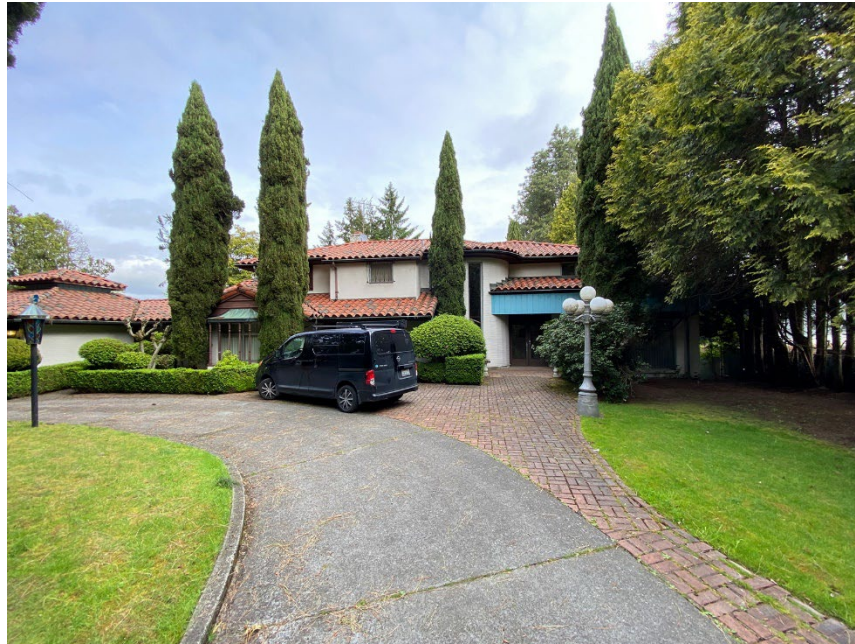
Plate 1. View of the south side of the existing residence at the site, looking north from near existing DADU.

Based on review of the project topographic survey and our observations while on site, the site and surrounding area generally slopes down from south to north with an average gradient of 4 to 5 percent and about 26 feet of elevation change across the length of the site. A low rockery is located north of the existing residence and provides a few feet of grade separation between the higher eastern portion of the backyard and the lower western portion of the backyard. The site is vegetated with mature Douglas fir, cedar and alder trees, lawns, ivy and landscaping trees and shrubs. Current site conditions are shown on Plates 1 and 2 on the following page.

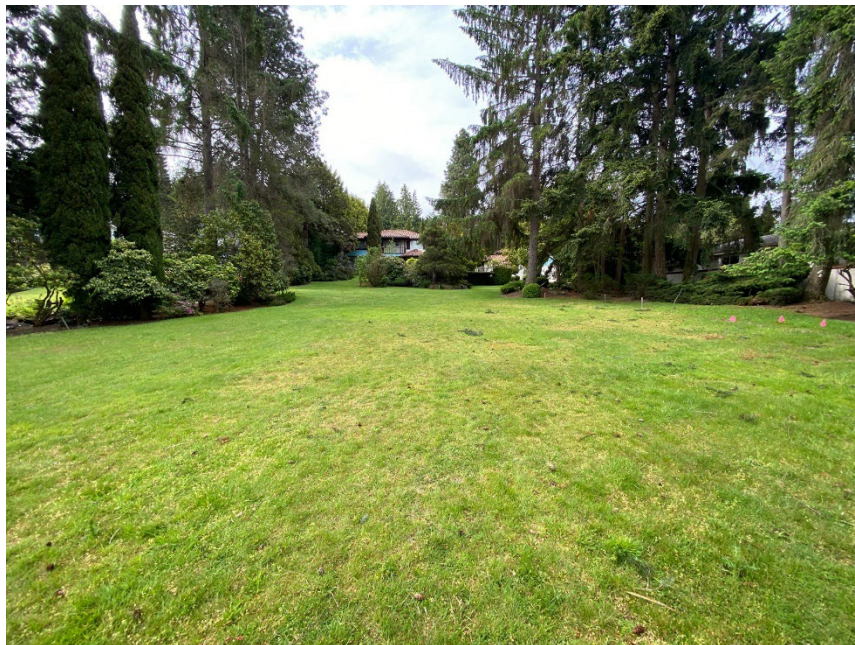
Plate 2. Looking south towards existing residence and location of proposed new residence from near the existing cabana.
