CRITICAL AREA STUDY

Laban Remodel – 10 Brook Bay Road City of Mercer Island, WA

Wetland Resources, Inc. Project #21151

First Submittal: May 2, 2023
Revision 1: September 21, 2023
Revision 2: November 8, 2023

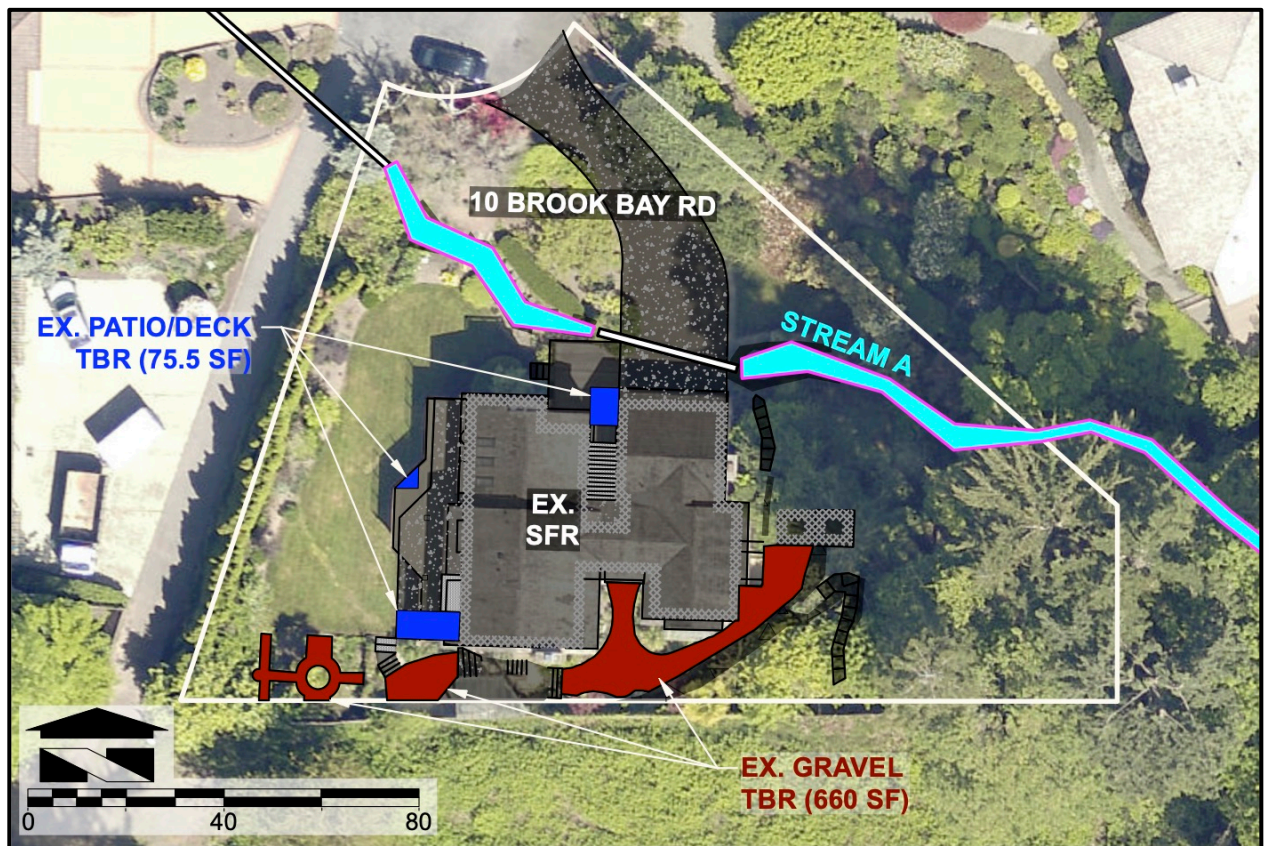
Figure 2: Proposed Hardscape Removal

The applicant proposes to remodel the existing single-family residence at 10 Brook Bay Road. The project includes remodeling the existing lower level, exterior alterations, raising and rebuilding the main level and roof, converting existing covered entry into interior space, and rebuilding existing patios and uncovered decks. The project will result in removal of 660 square feet of gravel and 75.5 square feet of existing patio/deck. See Figure 2 for proposed hardscape removal area.

No work is proposed in the regulatory floodplain. Removal of existing hardscape totaling ~150 square feet is proposed in shoreline jurisdiction. All redevelopment occurs within the standard 120-foot buffer associated with Stream A and a portion of the work occurs within the 10-foot piped watercourse setback associated with Stream A. Some of the work occurs in the inner 75 percent of the standard buffer.

Proposed development in shoreline jurisdiction is limited to removal of ~150 square feet of existing hardscape and replacement with mulch. The shoreline environment designation is Shoreline Residential. All elements of the project are correctly classified as “normal appurtenances” to the development of a single-family residence, as defined by WAC. Based on the WAC classification, the proposed development is exempt from shoreline substantial development permit requirements. More detailed discussion is provided below.

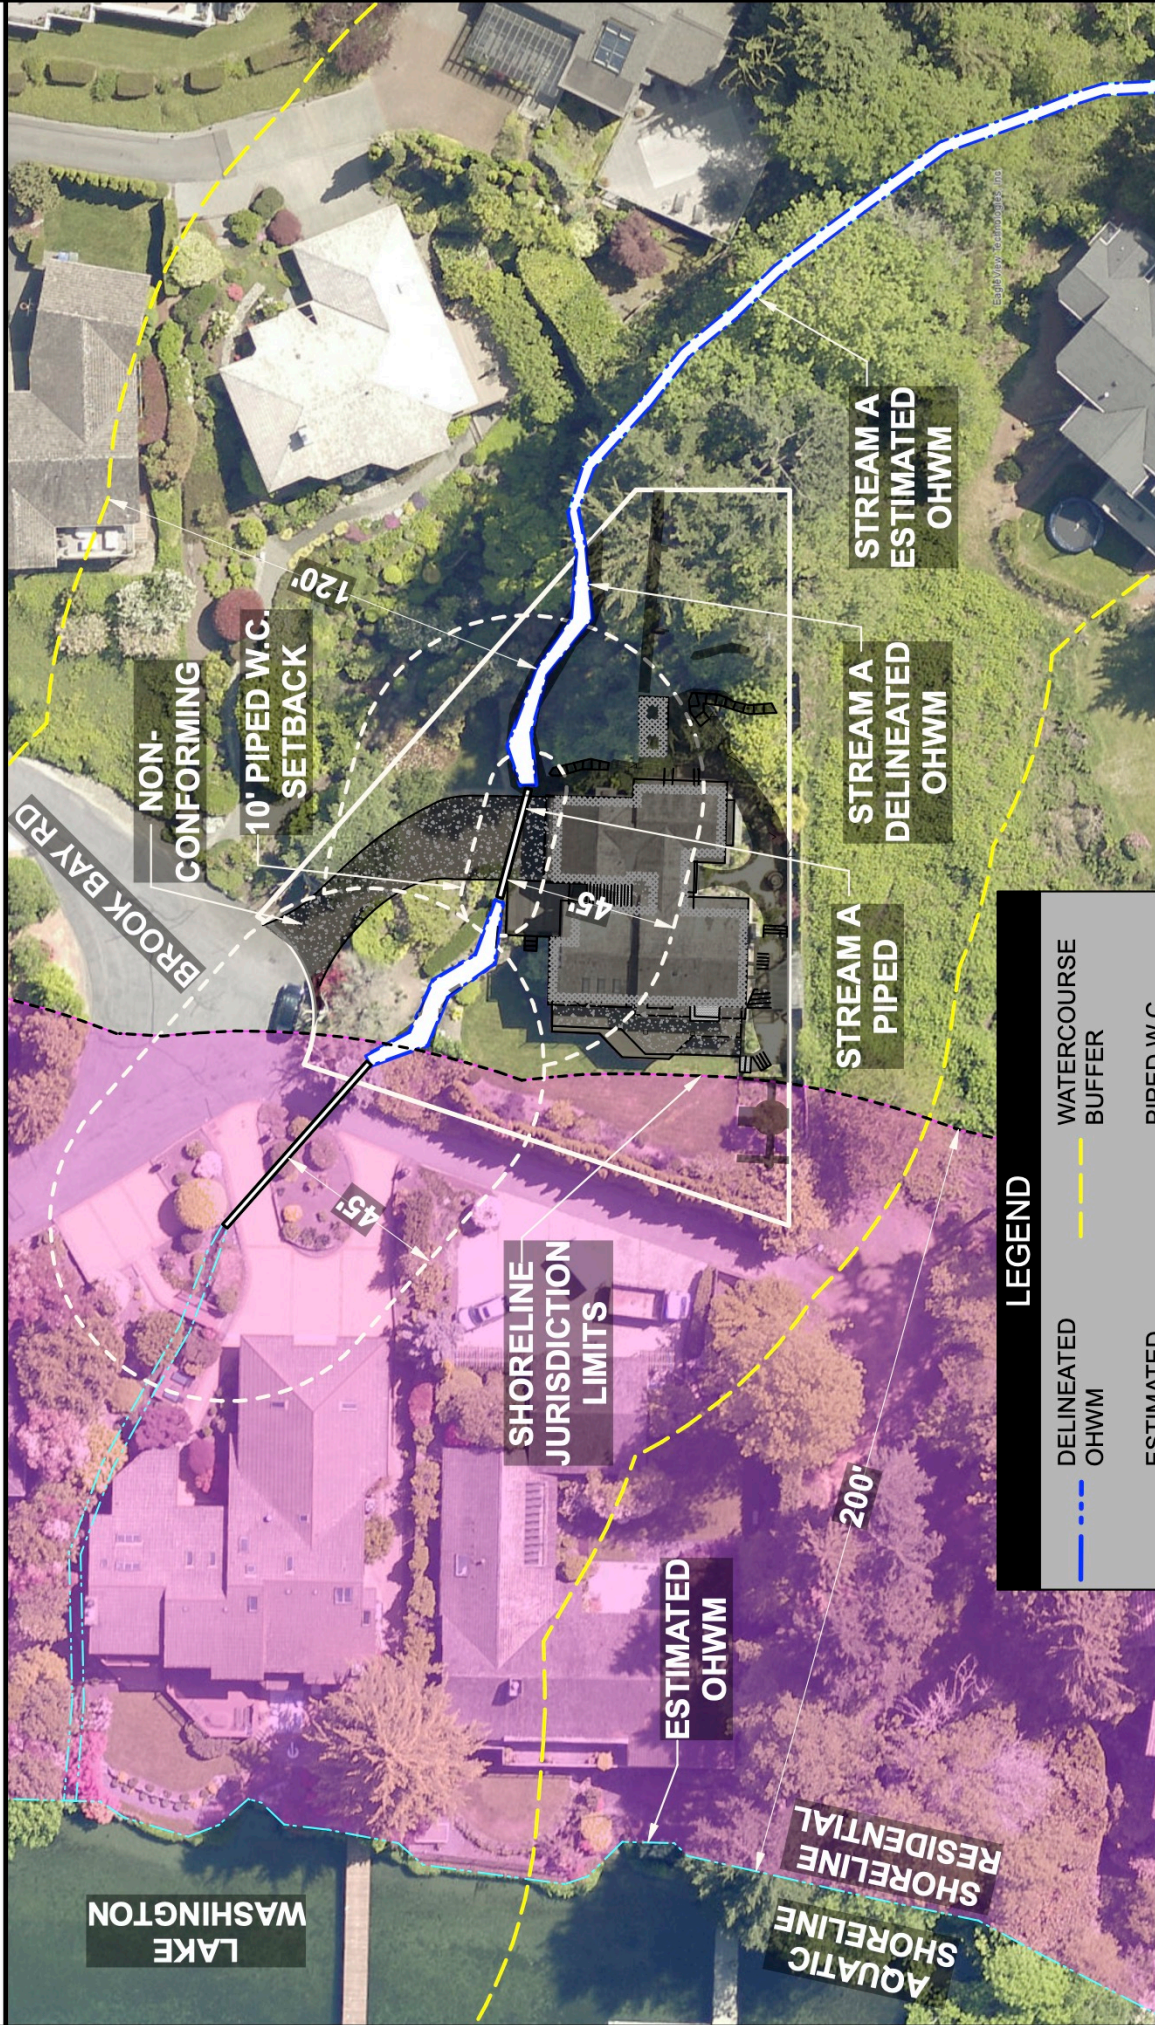
CRITICAL AREA STUDY MAP

WRI was contracted to delineate and catalogue regulated features on and near the subject property. No wetlands were observed in the study area. Two regulated features were observed. One Type F watercourse (Stream A) was identified on the subject property, and Lake Washington was observed approximately 160 feet west of the parcel. These features are depicted in the attached critical area study map (See Appendix A). Lake Washington is a shoreline of statewide significance

that requires a 25-foot structure setback from the OHWM. Stream A is a Type F stream. Open channel sections require 120-foot protective buffers and piped sections require a 45-foot setback.

EXISTING CONDITIONS

The shore of Lake Washington is located approximately 160 feet west of the site. Lake Washington is a 21,600-acre waterbody that drains much of WRIA 8. Waterbodies that exceed 1,000 acres in total size are recognized as shorelines of statewide significance (WAC 173-20). The area extending 200 feet from the ordinary high water mark of Lake Washington is considered the shoreland area, and development within this zone is subject to the provisions of the Mercer Island Shoreline Master Program (MICC 17.09.110). In Mercer Island, Lake Washington requires a 25-foot structure setback. A portion of the subject property is located within shoreline jurisdiction. See Appendix A.
