June 22, 2017 (Revised November 9, 2017)
Project Number 17029

**Regarding: Critical Area Study: Wetland & Watercourse Buffer Reduction
East Mercer Development
8375 + 8383 East Mercer Way – Mercer Island, Washington**

Evergreen Aquatic Resource Consultants, LLC

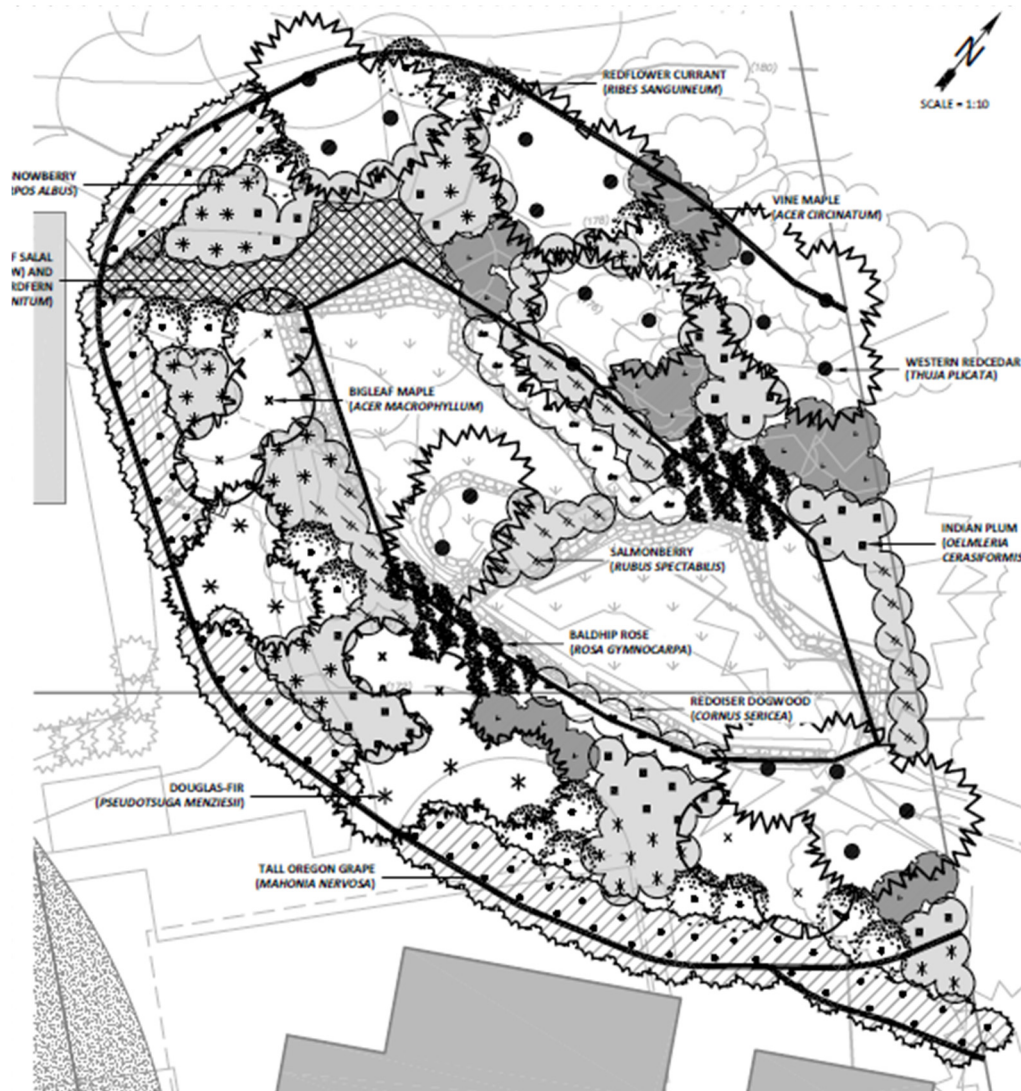
Figure 2 – Proposed Planting Plan

As part of the proposed project, the reduced buffer will be enhanced using native trees, shrubs, and groundcovers. The overall mitigation goal and objective is to enhance buffer functions by providing a dense, structurally diverse, and species rich native plant community within the reduced buffer area. Specific mitigation work includes the following:

- **Remove existing surface improvements:** Existing patios, walkways, a wood gazebo, and related improvements will be removed from the reduced buffer.

- **Remove non-native plants and noxious weed species:** Existing ornamental (landscape) shrubs and trees as well as noxious weeds will be removed from the reduced buffer.
- **Soil amendments and mulches:** Existing soils within the reduced buffer will be decompacted and then amended using organic compost. Mulch will be placed throughout the reduced buffer following plant installation.
- **Dense native plants:** Proposed mitigation plantings include 350 total plants comprising 3 tree species, 8 shrub species, and 2 groundcover species.
- **Temporary irrigation:** Two years of temporary irrigation will be provided to ensure installed plants are properly established.
- **Maintenance and Monitoring:** A five-year maintenance and monitoring program is included to ensure the mitigation performs as designed.

The proposed planting plan is shown in Figure 2

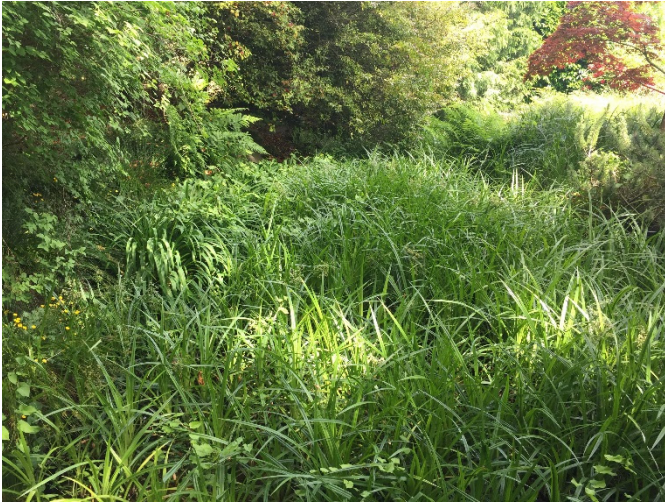
Photo 1 – View of Upper Landscape Pond Cell within Wetland A
Date: June 7, 2017

Wetland A is an excavated two-cell landscape pond located on Parcel A and Parcel C. The two cells within the wetland are separated by a small constructed island. The upper cell of the pond is dominated by a dense stand of small fruited bulrush (*Scirpus microcarpus*). The lower cell of the pond supports dense stands of both creeping spikerush (*Eleocharis palustris*) and mannagrass (*Glyceria* sp.) as well as areas of open water. Common lady fern (*Athyrium filix-femina*), soft rush (*Juncus effusus*), creeping buttercup (*Ranunculus repens*), an ornamental iris, and Himalayan blackberry (*Rubus armeniacus*) are present along the pond margins. Wetland A was rated by The Watershed Company as a Category IV wetland. A 35 foot buffer is required from the delineated limits of Wetland A.

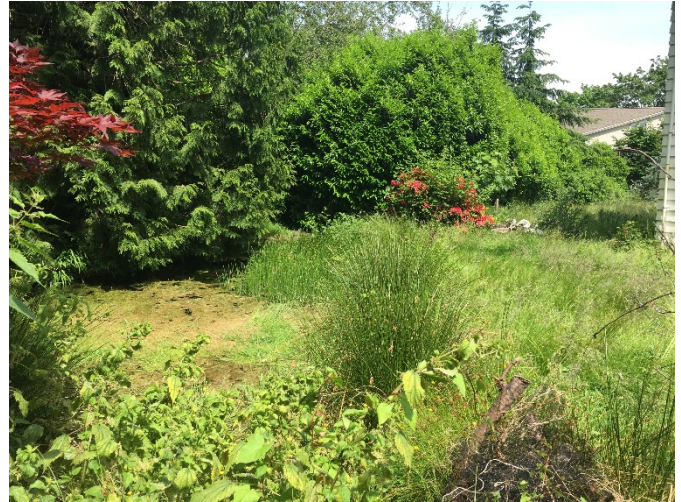
Photo 2 – View of Lower Landscape Pond Cell within Wetland A
Date: June 7, 2017

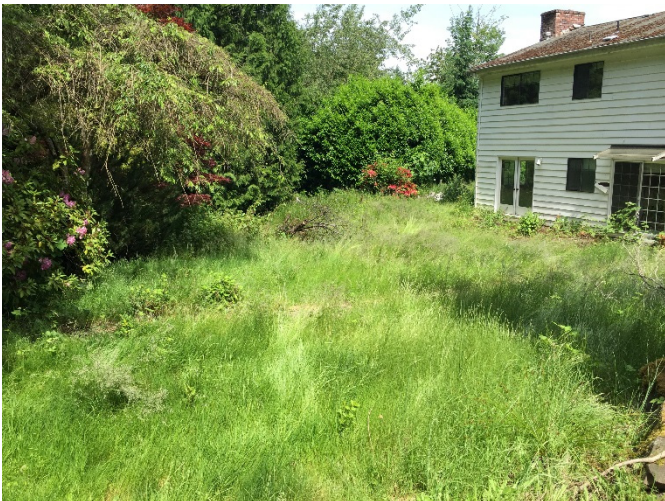
Photo 3 – Existing Buffer Conditions Located East of Wetland A
Date: June 7, 2017

Buffer areas located south and east of Wetland A include a portion of the residence located on Parcel A, an associated concrete patio/walkway, a wood gazebo, and an unmaintained lawn area comprising bentgrass (*Agrostis* sp.), bird's-foot trefoil (*Lotus corniculatus*), and clover (*Trifolium* sp.). A large English laurel (*Prunus laurocerasus*) also exists along the northeast property line of Parcel A.

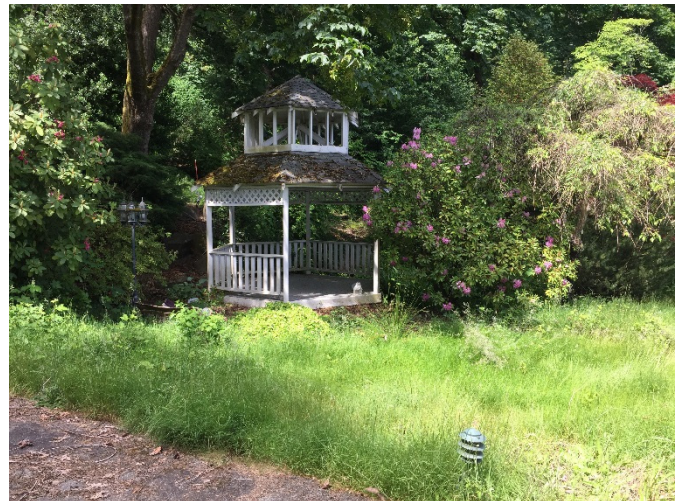
Photo 4 – Existing Gazebo located in Wetland Buffer
Date: June 7, 2017

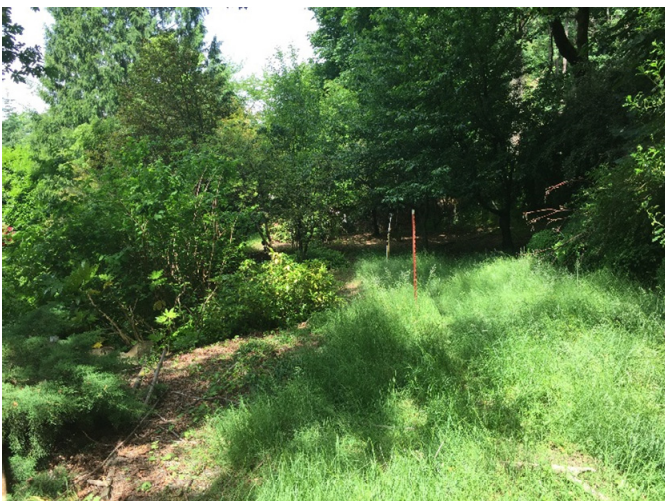
Photo 5 – Existing Buffer Conditions Located West of Wetland A
Date: June 7, 2017

Buffer areas located north and west of Wetland A include a large diameter bigleaf maple (*Acer macrophyllum*) and a large diameter western redcedar (*Thuja plicata*). The remaining vegetation within the buffer is a mix of non-native trees and tall shrubs including arborvitae (*Thuja occidentalis/orientalis*), apple (*Malus* sp.), rhododendron (*rhododendron* sp.), juniper (*Juniperus* sp.), English holly (*ilex aquifolium*), and camellia (*Camellia* sp.). A small patch of unmaintained bluegrass (*Poa* sp.) lawn exists along a gravel path that crosses the buffer and a stand of giant horsetail (*Equisetum telmateia*) exists near the northern property line.

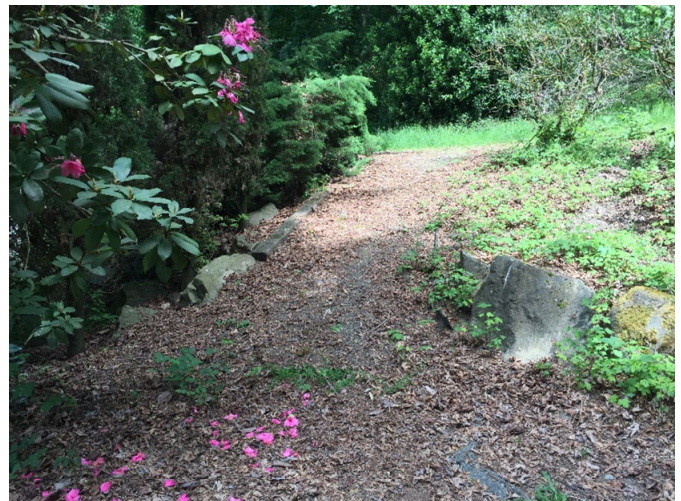
Photo 6 – Gravel Path Located West and South of Wetland A
Date: June 7, 2017
