WESTERN LANDSCAPE & PAVERS^{LLC} 425.979.1933		
Oquist <i>Soli Deo Gloria</i> Landscape Design www.OquistLandscapeDesign.com 425.219.1510 OquistLandscapeDesign@gmail.com	Scale: 1/8" = 1' Date: 7/22/2019 Site Address: 8100 SE 48th St Mercer Island, WA 98040 Drawing Description: Planting & Erosion Control Plan View	Property Owner: Ron Beresky Contact #: 608.609.4180 Designer Signature:

WESTERN LANDSCAPE & PAVERS^{LLC} 425.979.1933			
Oquist <i>Soli Deo Gloria</i> Landscape Design		Scale: 1/8" = 1' Date: 7/22/2019	Property Owner: Ron Beresky Contact #: 608.609.4180
www.OquistLandscapeDesign.com 425.219.1510 OquistLandscapeDesign@gmail.com		Site Address: 8100 SE 48th St Mercer Island, WA 98040	Designer Signature:
Drawing Description: Erosion Control Detial			Drawing Number: 2 of 2

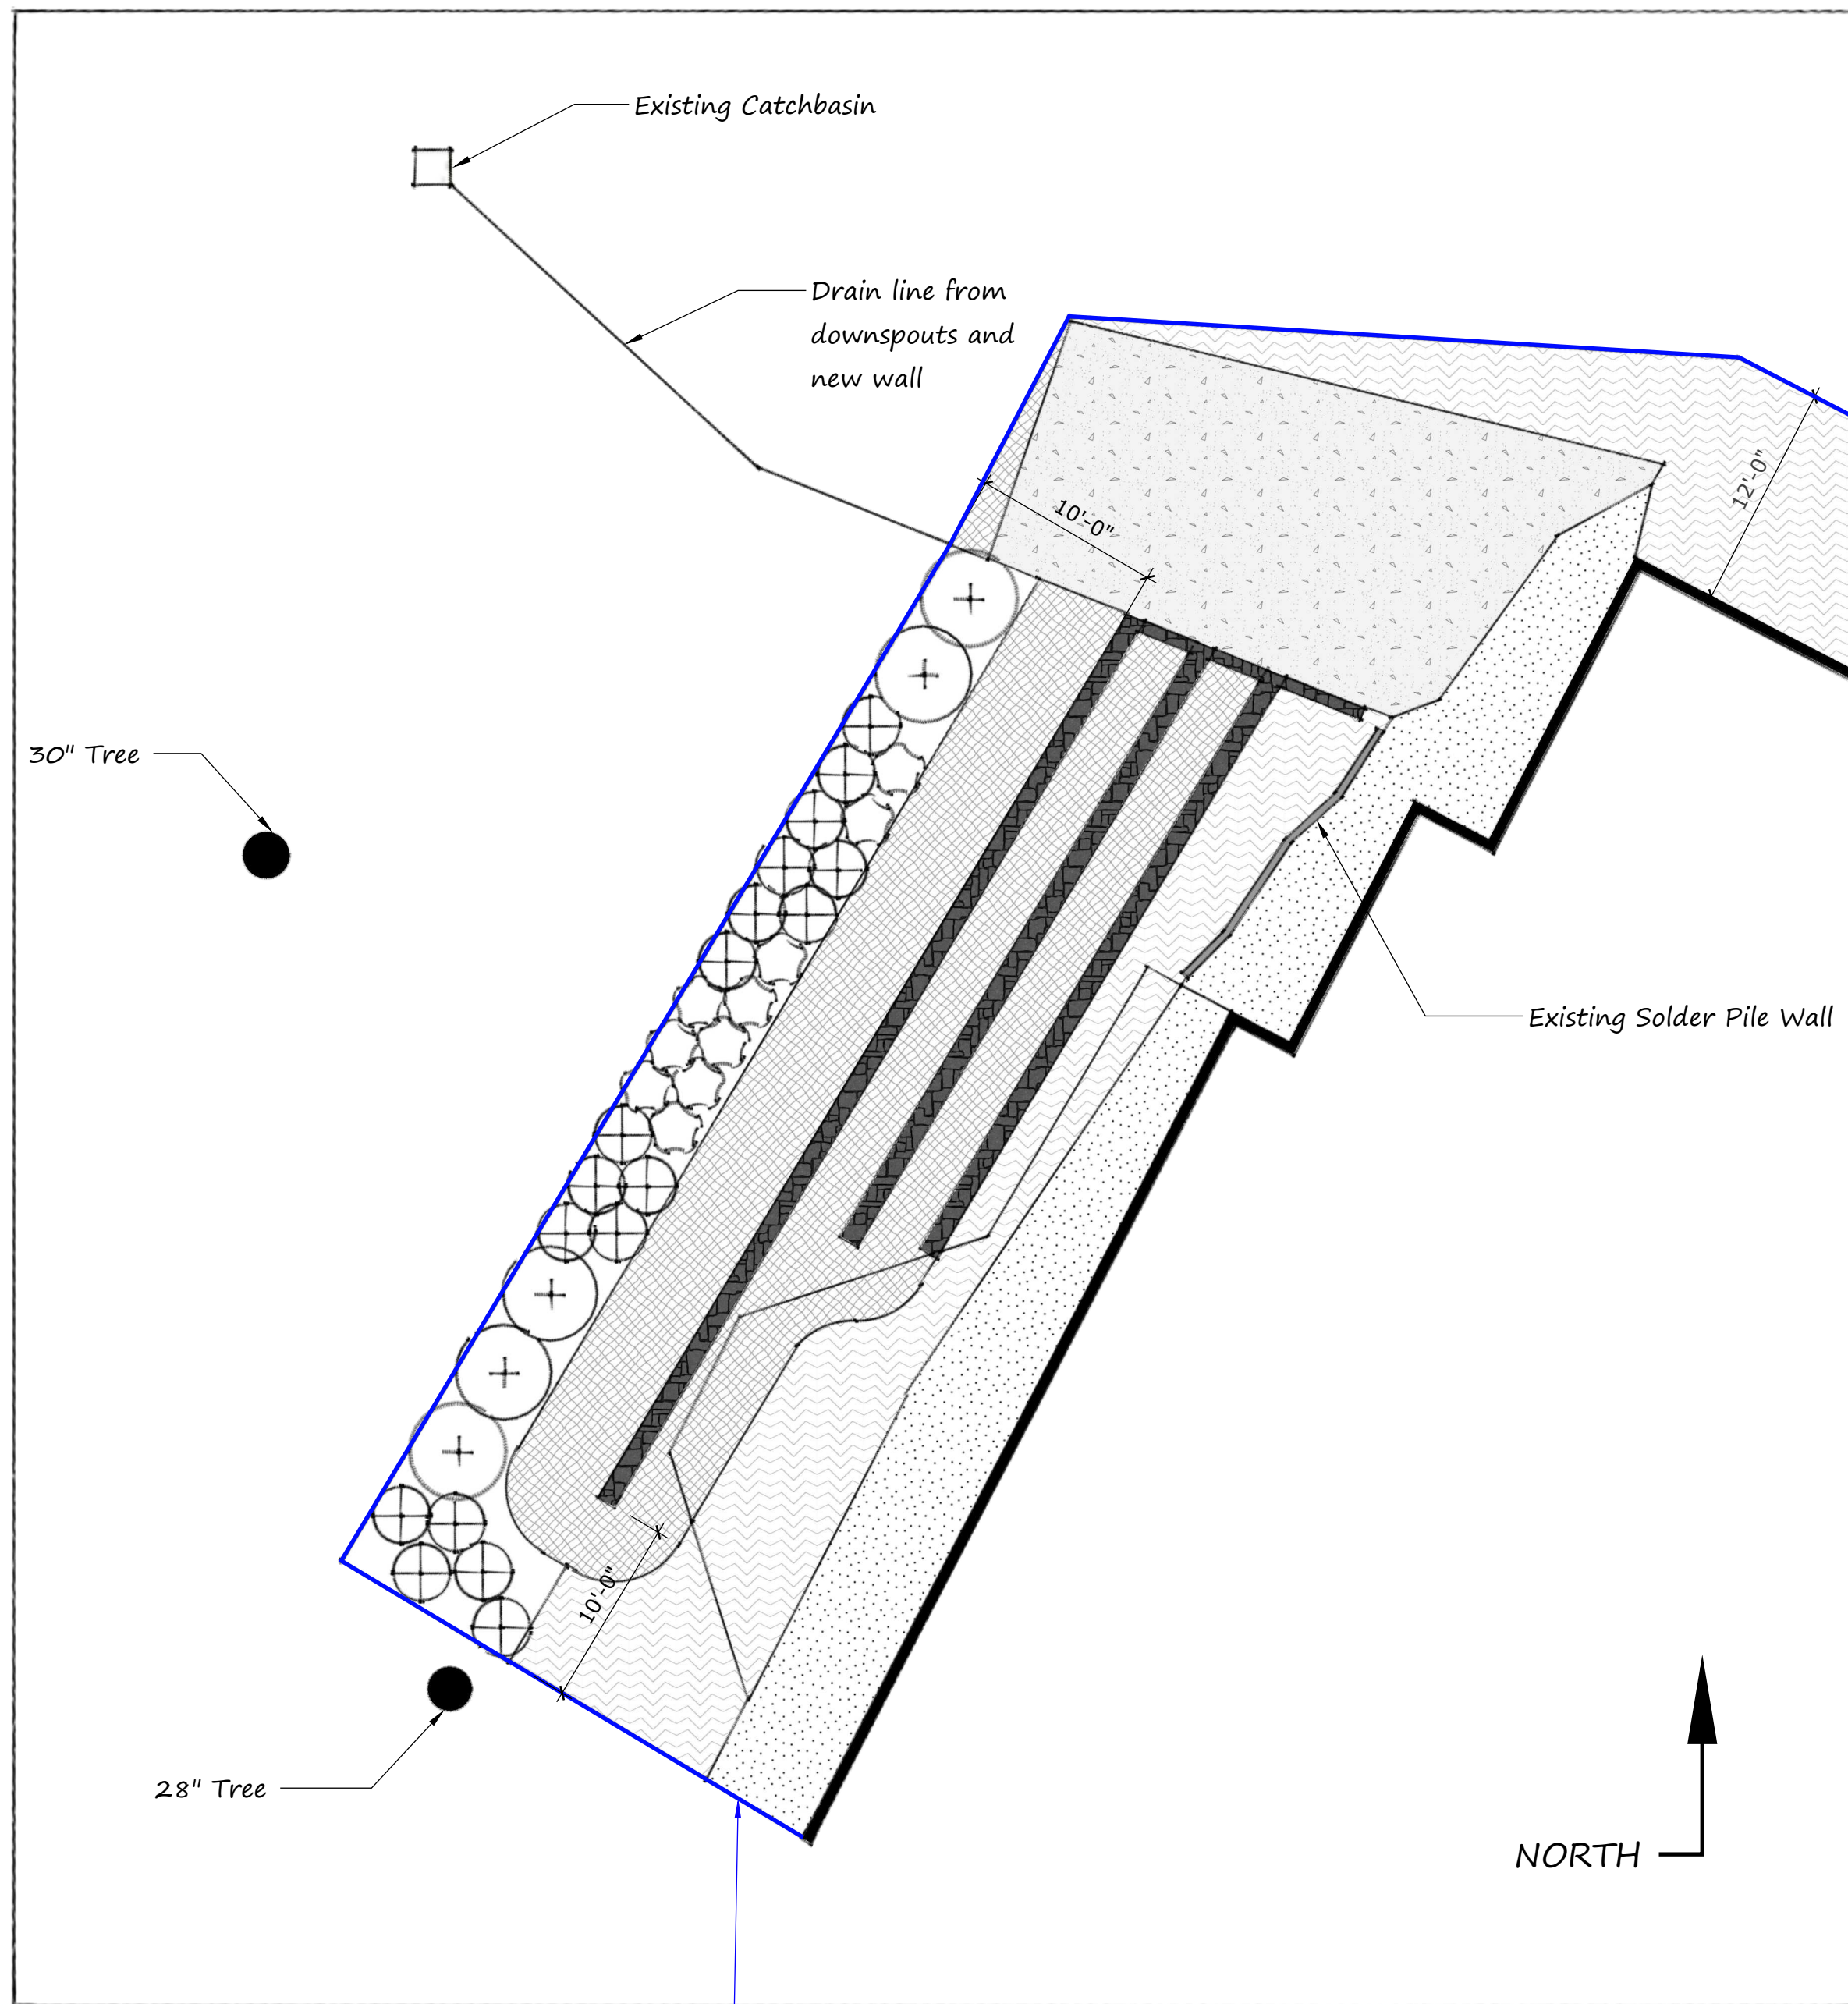
Drawing Number: 1 of 2

Continue erosion barrier along temporary access

Temporary Access Road

NEW ALLAN BLOCK WALL	SEE ENGINEERED PLANS

EXISTING SOLDER PILE WALL	SEE ENGINEERED PLANS

EROSION CONTROL BARRIER	AS SHOWN IN PLAN AND ALONG TEMP ACCESS ROAD SILT FENC AND WATTLE DETAIL PAGE 2

Continue erosion barrier up to house footing if possible

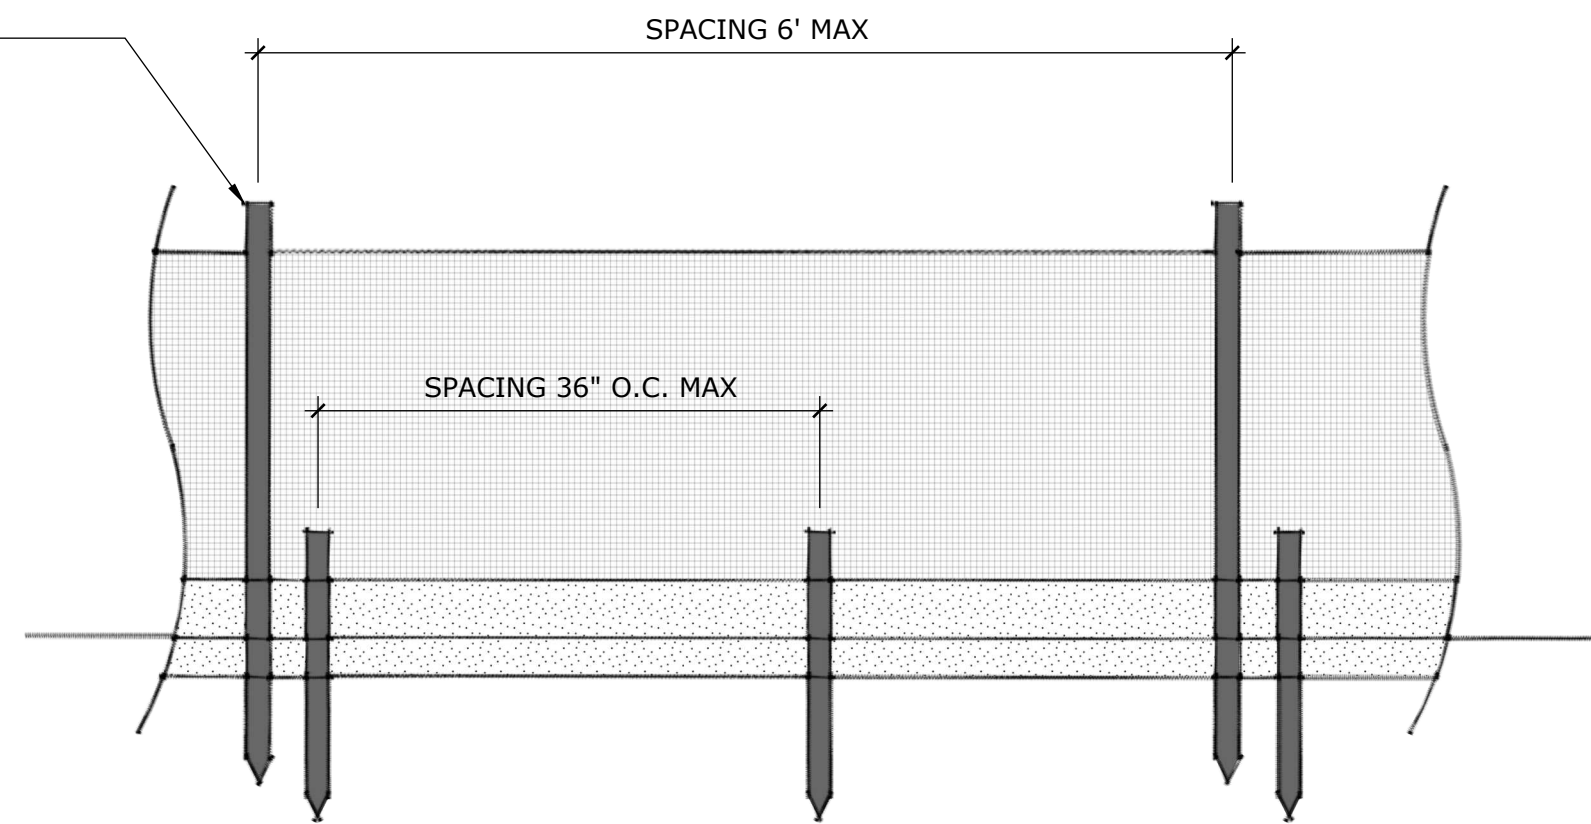
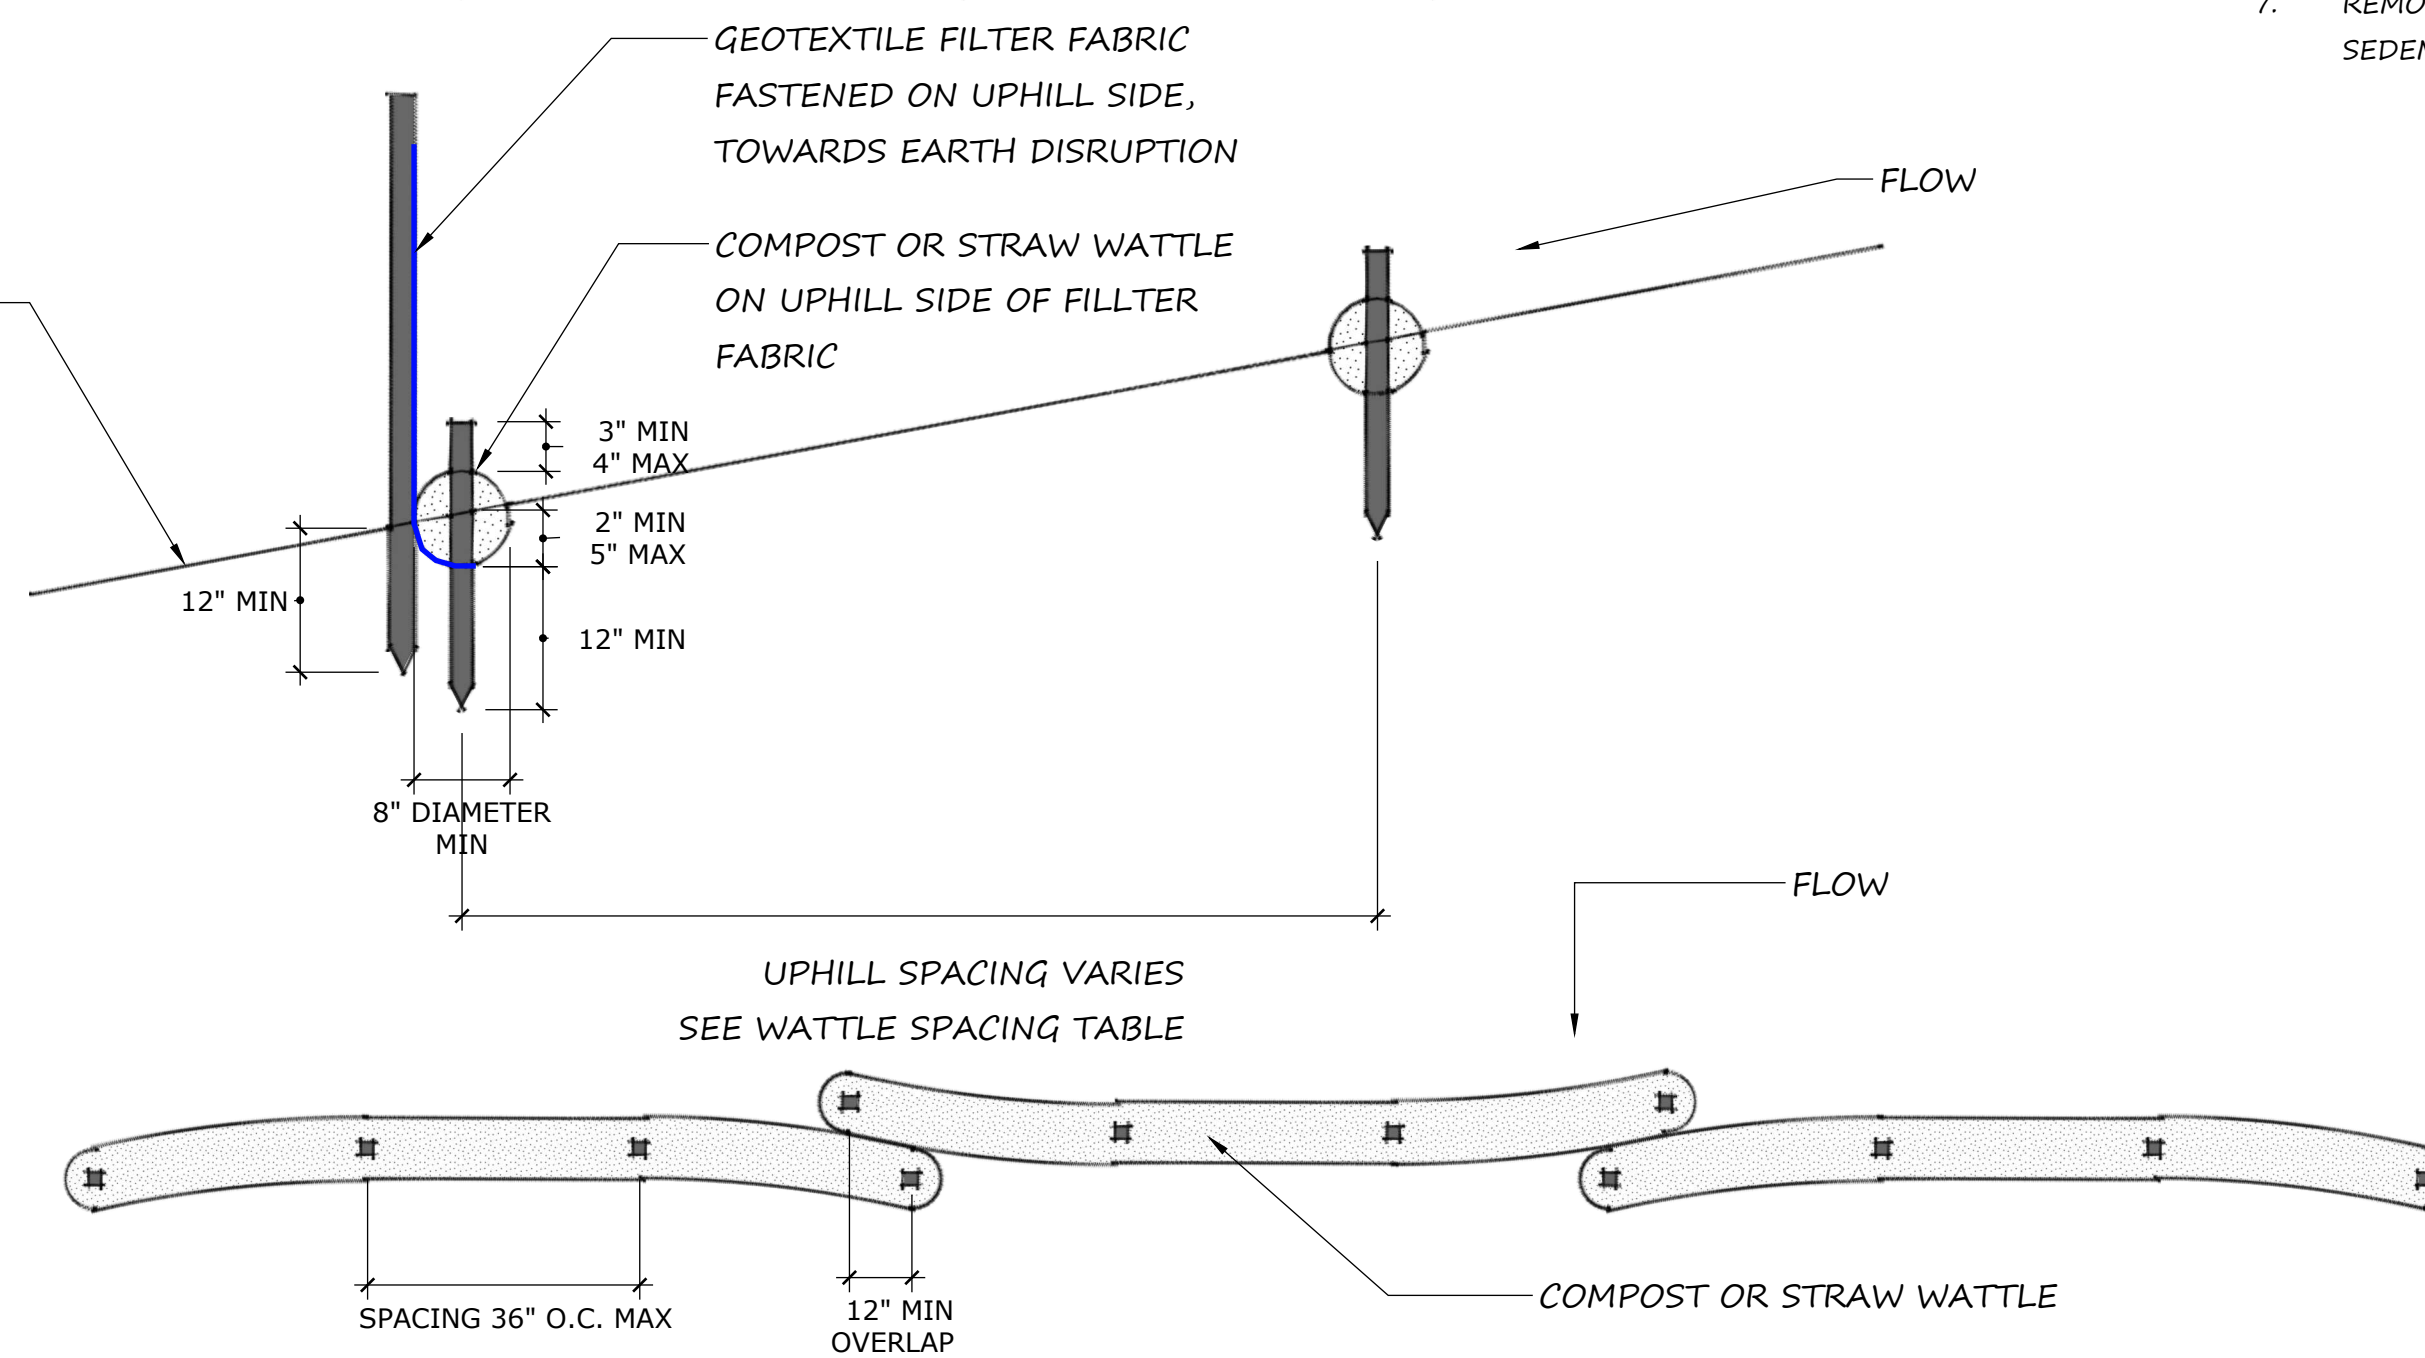
FENCE POSTS DRIVEN INTO GROUND 12" MIN

UNDISTURBED VEGETATION

8" DIAMETER WATTLE SPACING TABLE	
SLOPE	MAXIMUM SPACING
1H:1V	10'-0"
2H:1V	20'-0"
3H:1V	30'-0"
4H:1V	40'-0"
>4H:1V	ONE RUN ONLY
