CRITICAL AREAS REPORT

4006 E. Mercer Way – Shoreline Modification

July 2021

Shoreline Restoration Planting Plan

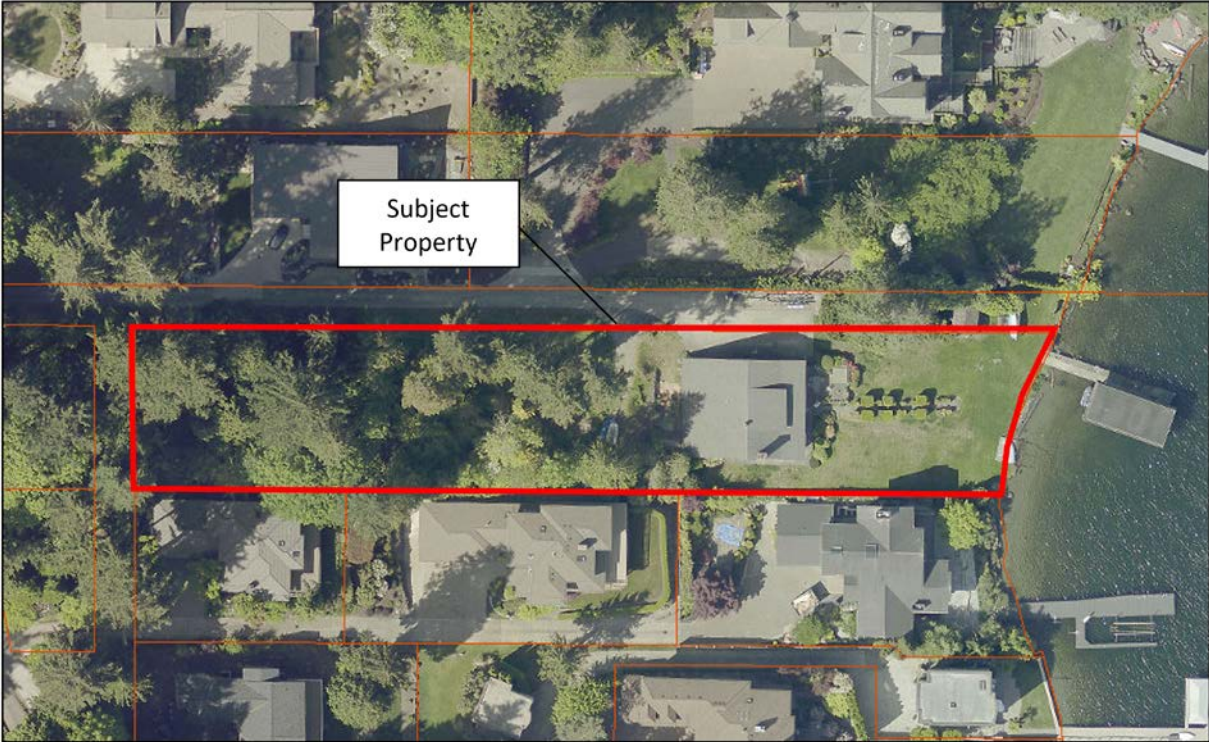
Figure 2. Aerial photograph of subject property (source: King County iMap).

The subject parcel (parcel # 4131900005) is located at 4006 E. Mercer Way in Mercer Island, Washington; in Section 17 of Township 24 North, Range 5 East of the Public Land Survey System (PLSS). The property is approximately 0.83 acres in size and situated in the Mercer Island sub-basin of the Cedar-Sammamish Watershed (Water Resource Inventory Area [WRIA] 8; Figure 1). The subject parcel is zoned residential (R-9.6).

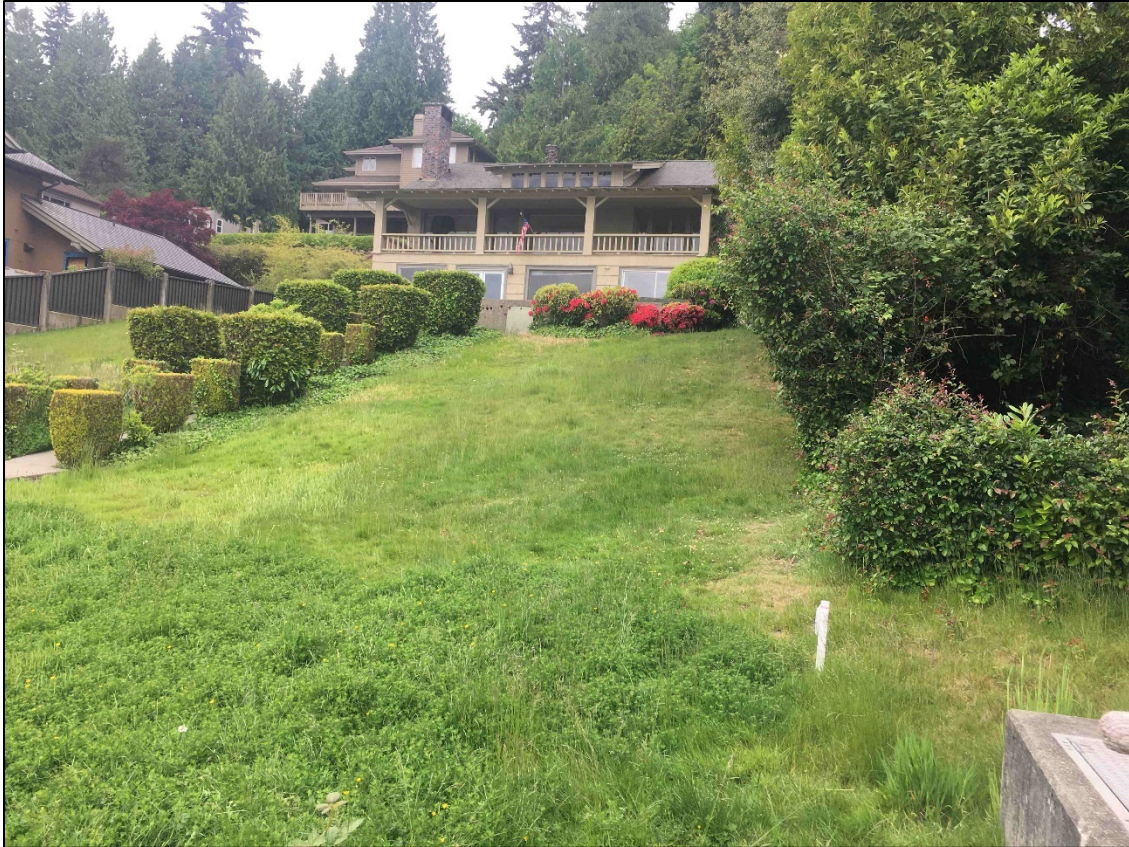
Figure 3: Existing residence and lawn area, facing east from Lake Washington shoreline (6/01/20)

The existing shoreline area is composed of medium-sized gravel below the OHWM. A small rock bulkhead is present along the northwest shoreline. An existing wooden dock and covered boat slip extends westward from the shoreline, and a concrete path extends from the existing residence towards the shoreline. Landward of the OHWM, the shoreline is composed entirely almost entirely of mowed lawn areas. The existing residence is located approximately 100 feet west of the OHWM, with the elevated patio encroaching to within approximately 85 feet of the shoreline at its closest point.

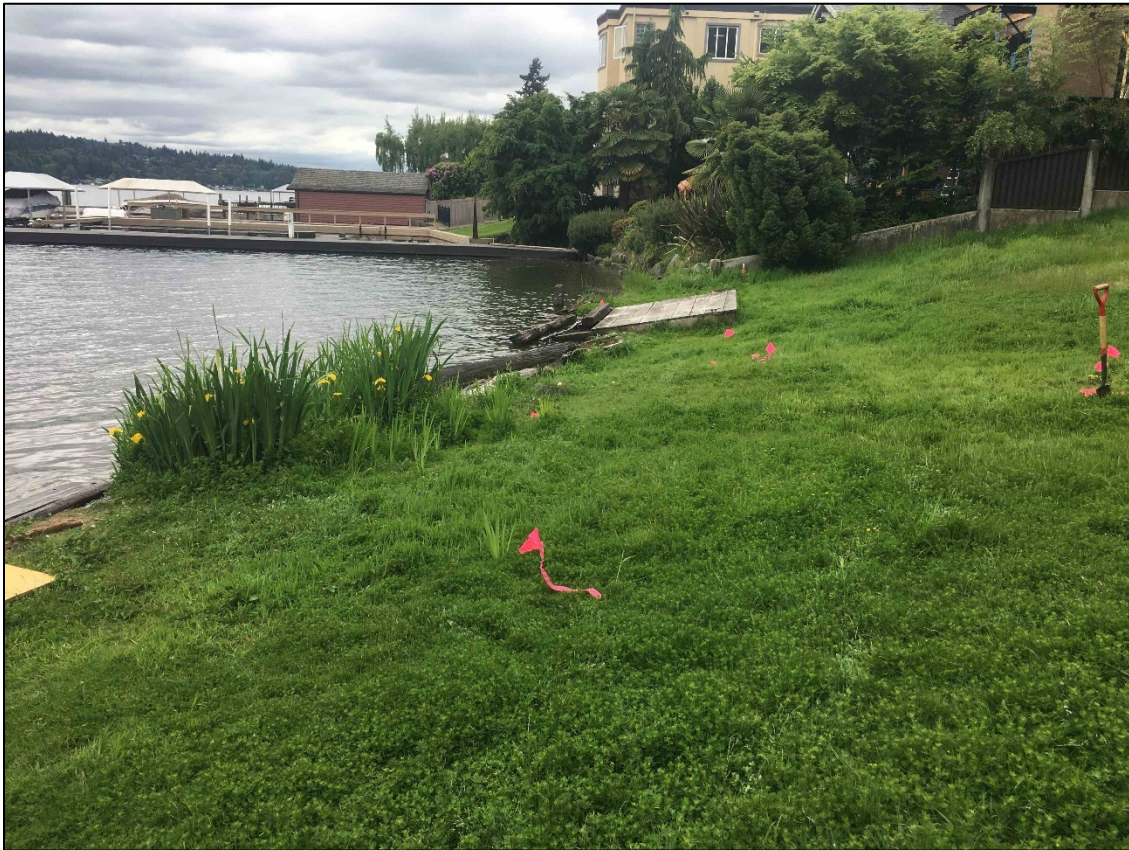
Figure 4. Wetland A and Lake Washington Shoreline with wooden boat ramp in background, facing south (6/01/20).

Wetland is a Category III, lake-fringe wetland that is contiguous with the Lake Washington shoreline, extending approximately 10-12 feet landward of the OHWM. The primary vegetation in Wetland A includes birds-foot trefoil (*Lotus corniculatus*), velvet grass (*Holcus lanatus*), and yellow-flag iris (*Iris pseudacorus*). The indicator soil in Wetland A is a very dark grey (10YR 3/1) sandy clay loam with redoximorphic features present. The soil satisfies the hydric soil criteria for Redox Dark Surface (F6). Hydrology for Wetland A is provided by a high water table associated with hyporheic flow from Lake Washington. Under the 2014 Rating System, Wetland A is a Category III wetland with three habitat points.

To further improve critical area functions, a 124-square-foot wooden boat ramp that is above grade and not structurally supported in Wetland A will be removed, as will 100 square feet of concrete path within the wetland buffer.

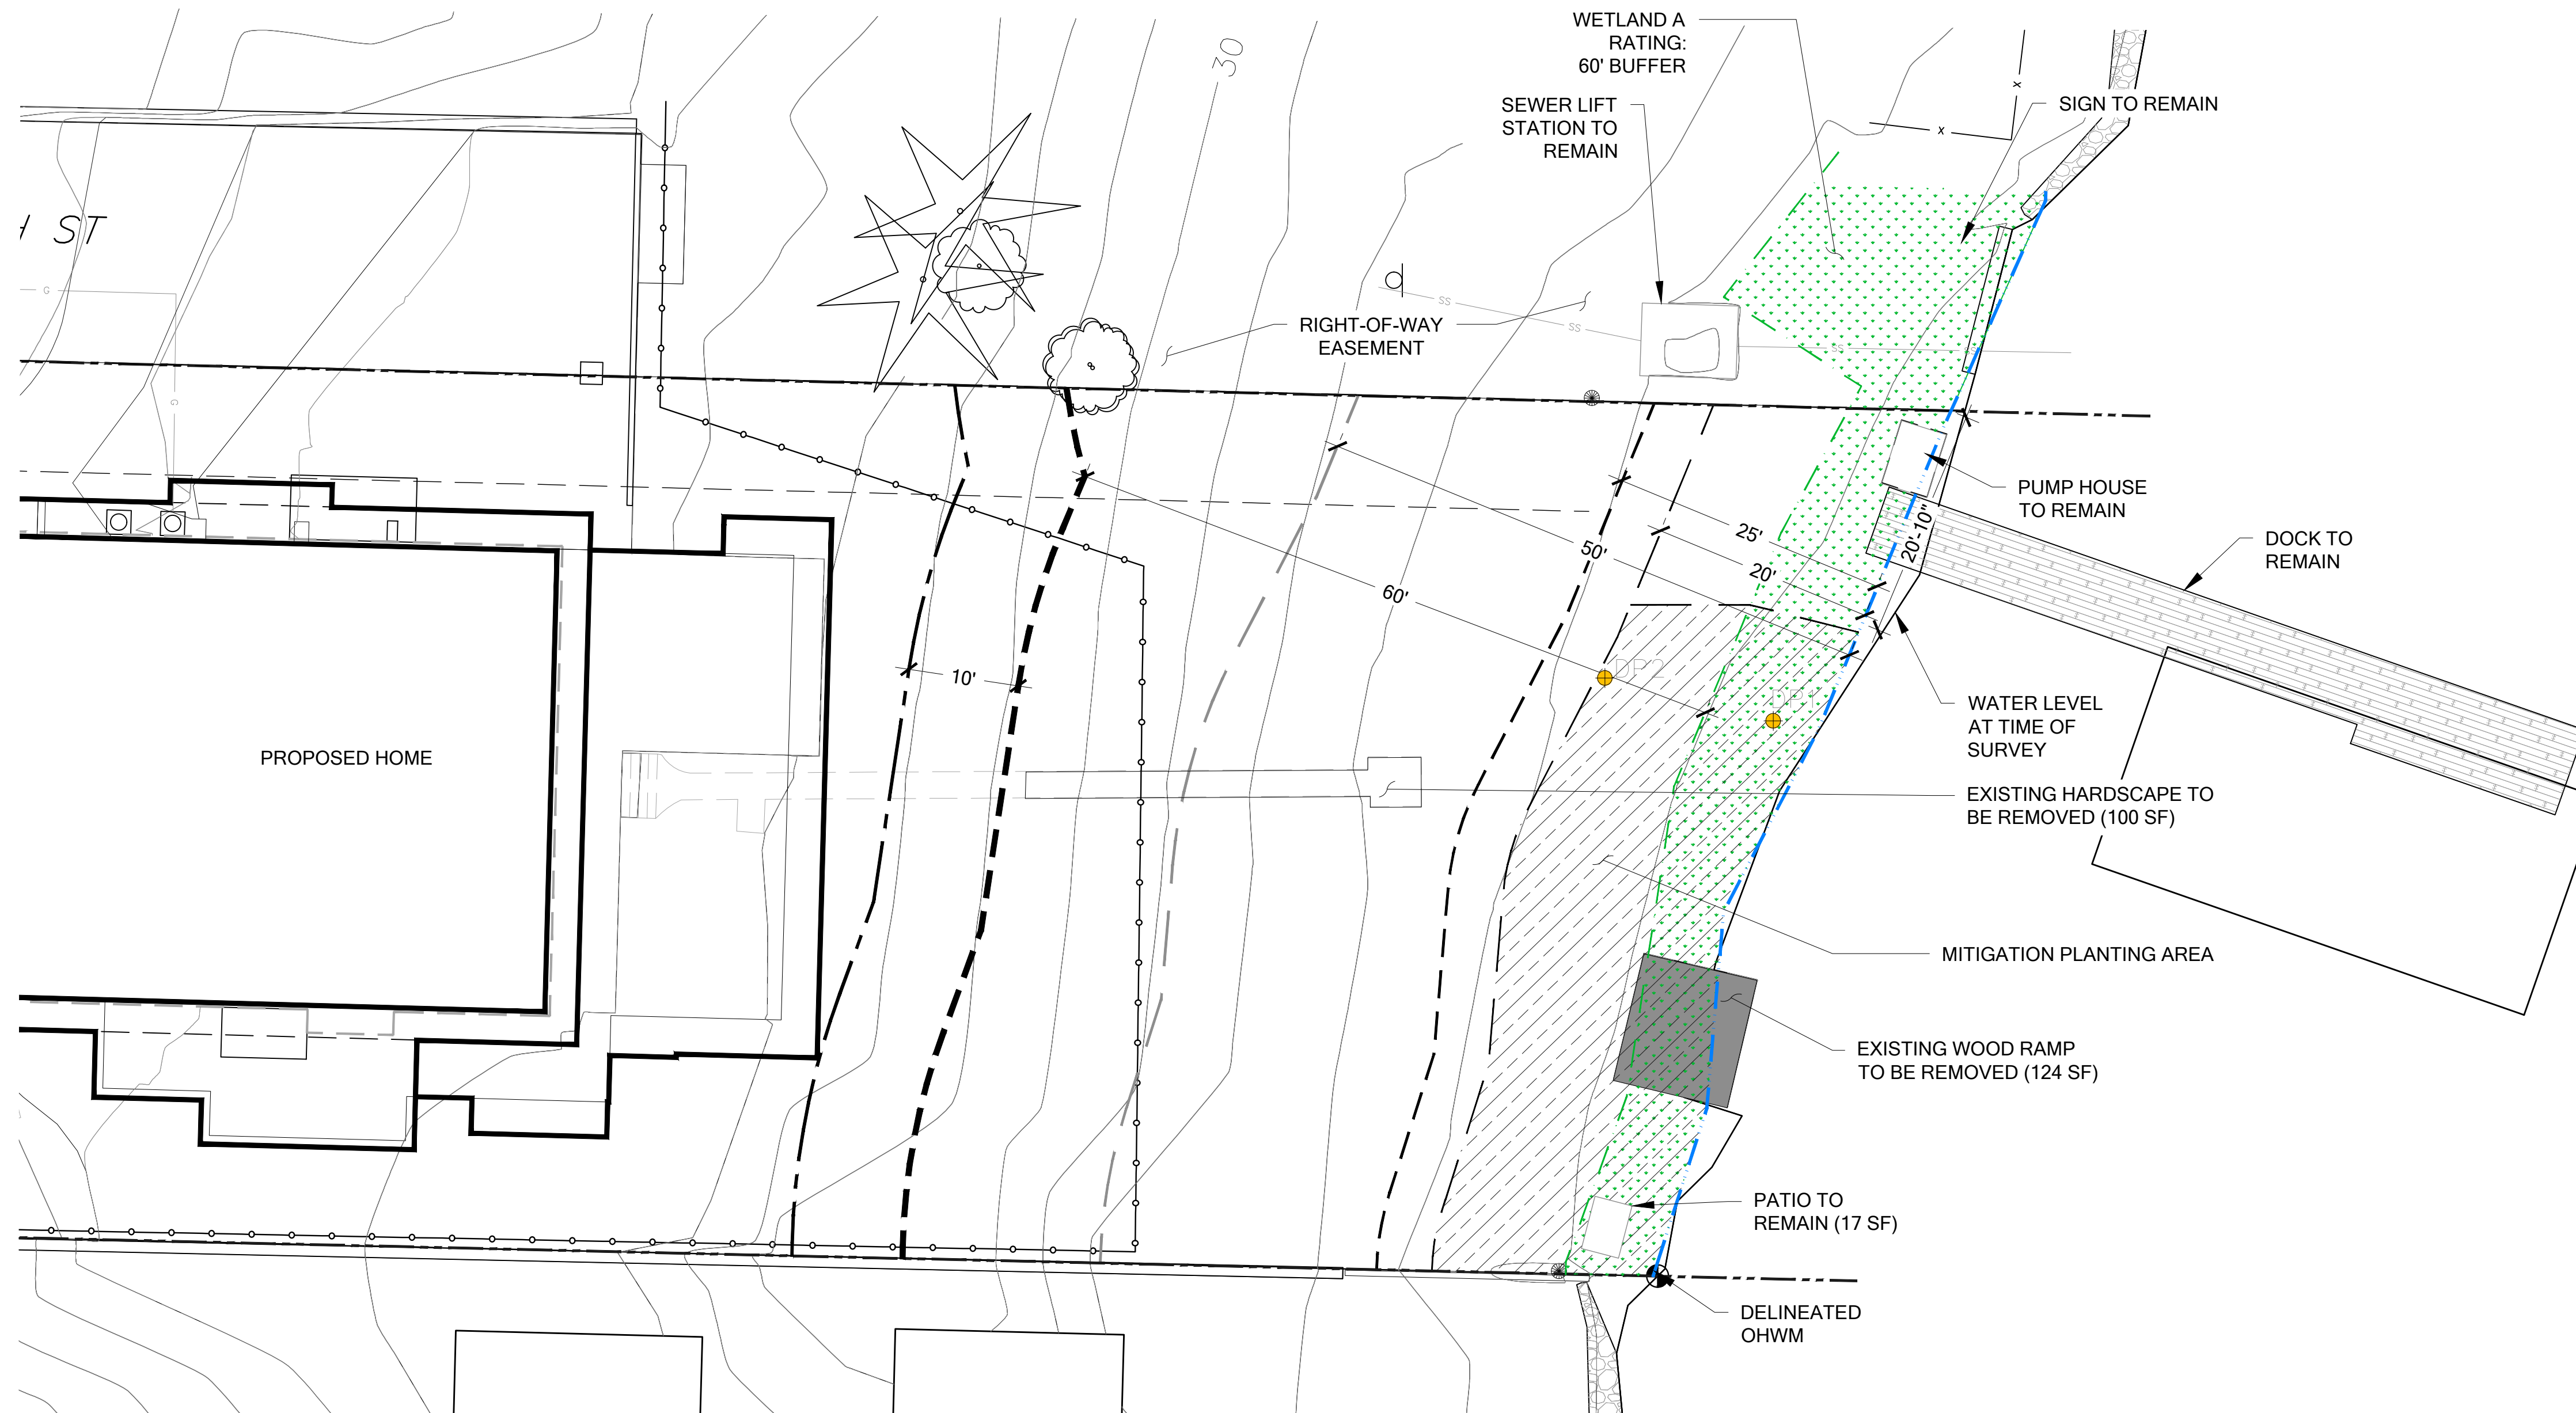
MITIGATION PLAN

1. WETLAND AND OHWM DELINEATED BY THE WATERSHED COMPANY ON MAY 19, 2020
2. SITE PLAN PROVIDED BY STURMAN ARCHITECTS; 103RD AVENUE NE, SUITE 203, BELLEVUE, WA 98004 (425) 451-7003

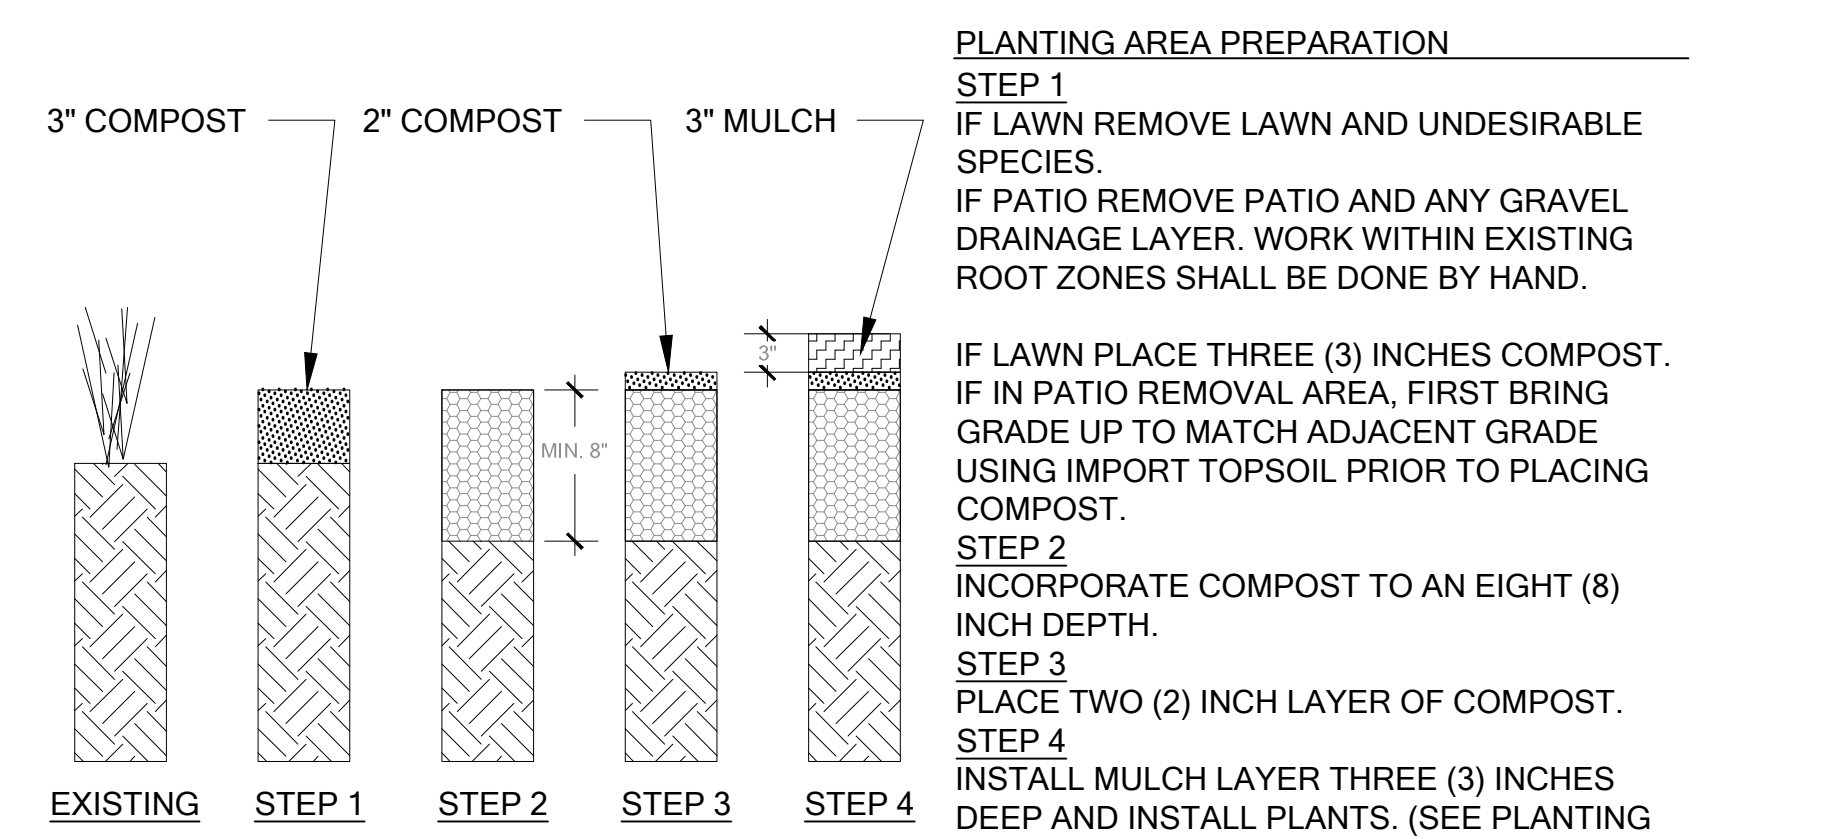
A BUFFER MITIGATION AREA SITE PREPARATION SEE SHEET W1 Scale: NTS

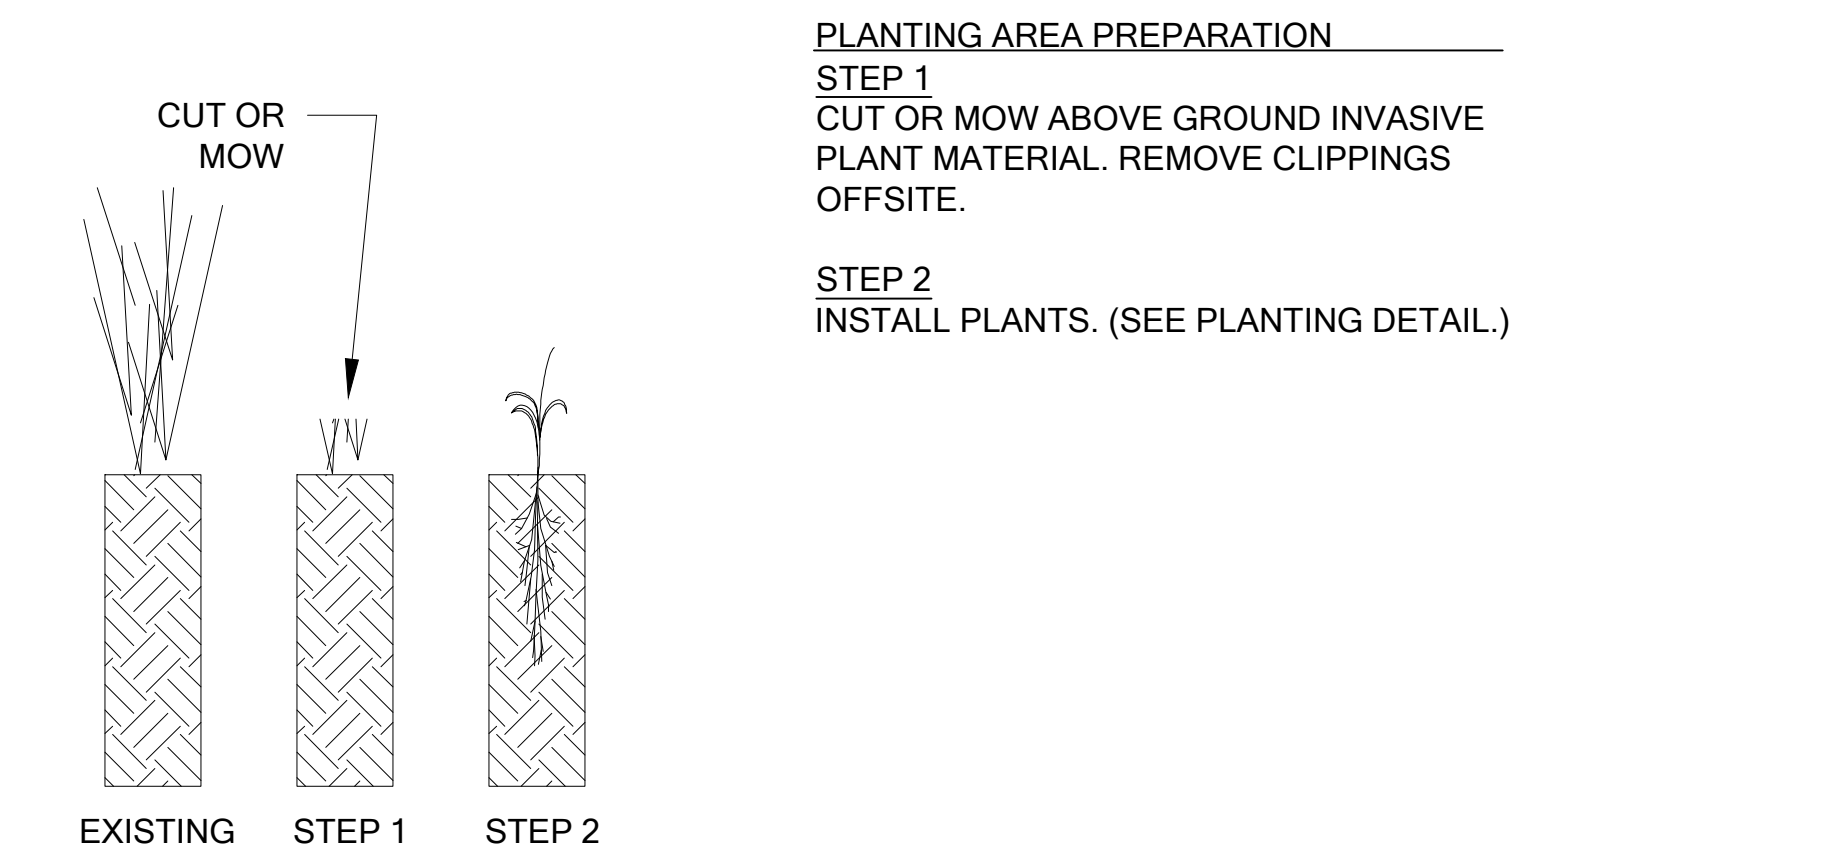
B WETLAND MITIGATION AREA SITE PREPARATION SEE SHEET W1 Scale: NTS

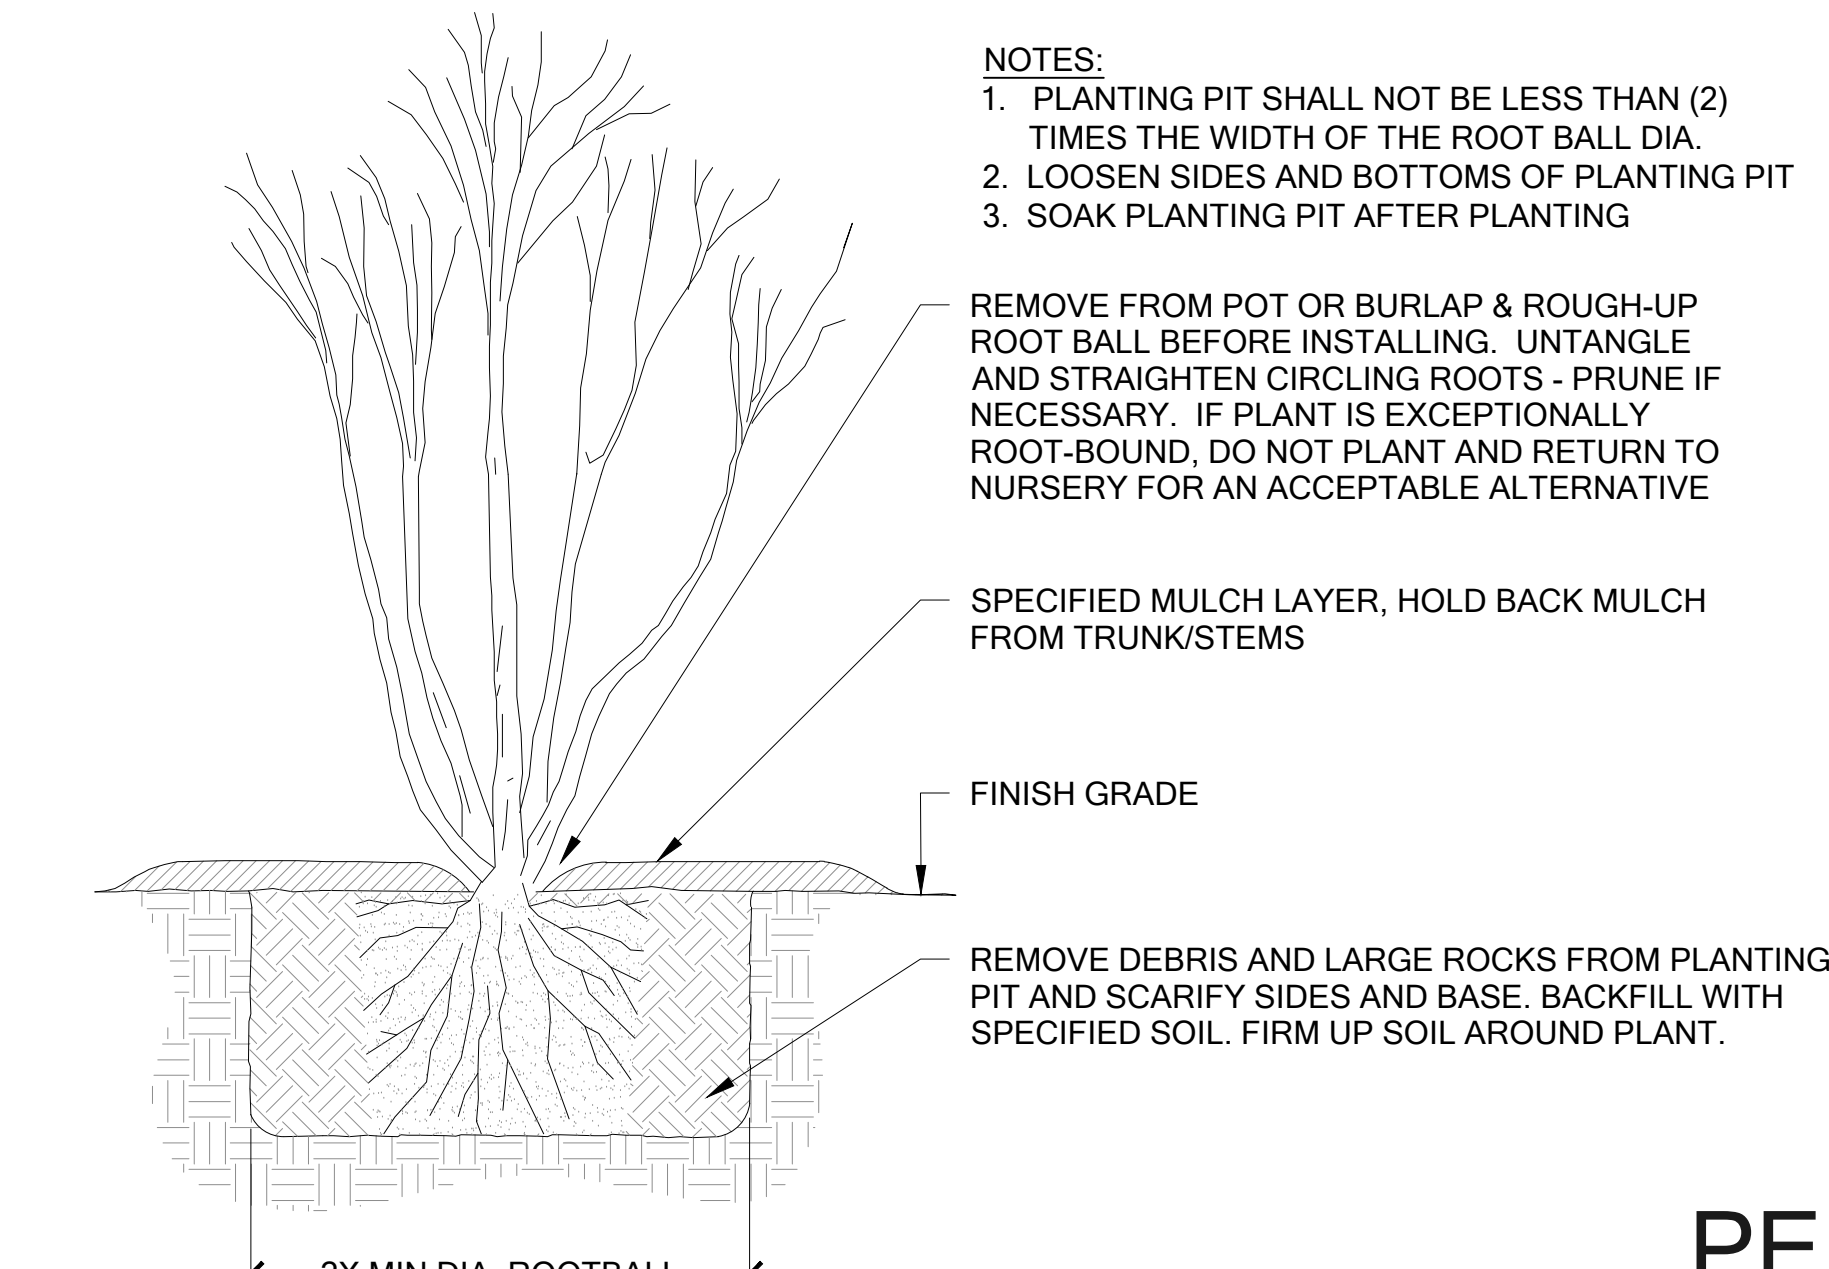
C CONTAINER PLANTING DETAIL Scale: NTS

- CONTAINER GROWN PLANTS (INCLUDES PLUGS): PLANT ROOT BALLS MUST HOLD TOGETHER WHEN THE PLANT IS REMOVED FROM THE POT, EXCEPT THAT A SMALL AMOUNT OF LOOSE SOIL MAY BE ON THE TOP OF THE ROOTBALL.
- PLANTS MUST NOT BE ROOT-BOUND; THERE MUST BE NO CIRCLING ROOTS PRESENT IN ANY PLANT INSPECTED.
- ROOTBALLS THAT HAVE CRACKED OR BROKEN WHEN REMOVED FROM THE CONTAINER SHALL BE REJECTED.

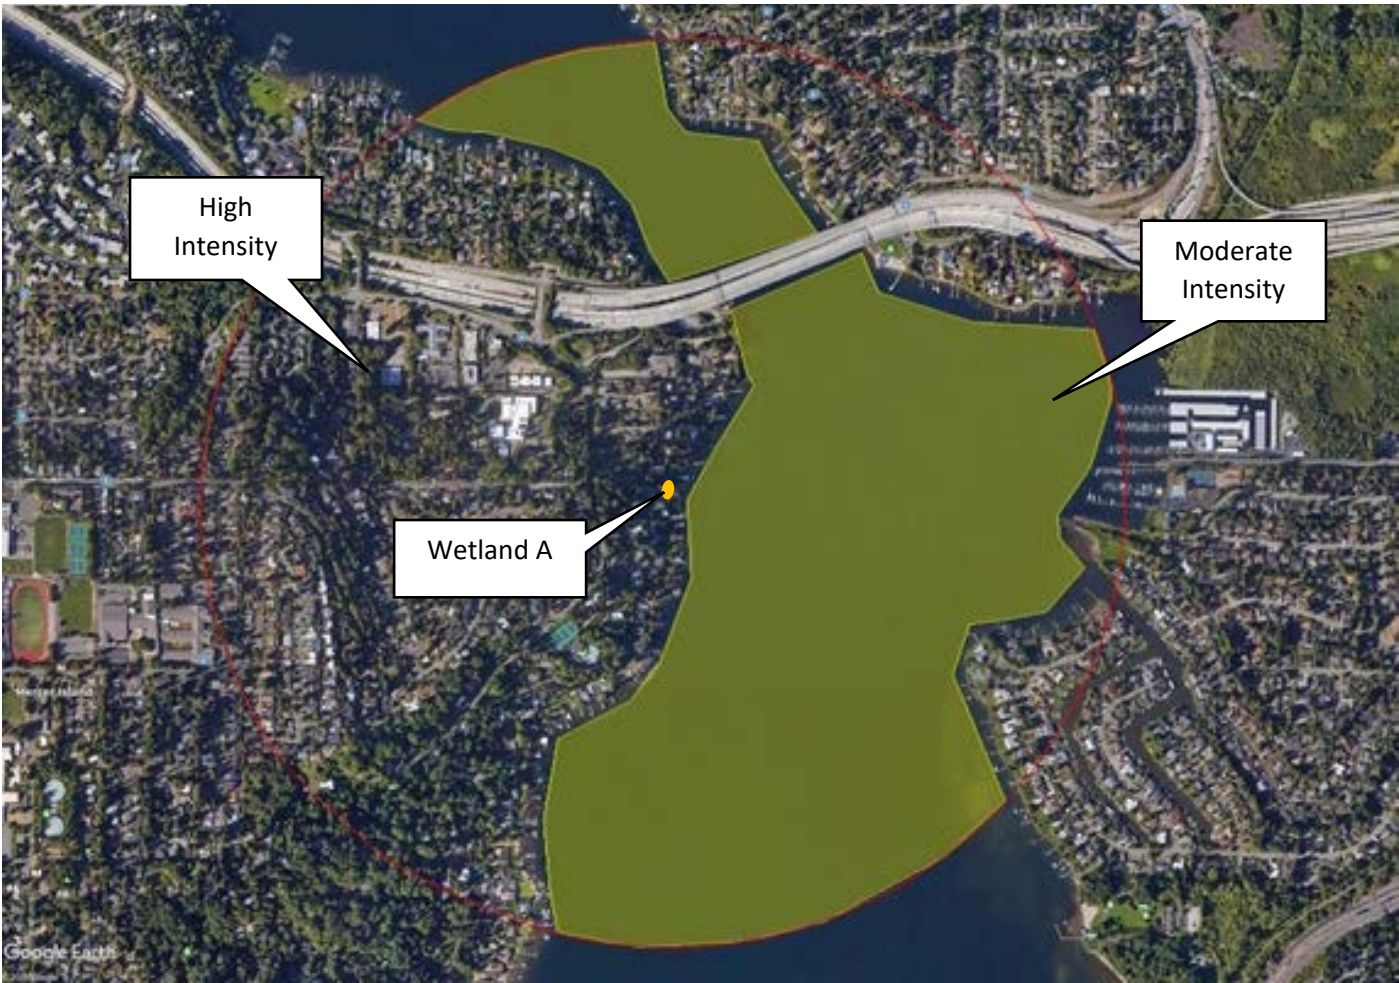
Figure 2: H2.1, H2.2, H2.3

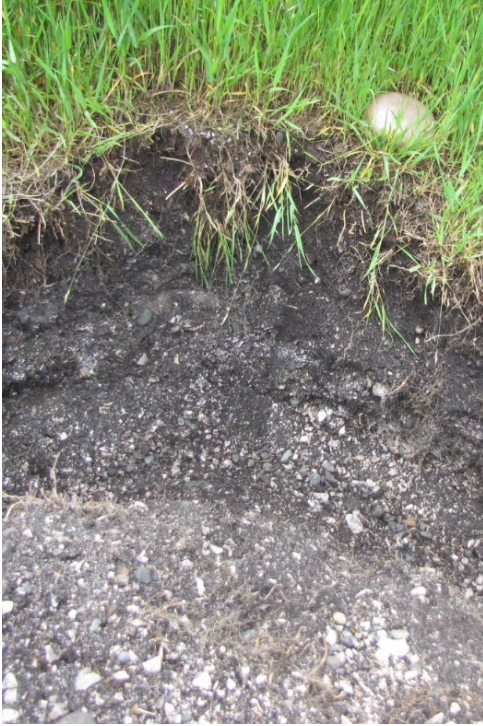
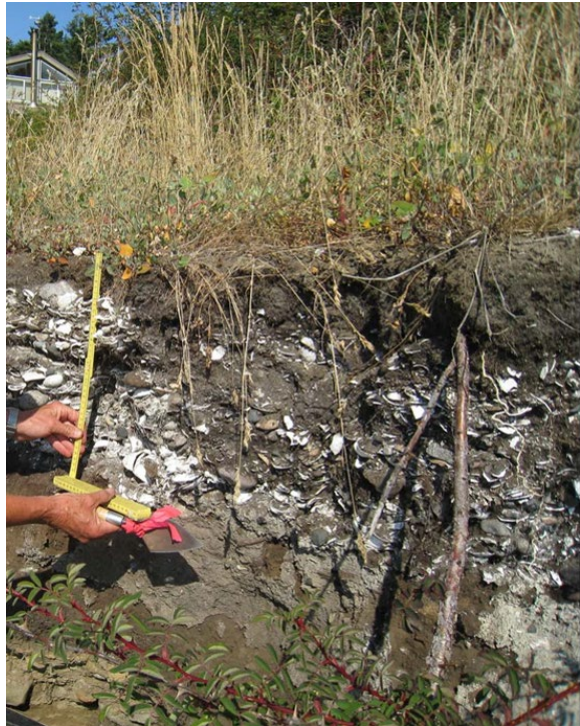
Figure 1: Shell Middens. These middens can extend into the intertidal zone in areas that have undergone sea level rise during the precontact period.

1. Buried layers of black soil with layers of shell, charcoal, and fish and mammal bones that may be part of a shell midden site (Figure 1, top)
2. Buried cobbles—especially those that are reddened, blackened, or feature jagged breaks—that may indicate a hearth feature (Figure 1, bottom);

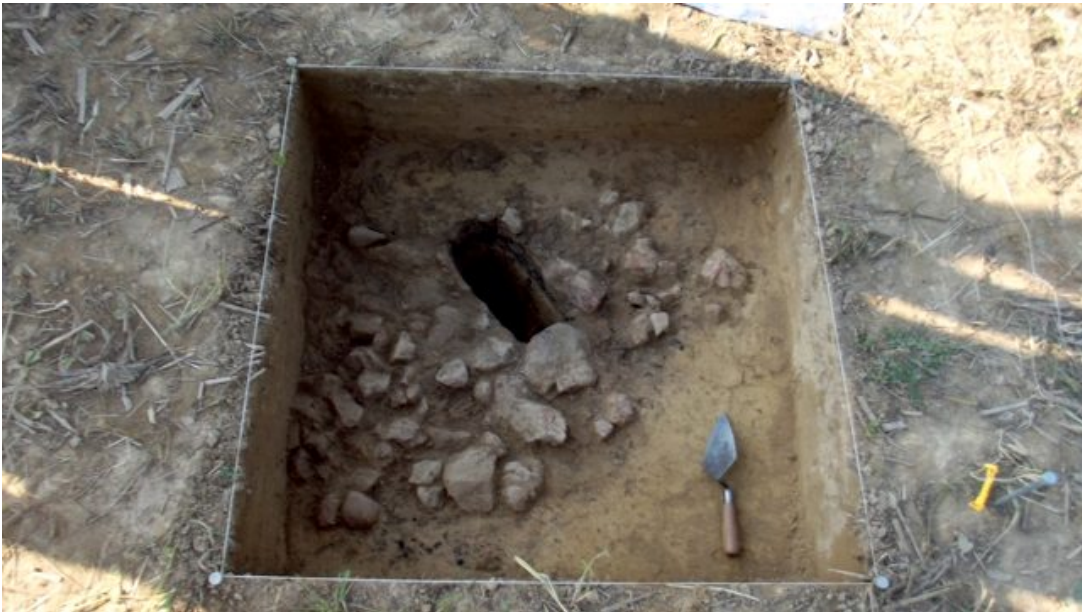
Figure 2: Examples of stone and bone tools.

3. Non-natural sediment or stone deposits that may be related to cultural activity areas;
4. Stone, bone, shell, horn, or antler tools that may include projectile points (arrowheads/spear points), scrapers, cutting tools, wood working wedges or axes, or grinding stones (Figures 2 & 3);

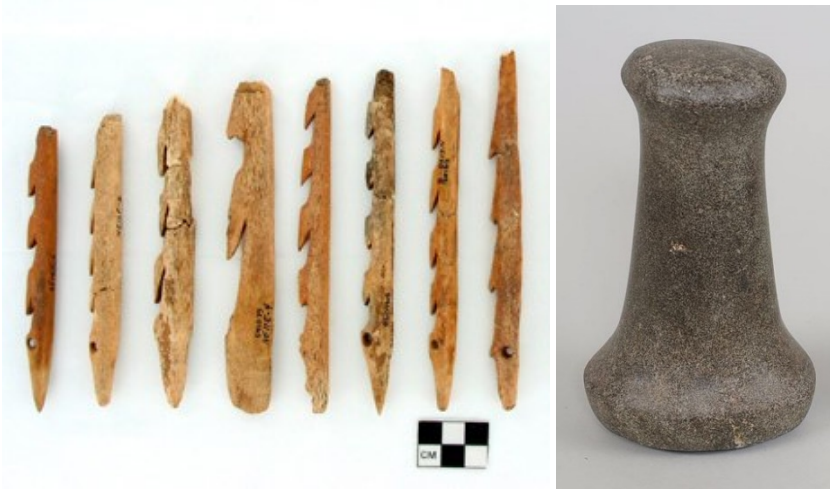
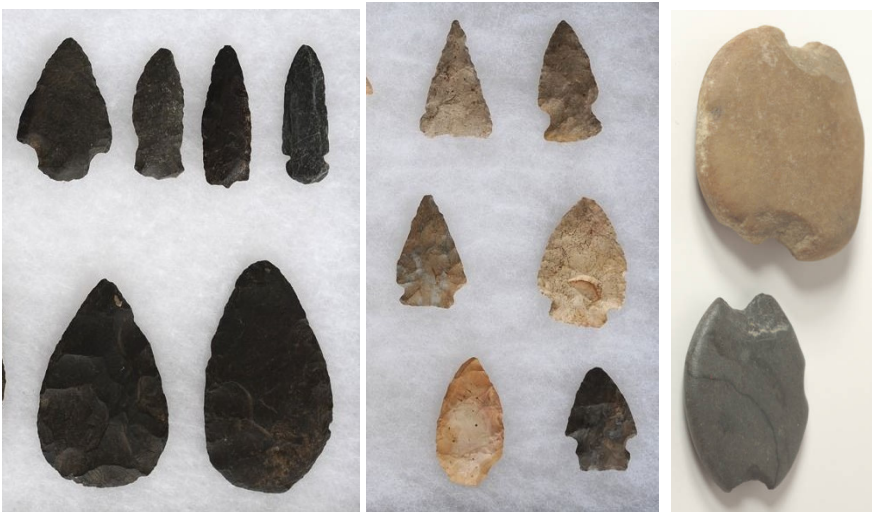
Figure 3: Examples of stone flakes (left) and a stone core that is a source of flakes (right) from archaeological sites.

5. Stone tools or stone flakes (Figures 2 and 3);
6. Perennially damp areas may have preservation conditions that allow for remnants of wood and other plant fibers; in these locations there may be remains including fragments of basketry, weaving, wood tools, or carved pieces (Figure 4);

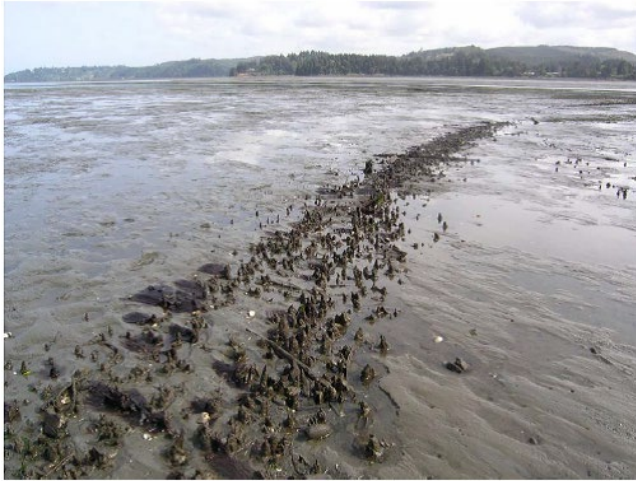
Figure 4: Examples of underwater/intertidal archaeological features including wood or stone fish weirs (top), clam gardens (middle), sunken canoes (bottom) or other watercraft. Basketry (bottom) and other wood and fibrous artifacts can preserve in submerged environments.

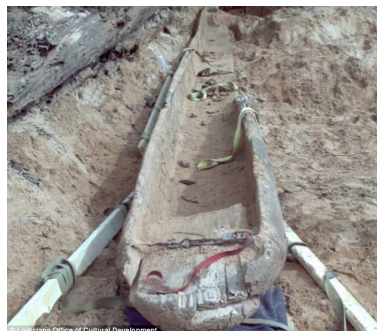
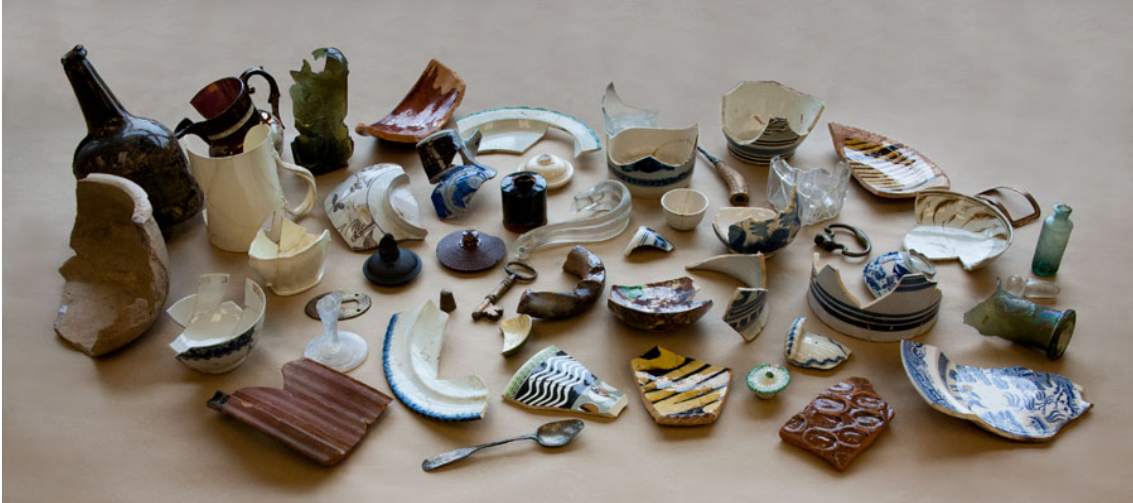
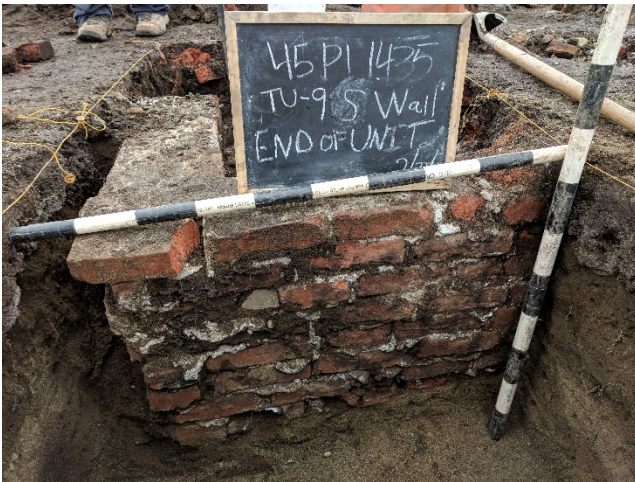
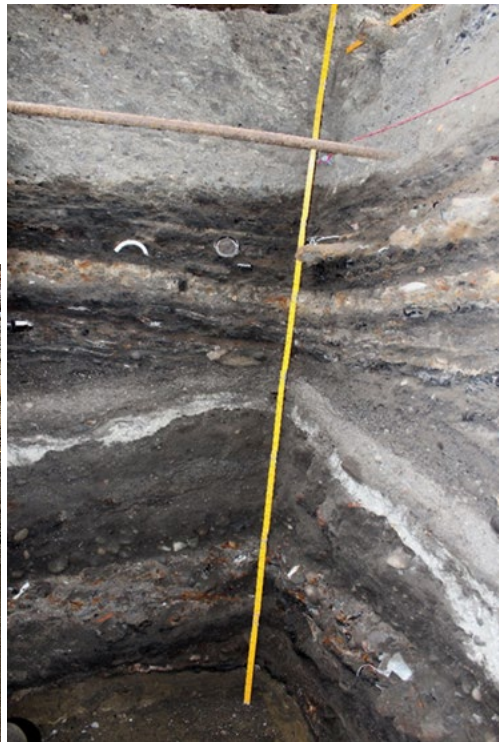
Figure 5. Historic period sites (more than 50 years in age) are also protected by cultural resource laws. These can include concentrations of broken ceramics, bottles, bricks, and metal objects (top) or historical period building foundations (bottom left) and historical period trash deposits (bottom right).

7. Concentrations of historical period artifacts (> 50 years old) (Figure 5); and
8. Human remains. This includes complete burials as well as fragmentary remains.
