**GEOTECHNICAL ENGINEERING STUDY
4740 WEST MERCER WAY
MERCER ISLAND, WASHINGTON**

ES-8380

PREPARED FOR
JAYMARC CUSTOM HOMES, LLC

April 4, 2022

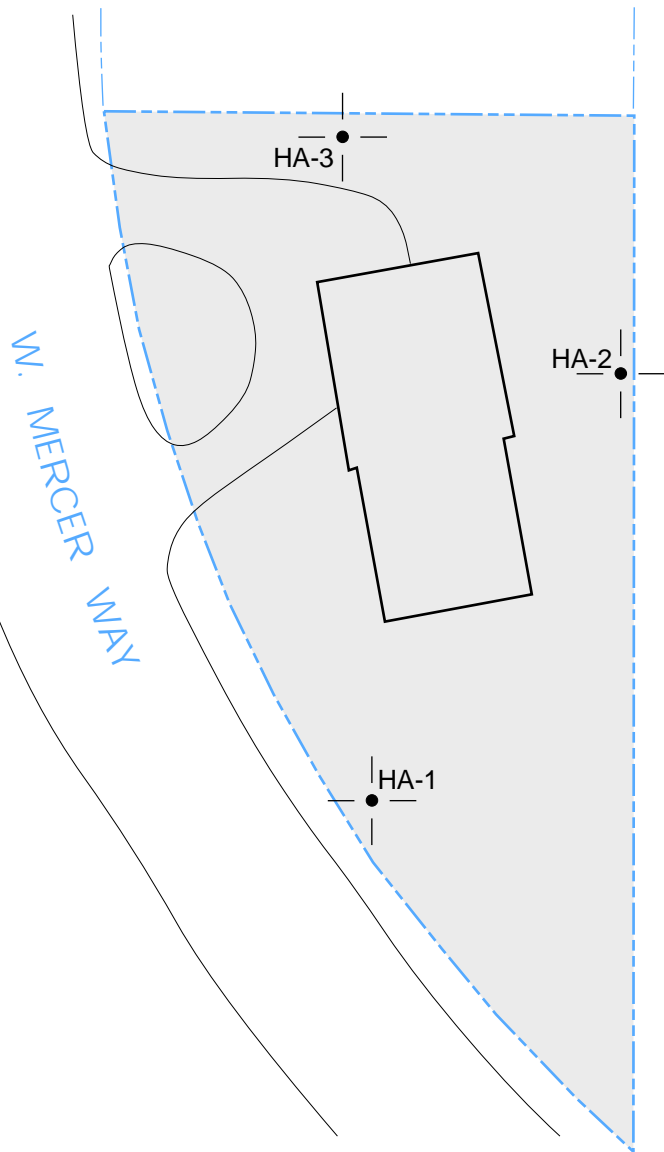
Earth Solutions NW_{LLC} Geotechnical Engineering, Construction Observation/Testing and Environmental Services	
Hand Auger Boring Location Plan 4740 W. Mercer Way Mercer Island, Washington			
Drwn. MRS	Date 03/23/2022	Proj. No. 8380	
Checked SES	Date Mar. 2022	Plate 2

The subsurface conditions at the site were explored by excavating a total of three hand-auger borings across accessible portions of the property. The subsurface explorations were completed in January of 2022. The approximate test locations are illustrated on Plate 2 of this report. Logs of the borings are provided in this Appendix. The borings were excavated to a maximum depth of four feet below existing grades.

ESNW representatives observed, logged and sampled three hand-auger borings across accessible portions of the site. The borings were advanced using hand tools, and advanced to a maximum depth of four feet. The approximate location of the borings is depicted on the Hand Auger Boring Location Plan (Plate 2). Please refer to the soil logs provided in Appendix A for a more detailed description of the subsurface conditions.

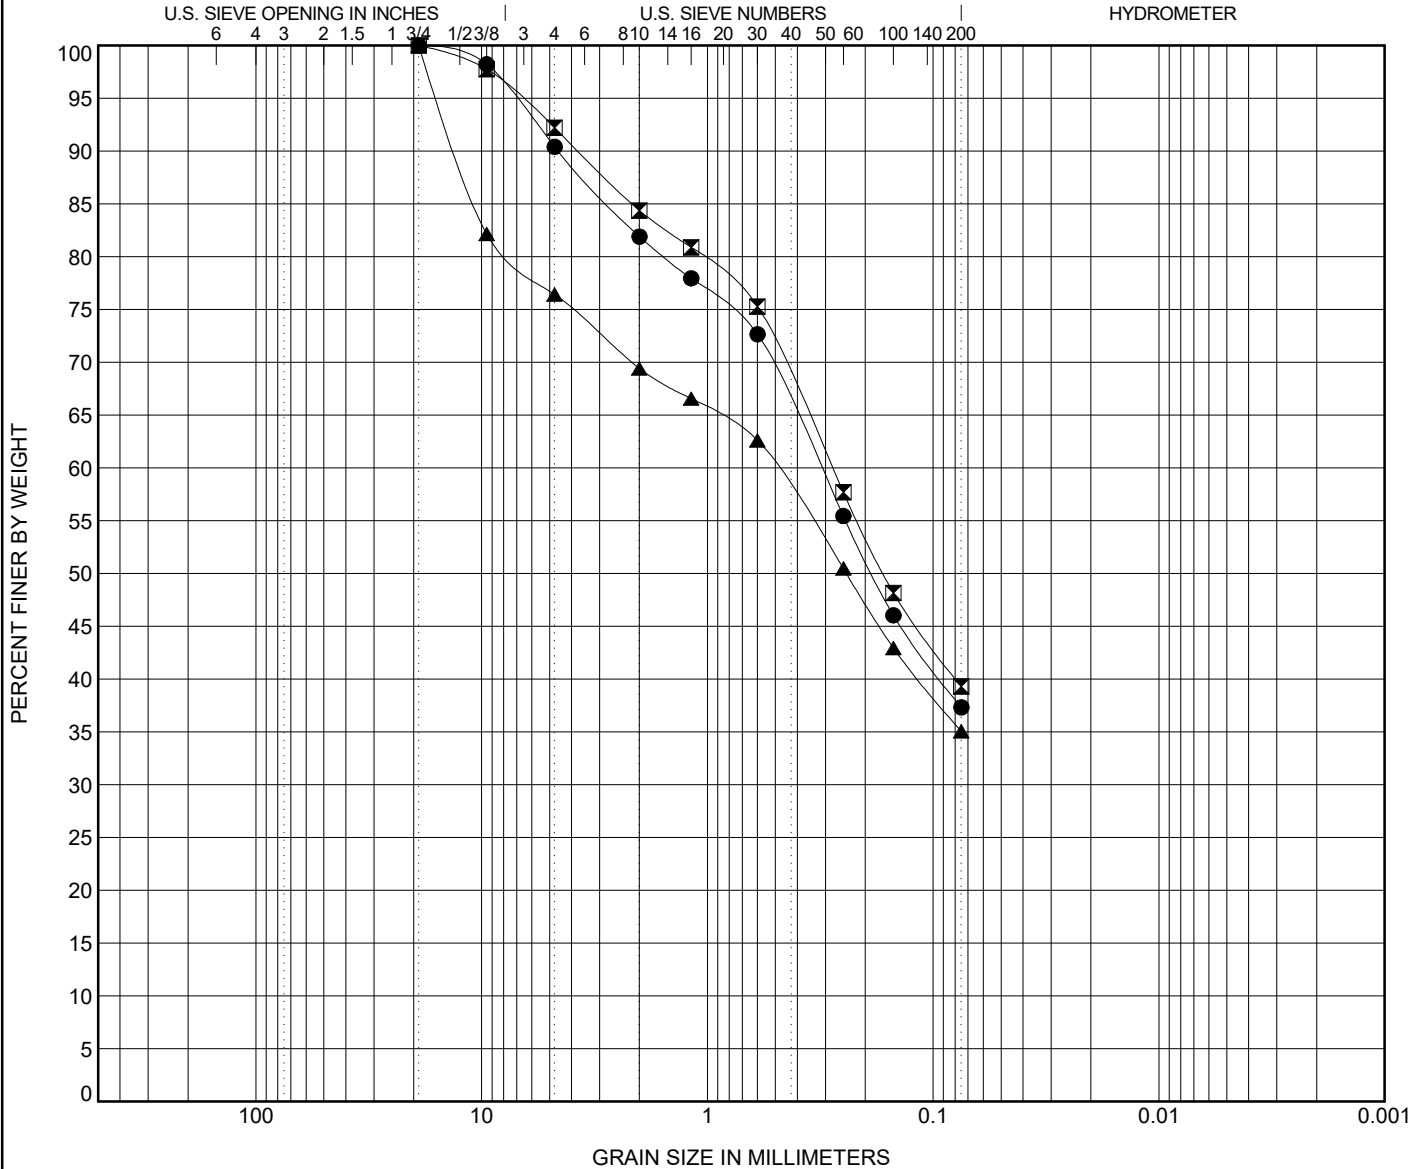
GRAIN SIZE USDA ES-8380 4740 W. MERCER WAY.GPJ GINT US LAB.GDT 2/4/22

Specimen Identification	Classification						Cc	Cu
● HA-01 4.00ft.	USDA: Brown Gravelly Sandy Loam. USCS: SM.							
☒ HA-02 3.50ft.	USDA: Brown Gravelly Sandy Loam. USCS: SM.							
▲ HA-03 4.00ft.	USDA: Brown Gravelly Loam. USCS: SM with Gravel.
