Cobalt Geosciences, LLC
P.O. Box 1792
North Bend, WA 98045

March 26, 2024
Updated April 23, 2024

RE: Geotechnical/Geologic Evaluation
Proposed Addition
3777 79th Ave SE
Mercer Island, Washington

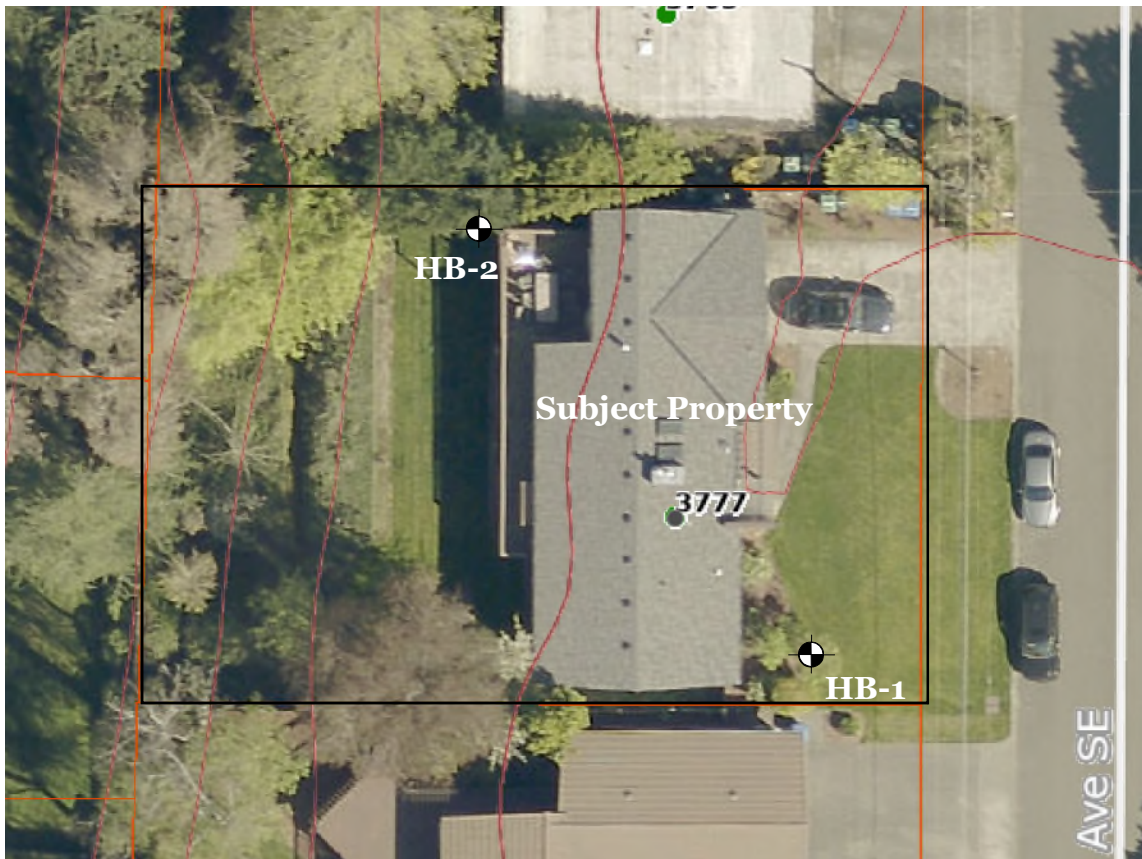
Site Images
Figure 1

The City of Mercer Island GIS maps indicate that the site contains localized erosion and potential landslide hazard areas.

City of Mercer
Island GIS

King County imap Image

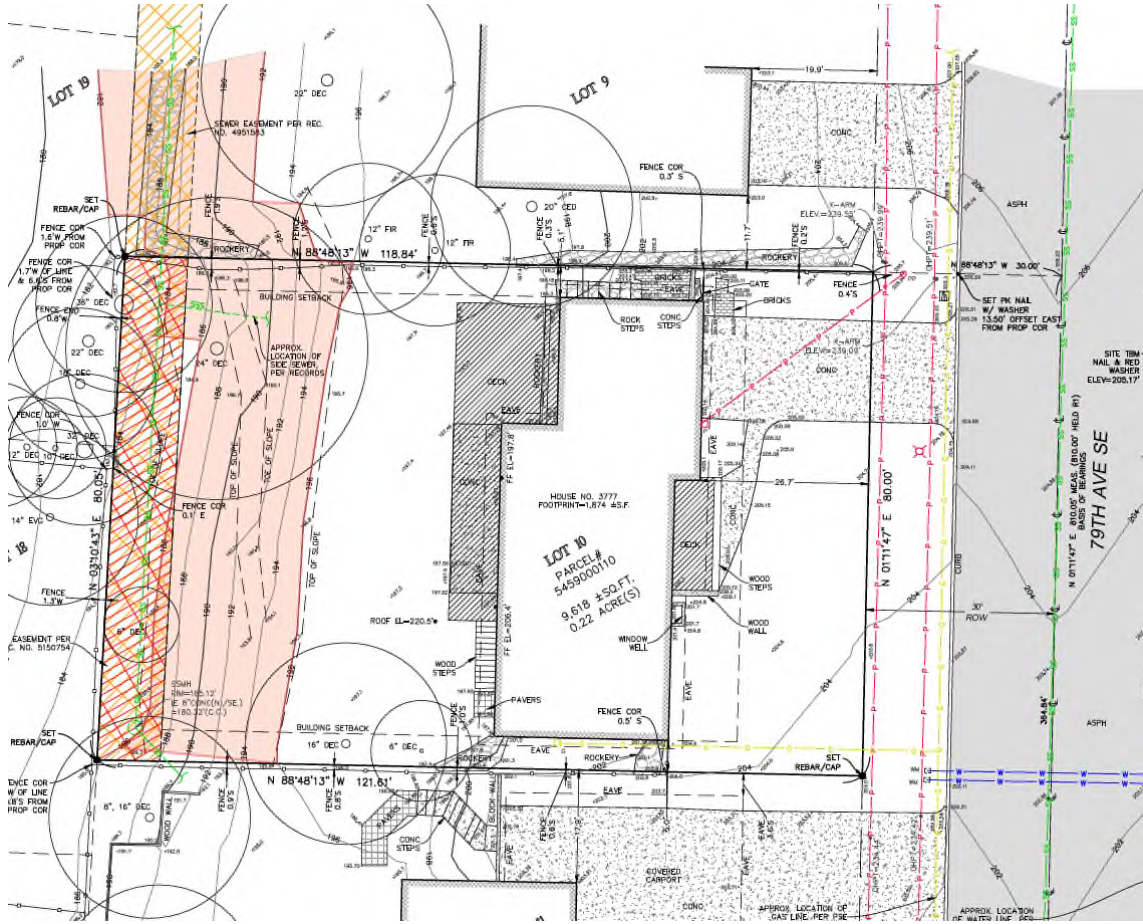
**Topo Map
 Figure 2**

Approximate Scale 1"=30'

Provided topographic map

We have provided the topographic survey information in Figure 2.

We have provided a scaled topographic survey in Figure 2.

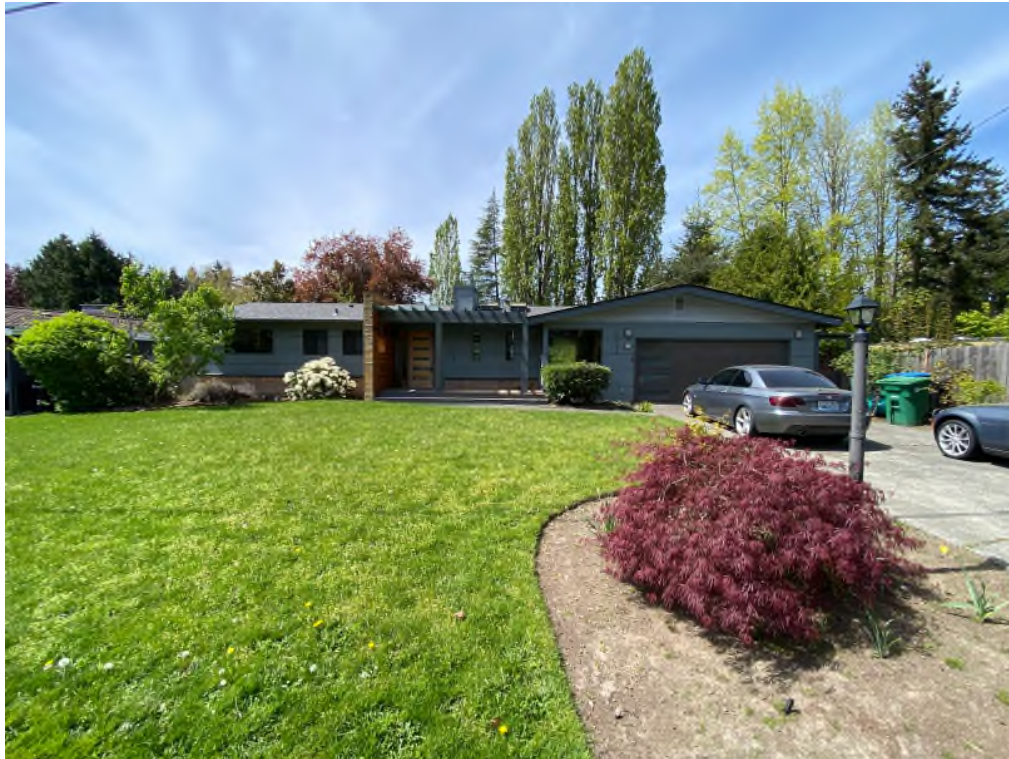
Looking west at property.

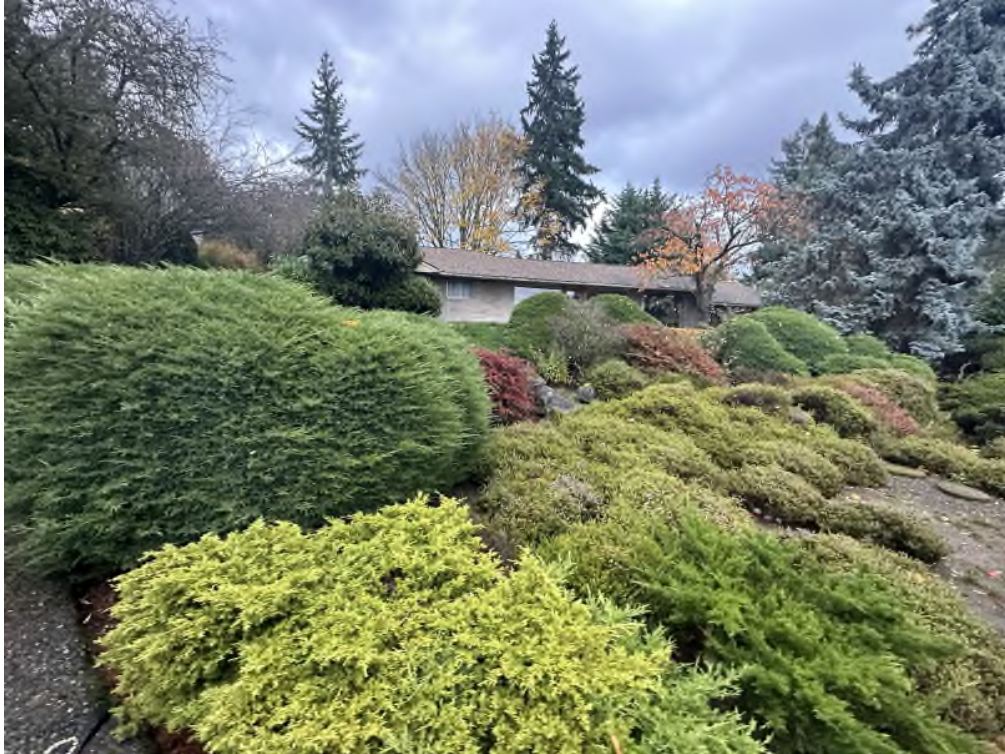
Looking into the property and residence. No steep slopes noted.

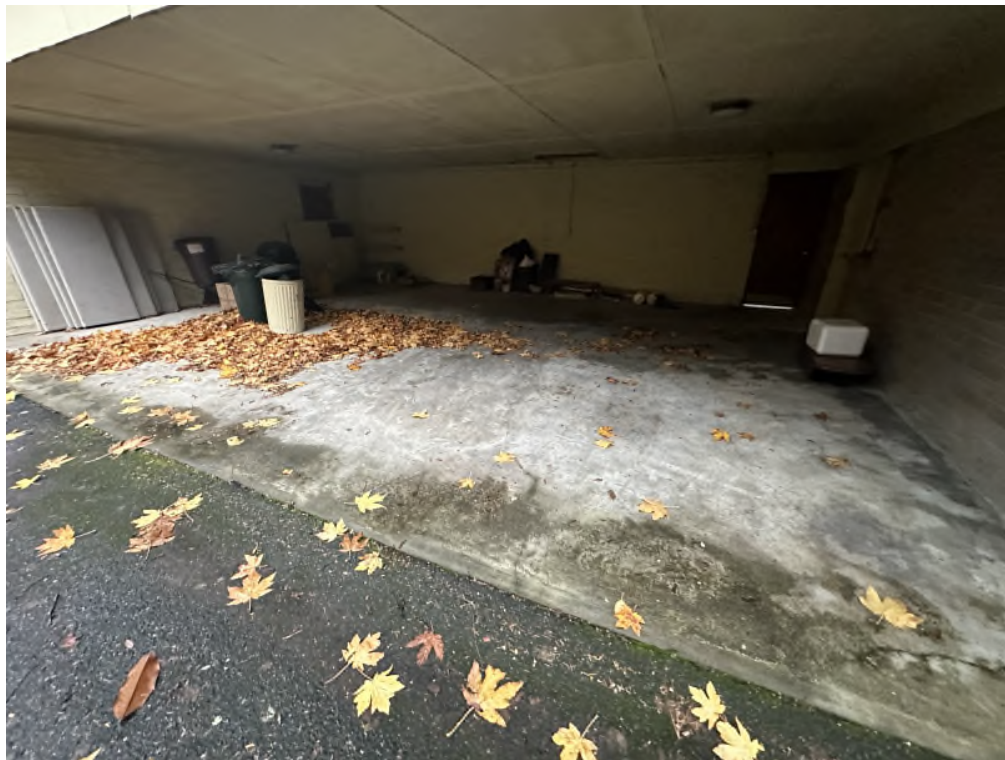
Looking into carport of structure.

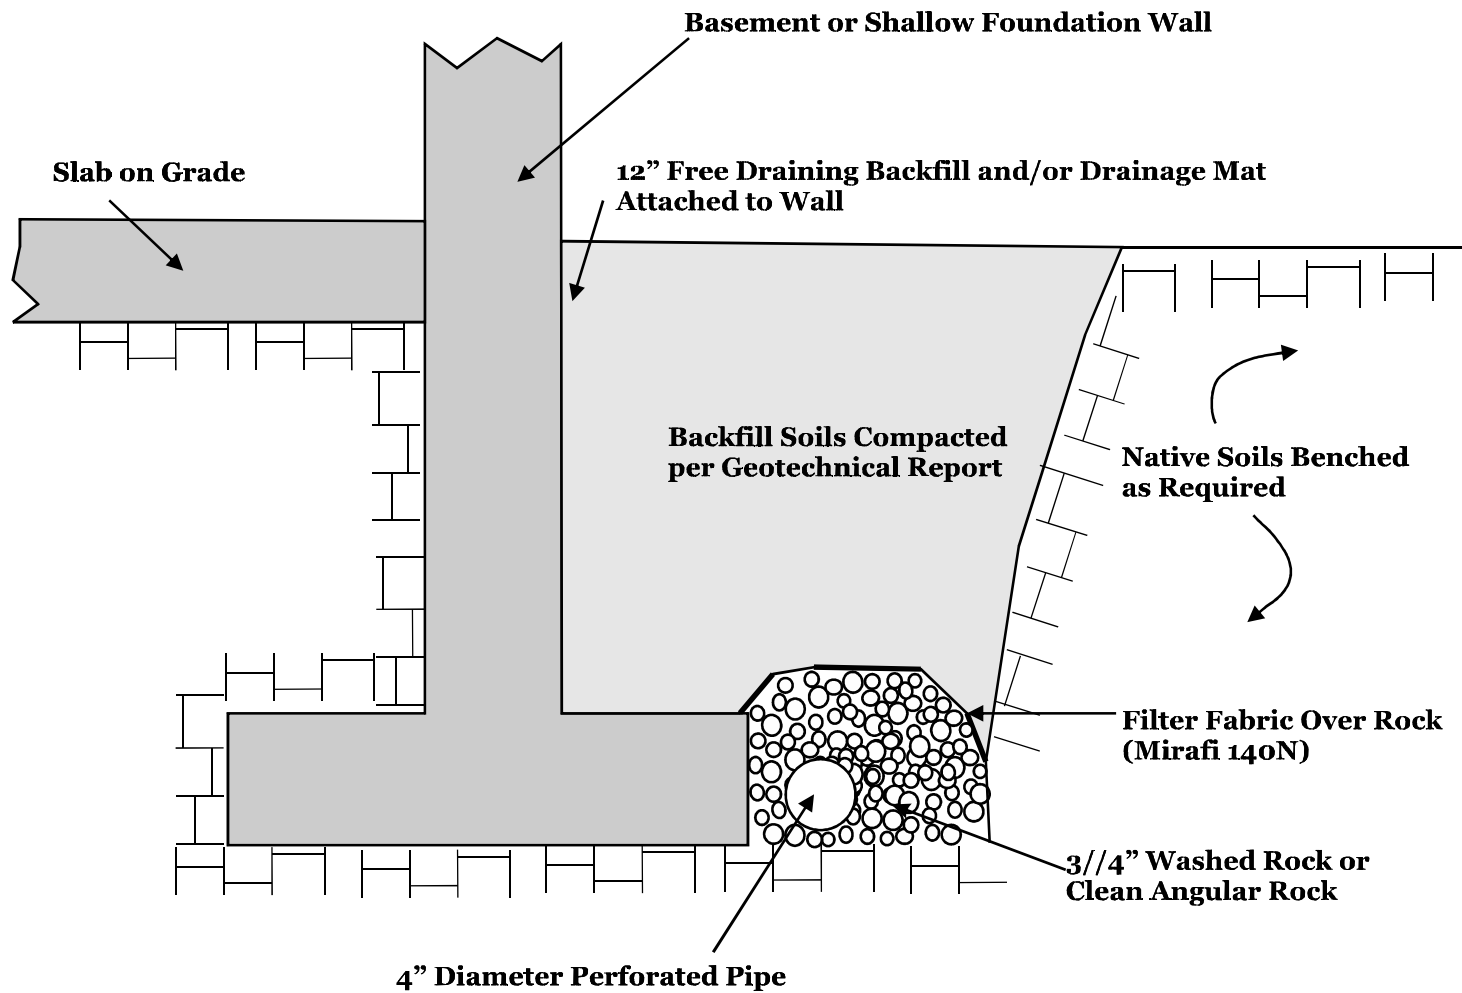
Typical Foundation Drain Detail

Not to Scale

A perimeter drainage system is recommended unless interior slab areas are elevated a minimum of 12 inches above adjacent exterior grades. If installed, a perimeter drainage system should consist of a 4-inch diameter perforated drain pipe surrounded by a minimum 6 inches of drain rock wrapped in a non-woven geosynthetic filter fabric to reduce migration of soil particles into the drainage system. The perimeter drainage system should discharge by gravity flow to a suitable stormwater system.
