GEOTECHNICAL ENGINEERING REPORT

RGI PROJECT NO. 2020-404-1

**MERCER ISLAND 3-LOT
7621 SOUTHWEST 22ND STREET
MERCER ISLAND, WASHINGTON**

MAY 4, 2022

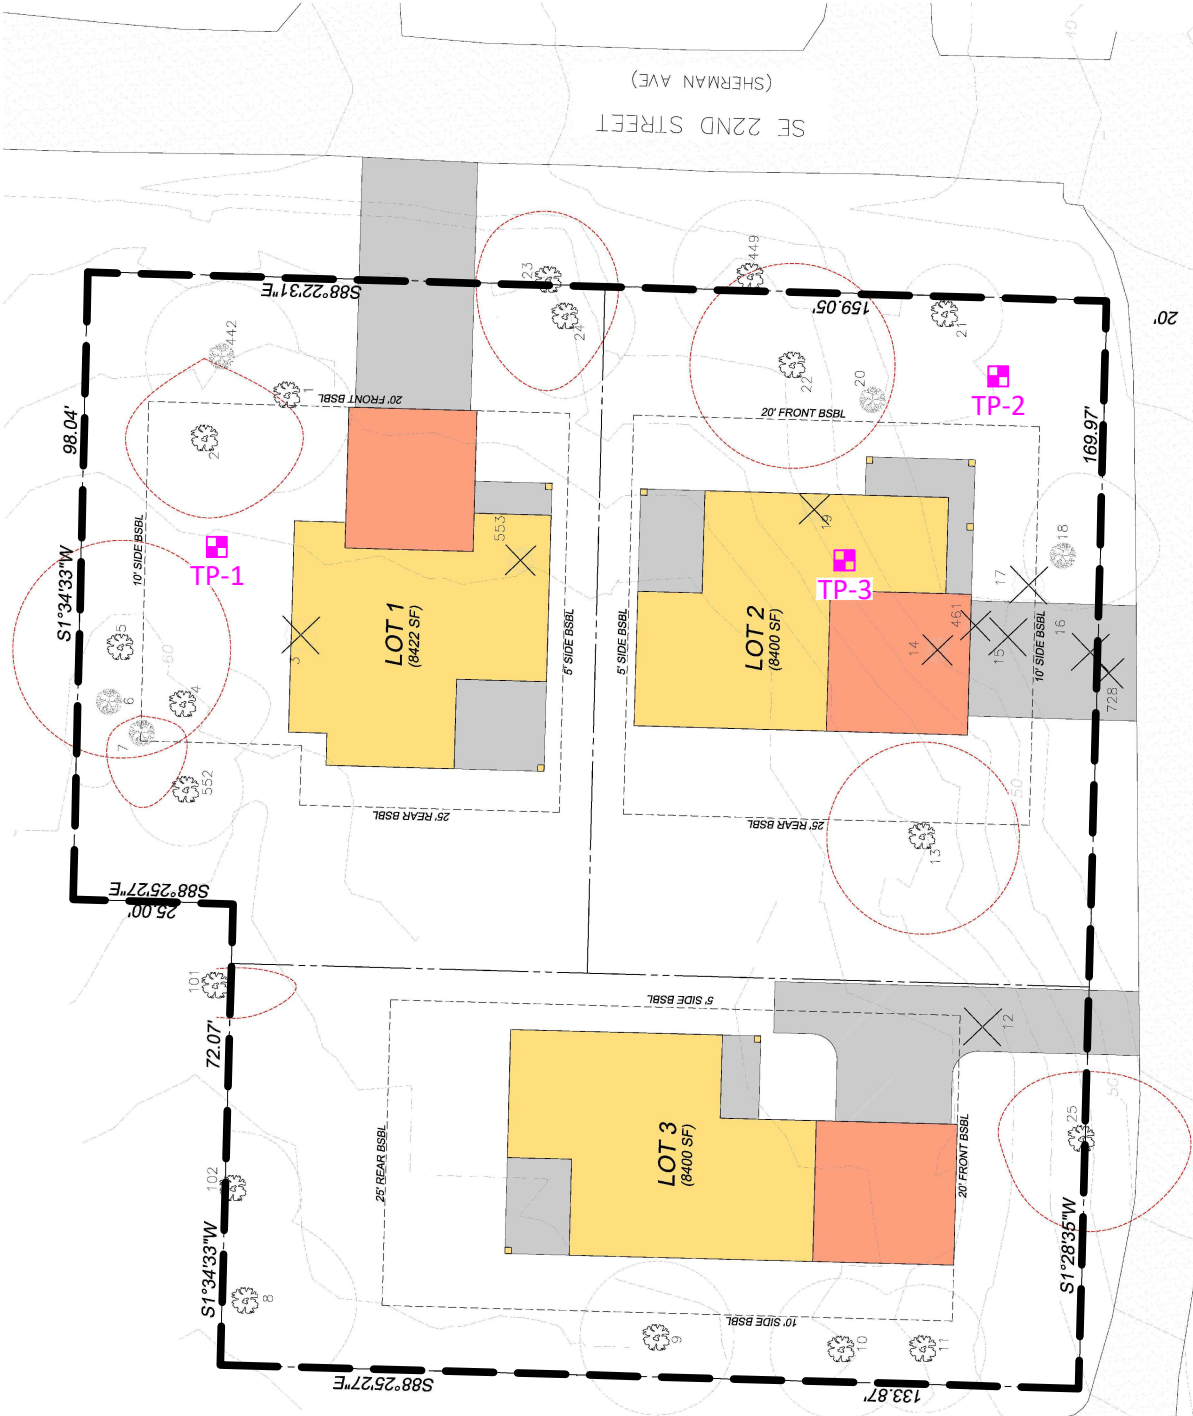
Mercer Island 3-Lot		Figure 2
RGI Project Number: 2020-404-1	Geotechnical Exploration Plan	Date Drawn: 09/2020
Address: 7621 Southeast 22nd Street, Mercer Island, Washington 98040

■ = Test pit by RGI, 08/28/20
 = Site boundary

On August 28, 2020, RGI observed the excavation of three test pits across the site. The approximate exploration locations are shown on Figure 2.

On August 28, 2020, RGI explored the subsurface soil conditions at the site by observing the excavation of three test pits to depths up to 9 feet bgs. The test pit locations are shown on Figure 2. The test pit locations were approximately determined by measurements from existing property lines and paved roads.

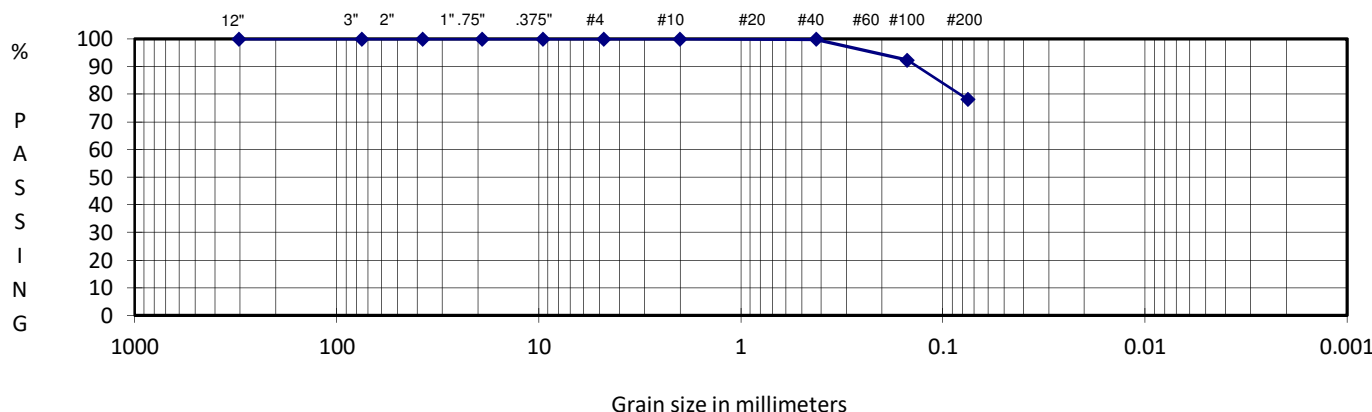
DESCRIPTION: SILT with some sand
 USCS: ML
