**PUBLIC WORKS DEPARTMENT
CITY OF MERCER ISLAND, WASHINGTON**

Luther Burbank Park Waterfront Improvements Shoreline Vegetation Plan

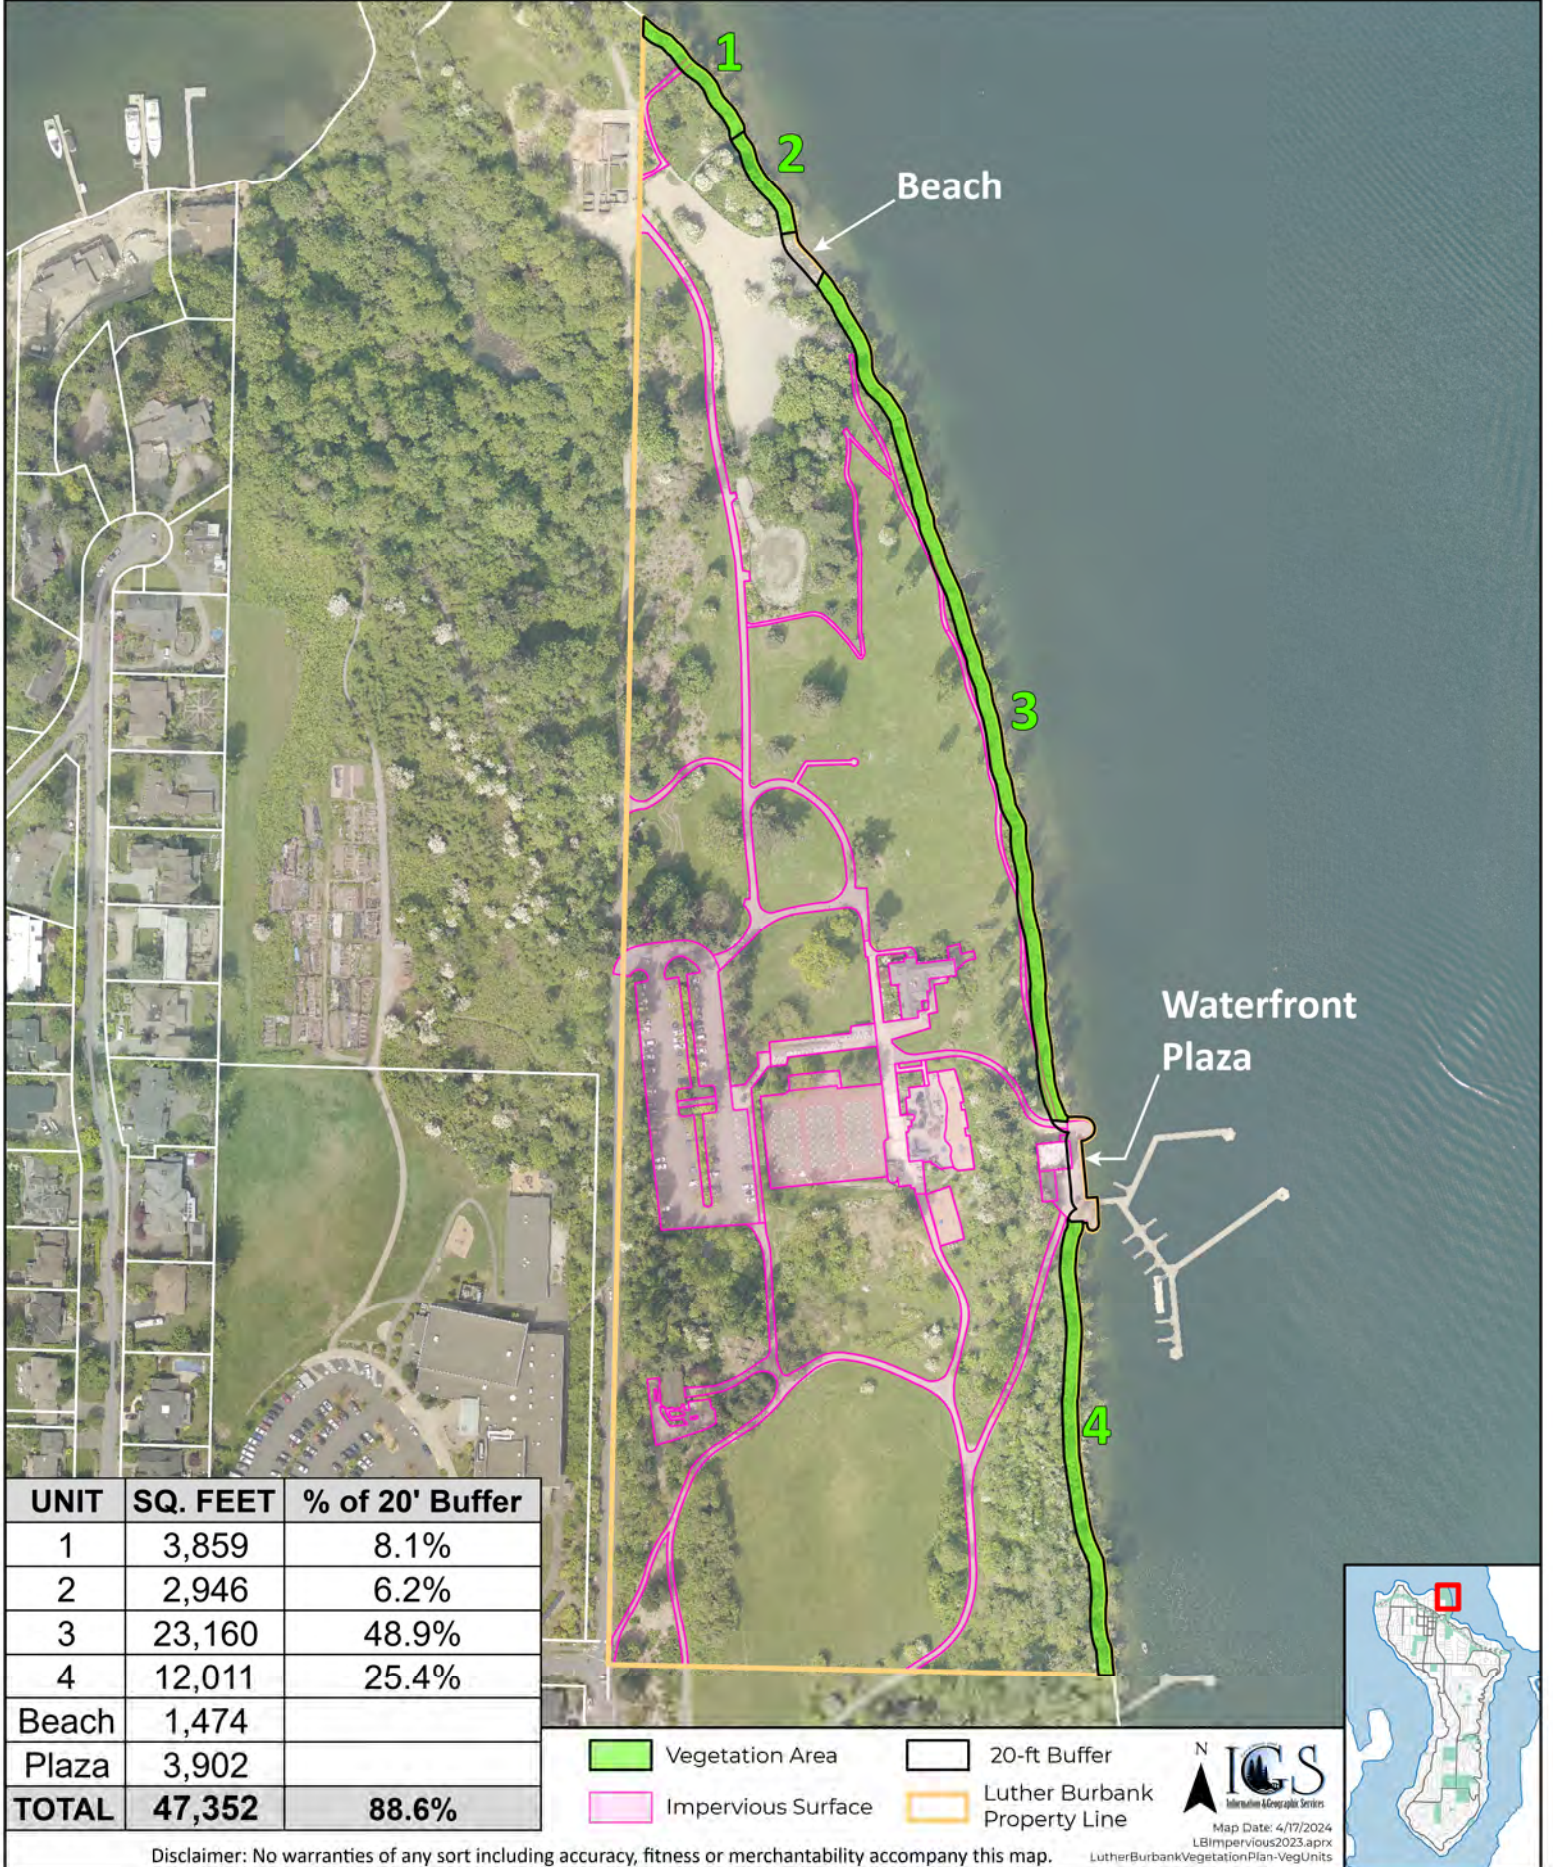
LUTHER BURBANK SHORELINE VEGETATION PLAN: VEGETATION UNITS

Eighty-nine percent (41,976 square feet) of the shoreline buffer is vegetated, while 11% (5,376 square feet) is made up of a swim beach and plaza. The vegetated shoreline buffer was divided into vegetation units based on vegetation composition, management history, and landscape features. A map of the vegetation units is shown in Map 1. A summary of the vegetation survey is provided in Table 1. Expanded evaluations of each vegetation unit follow.

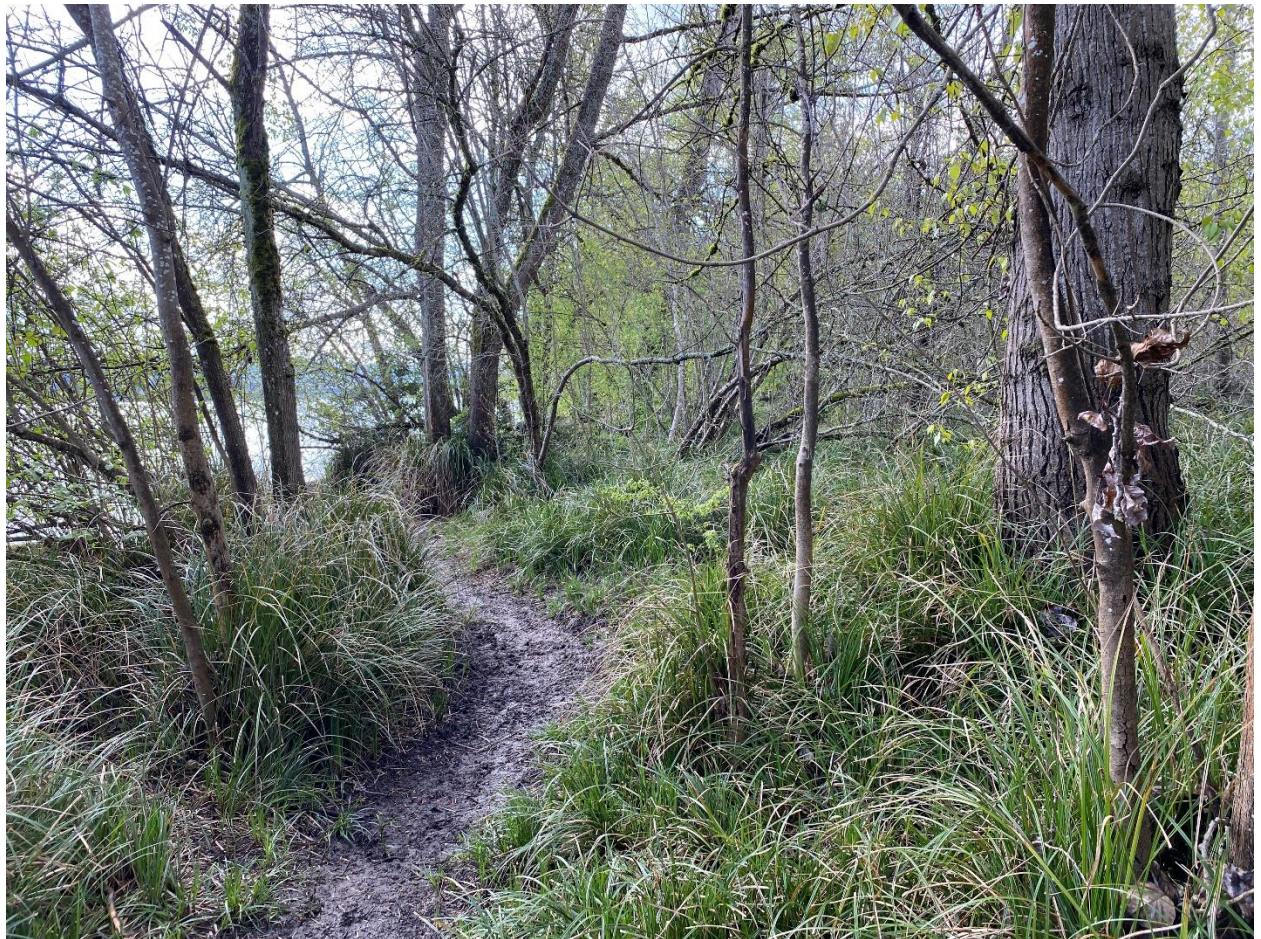
Condition Description: The shoreline vegetation consists of cottonwood trees *Populus balsamifera* spp. *trichocarpa* with an understory of sedges. It is classified in the 75-100 percent quartile of native coverage, and the actual coverage is over 100% with multiple layers of vegetation present. Plant cover is continuous except for bare soil where social trails have formed from park users. The noxious weed Himalayan blackberry *Rubus armeniacus* is present in combination with native plants at the north end of the unit.

Figure 1: Representative image of Vegetation Unit 1. Note social trail through dense sedge understory.

Proposed Action: The City will continue monitoring Vegetation Unit 1 for noxious weeds and prioritize weed removal with other vegetation management in the park.

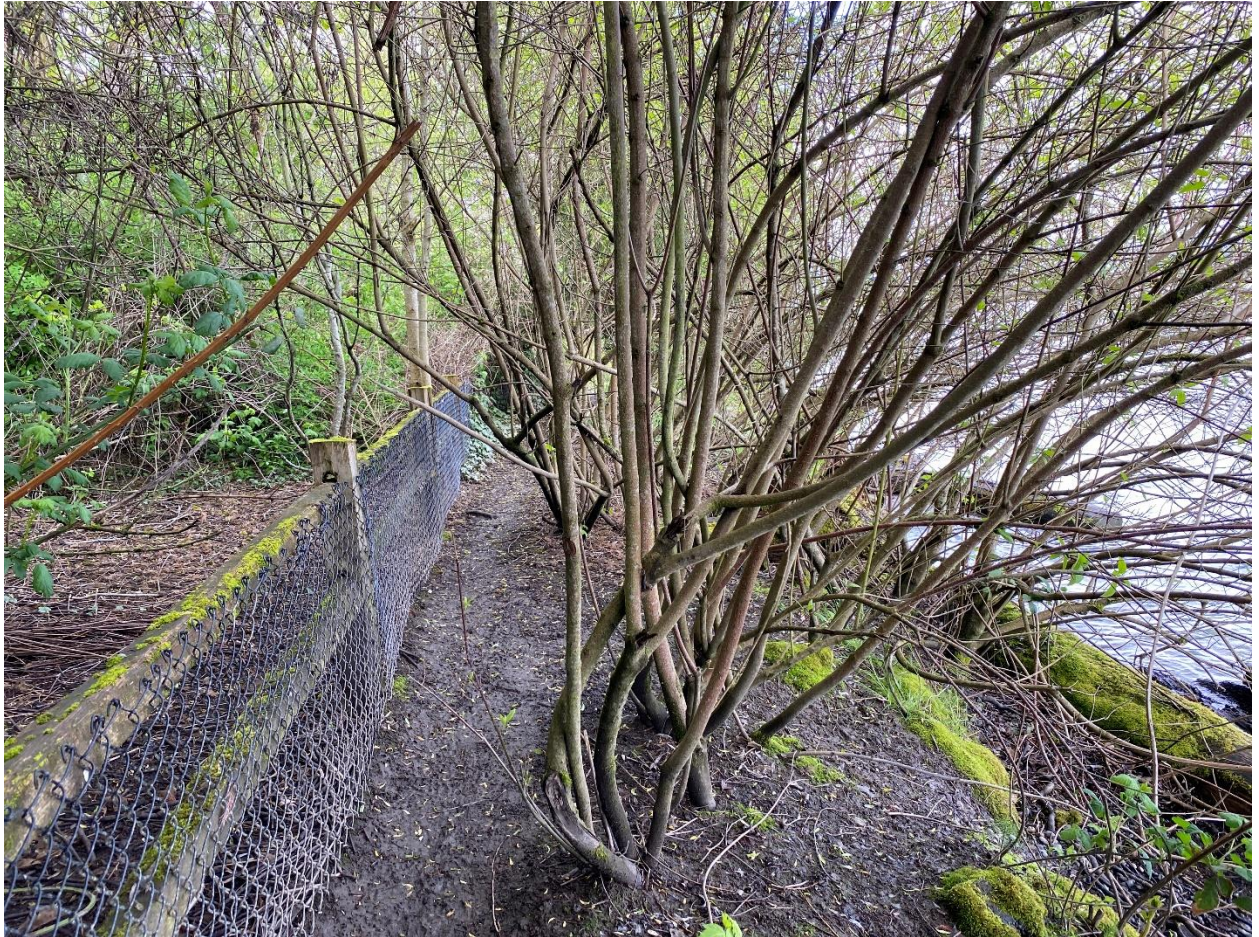
Condition Description: This shoreline vegetation unit consists of deciduous tree and tall red osier dogwood *Cornus sericea* canopy with significant areas of bare soil. It is classified in the 75-100 percent quartile of native coverage because of tree and shrub coverage, but this does not reflect an underlying management issue of bare soil. The noxious weeds Himalayan blackberry *Rubus armeniacus*, and English ivy *Hedera helix* are present in small patches.

Figure 2: Representative image of Vegetation Unit 2. Note bare ground around mature native dogwood shrubs.

Proposed Action: The City will enhance dog exclusion along this stretch of shoreline, plant native understory plants, maintain the buffer plantings, and continue to monitor the unit.

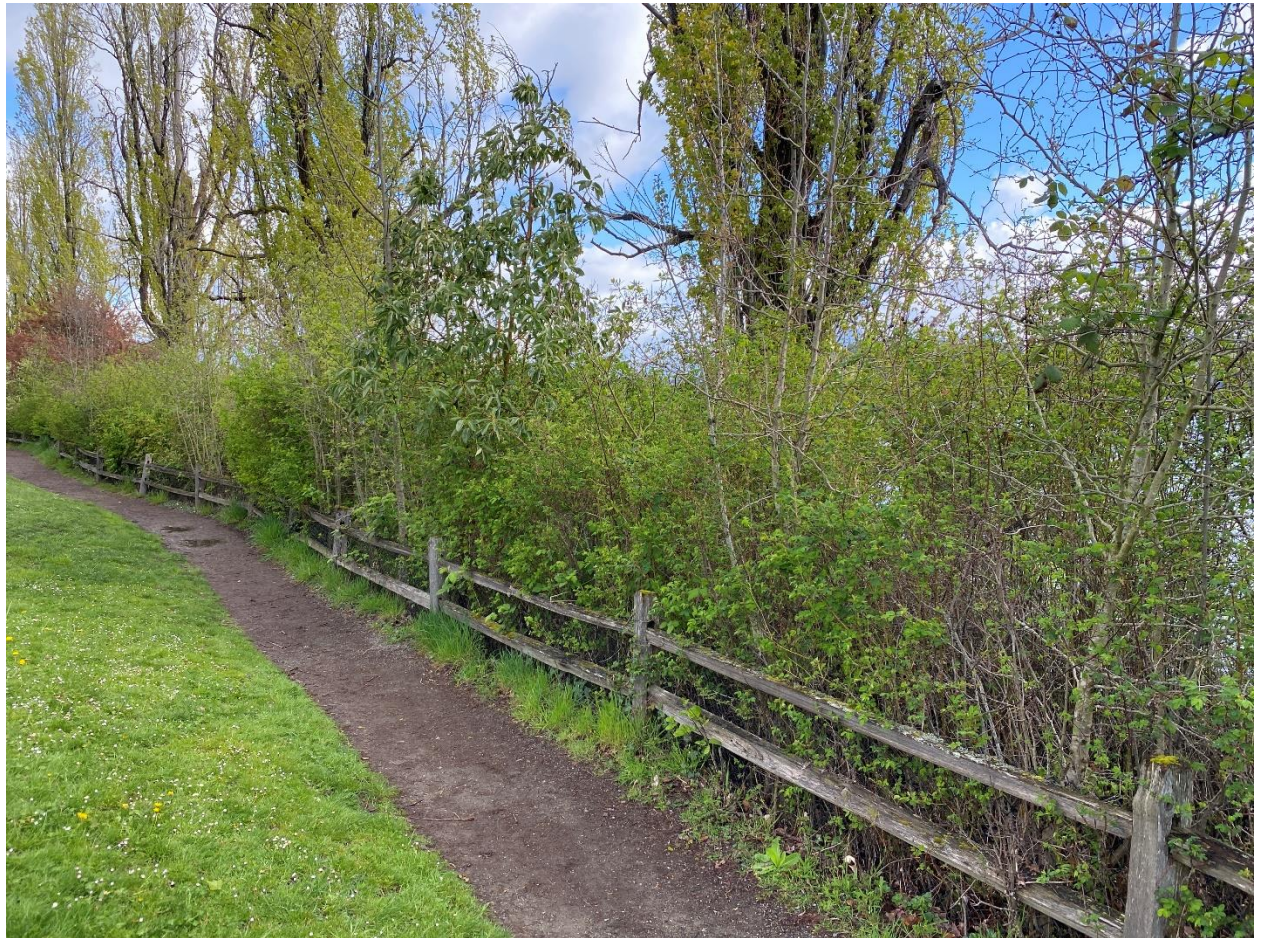
Condition Description: This shoreline vegetation unit consists of mature Lombardy poplar *Populus nigra 'Italica'* trees with dense native tree and tall shrub canopy. It is classified in the 75-100 percent quartile of native coverage, and the actual coverage is over 100% with multiple layers of vegetation present. The noxious weed Himalayan blackberry *Rubus armeniacus* is present but does not represent significant cover.

Figure 3: Representative image of Vegetation Unit 3

Proposed Action: The City will continue monitoring for noxious weeds in Vegetation Unit 3 and prioritize weed removal with other vegetation management in the park.

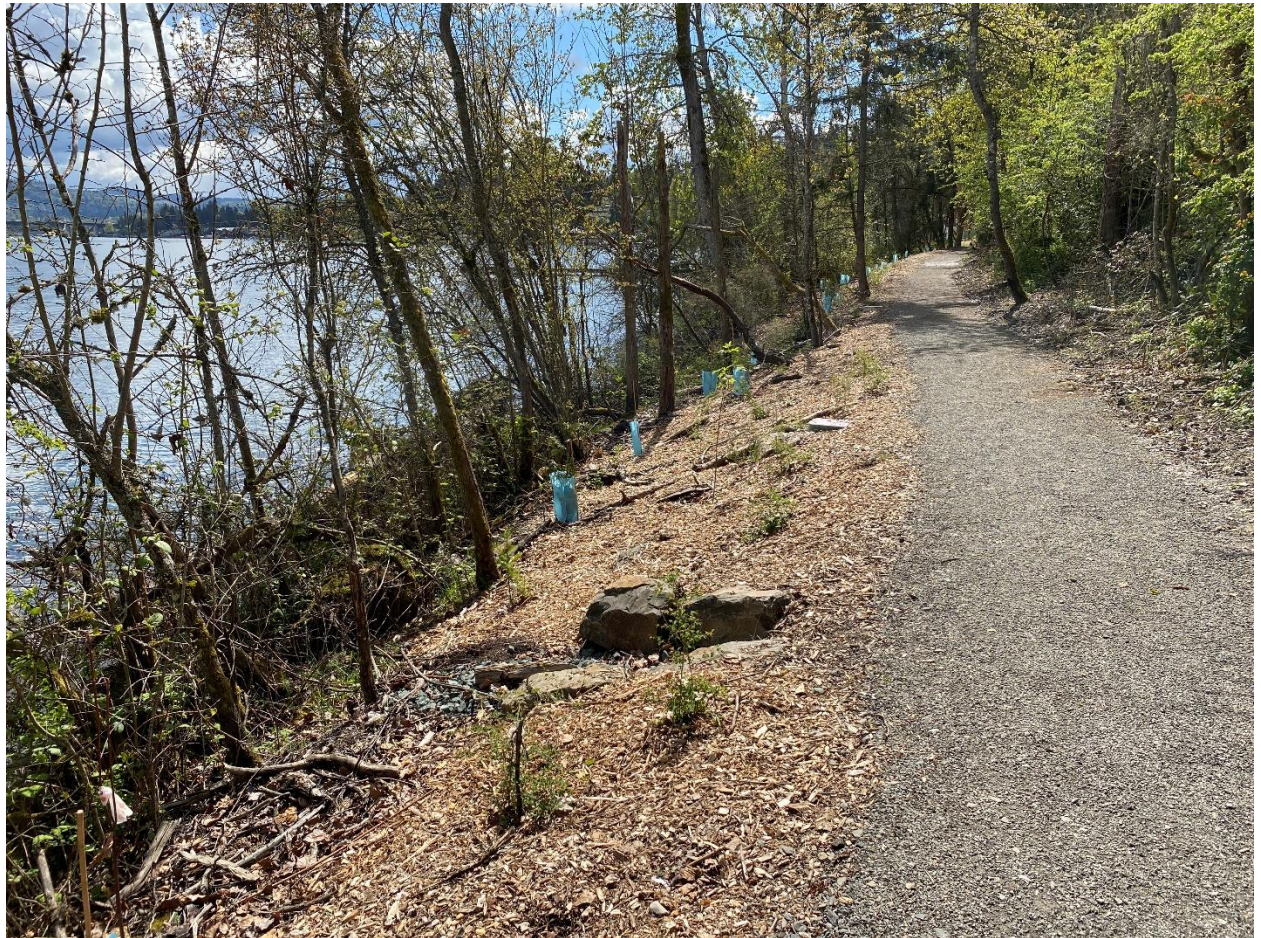
Condition Description: This shoreline vegetation unit consists of native deciduous trees, predominantly Oregon Ash *Fraxinus latifolia* on approximately half of the unit, with dense shoreline buffer vegetation and new restoration plantings on the other half. Overall, the unit is classified in the 25-50% quartile of native coverage. The noxious weeds Himalayan blackberry *Rubus armeniacus*, English Holly *Ilex aquifolium*, and English ivy *Hedera helix* are present but do not represent significant cover. A non-native *Viburnum* species has naturalized in parts of this shoreline but does not appear to be invasive.

Figure 4: representative image of Vegetation Unit 4. Blue plant covers prevent deer browse on tree seedlings.

Proposed Action: The City will maintain this buffer to ensure successful establishment of over 800 native plants installed in the fall of 2023. Maintenance will include irrigation, weeding, mulching, and deer protection. The City will install additional plants as needed to establish successful native cover throughout the buffer.
