GEOTECHNICAL REPORT

**Cheshire Short Plat
7615 East Mercer Way
Mercer Island, Washington**

Project No. T-8264

May 12, 2020

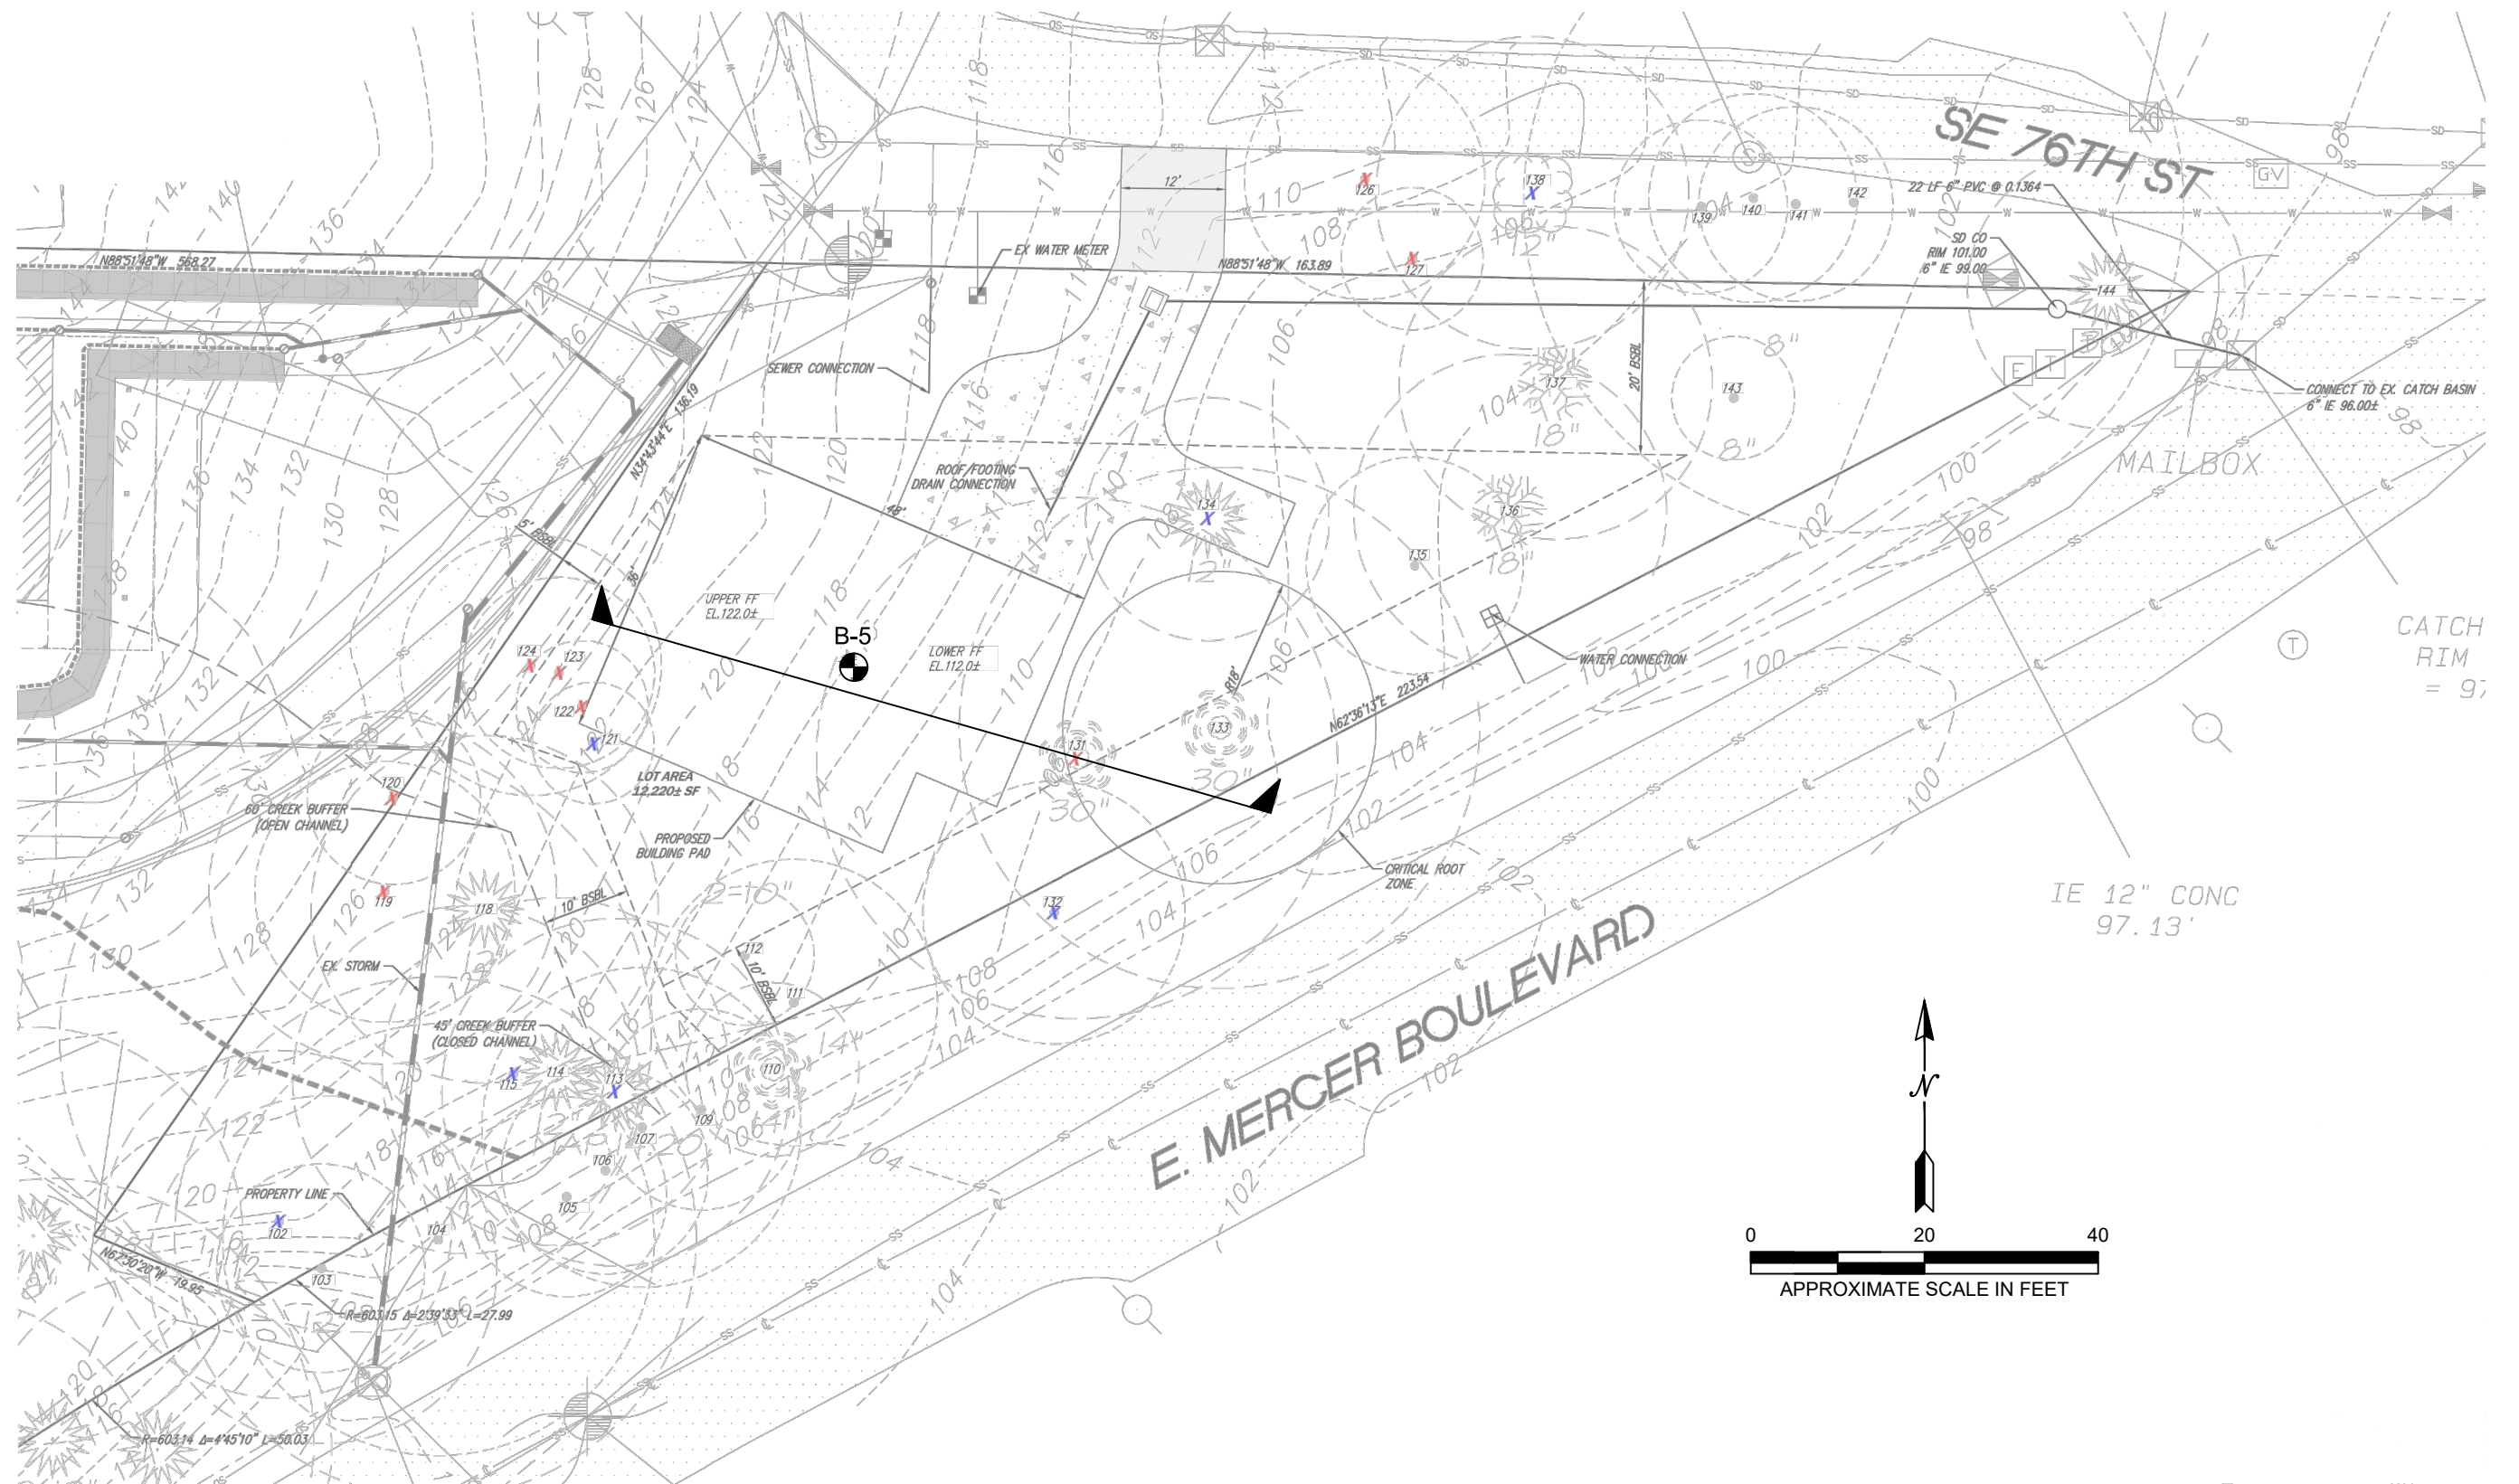
Figure 2

EXPLORATION LOCATION PLAN
CHESHIRE SHORT PLAT MERCER
ISLAND, WASHINGTON

The preceding discussion is intended to be a general review of the soil conditions encountered. For more detailed descriptions, please refer to the Test Boring Log by others in Appendix A. The approximate location of the Test Boring is shown on Figure 2.

Since the boring completed by GeoTech Consultants describes some of the silt soils are ancient landslide soil, we completed a slope stability analysis through the site to determine if the proposed construction can alter the area without causing instability. Our analysis was completed at a location designated as Cross-Section A-A’ using the computer program Slide 2018. The approximate cross-section location is shown on Figure 2.

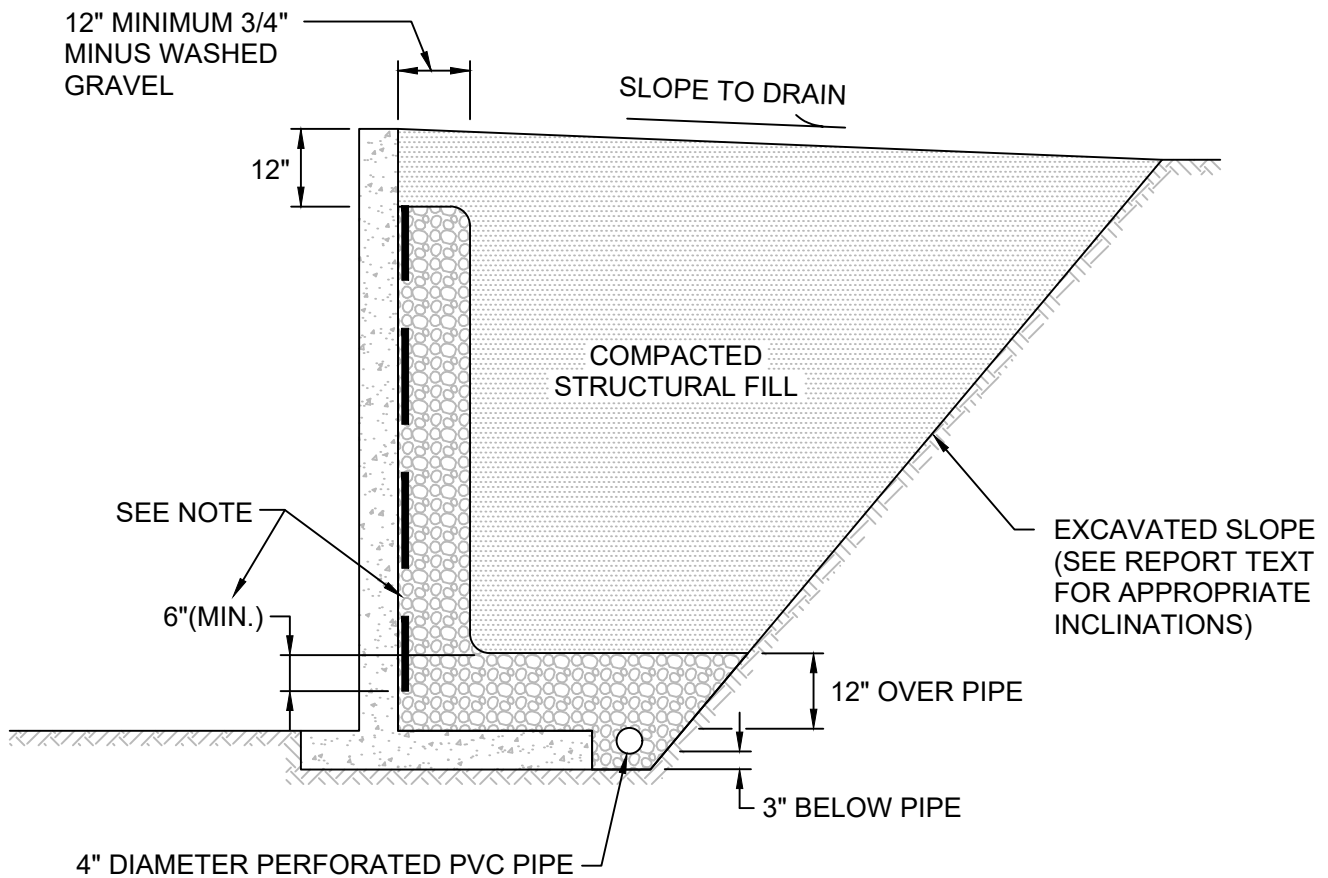
TYPICAL WALL DRAINAGE DETAIL
 CHESHIRE SHORT PLAT
 MERCER ISLAND, WASHINGTON

The magnitude of earth pressure development on retaining walls will partly depend on the quality of the wall backfill. We recommend placing and compacting wall backfill as structural fill as described in Section 4.2 of this report. To guard against hydrostatic pressure development, drainage must be installed behind the wall. A typical wall drainage detail is shown on Figure 3.

We recommend installing perimeter foundation drains adjacent to exterior shallow foundations. The drains can be laid to grade at an invert elevation equivalent to the bottom of footing grade. The drains can consist of four-inch diameter perforated PVC pipe that is enveloped in washed pea gravel-sized drainage aggregate. The aggregate should extend six inches above and to the sides of the pipe. Roof and foundation drains should be tightlined separately to the storm drains. All drains should be provided with cleanouts at easily accessible locations.

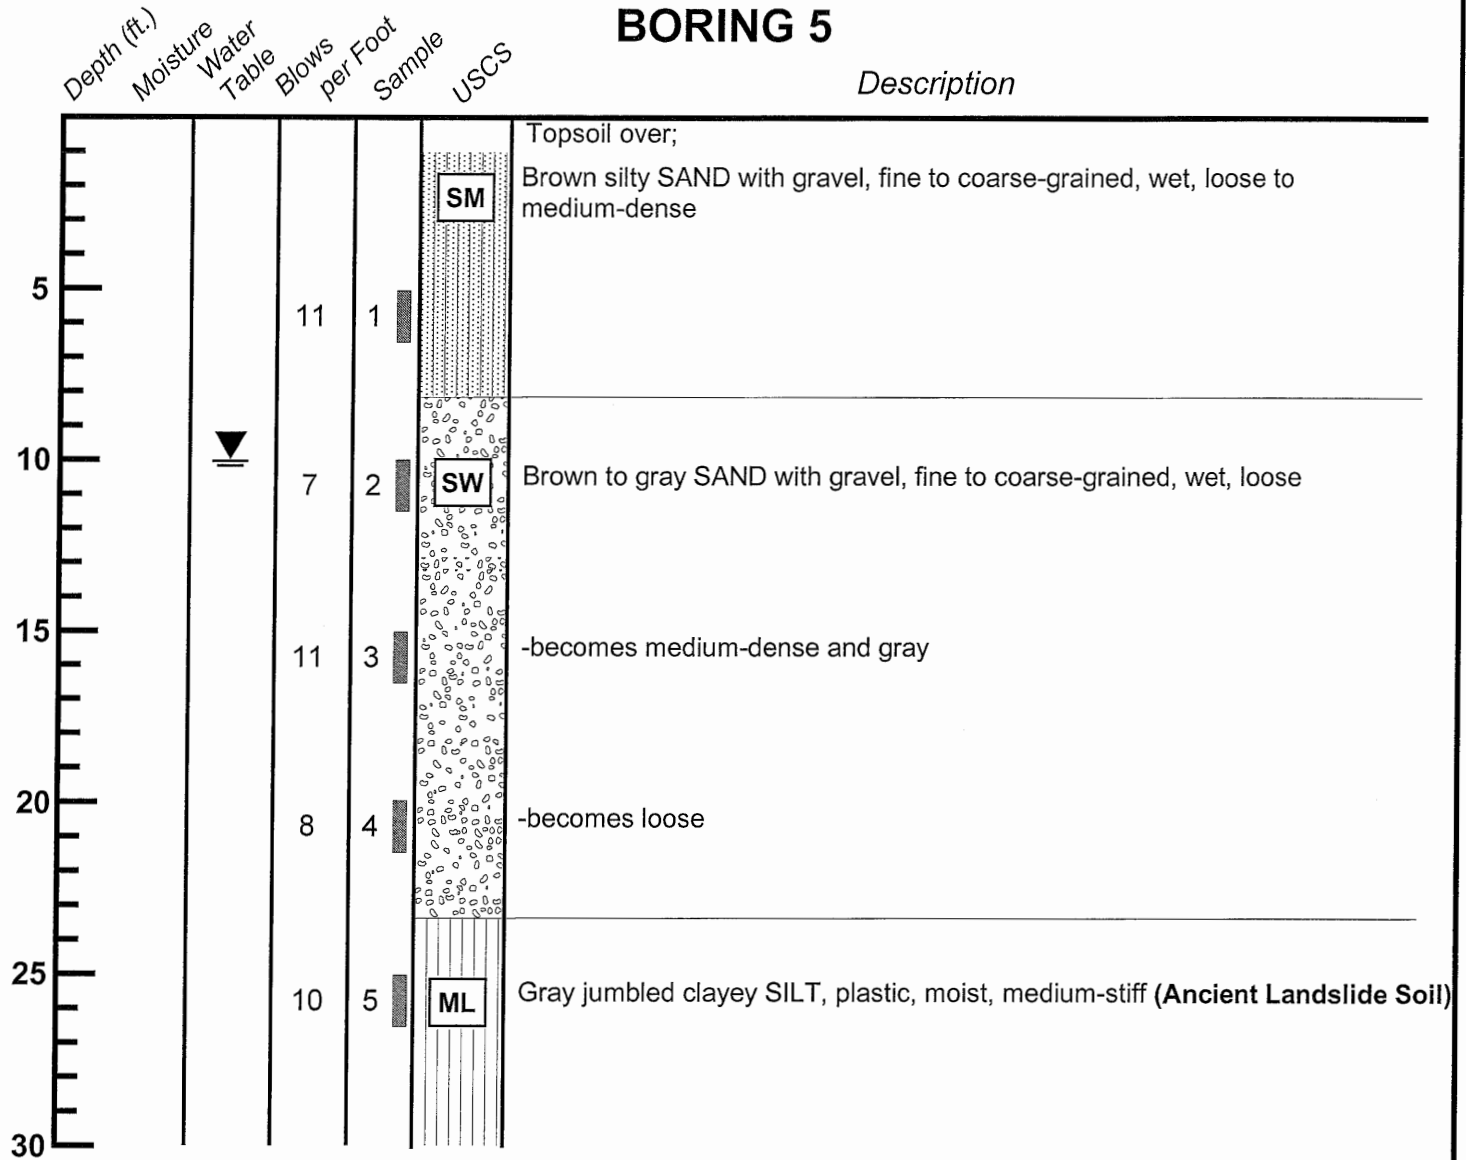
BORING 5

TEST BORING LOG
7615 East Mercer Way
Mercer Island, Washington

Job 16095	Date: March 2016	Logged by: TRC	Plate: 9
---------------------	----------------------------	--------------------------	--------------------

Based on the previous boring completed in this area, the soil conditions at the site generally consist of approximately 9 feet of medium dense silty sand with gravel overlying approximately 15 feet of loose to medium dense sand with gravel over medium stiff to stiff silt and clay to the termination of the test boring.

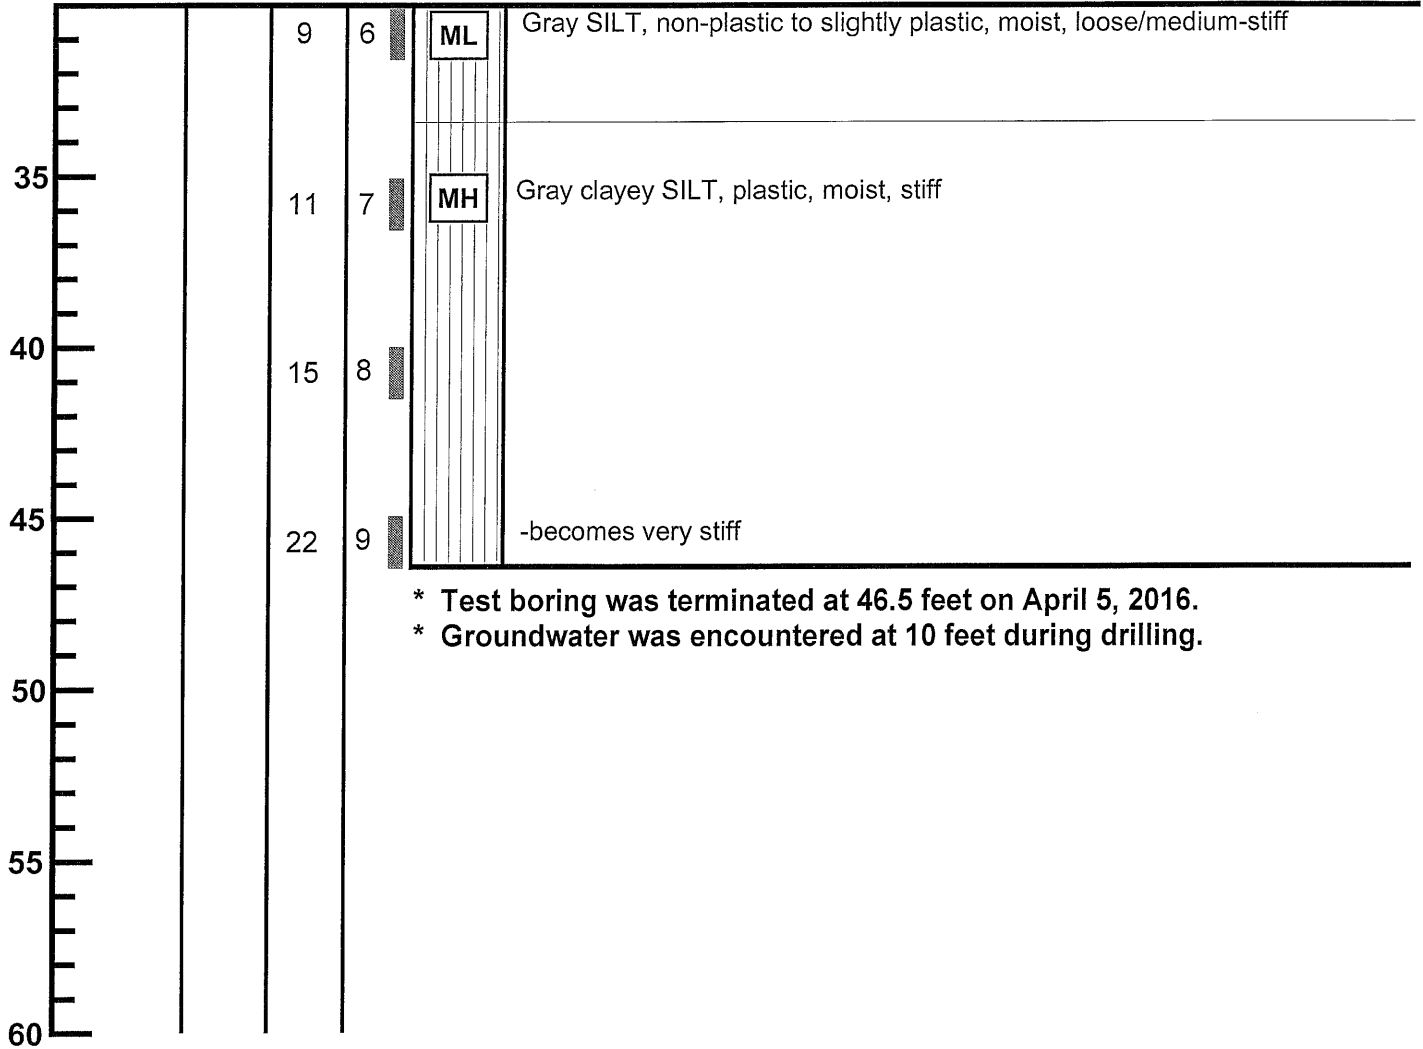
BORING 5 (CONTINUED)

TEST BORING LOG
 7615 East Mercer Way
 Mercer Island, Washington

Job 16095	Date: March 2016	Logged by: TRC	Plate: 10
---------------------	----------------------------	--------------------------	------------------

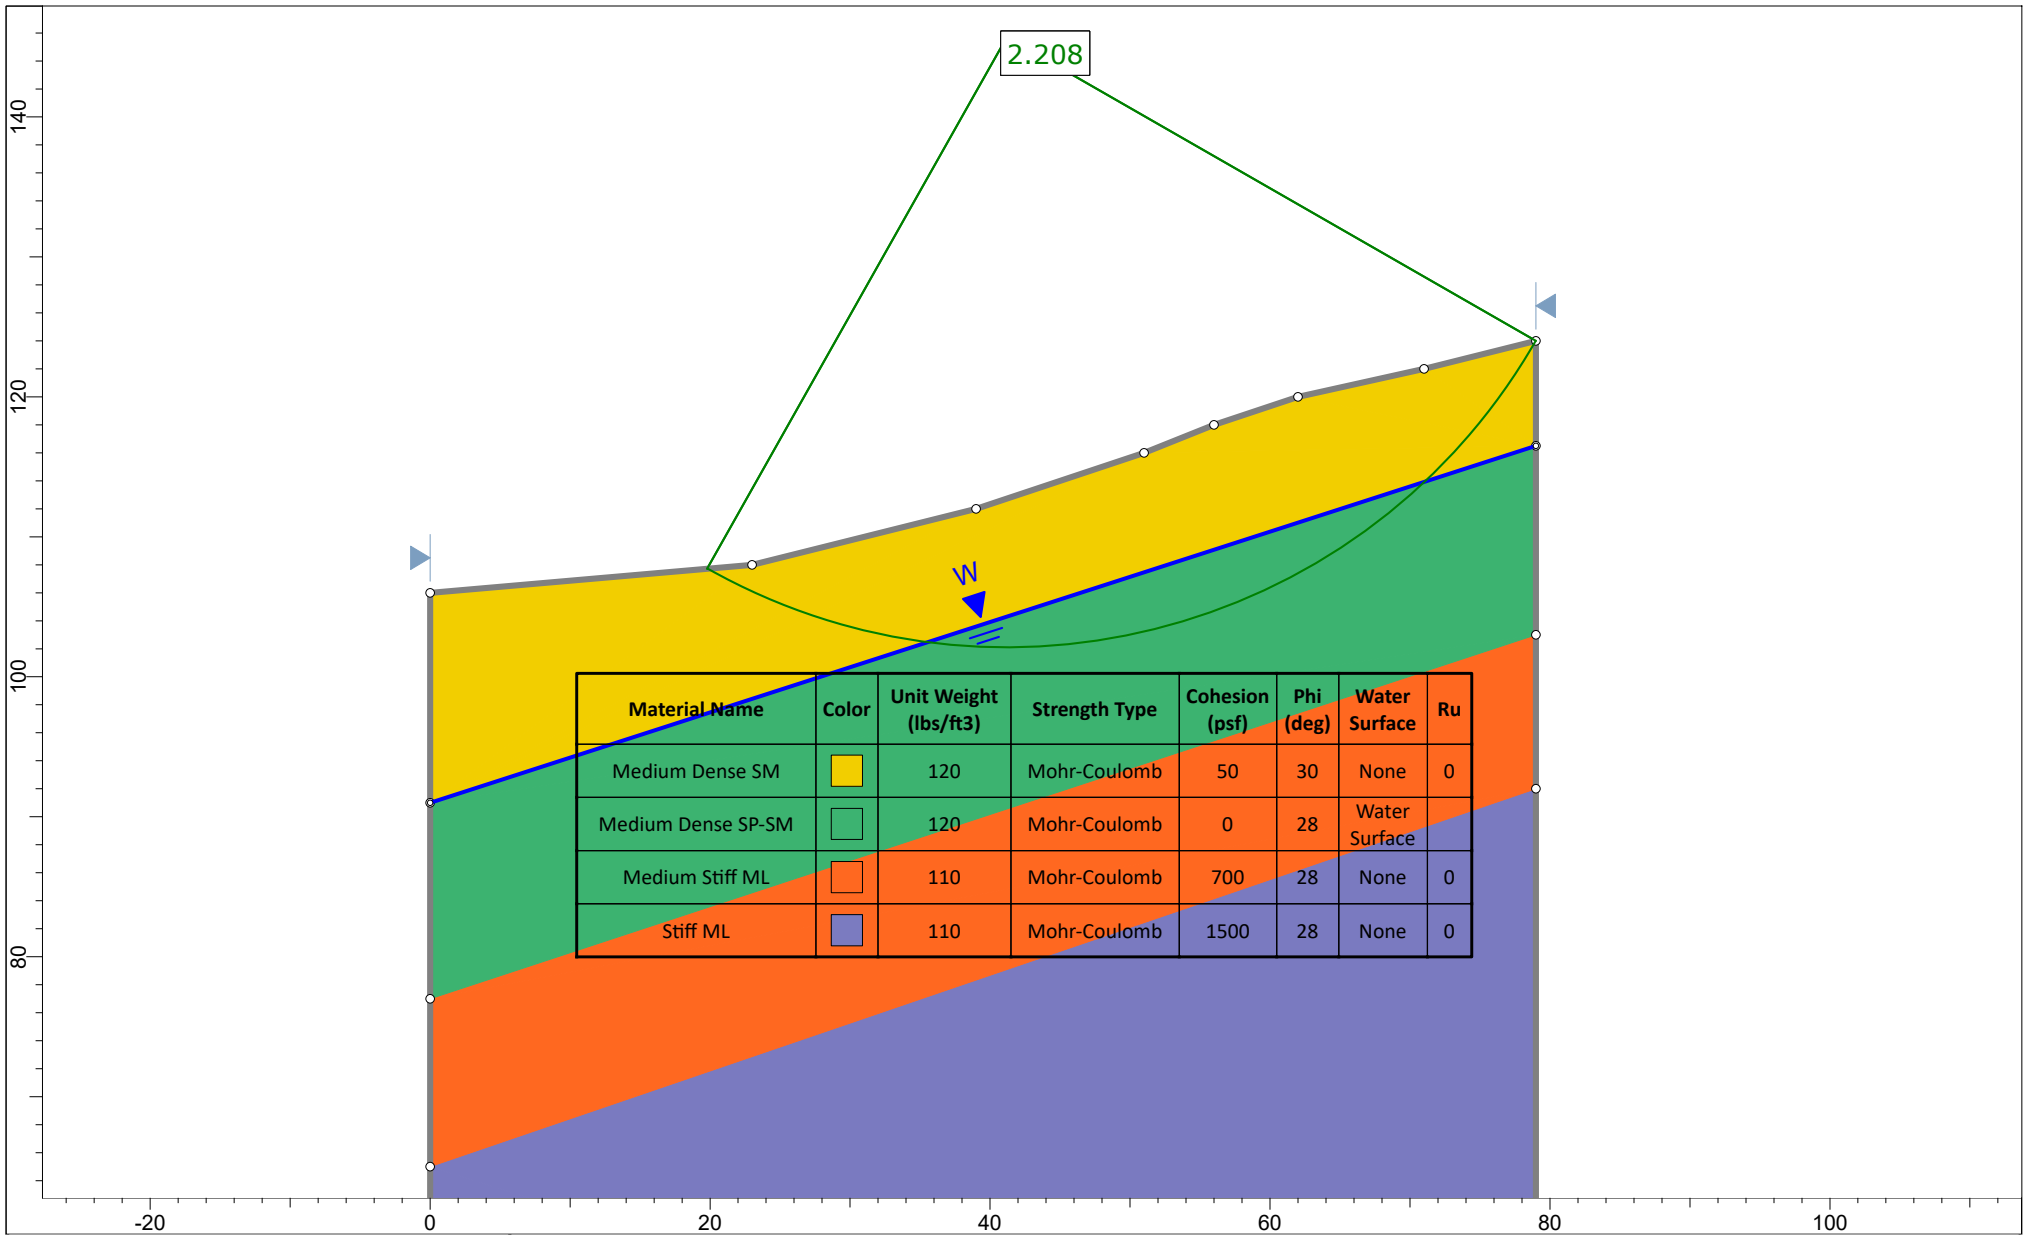
Material Name	Color	Unit Weight (lbs/ft ³)	Strength Type	Cohesion (psf)	Phi (deg)	Water Surface	Ru
Medium Dense SM	 	120	Mohr-Coulomb	50	30	None	0
Medium Dense SP-SM	 	120	Mohr-Coulomb	0	28	Water Surface	0
Medium Stiff ML	 	110	Mohr-Coulomb	700	28	None	0
Stiff ML	 	110	Mohr-Coulomb	1500	28	None	0

Project			Cheshire Short Plat		
	Analysis Description			Cross Section A-A' - Existing Conditions		
	Drawn By	C. Decker	Scale	1:165	Company	Terra Associates, Inc.
	Date	May 12, 2020	File Name	Cross Section A-A'.slmd

Cross Section	Minimum Safety Factors	
	<i>Existing Conditions</i>	<i>Post Construction</i>
A-A'	2.21 (Seismic FS = 1.03)	2.87 (Seismic FS = 1.39)

Based on our analysis, the proposed project will increase the overall stability of the site and thereby the development has been designed so that the risk to the site and adjacent property is mitigated such that the site is determined to be safe. Therefore, per Section 19.07.160.3.b of the MICI and our opinion, the site can be constructed, as proposed. The results of our analysis are attached in Appendix B.

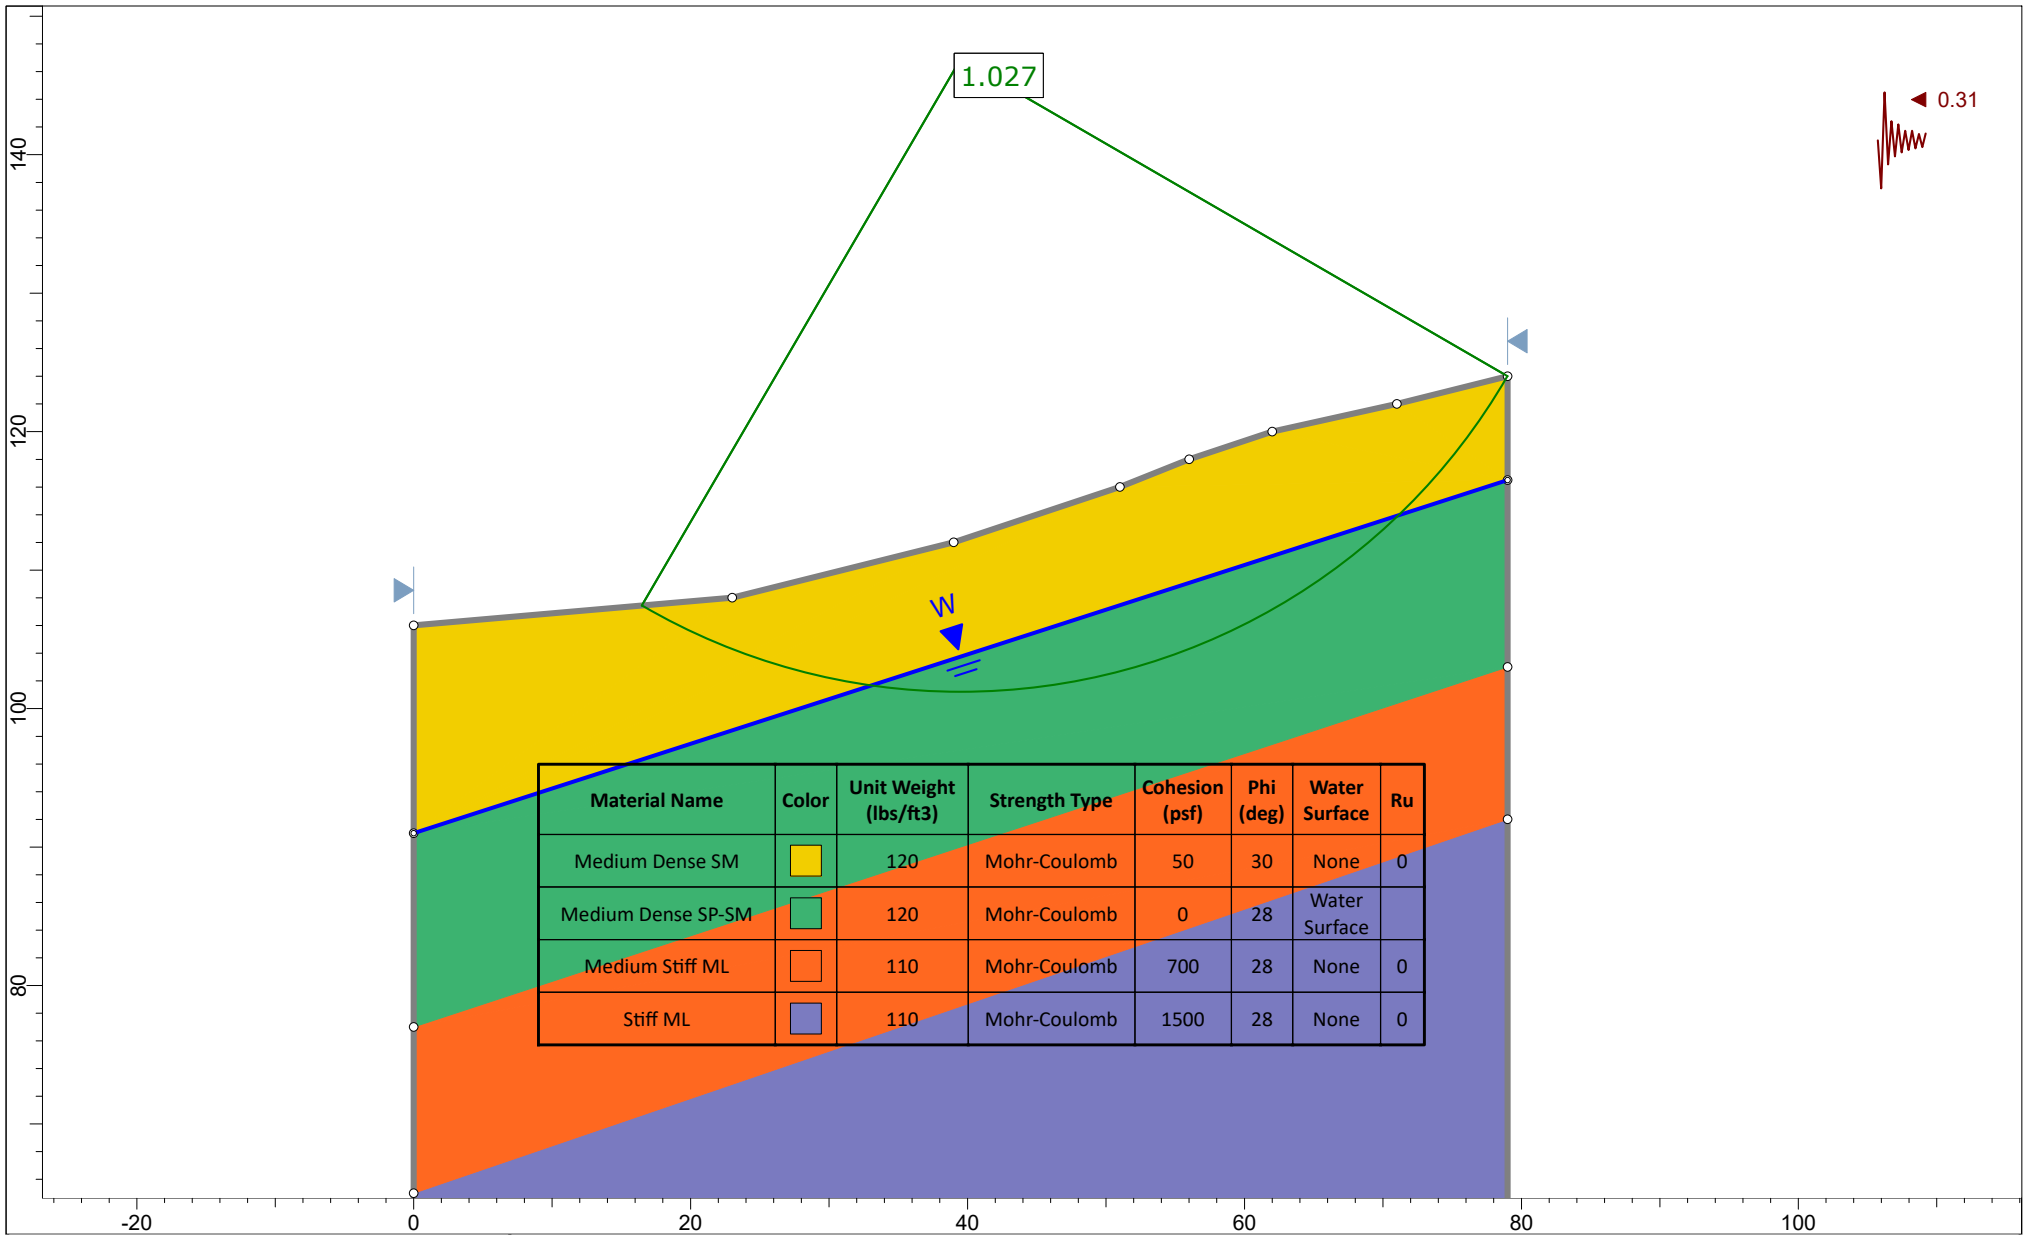
Material Name	Color	Unit Weight (lbs/ft ³)	Strength Type	Cohesion (psf)	Phi (deg)	Water Surface	Ru
Medium Dense SM	Yellow	120	Mohr-Coulomb	50	30	None	0
Medium Dense SP-SM	Green	120	Mohr-Coulomb	0	28	Water Surface	
Medium Stiff ML	Orange	110	Mohr-Coulomb	700	28	None	0
Stiff ML	Blue	110	Mohr-Coulomb	1500	28	None	0

Project				Cheshire Short Plat			
Analysis Description				Cross Section A-A' - Existing Conditions - Seismic			
Drawn By		C. Decker		Scale		1:166	
Date		May 12, 2020		Company		Terra Associates, Inc.	
				File Name		Cross Section A-A'.slmd

Our analysis considered both static and the pseudostatic (seismic) conditions. A horizontal acceleration of 0.31g was used in the pseudostatic analysis to simulate slope performance under earthquake loading. This acceleration is equal to one-half of the peak horizontal ground acceleration with a two percent in 50-year probability of exceedance as defined by the 2018 International Building Code. A groundwater table was also modeled.

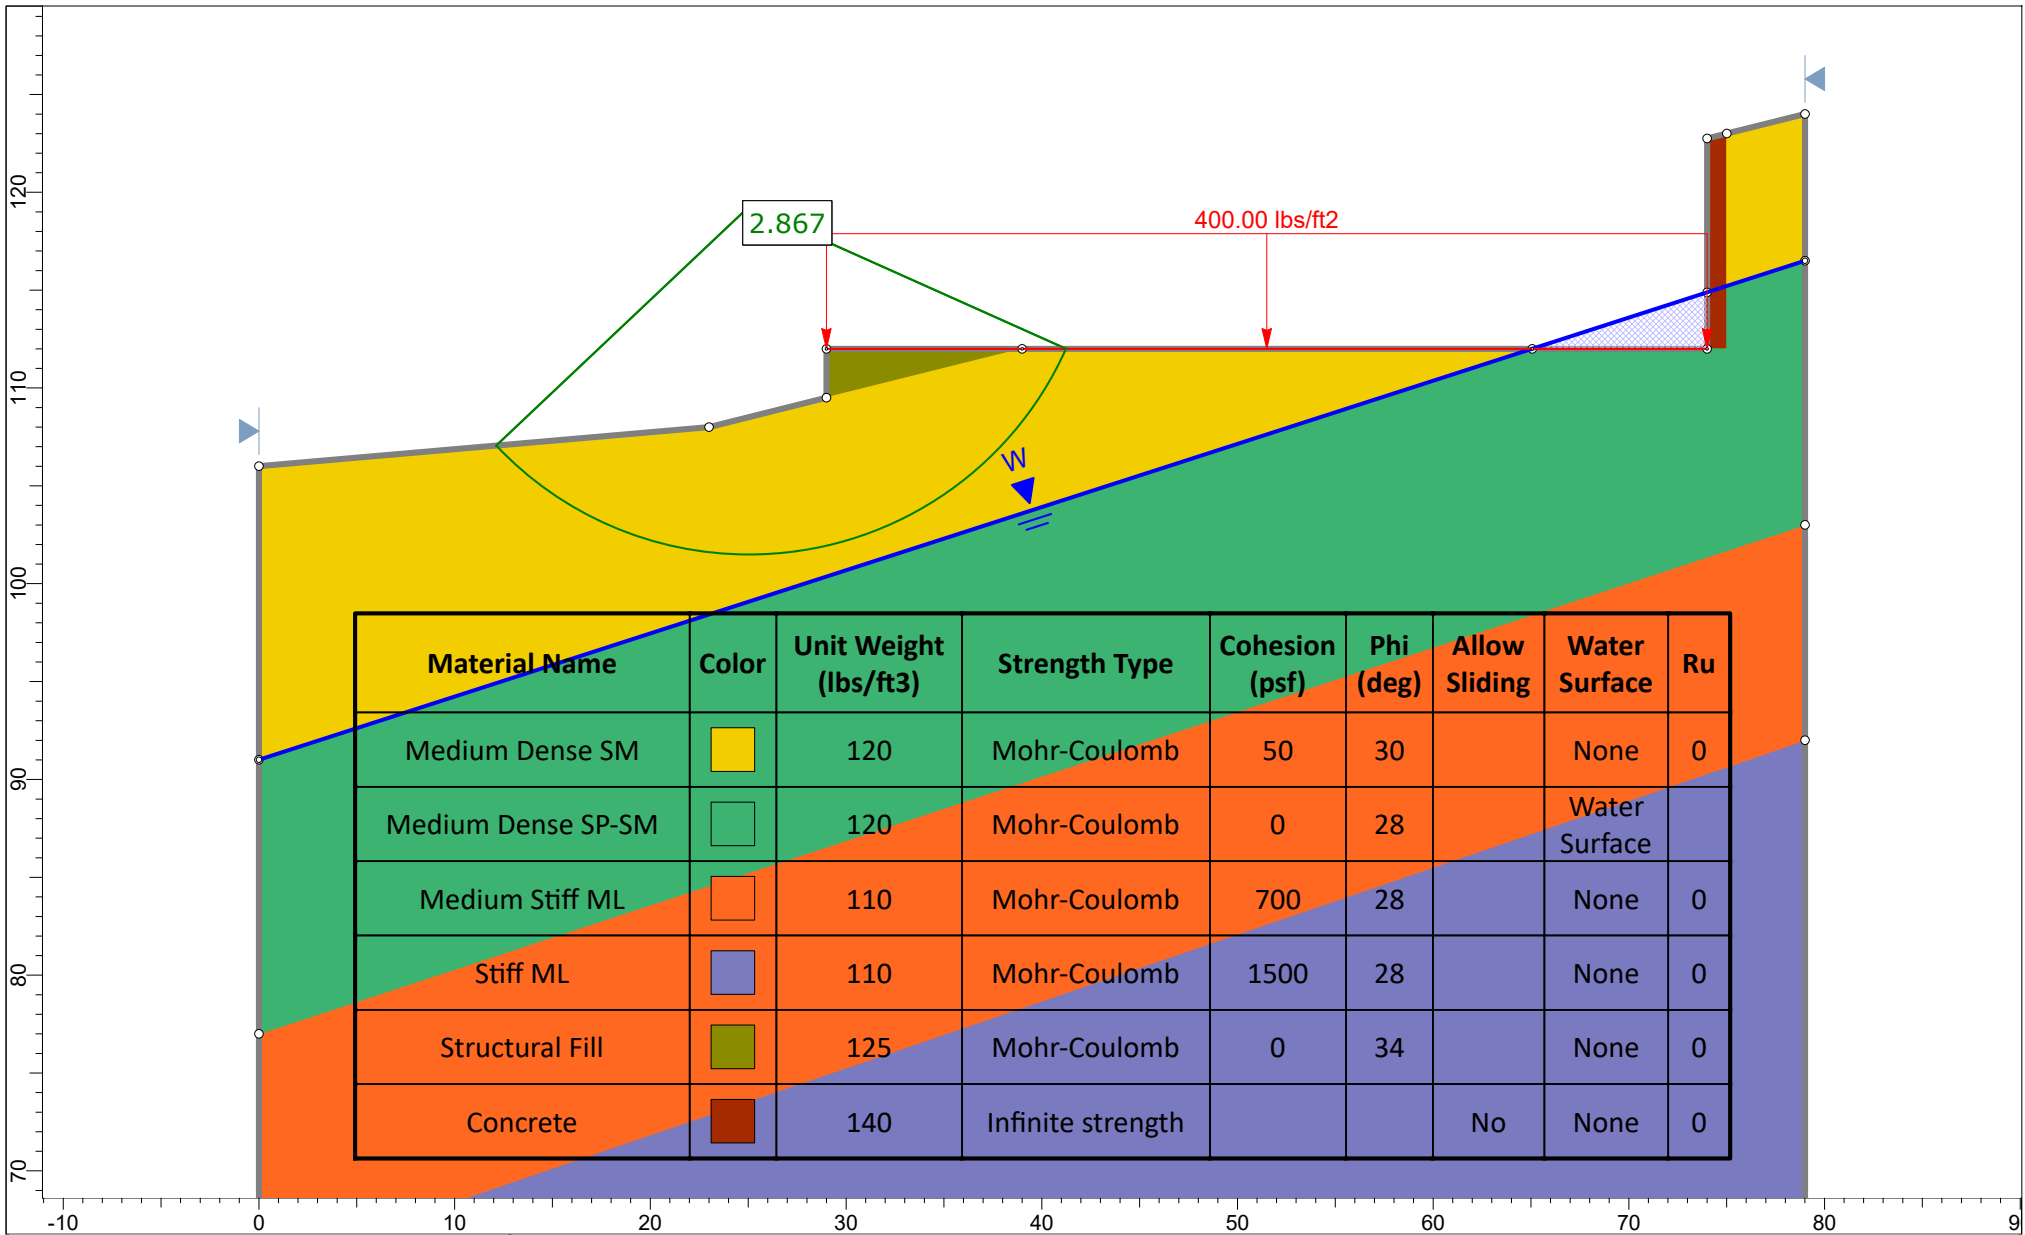
Material Name	Color	Unit Weight (lbs/ft ³)	Strength Type	Cohesion (psf)	Phi (deg)	Allow Sliding	Water Surface	Ru
Medium Dense SM		120	Mohr-Coulomb	50	30		None	0
Medium Dense SP-SM		120	Mohr-Coulomb	0	28		Water Surface	
Medium Stiff ML		110	Mohr-Coulomb	700	28		None	0
Stiff ML		110	Mohr-Coulomb	1500	28		None	0
Structural Fill		125	Mohr-Coulomb	0	34		None	0
Concrete		140	Infinite strength			No	None	0

Project				Cheshire Short Plat			
Analysis Description				Cross Section A-A' - Post Construction Conditions			
Drawn By	C. Decker	Scale	1:118	Company	Terra Associates, Inc.		
Date	May 12, 2020		File Name	Cross Section A-A'.slmd

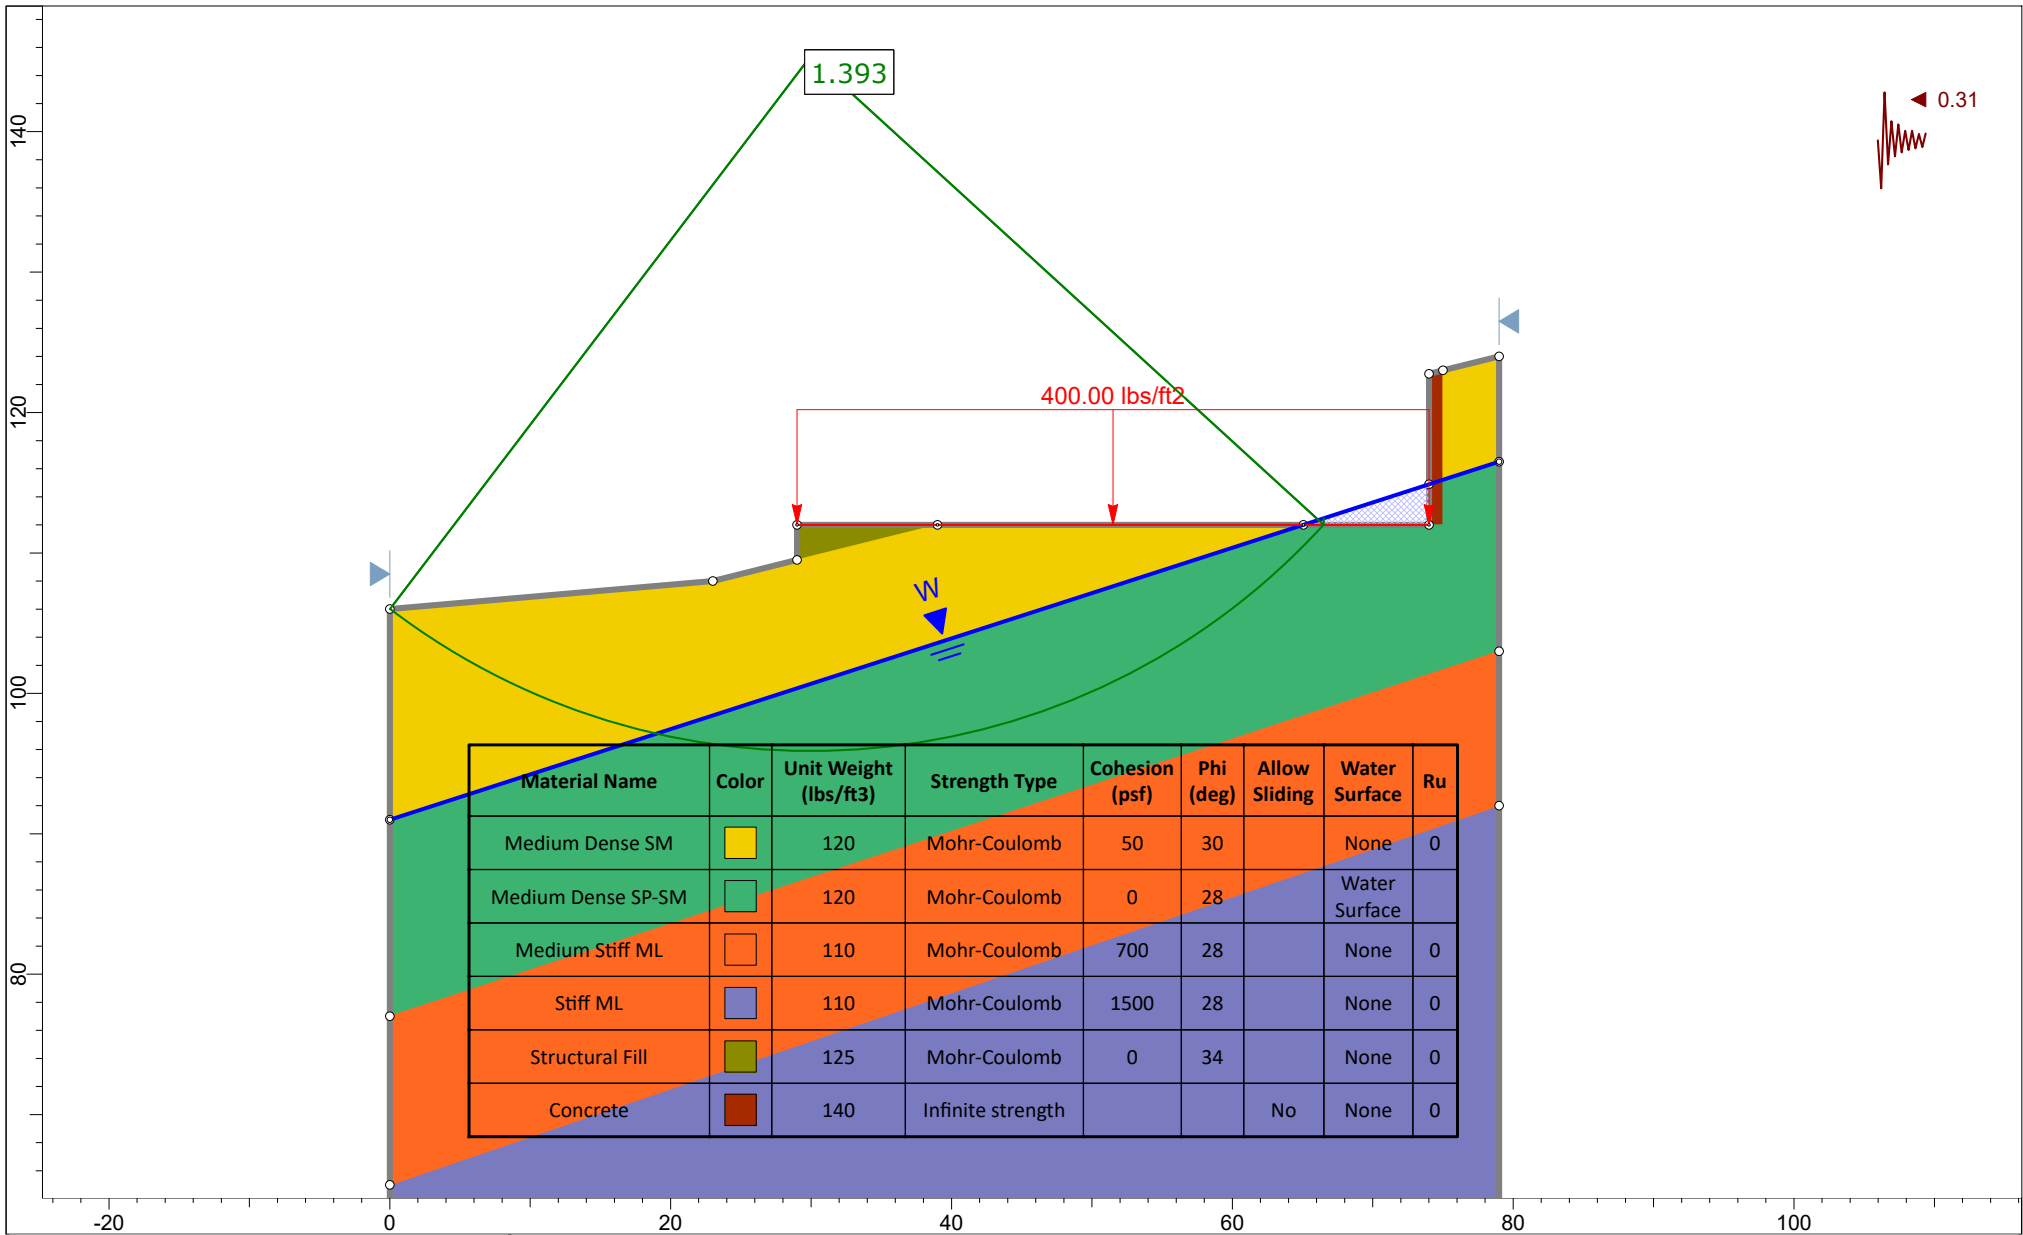
Material Name	Color	Unit Weight (lbs/ft ³)	Strength Type	Cohesion (psf)	Phi (deg)	Allow Sliding	Water Surface	Ru
Medium Dense SM		120	Mohr-Coulomb	50	30		None	0
Medium Dense SP-SM		120	Mohr-Coulomb	0	28		Water Surface	
Medium Stiff ML		110	Mohr-Coulomb	700	28		None	0
Stiff ML		110	Mohr-Coulomb	1500	28		None	0
Structural Fill		125	Mohr-Coulomb	0	34		None	0
Concrete		140	Infinite strength			No	None	0

Project			Cheshire Short Plat		
	Analysis Description			Cross Section A-A' - Post Construction Conditions - Seismic		
	Drawn By	C. Decker	Scale	1:164	Company	Terra Associates, Inc.
	Date	May 12, 2020	File Name	Cross Section A-A'.slmd
