CRITICAL AREA STUDY

Cheshire Residence: Wetland and Watercourse Buffer Reduction, Revised

November 2017

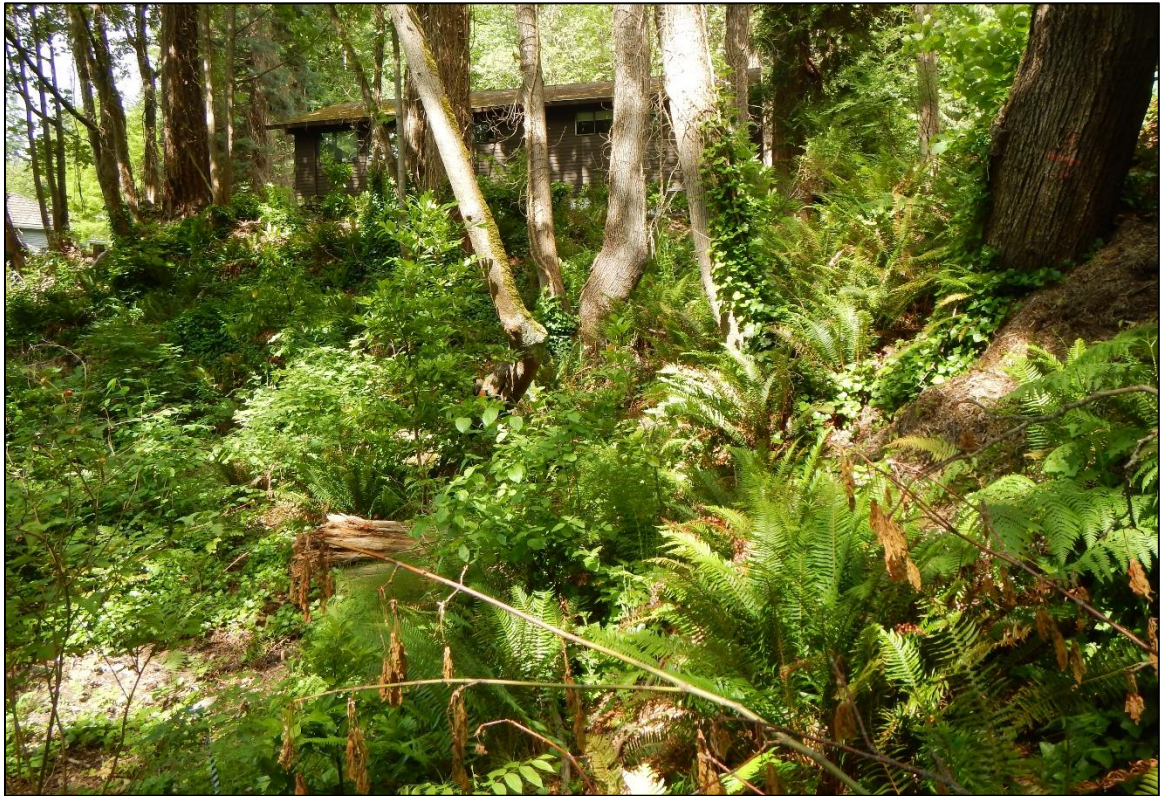
Figure 3. Photo of the forest understory east of the existing residence (photo taken 5/23/2016).

Understory vegetative structure is low on the east side of the residence; there is little to no sub-canopy present, and shrubs and groundcover plants are generally less than 10 feet in height (Figure 3). Understory plants are composed of native and non-native species. The most common plant species observed in this area include English ivy, sword fern, low Oregon grape, English laurel, beaked hazelnut, and Indian plum.

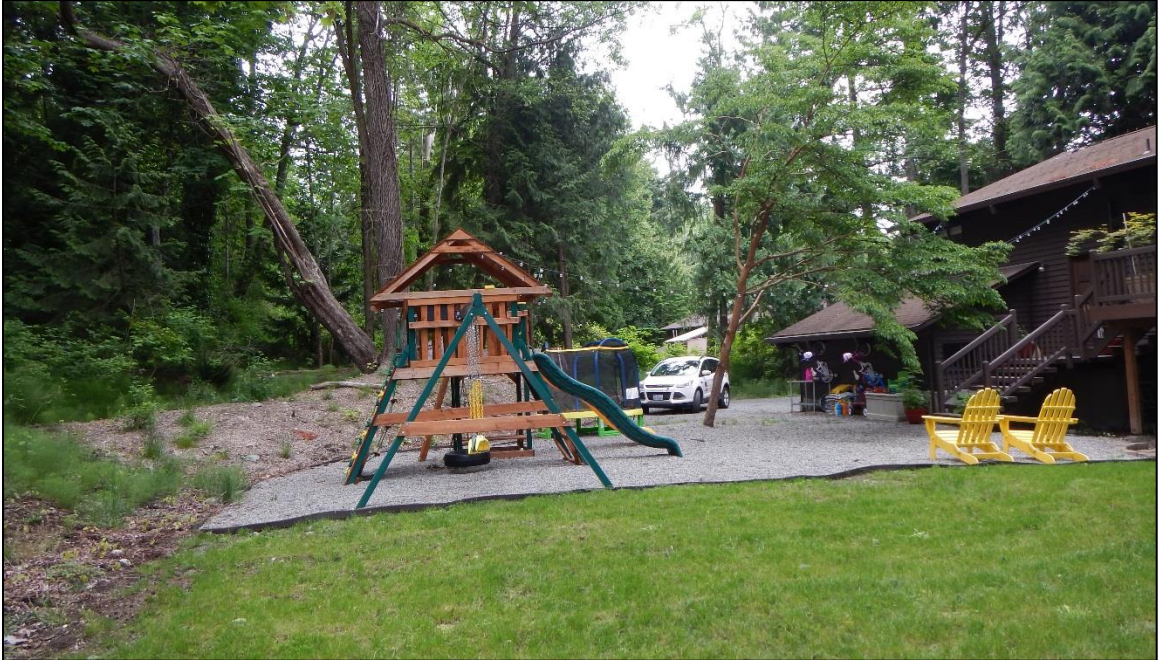
Figure 4. Photo of critical area buffer located west of the existing residence (photo taken 5/23/3016).

The critical area buffer immediately north and west of the residence is sparsely vegetated. Existing buffer intrusions are located in this area and include portions of a children's play structure with a compact gravel base and maintained lawn area (Figure 4). Vegetation in this portion of the buffer is maintained as lawn or is a sparsely

vegetated berm (Figures 4 and 5). Common plants include bigleaf maple in the canopy and giant horsetail in the understory.

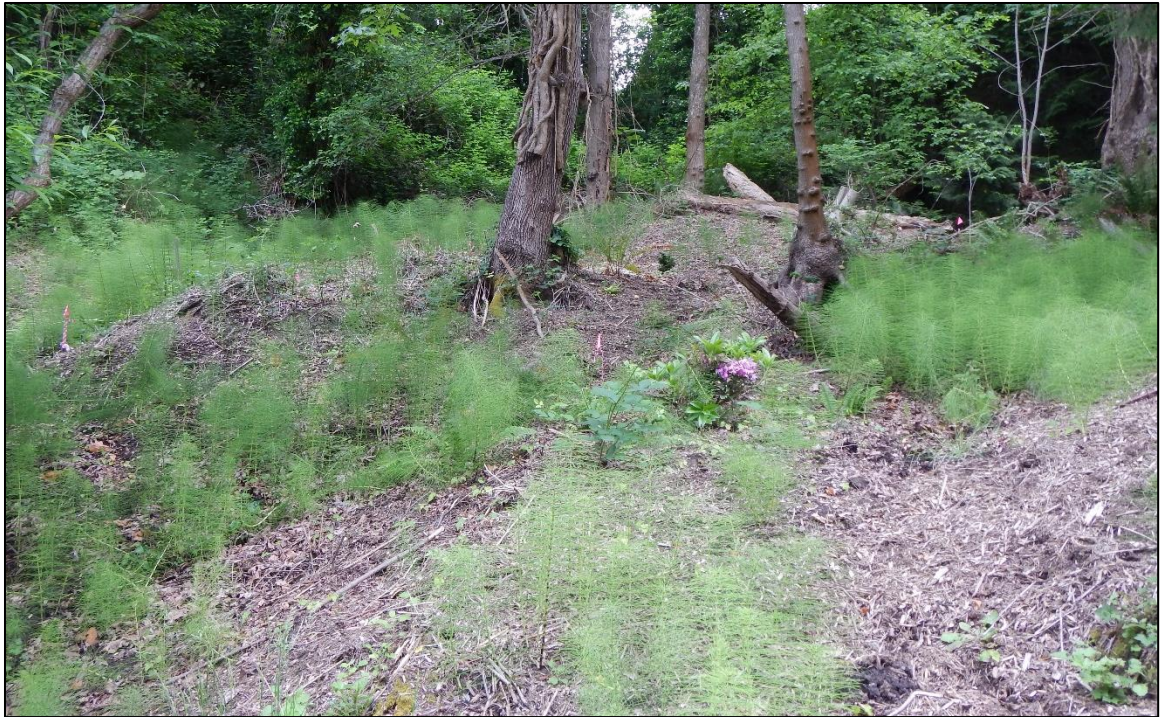
Figure 5. Photo of sparsely vegetated understory of berm located in critical area buffer north and west of the existing residence (photo taken 5/23/2016).

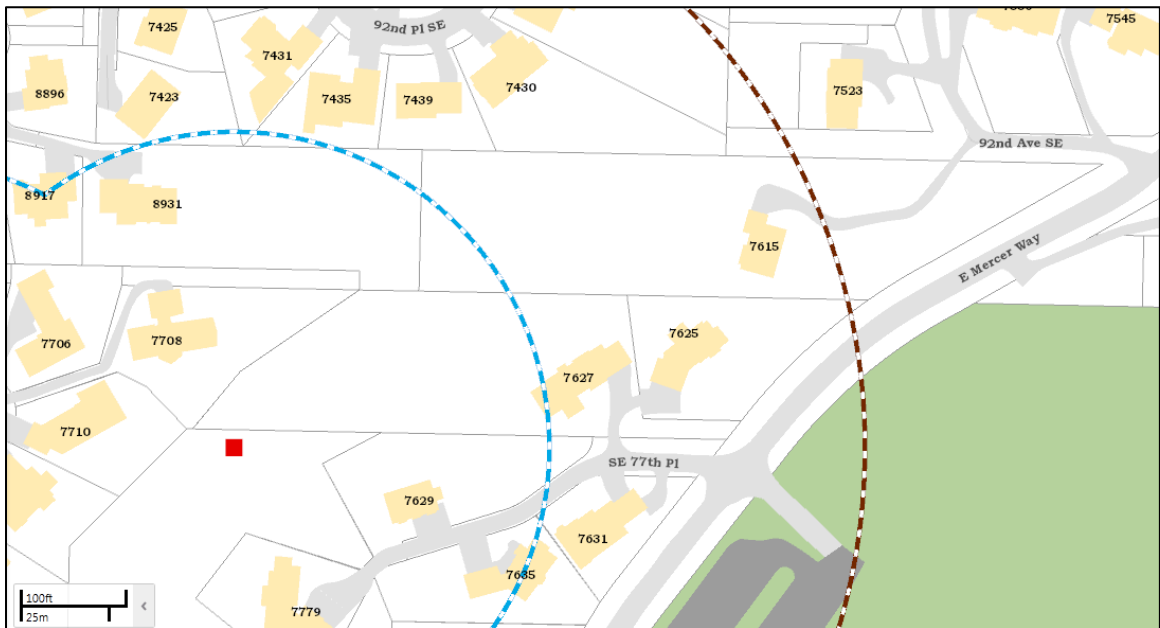
Figure 7. Mapped nest location (red square) in vicinity of subject parcel showing 330-foot buffer (blue dashed-line) and 660-foot buffer (brown dashed-line) from the nest (imagery source: Mercer Island online mapping portal).

As indicated by both the City of Mercer Island's online mapping portal and PHS maps (WDFW 2016), an active bald eagle nest is present southwest of the subject property. The nest was visually confirmed during a May 2016 site inspection. The nest is located in a large and prominent Douglas-fir tree with a broken leader (Figure 6). According to online sources, the study area is located within 660 feet of the nest site (Figure 7). No other sensitive species are known to occur within or immediately adjacent to the project area.

A verified bald eagle nest is located approximately 500 feet southwest of the project area. The applicant has discussed the potential effects and limitations regarding the nest with USFWS staff. Since project construction is planned for July (the latter half of the nesting season), project activities will occur more than 330 feet from the nest, and existing vegetative screening areas will remain undisturbed, the project complies with regular building construction requirements; therefore, USFWS permits are not required (Jamie Hanson, USFWS, email communication, April 2017).
